# BORESCOPE INSPECTION REPORT

GAS TURBINE ENGINE  
TAURUS 60  
COLD END DRIVE

Engine Serial Number  
**OHA22-T3018**

Inspection Date  
**Monday, May 22, 2023**

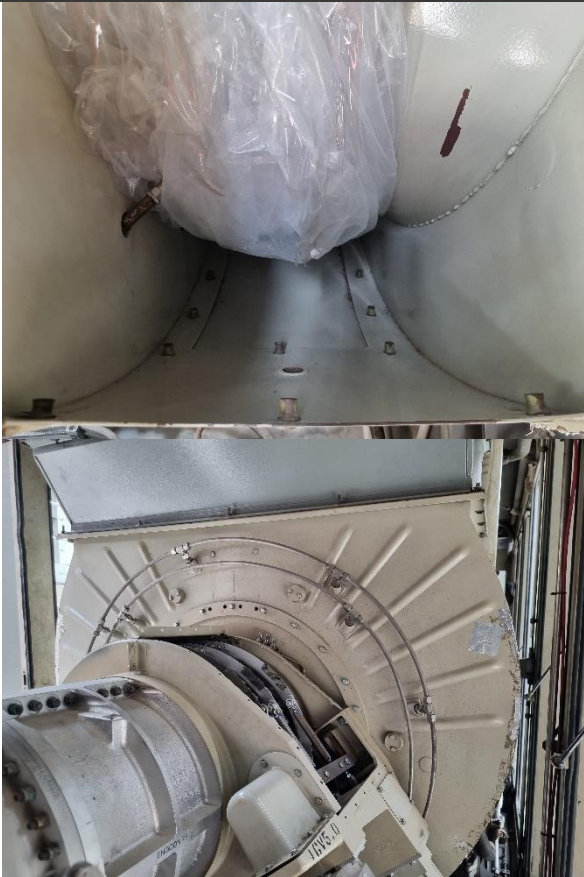
| Access Port | Location | Inspection for | Normal Condition | Minor | Moderate | Severe | Comments |
|---|---|---|---|---|---|---|---|
| <u>A</u> | Air Inlet Duct | a)Potential FOD<br>b)Corrosive Pitting<br>c)Cracks<br>d)Excessive fouling | | ✓ | | | The Air inlet duct is contaminated with minute particles of dust |

| Access location<br>Description | Picture | Inspection for | Severity / Comments |
|---|---|---|---|
| A<br><br>Air Inlet Duct | | a)Potential FOD<br>b)Corrosive Pitting<br>c)Cracks<br>d)Excessive fouling | Minor<br><br>Contamination<br><br>The Air inlet duct is contaminated with minute particles of dust |

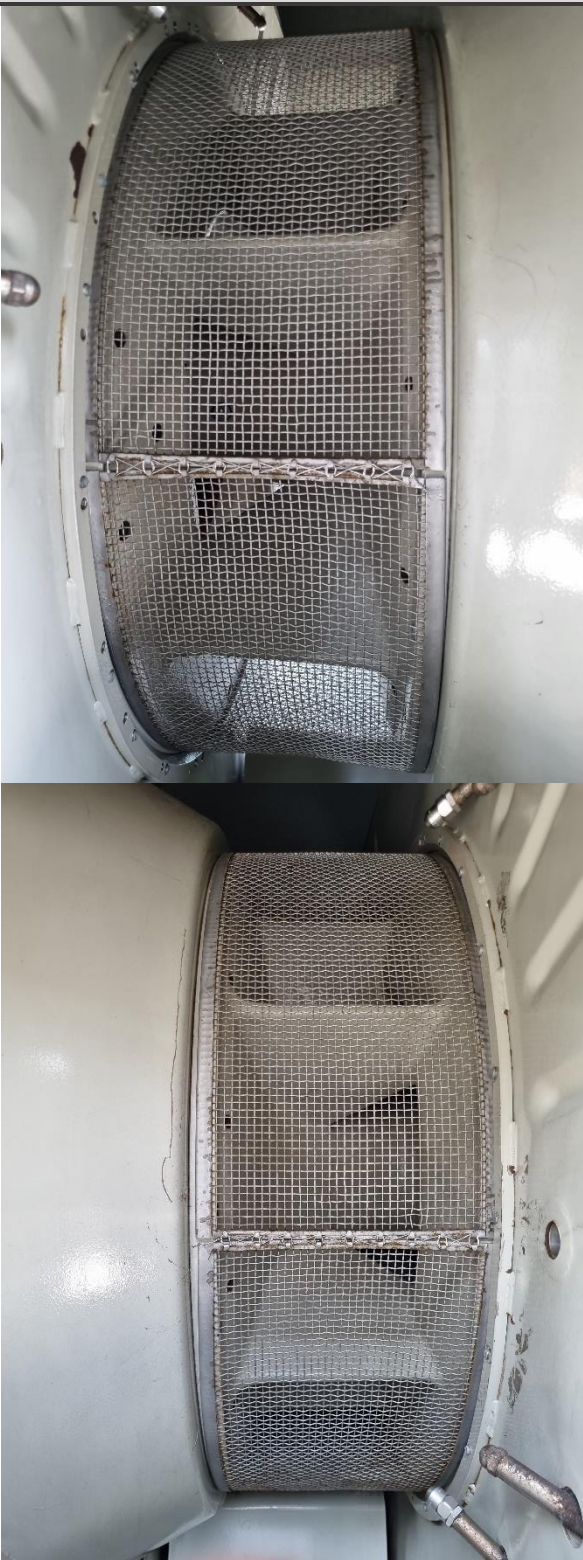
| Access Port | Location | Inspection for | Normal Condition | Minor | Moderate | Severe | Comments |
|---|---|---|---|---|---|---|---|
| <u>A</u> | Air Inlet Screen | a)Potential FOD<br>b)Cracks, damaged mesh | | ✓ | | | Minor contamination was left after water washing and slight rusting has started on the edges |

| Access location<br>Description | Picture | Inspection for | Severity / Comments |
|---|---|---|---|
| A<br><br>Air Inlet Screen | | a) Potential FOD<br>b) Cracks, damaged mesh | Minor<br><br>Contamination<br><br>Minor contamination was left after water washing and slight rusting has started on the edges |

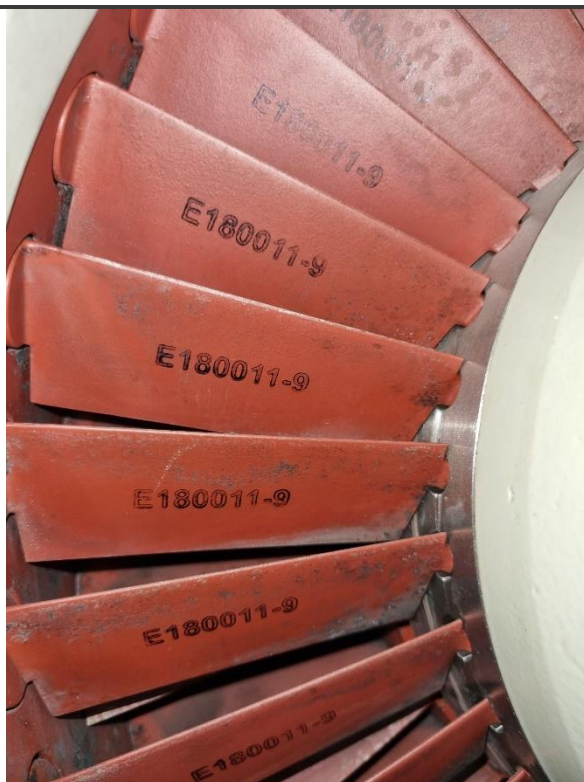
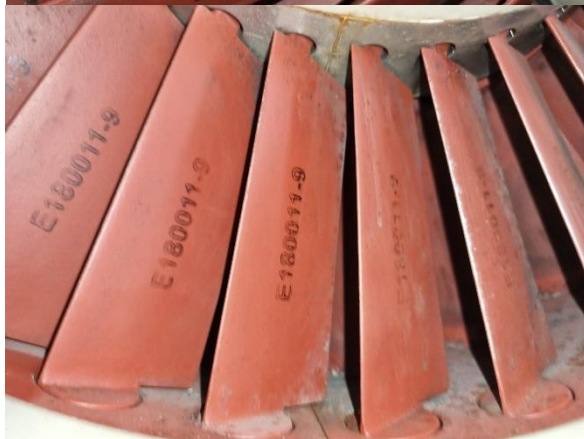
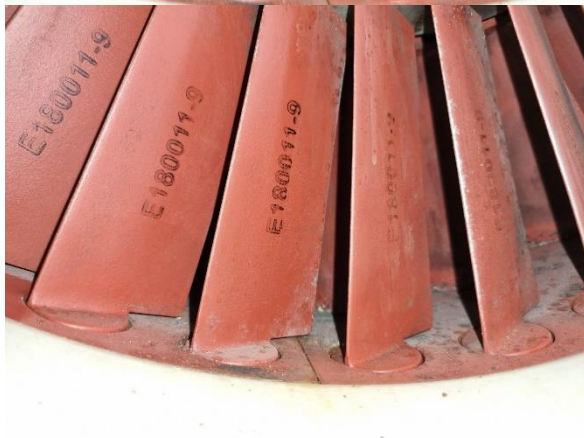
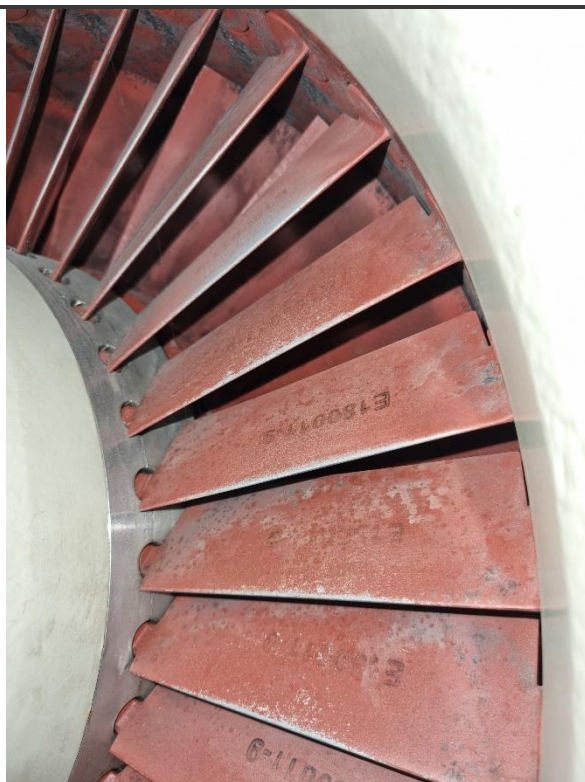
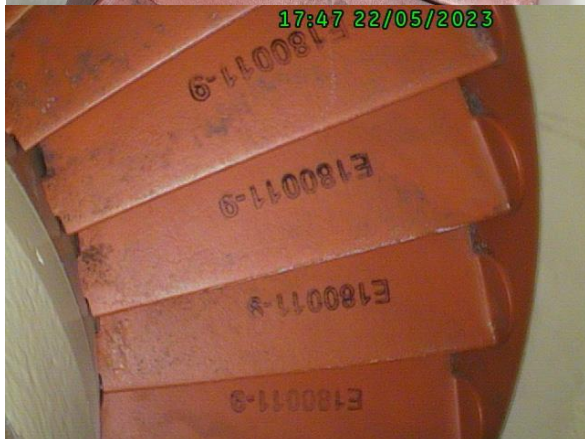
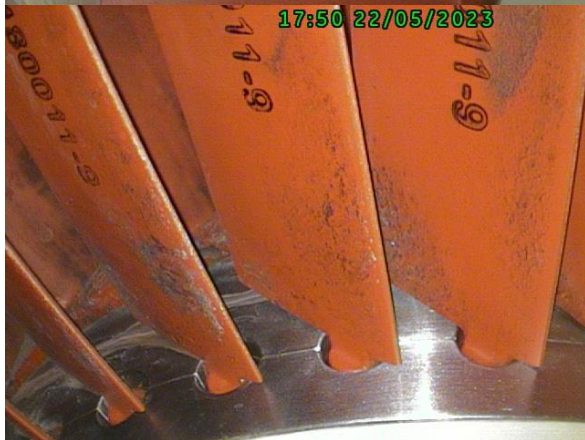
| Access Port | Location | Inspection for | Normal Condition | Minor | Moderate | Severe | Comments |
|---|---|---|---|---|---|---|---|
| <u>A</u> | IGV | a)Nicks and dents. Quantity and size<br>b)Excessive fouling<br>c)Corrosive pitting. Affected area | | | ✓ | | Contamination can be observed on the IGVs , this is heavy contamination considering the running hours |

Moderate

Contamination

Contamination can be observed on the IGVs, this is heavy contamination considering the running hours

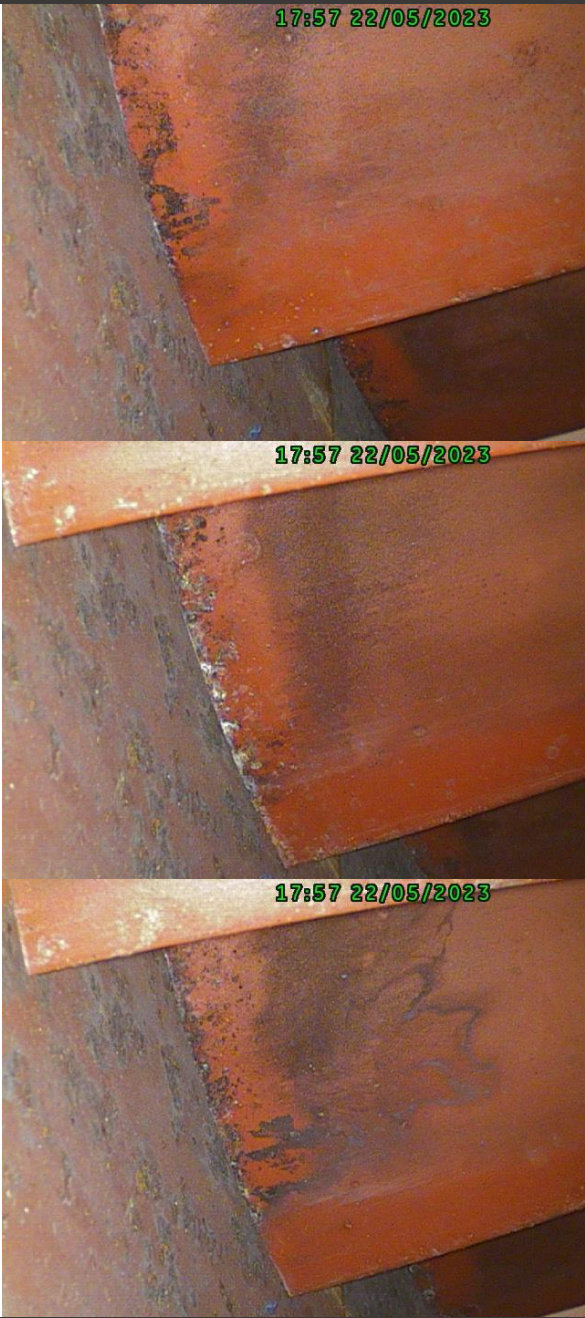
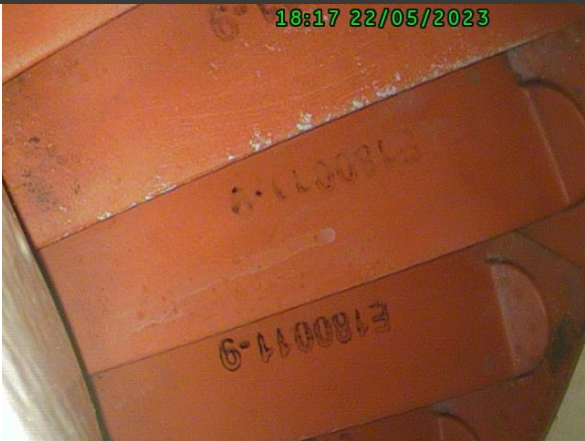
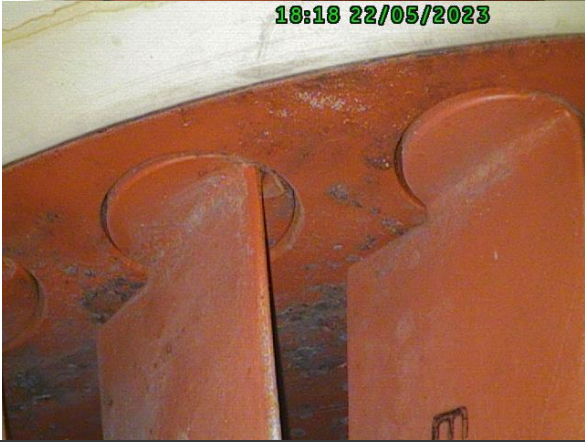
| Access Port | Location | Inspection for | Normal Condition | Minor | Moderate | Severe | Comments |
|---|---|---|---|---|---|---|---|
| <u>A</u> | 0 Stg Compressor Blades | a)Nicks and dents. Quantity and size<br>b)Excessive fouling<br>c)Corrosive pitting.<br>d)Tip rub, gap width, curling | | | ✓ | | Contamination can be observed on the blades , this is heavy contamination considering the running hours |

Moderate

Contamination

Contamination can be  
observed on the  
blades , this is heavy  
contamination  
considering the  
running hours

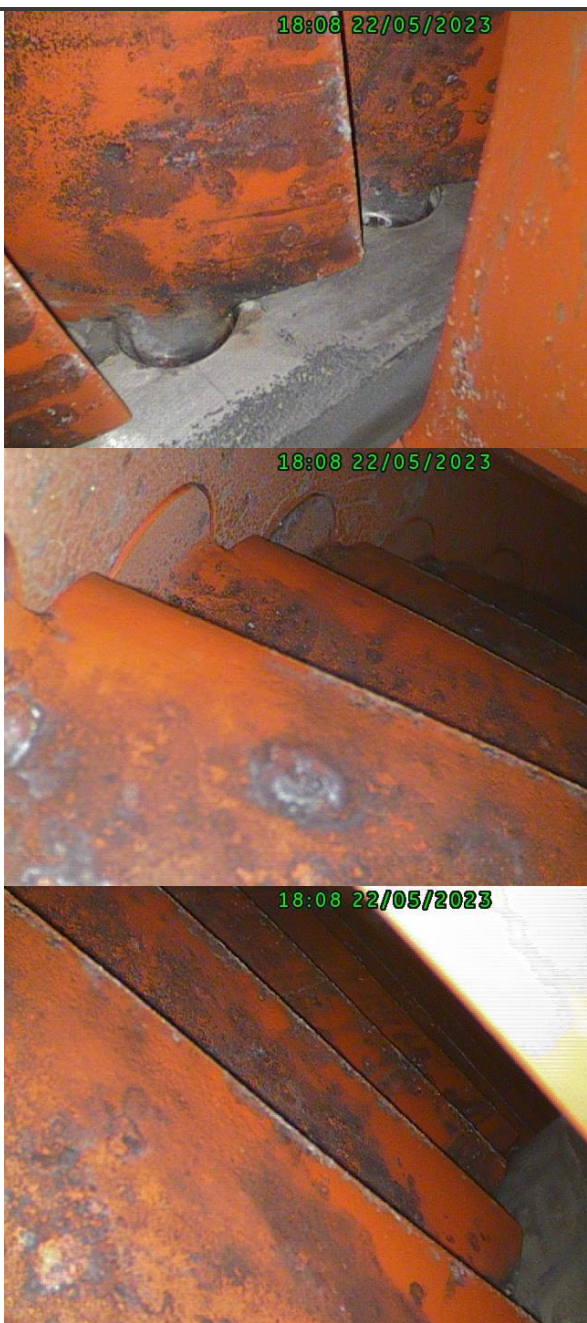
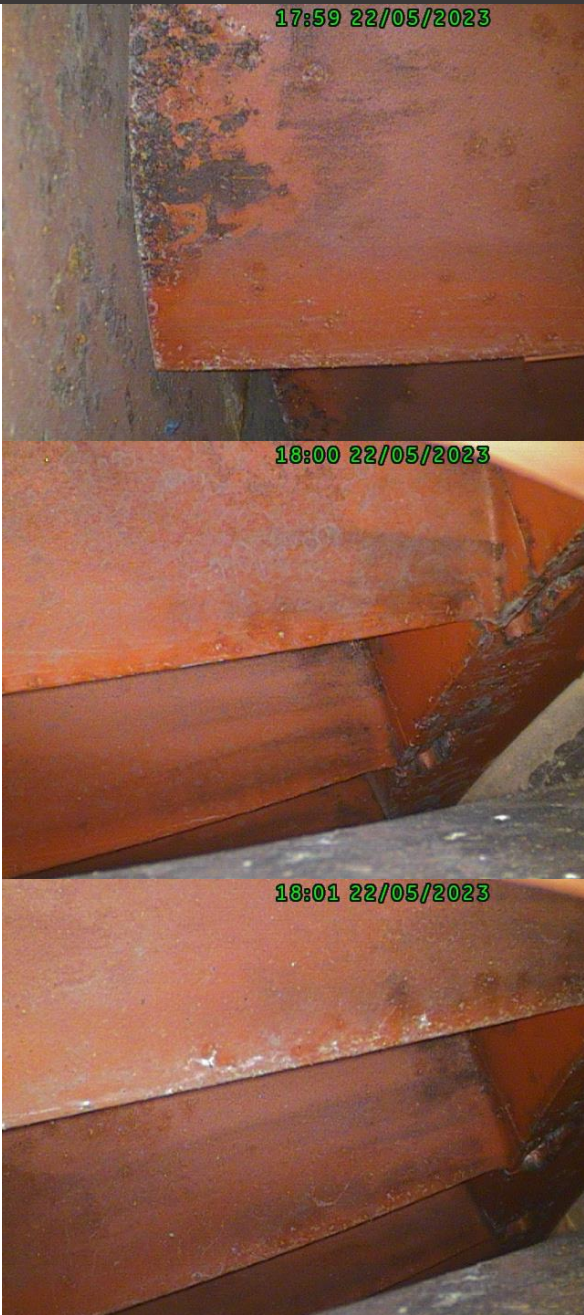
| Access Port | Location | Inspection for | Normal Condition | Minor | Moderate | Severe | Comments |
|---|---|---|---|---|---|---|---|
| <u>A</u> | 0 Stg Compressor GV | a)Nicks and dents. Quantity and size<br>b)Excessive fouling<br>c)Corrosive pitting. Affected area | | | | ✓ | Contamination can be observed on the GV's , this is heavy contamination considering the running hours |

| <p>A</p> <p>0 Stg<br/>Compressor GV</p> | | <p>a)Nicks and dents.<br/>Quantity and size</p> <p>b)Excessive fouling</p> <p>c)Corrosive pitting.<br/>Affected area</p> | <p>Severe</p> <p>Contamination</p> <p>Contamination can be observed on the GVs , this is heavy contamination considering the running hours</p> |

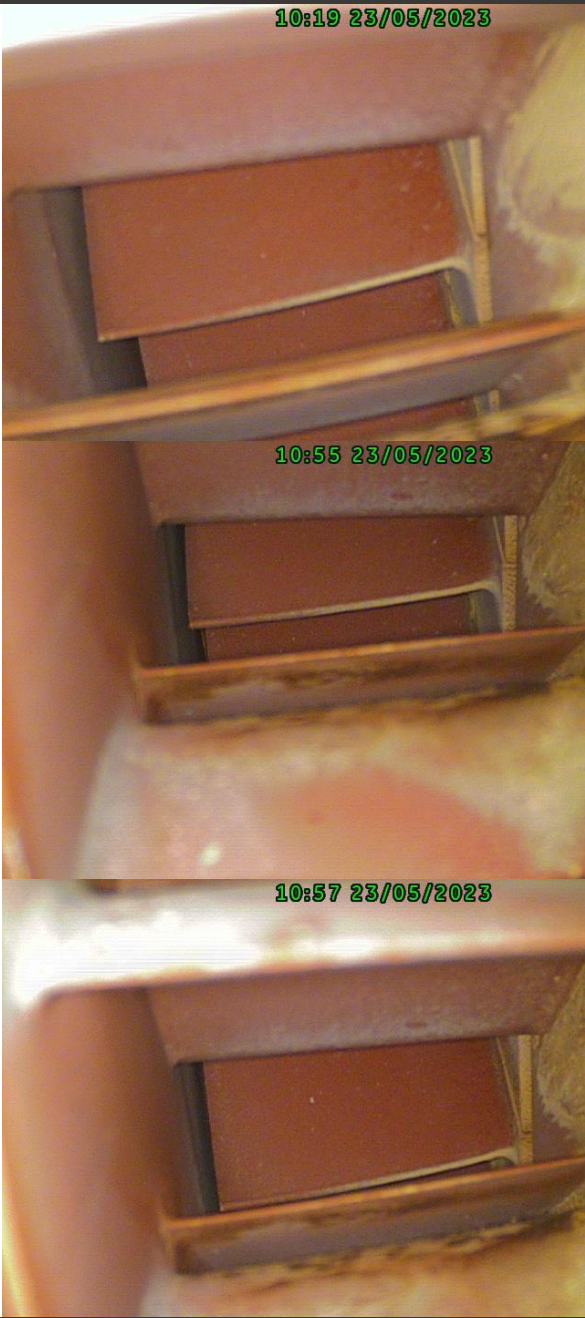
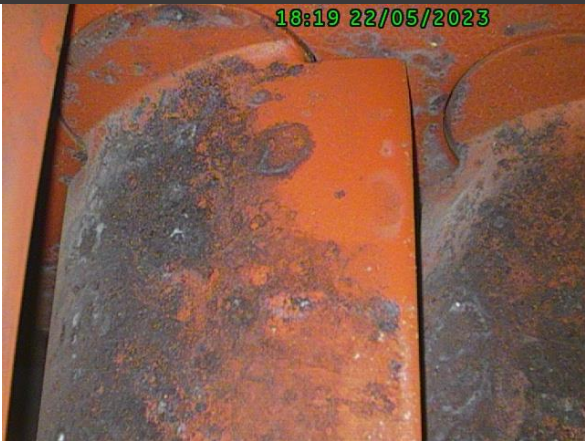
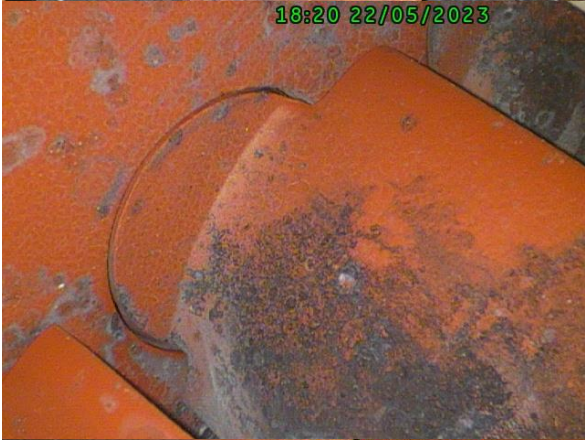
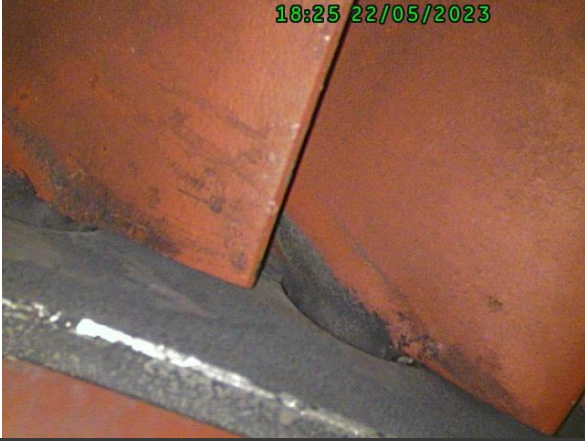
| Access Port | Location | Inspection for | Normal Condition | Minor | Moderate | Severe | Comments |
|---|---|---|---|---|---|---|---|
| <u>B</u> | 11th Stg Compressor Blades | a)Nicks and dents. Quantity and size<br>b)Excessive fouling<br>c)Corrosive pitting.<br>d)Tip rub, gap width, curling | | ✓ | | | Considering the running hours the contamination is higher than expected . |

Minor

Contamination

Considering the running hours the contamination is higher than expected .

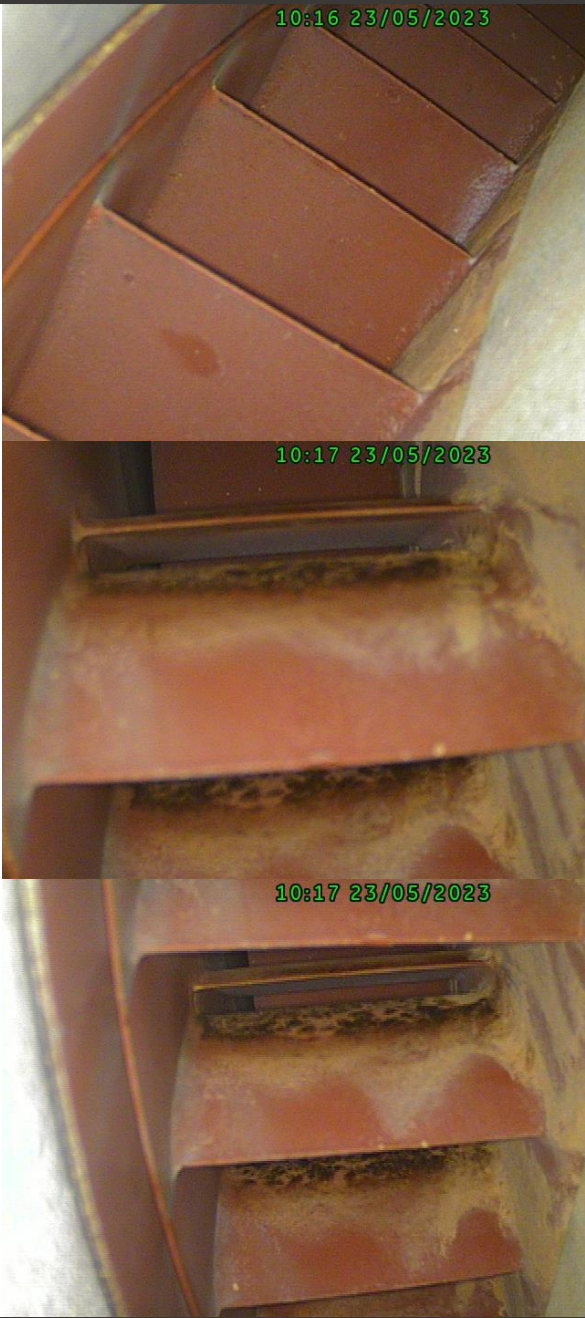
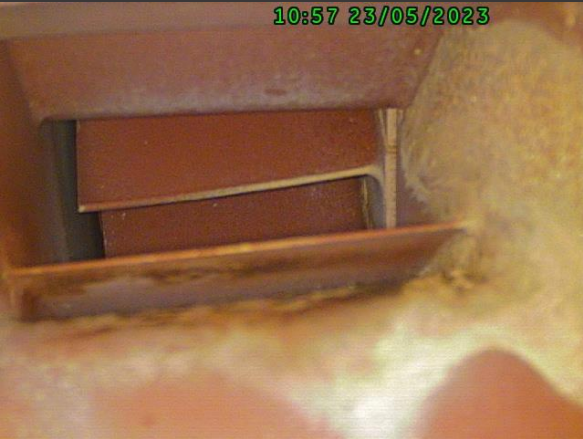
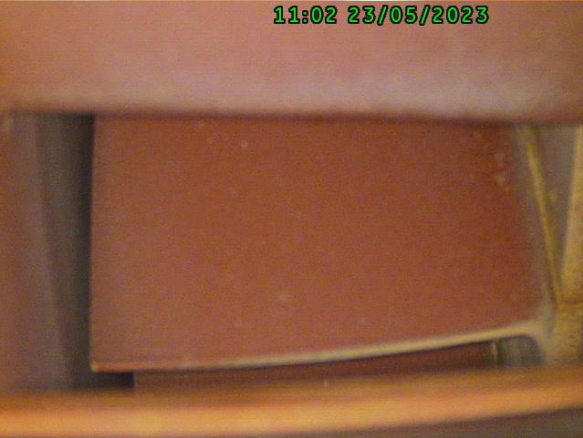
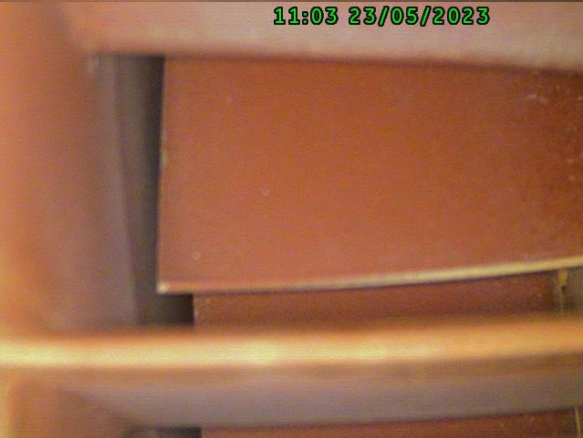
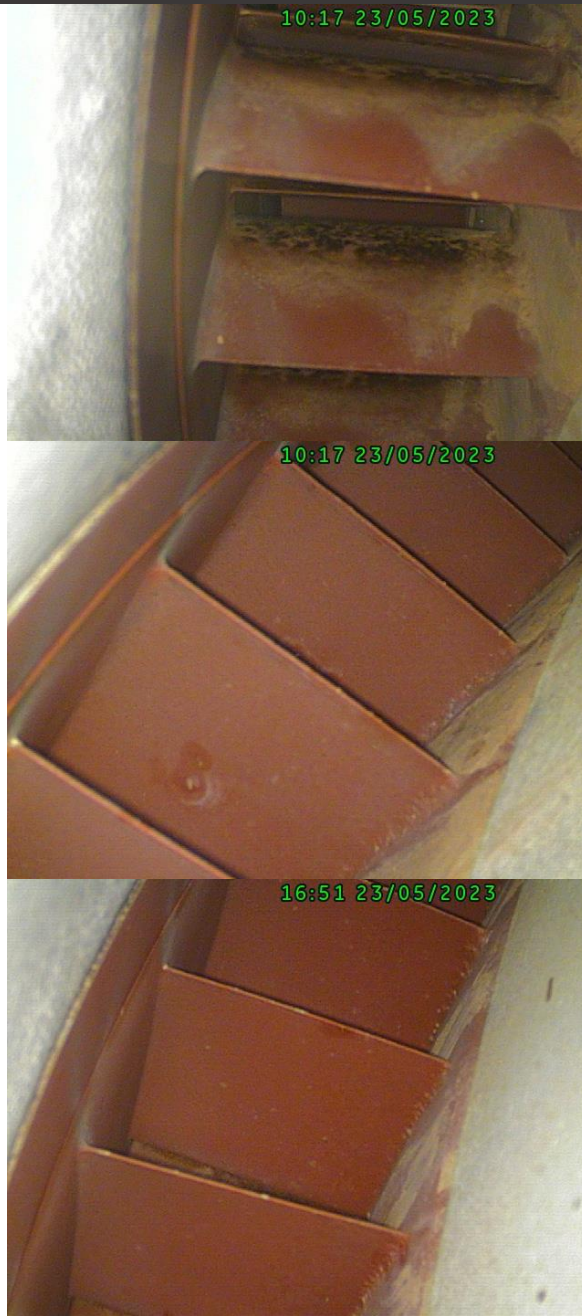
| Access Port | Location | Inspection for | Normal Condition | Minor | Moderate | Severe | Comments |
|---|---|---|---|---|---|---|---|
| <u>B</u> | Compressor Exit GV | a)Nicks and dents. Quantity and size<br>b)Excessive fouling<br>c)Corrosive pitting. Affected area | | | ✓ | | Considering the running hours the contamination is higher than expected |

Moderate

Contamination

Considering the  
running hours the  
contamination is  
higher than expected

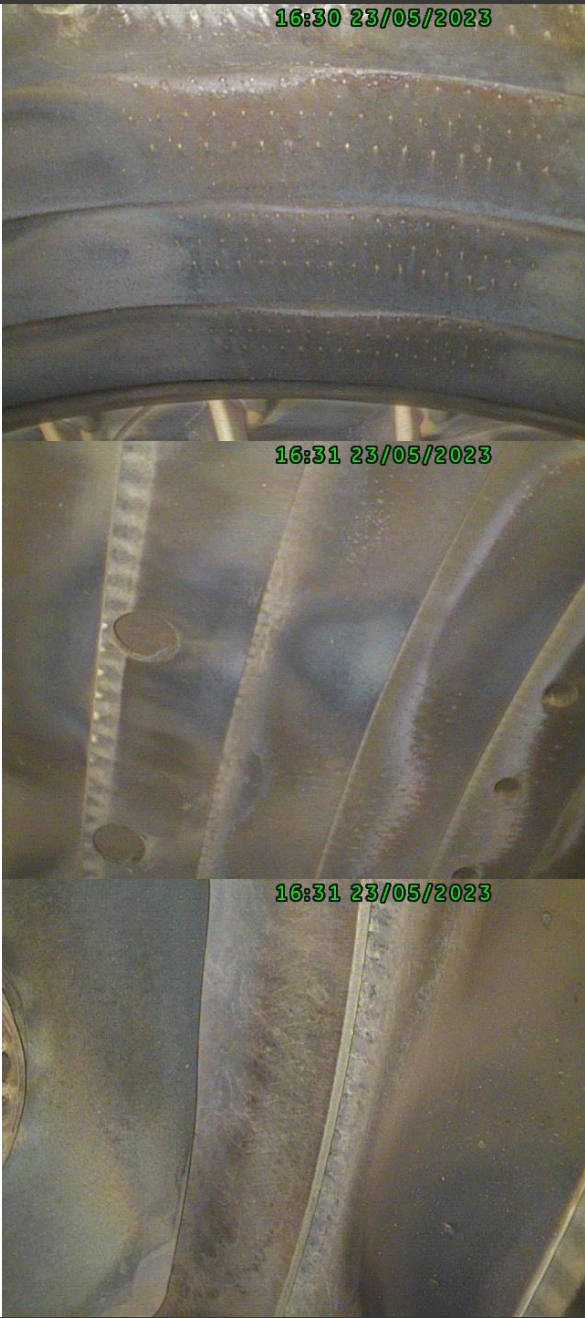
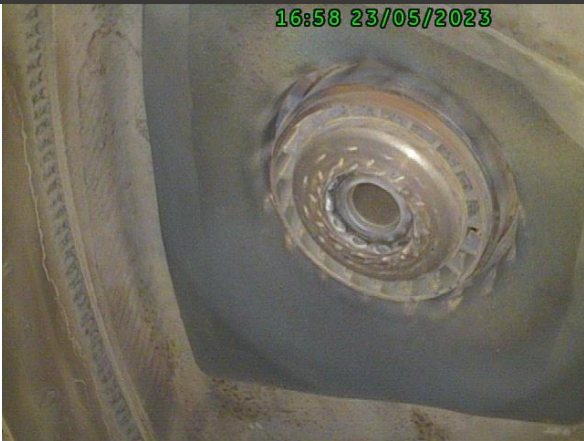
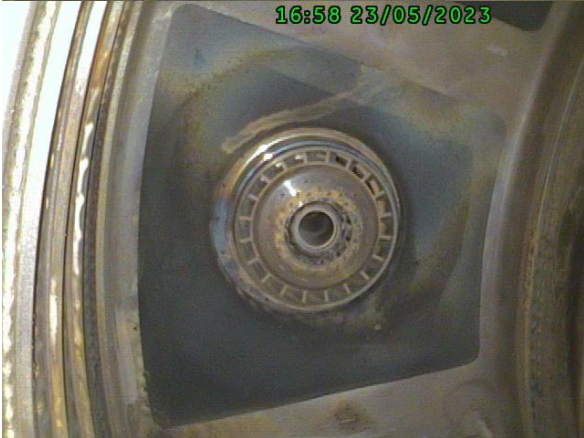
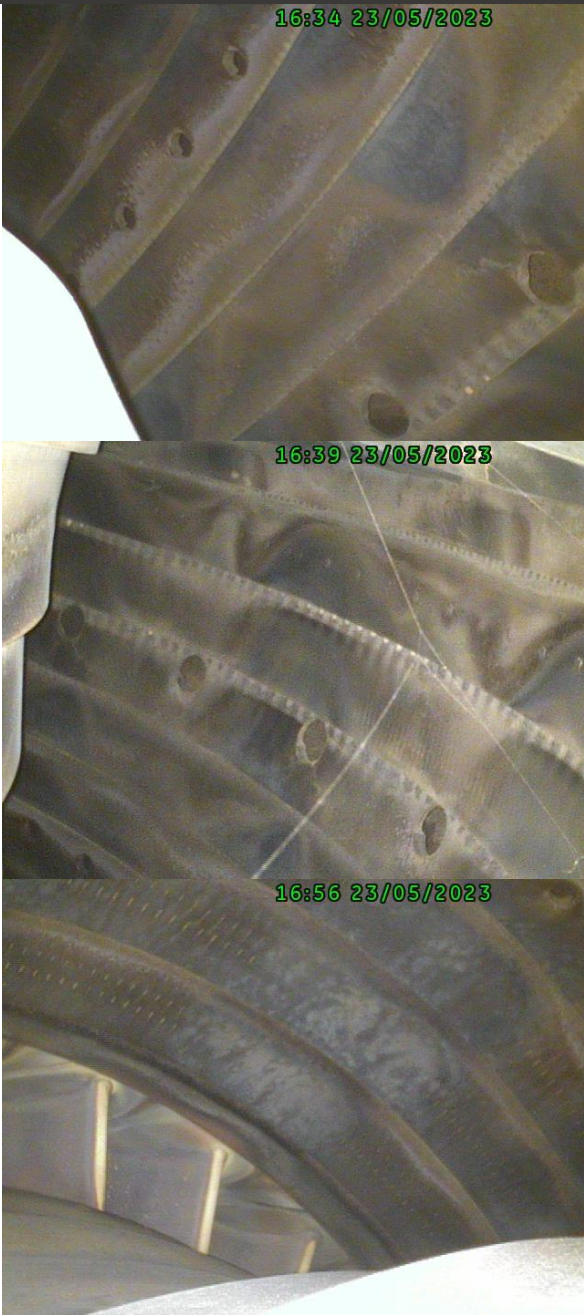
| Access Port | Location | Inspection for | Normal Condition | Minor | Moderate | Severe | Comments |
|---|---|---|---|---|---|---|---|
| <u>B</u> | Combustor Interior | a)Crack, Qty and size<br>b)Thermal erosion<br>c)Hot spots<br>d)Buckling or warpage | | ✓ | | | Considering the running hour the marks inside the combustion chamber are unusual |

Minor

Burn spots

Considering the running hour the marks inside the combustion chamber are unususal

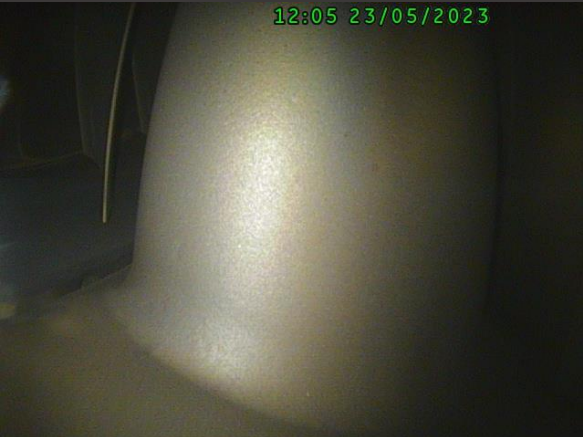
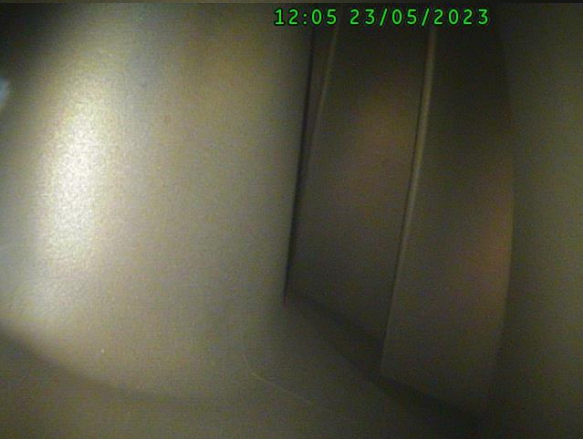
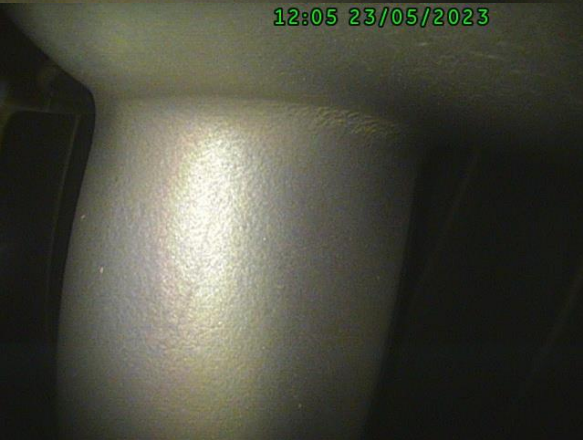
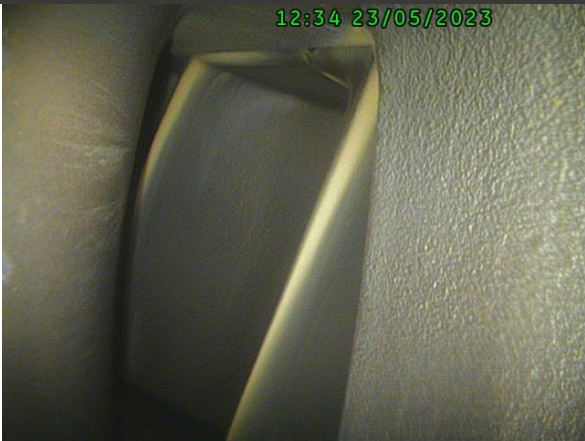
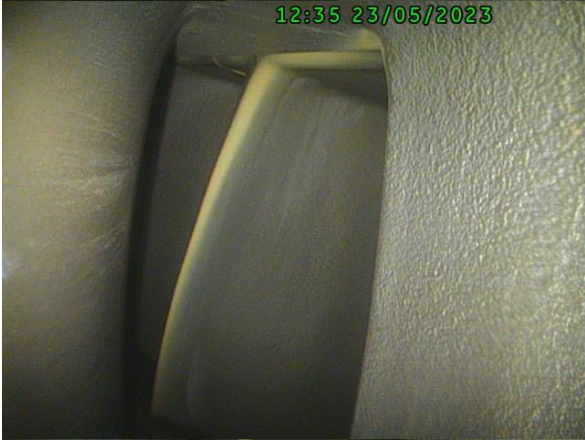
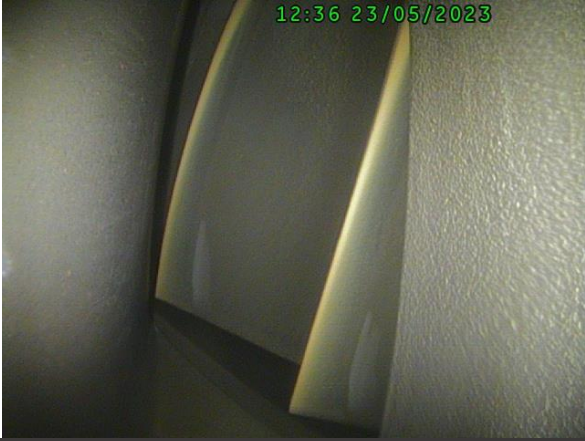
| Access Port | Location | Inspection for | Normal Condition | Minor | Moderate | Severe | Comments |
|---|---|---|---|---|---|---|---|
| <u>D</u> | 3rd Stg Turbine Nozzles | a)Cracks, Qty, length, orientation<br>b)Thermal erosion, Depth, Affected area | | ✓ | | | Previously minor pitting was observed , however currently the image is not attached . |

| | | a)Cracks, Qty, length, orientation<br><br>b)Thermal erosion, Depth, Affected area | Minor<br><br>Pitting<br><br>Previously minor pitting was observed , however currently the image is not attached . |

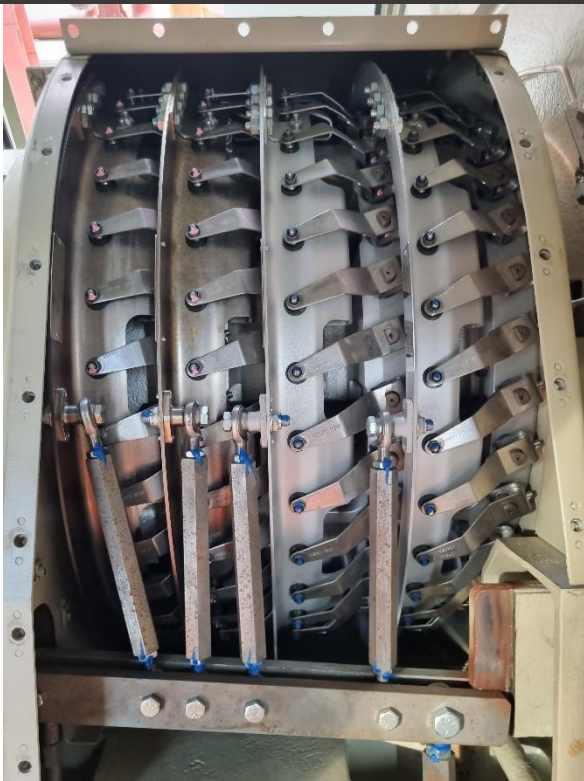
| Access Port | Location | Inspection for | Normal Condition | Minor | Moderate | Severe | Comments |
|---|---|---|---|---|---|---|---|
| <u>VGV</u> | IGV | a)Cracks<br>b)Lever arms bent<br>c)Grommet out of position on unison ring<br>d)Corrosion | | ✓ | | | Rust can be observed on the turn buckles |

| Access location<br>Description | Picture | Inspection for | Severity / Comments |
|---|---|---|---|
| VGV<br><br>IGV | | a)Cracks<br>b)Lever arms bent<br>c)Grommet out of position on unison ring<br>d)Corrosion | Minor<br><br>Corrosion<br><br>Rust can be observed on the turn buckles |

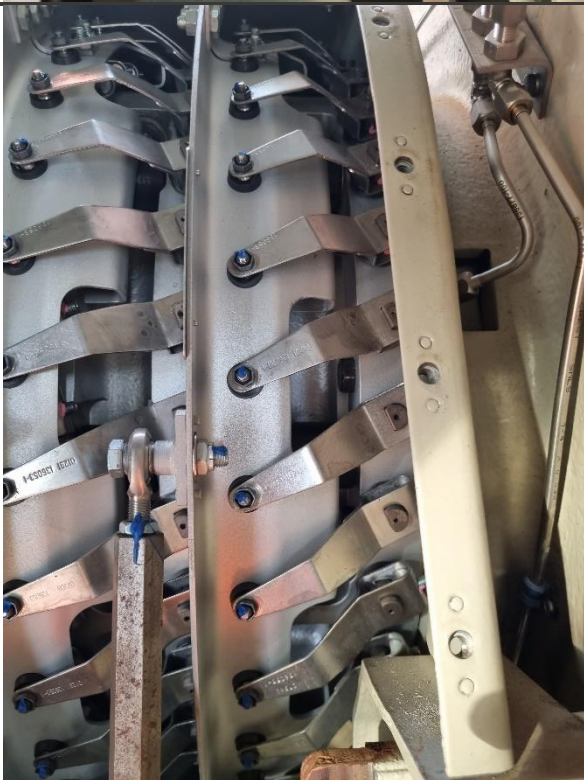
| Access Port | Location | Inspection for | Normal Condition | Minor | Moderate | Severe | Comments |
|---|---|---|---|---|---|---|---|
| <u>VG</u> V | 0 Stg VGV | a)Cracks<br>b)Lever arms bent<br>c)Grommet out of position on unison ring<br>d)Corrosion | | ✓ | | | Rust can be observed on the 0stg VGV turn buckle |

| Access location<br>Description | Picture | Inspection for | Severity / Comments |
|---|---|---|---|
| VGV<br><br>0 Stg VGV | | a)Cracks<br>b)Lever arms bent<br>c)Grommet out of position on unison ring<br>d)Corrosion | Minor<br><br>Corrosion<br><br>Rust can be observed on the 0stg VGV turn buckle |

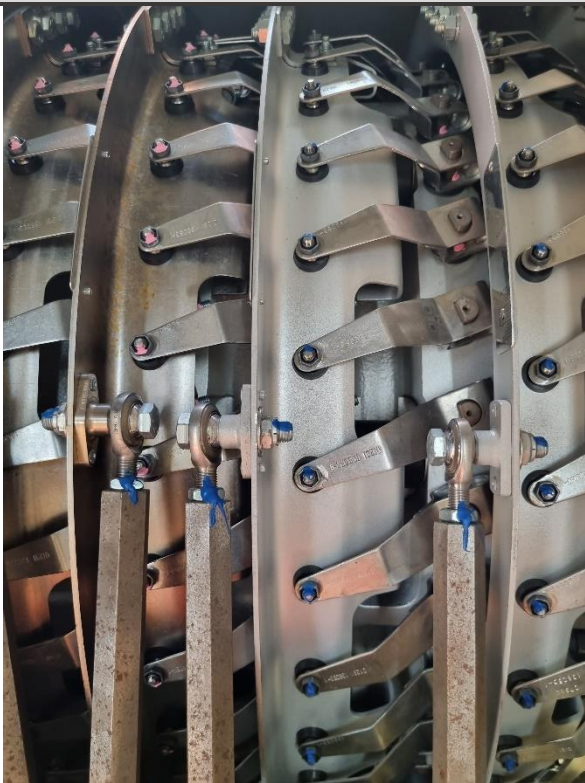
| Access Port | Location | Inspection for | Normal Condition | Minor | Moderate | Severe | Comments |
|---|---|---|---|---|---|---|---|
| <u>VG</u> V | 1st Stg VGV | a)Cracks<br>b)Lever arms bent<br>c)Grommet out of position on unison ring<br>d)Corrosion | | ✓ | | | Rust can be observed on the 1stg VGV turn buckles |

| Access location<br>Description | Picture | Inspection for | Severity / Comments |
|---|---|---|---|
| VGV<br><br>1st Stg VGV | | a)Cracks<br>b)Lever arms bent<br>c)Grommet out of position on unison ring<br>d)Corrosion | Minor<br><br>Corrosion<br><br>Rust can be observed on the 1stg VGV turn buckles |

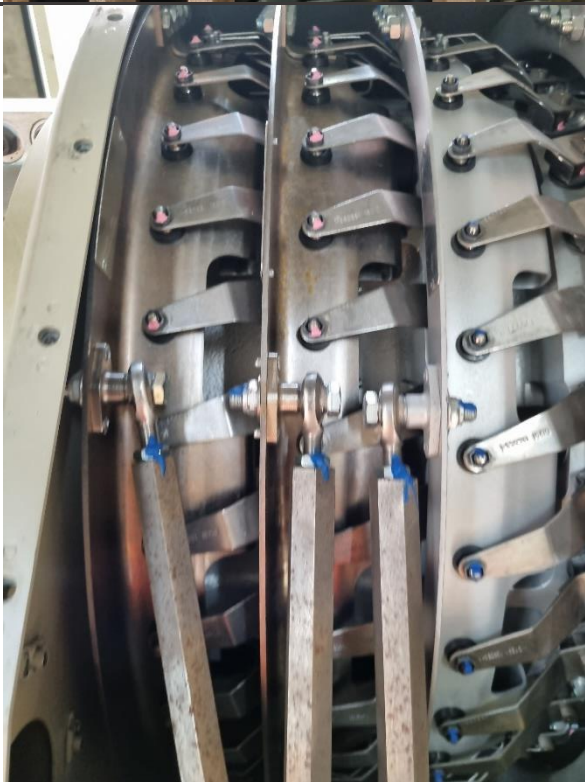
| Access Port | Location | Inspection for | Normal Condition | Minor | Moderate | Severe | Comments |
|---|---|---|---|---|---|---|---|
| <u>VG</u> V | 2nd Stg VGV | a)Cracks<br>b)Lever arms bent<br>c)Grommet out of position on unison ring<br>d)Corrosion | | ✓ | | | Rust can be observed on the 3rdstg VGV turn buckles |

| Access location<br>Description | Picture | Inspection for | Severity / Comments |
|---|---|---|---|
| VGV<br><br>2nd Stg VGV | | a)Cracks<br>b)Lever arms bent<br>c)Grommet out of position on unison ring<br>d)Corrosion | Minor<br><br>Corrosion<br><br>Rust can be observed on the 3rdstg VGV turn buckles |
