**Job Scope:** To perform informational Visual Inspections with Ultrasonic Testing (UT) on a Horizontal Separator Package (A0521805). This package includes a horizontal Separator and Blowcase.

**Visual Inspection Information – 72” ID Horizontal Separator (A0521805)**

**Informational Visual  
Inspection Report**  
*Informational Visual  
Inspection\_A0521805 Separator  
Package\_oct2025*

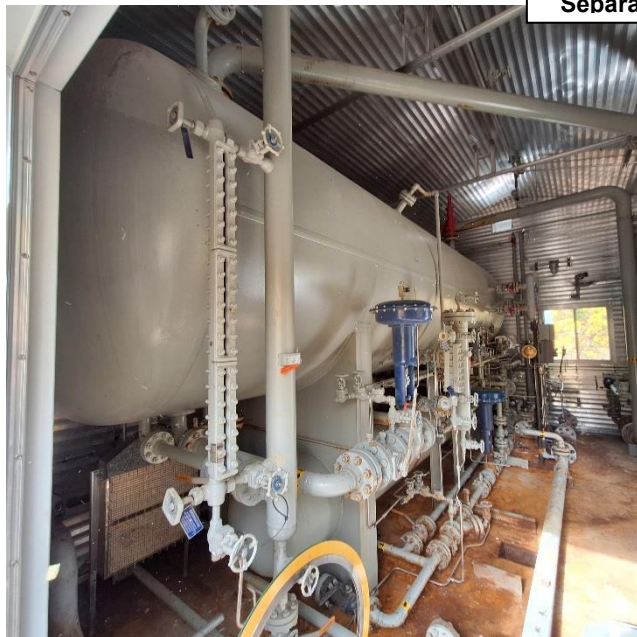
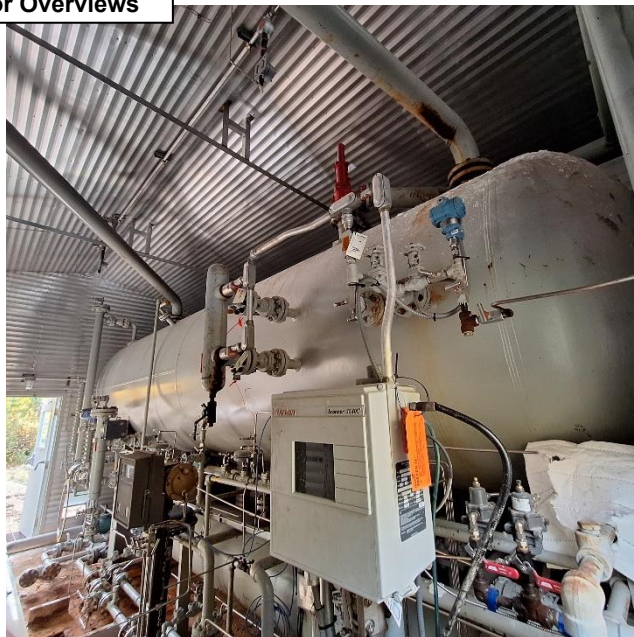
Separator Overviews

- **Nameplate:** Firmly fastened and legible.
- **Foundation/Support:** This vessel is supported by two saddle supports. No visible signs of damage.
- **External Surface:** This vessel is carbon steel, painted, and uninsulated. No mechanical damage or deflection observed. Minor paint damage and staining noted on vessel shell.

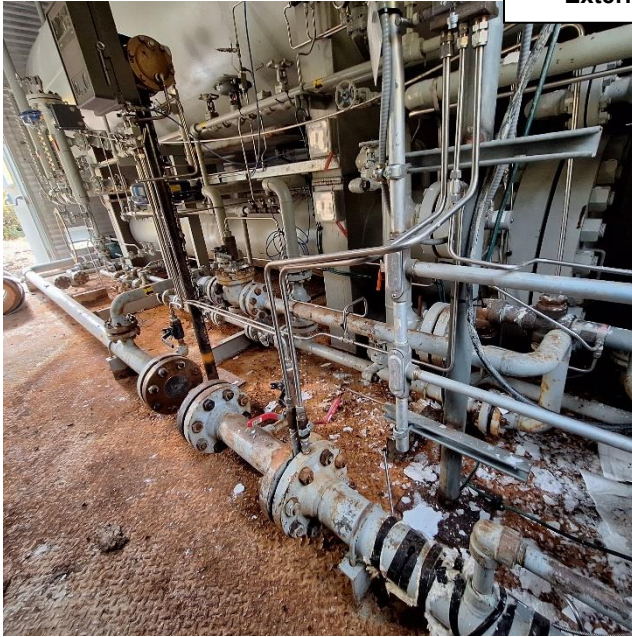
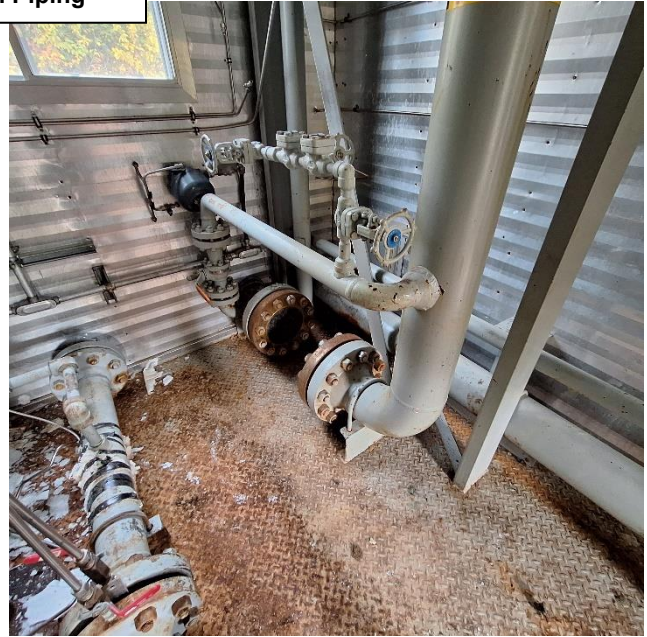
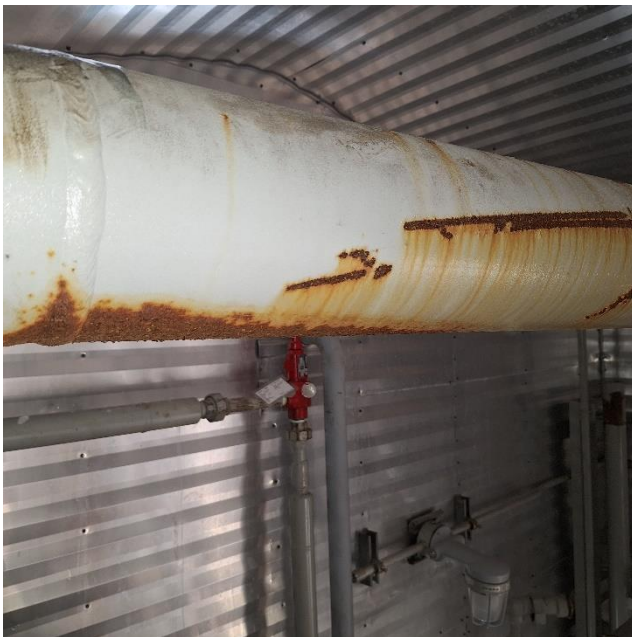
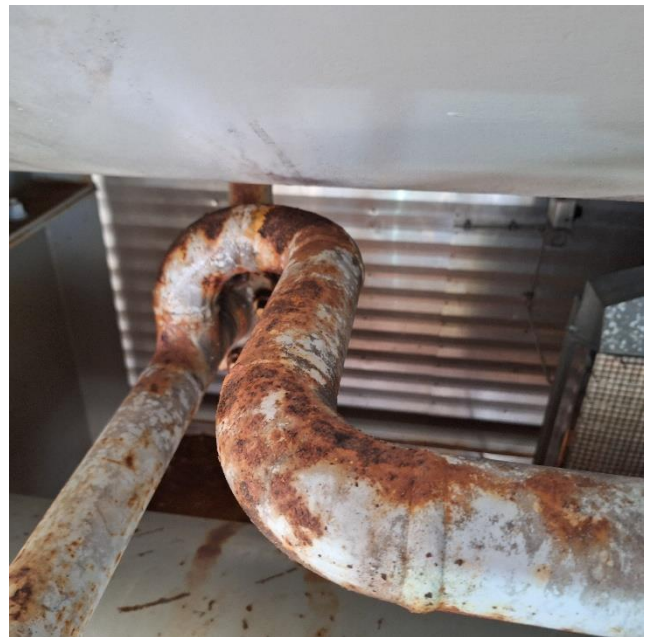
External Piping

- **Insulation:** This vessel is uninsulated.
- **Ladder/Platform:** No associated ladder or platform.
- **External Piping:** All external piping is painted and appears to be properly supported with no signs of overload or external damage. Surface corrosion with no notable wall loss was observed in some external piping. Some piping was disconnected/not installed at the time of inspection.

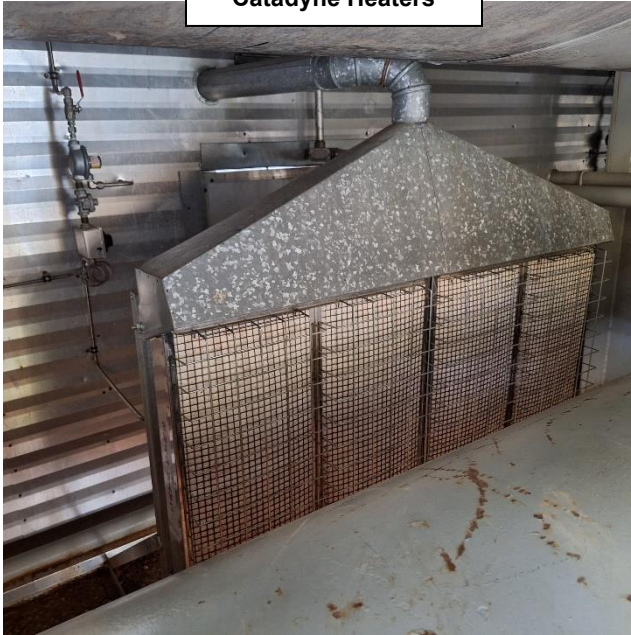
**Catadyne Heaters**

- **External Components:** This package has three attached liquid level columns, four Catadyne heaters, one Roughneck heater, a Barton Meter, a Wizard Controller and an air quality monitoring system installed. All appear to be in good condition.

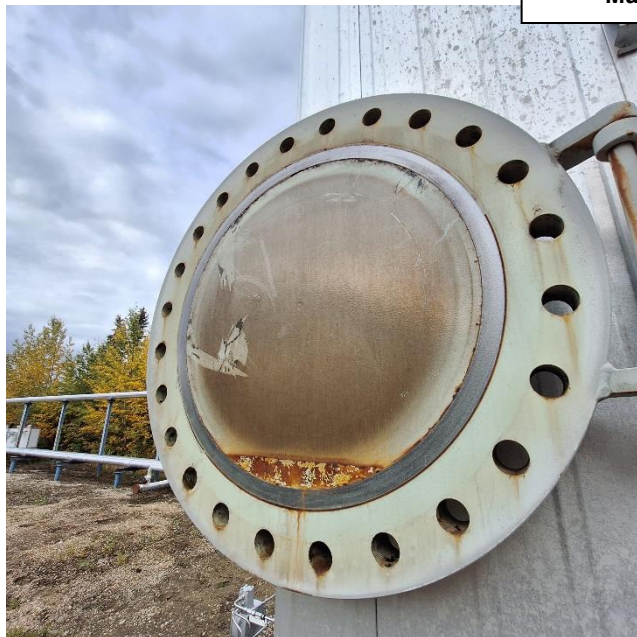
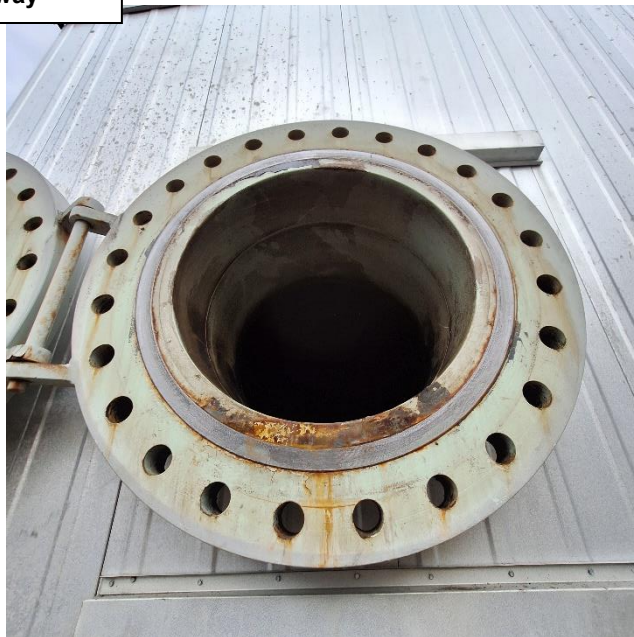
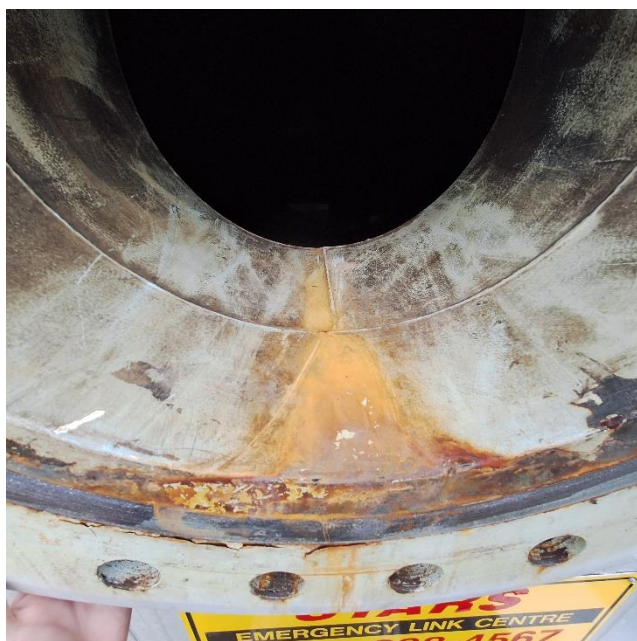
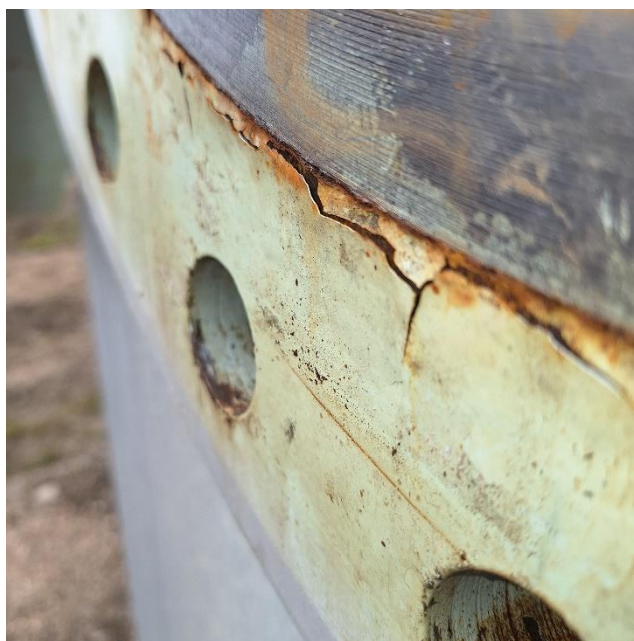
Manway

- **Internal Coating:** Appears to be in good visible condition from the manway. The coating on the manway edges is starting to deteriorate. Some surfaces are not visible due to residual product in the bottom.

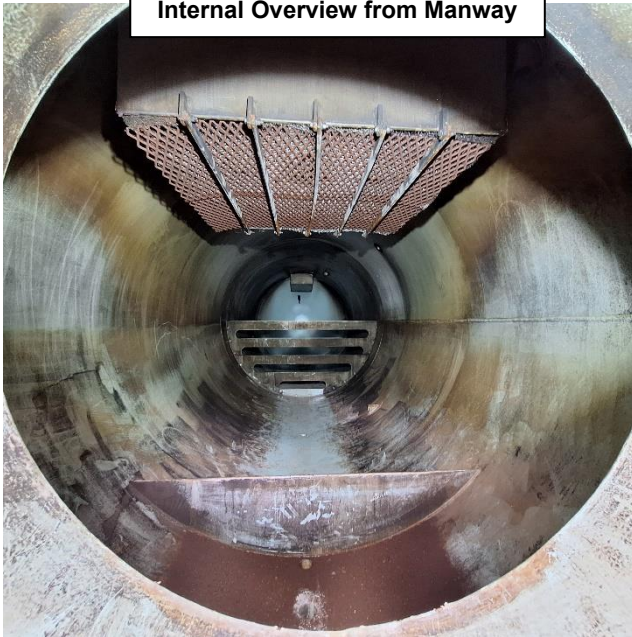
Internal Overview from Manway

- **Internal Components:** Visible internal components from the manway include, a demister vane plate, a deflector plate, one side of a weir, one side of a baffle, and internal nozzles. All visible internal components appear to be in good condition.

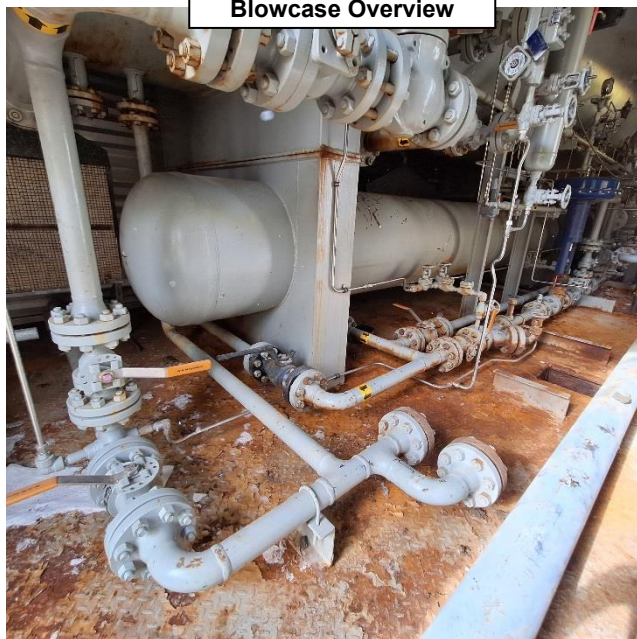
**Blowcase Overview**

- **24” OD Horizontal Blowcase (A0521806):** Data plate attached and legible. Painted and Uninsulated. No signs of mechanical damage or deflection. One PSV installed; SN IBT01612-48, last serviced on May 16, 2013 by Unified Valve. 24” Manway not opened for internal assessment at the time of inspection.
