USED TANK FIELD INSPECTION

2000 bbl Tank – 03-07-11 12394

EMPRESS ENGINEERING LTD.

November 18, 2024

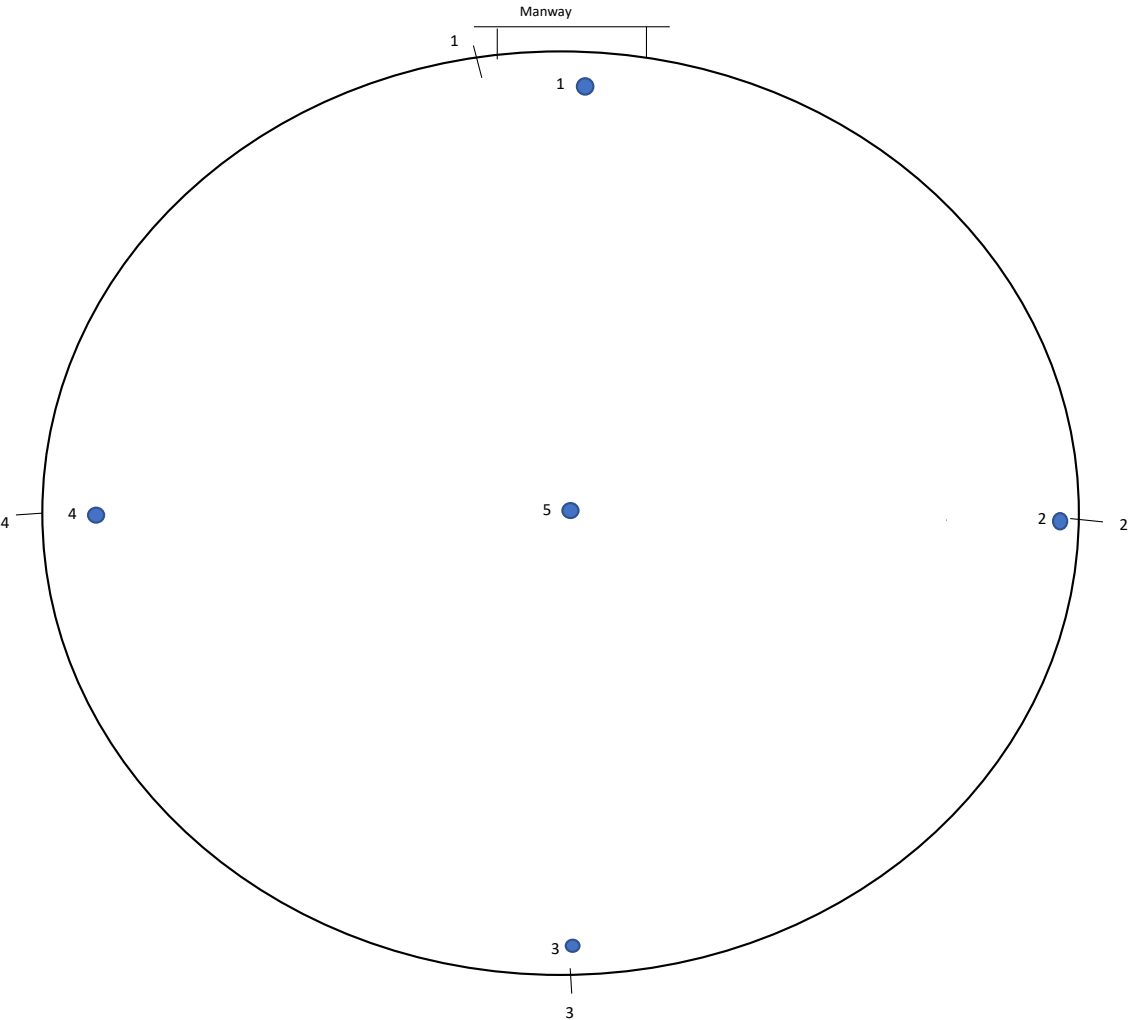
Ultrasonic Thickness Test

0.25"
0.228
0.219
0.224

0.25"
0.251
0.252
0.252
0.252
0.253

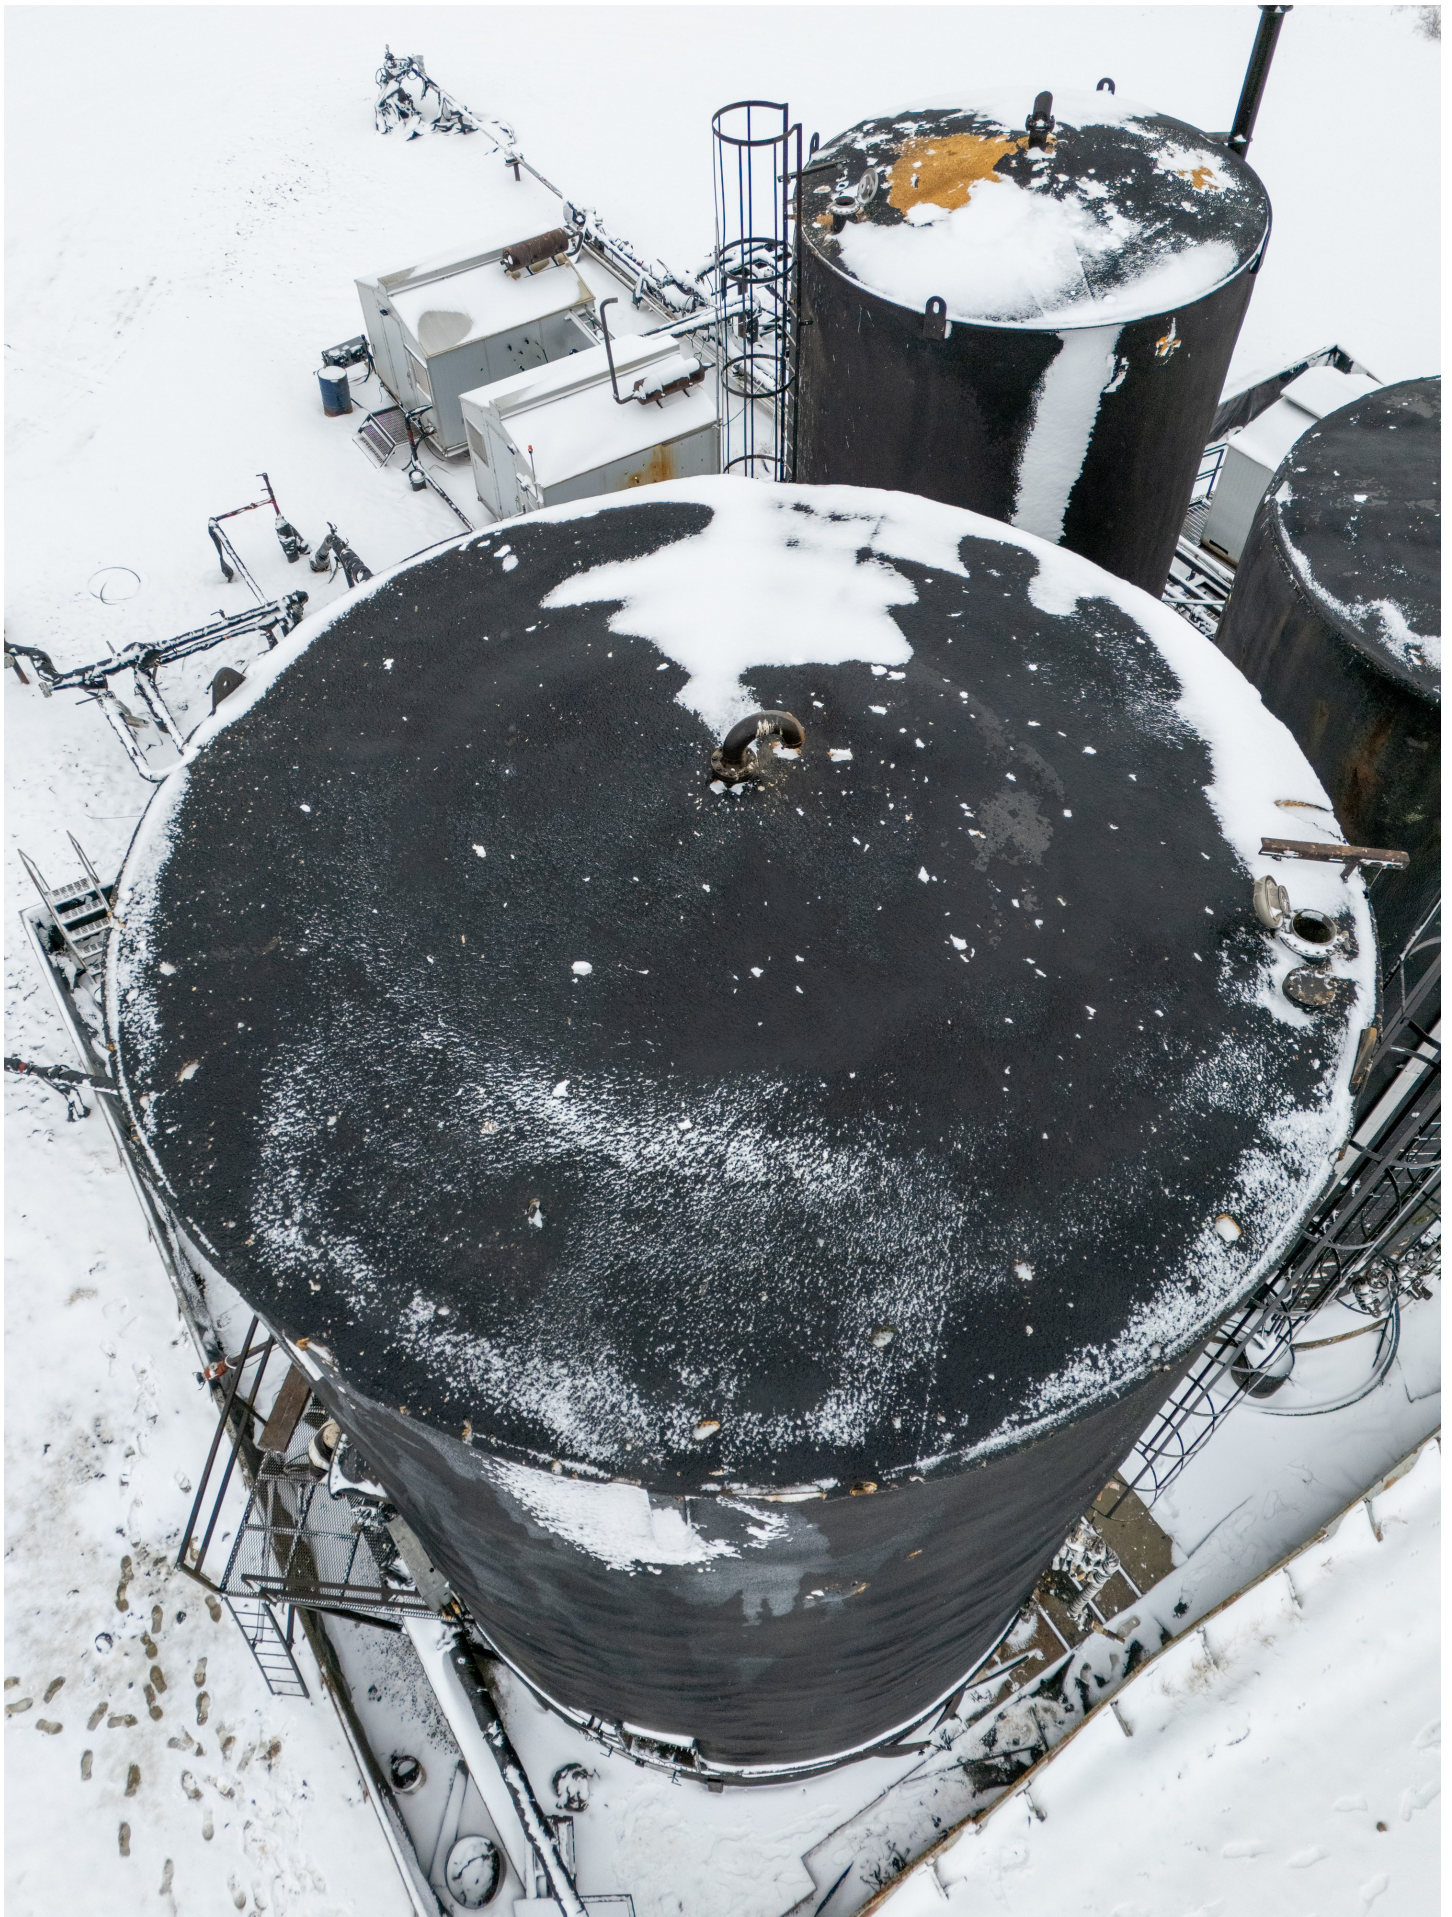
Roof

*Some damage at the roof to shell and some bubbles that have opened from birds.

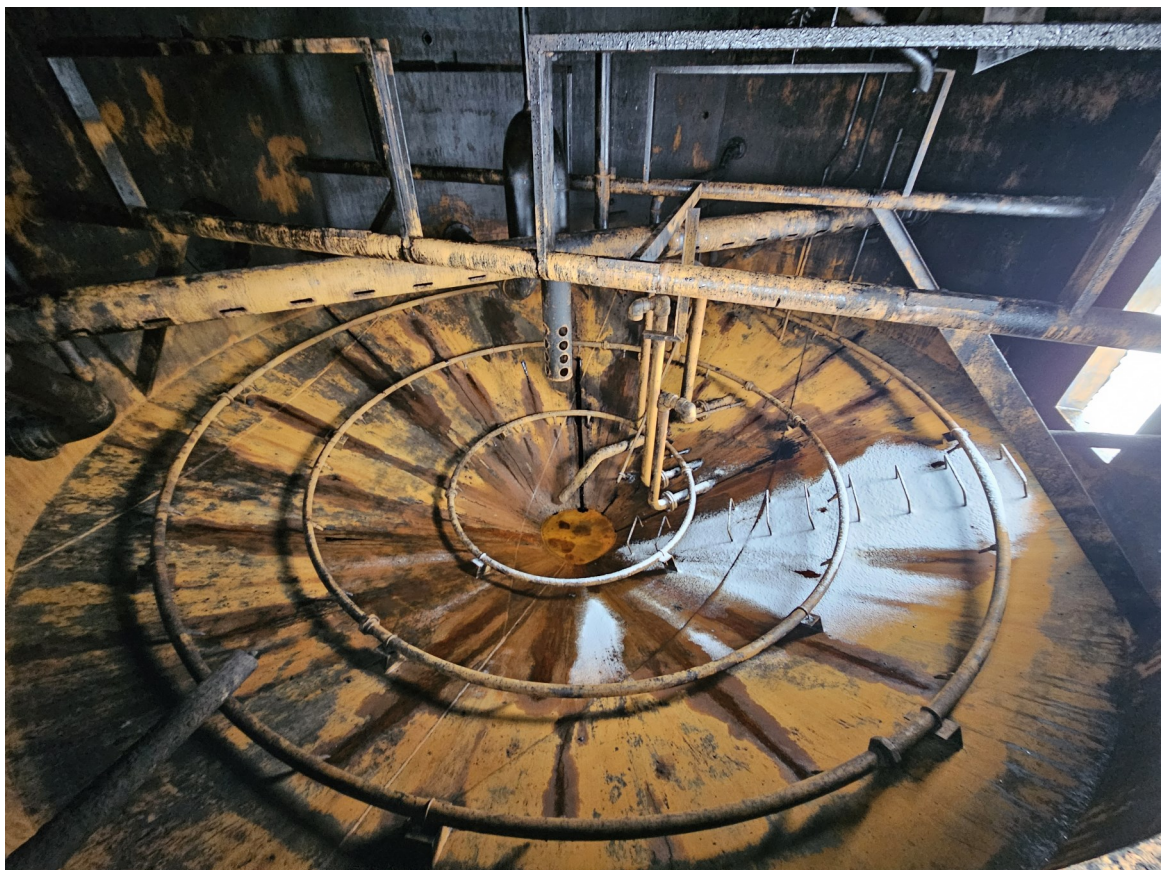
FLOOR

The tank is sitting on concrete rig mats. There is internal corrosion on the skirt up 2' around the tank.
There are three desand rings and a floating suction.
Firetubes are not included, but there are blinds for the throats.
This tank is good to put into service.
