API 510 PRESSURE VESSEL INSPECTION REPORT

CLIENT:	Tourmaline Oil Corporation	REPORT NUMBER:	
PROJECT:		INSPECTION DATE:	9/22/2025
FACILITY:	Septimus Compressor Station	APPLUS JOB NO.:	4051051
LOCATION / LSD:	09-36-81-19W6M	ORIENTATION:	<input checked="" type="checkbox"/> Horizontal <input type="checkbox"/> Vertical
VESSEL NAME:	Glycol Reboiler	STATUS:	<input type="checkbox"/> In-service <input checked="" type="checkbox"/> Out of Service
EQUIPMENT NO.:		INSPECTION TYPE:	<input checked="" type="checkbox"/> Regulatory <input type="checkbox"/> Inventory <input checked="" type="checkbox"/> VE <input type="checkbox"/> VI

PROV. REG. NO.:	V116559		CRN NUMBER:	NON-CODE	
SERIAL NUMBER:	2004-7269-05		SIZE:		
MANUFACTURER:	ALCO GAS & OIL PRODUCTION EQUIP.		CODE PARAMETERS:	NON-CODE	
YEAR BUILT:	2004		MANWAY ACCESS:		
RADIOGRAPHY:			HEAT TREATMENT:	NO	
COATED:			CORR. ALLOWANCE:	NIL	
SHELL THICKNESS:	0.250"		SHELL MATERIAL:	SA 36	
HEAD THICKNESS:	0.250"/0.375"		HEAD MATERIAL:		
TUBE THICKNESS:			TUBE MATERIAL:		
TUBE DIAMETER:			TUBE LENGTH:		
DESIGN PRESSURE:	SHELL:	O PSI	OPERATING PRESSURE:	SHELL:	
	TUBES:			TUBES:	
DESIGN TEMPERATURE:	SHELL:		OPERATING TEMPERATURE:	SHELL:	
	TUBES:			TUBES:

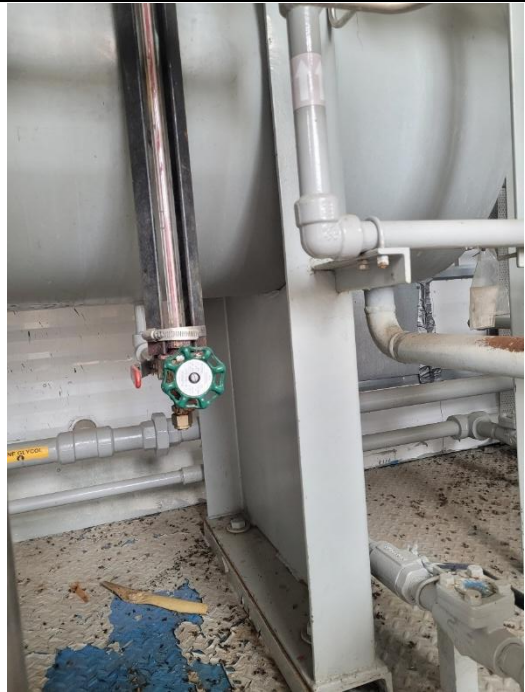
Saddle support

Anchor Bolts Hammer tap to ensure secure. Look for cracking in treads or signs of deformation.	Good	Securely bolted to the skid deck
Foundation Check for cracks, spalling, etc.	N/A	Steel skid
Ladder / Platform Describe general condition, ensure support is secure to vessel, describe any hazards.	N/A	None
Nozzle Assess paint, look for leakage, and ensure stud threads are fully engaged. Record any damage, deflection, etc. Are nozzles gusseted?	Good	Paint is in good condition – no leakage. No damage or deflection
Gauges Ensure gauges are visible, working, no leakage, and suitable for range of MAWP/ Temp.	Good	Temperature gauge 50-500° F
External Piping Ensure pipe is well supported. All clamps, supports, shoes, etc. in place. Look for evidence of structural overload, deflection, etc. Paint condition, external corrosion?	Good	Piping is well supported – all clamps, supports, and shoes are in place. No evidence of structural overload. Paint is in good condition – no corrosion

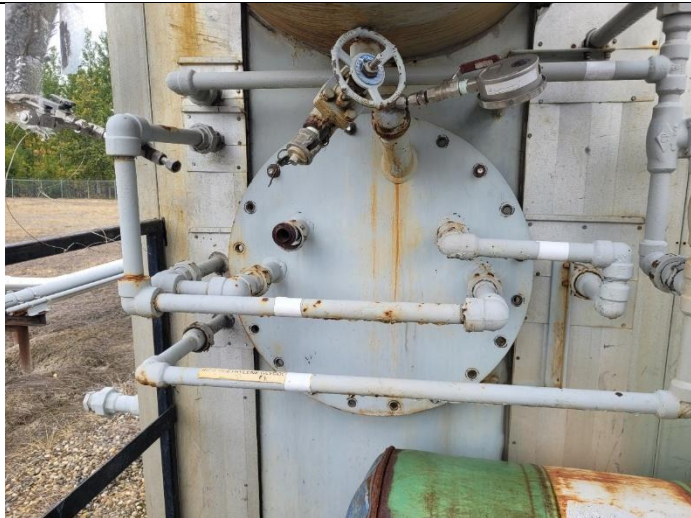
RECOMMENDATIONS:	1. Perform an internal inspection on the both the reboiler and accumulator prior to returning to service	
NCRs / CORRECTIVE ACTIONS / REPAIRS REQUIRED:	None	
SUMMARY OF NDE RESULTS:	Ultrasonic thickness testing carried out – corrosion detected throughout the to shell of the accumulator – minimum thickness recorded was 4.0mm (nominal 6.4mm)

Accumulator has removable coil

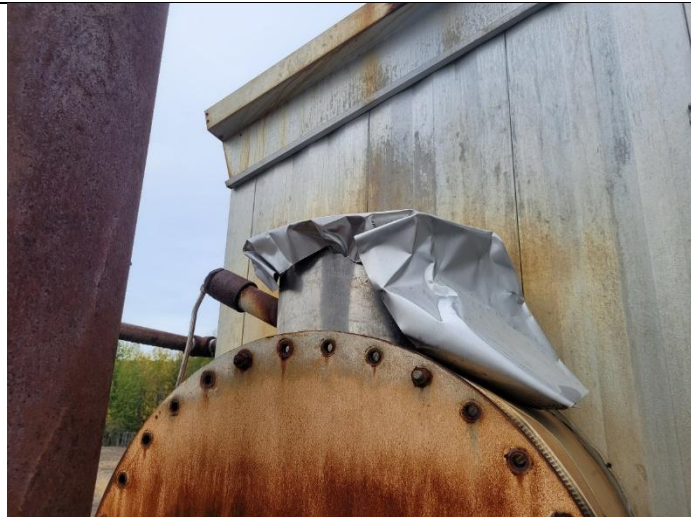
Valving Ensure no leaks are visible. Valves are properly supported and chained if necessary.	Good	No leaks – well supported
Sight Glasses, Bridles, Auxiliary Equipment Are sight glasses clean? Any leakage or concerning vibration? Ensure any added supports are intact.	Good	Accumulator sight glass is in good overall condition – minor fouling
PSV Ensure PSV is set at pressure at or below that of vessel. Discharge piping is same size as inlet to valve and is properly supported and routed. Ensure no block valves between PSV and vessel or if there are they are locked open.		PSV is set at 3 PSI above MAWP – discharge piping is properly supported and routed – no block valve. PSV is due for service
VISUAL EXTERNAL SUMMARY:	Visual external inspection carried out – vessel is in good overall condition. Equipment has been out of service for several years. No corrosion or mechanical damage. No sign of leaks. No items of concern. PSV requires service. Still column was not in the vicinity at time of inspection. Fit for Service

Still column removed at time of inspection
