API 653 ABOVE GROUND STORAGE TANK INTERNAL AND EXTERNAL INSPECTION REPORT

TANK SERIAL # STTK-QI-T1-15643

DATE: JULY 8 / 2025

NEXTGEN JOB # 18248

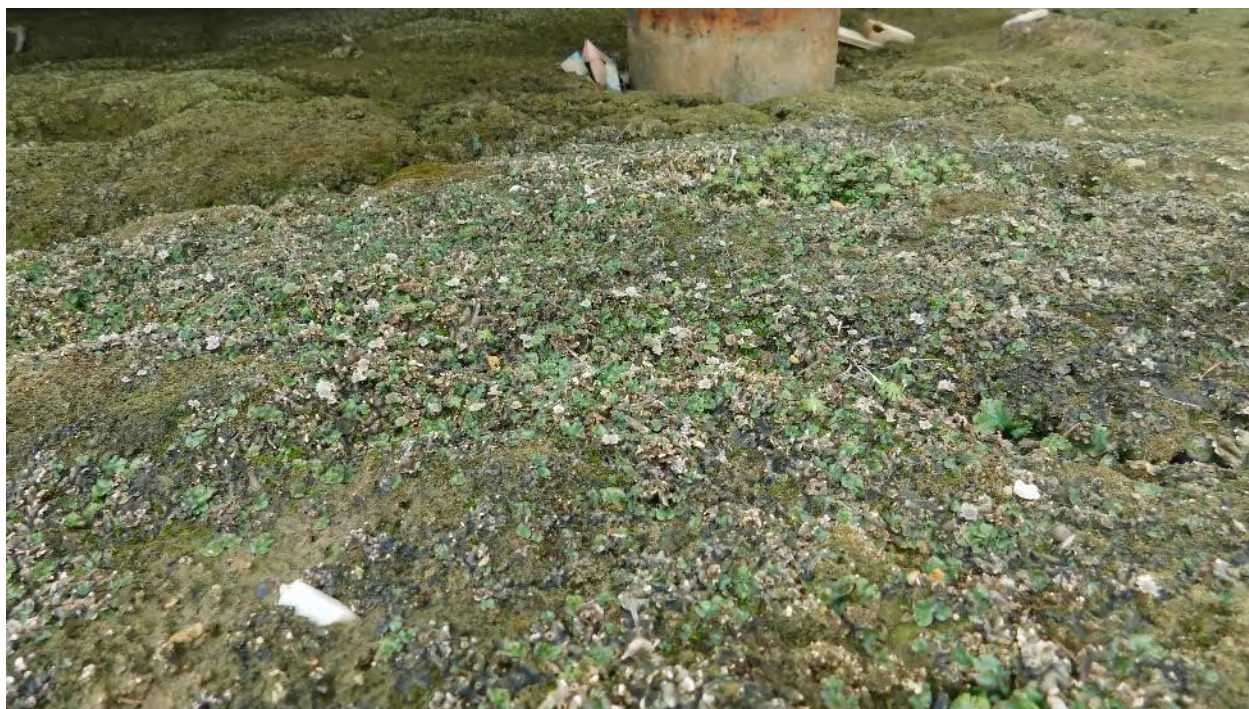
- 1.2.1 The secondary containment berm walls were observed to be earth and gravel and encompass the entire site perimeter.
- 1.2.2 Moss growth was observed to be present around the tank bottom plate projection and in areas throughout the secondary containment.
- 1.2.3 Refer to Foundation Photographs for additional details on the items mentioned above.

Photograph 12: Secondary Containment Overview – Moss Growth

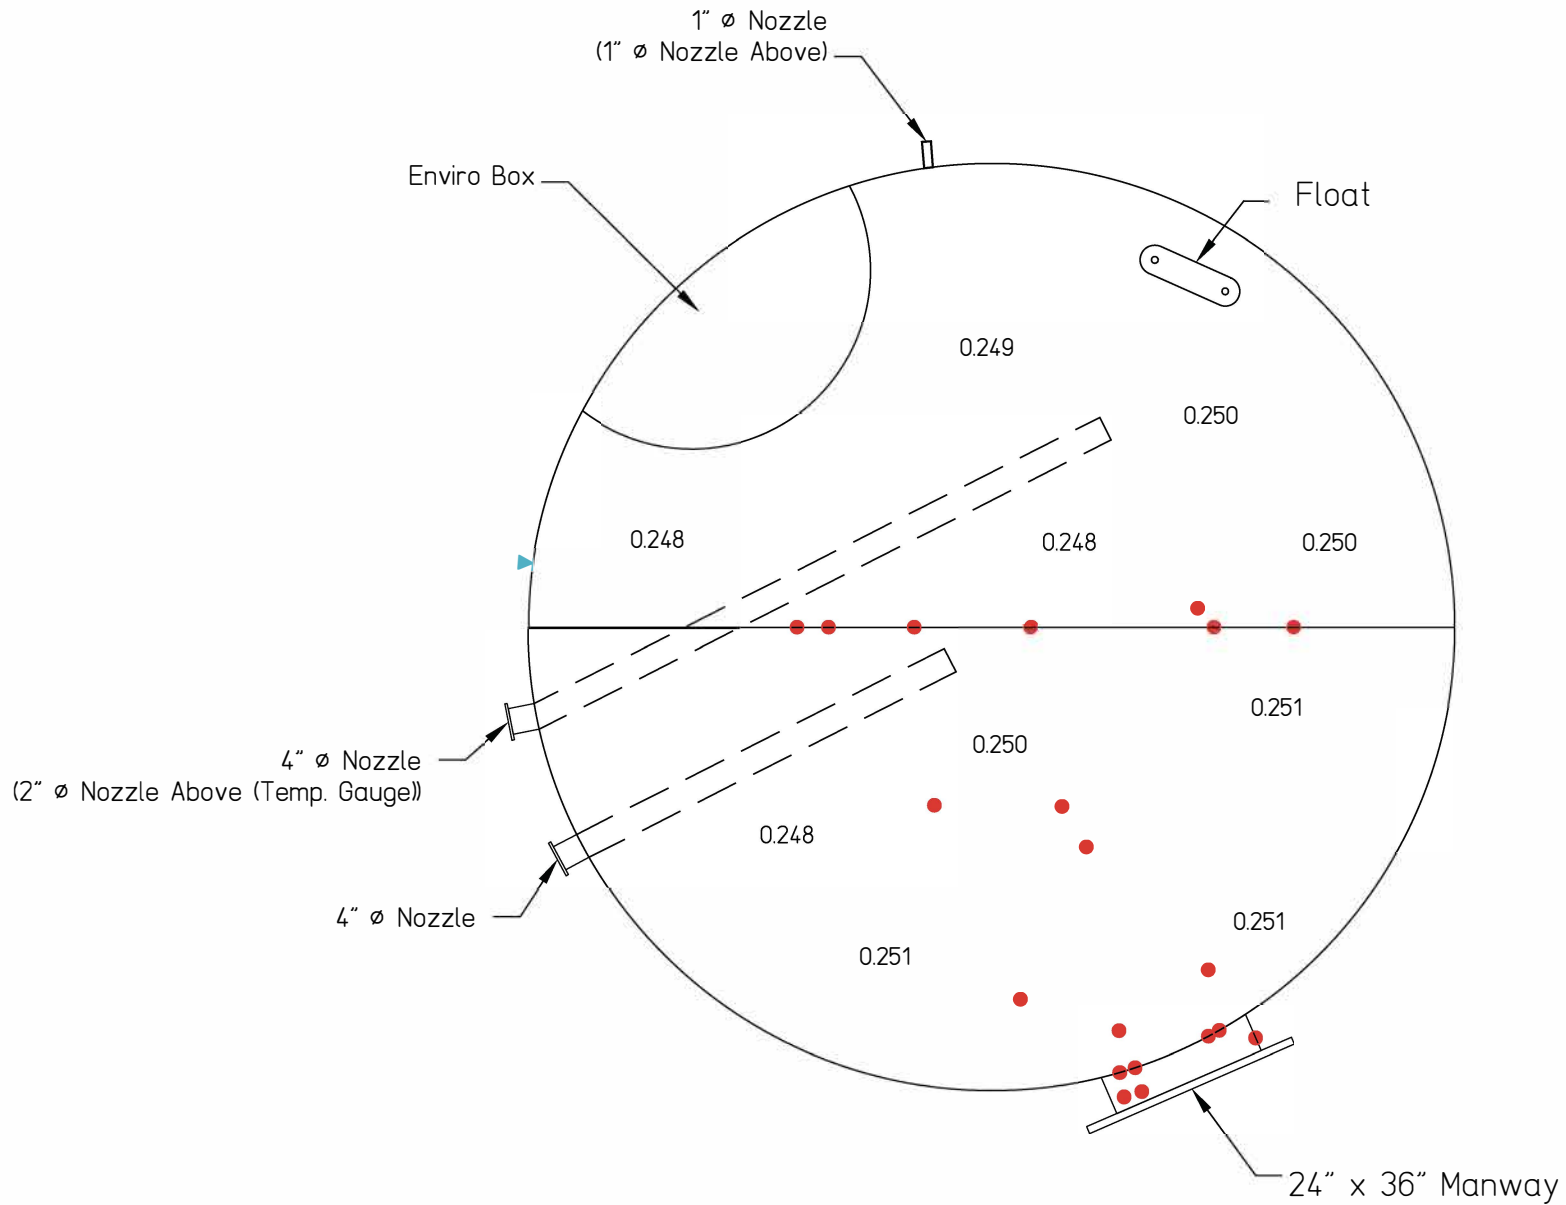
6.4 Bottom Plate Layout Drawing

- 1.1.2 Internally, the visual examination was limited due to the product residue on the floor. The bottom plate was observed to be epoxy coated. Eight (8) coating failures was observed on the bottom plate and seven (7) on the bottom weld. Refer to Bottom Plate Layout Drawing for additional details.

- 1.1.3 Random ultrasonic thickness (UT) measurements were taken on the bottom plate. Five (5) readings were recorded per plate. No material loss was observed. The minimum reading found was 0.248 inch with a nominal thickness of 0.250 inch. Refer to Bottom Plate Layout Drawing for additional details.

- 12.1.1 It is recommended to repair the coating failures observed on the bottom plate and bottom weld.
- 12.1.2 Consideration should be given to removing the moss growth from underneath the bottom plate projection and investigate the cause of accumulated water in these areas to prevent insulation degradation.

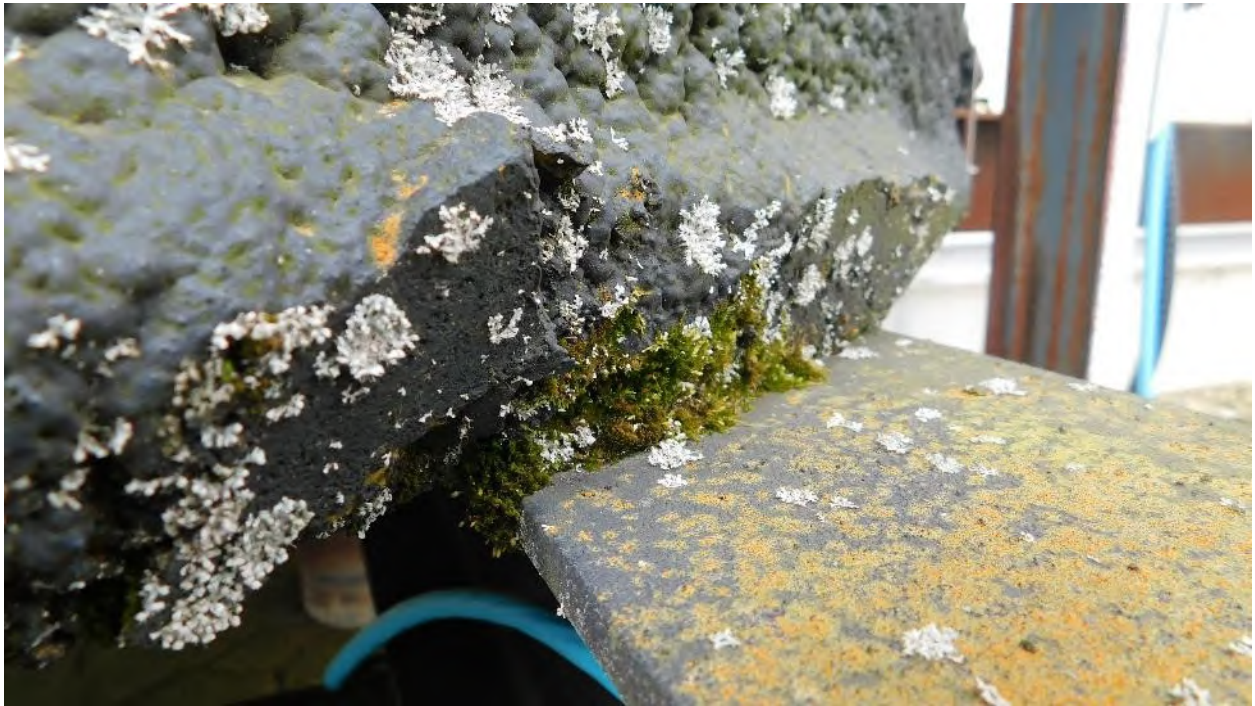
- 1.1.5 The internal shell to bottom weld was observed to be coated and in acceptable condition.
- 1.1.6 The bottom plate projection was observed to be foam insulated and some areas of moss growth were noted underneath the edge perimeter.

Photograph 17: Bottom Plate Projection – Moss Growth

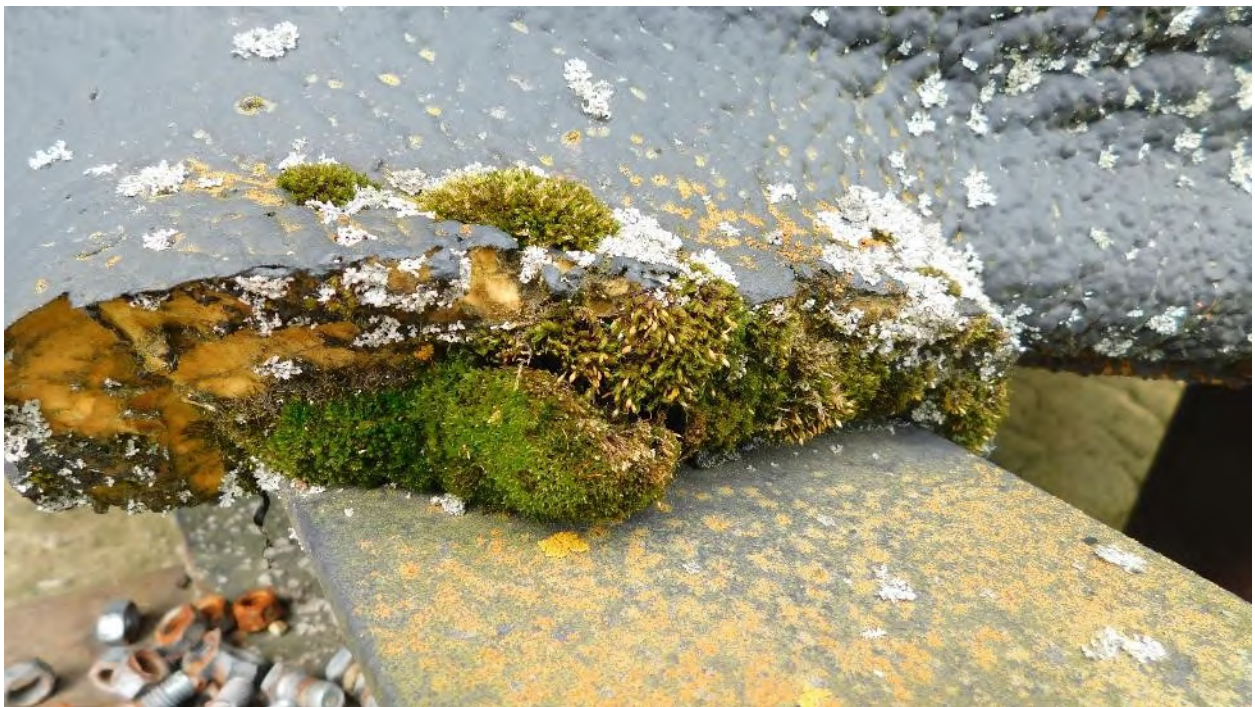
Photograph 18: Bottom Plate Projection – Moss Growth

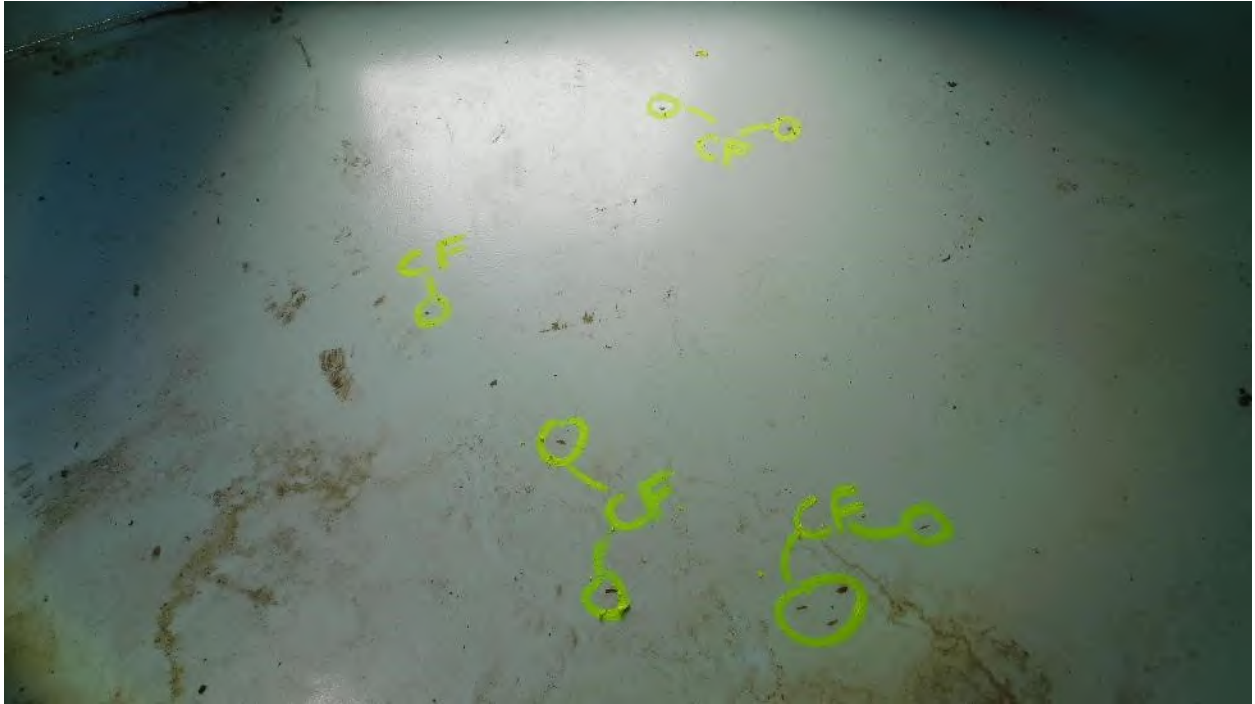
Photograph 21: Bottom Plate Coating Failure Overview

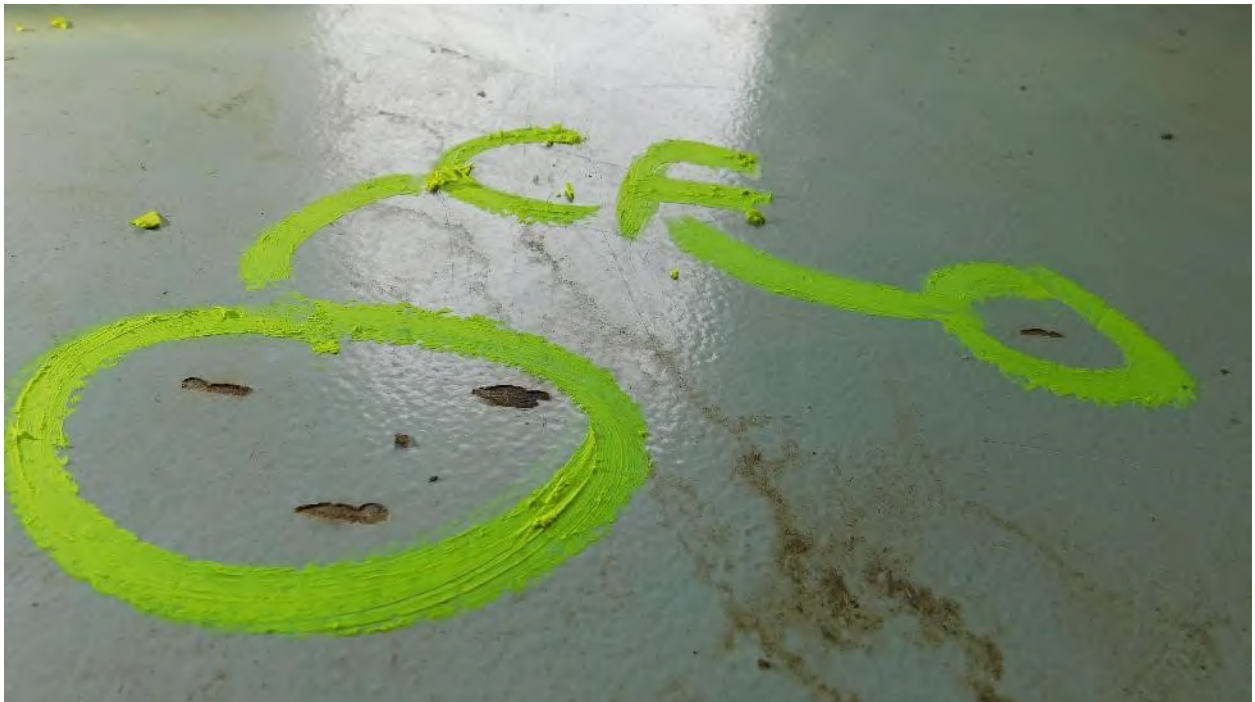
Photograph 22: Bottom Plate Coating Failure Detail

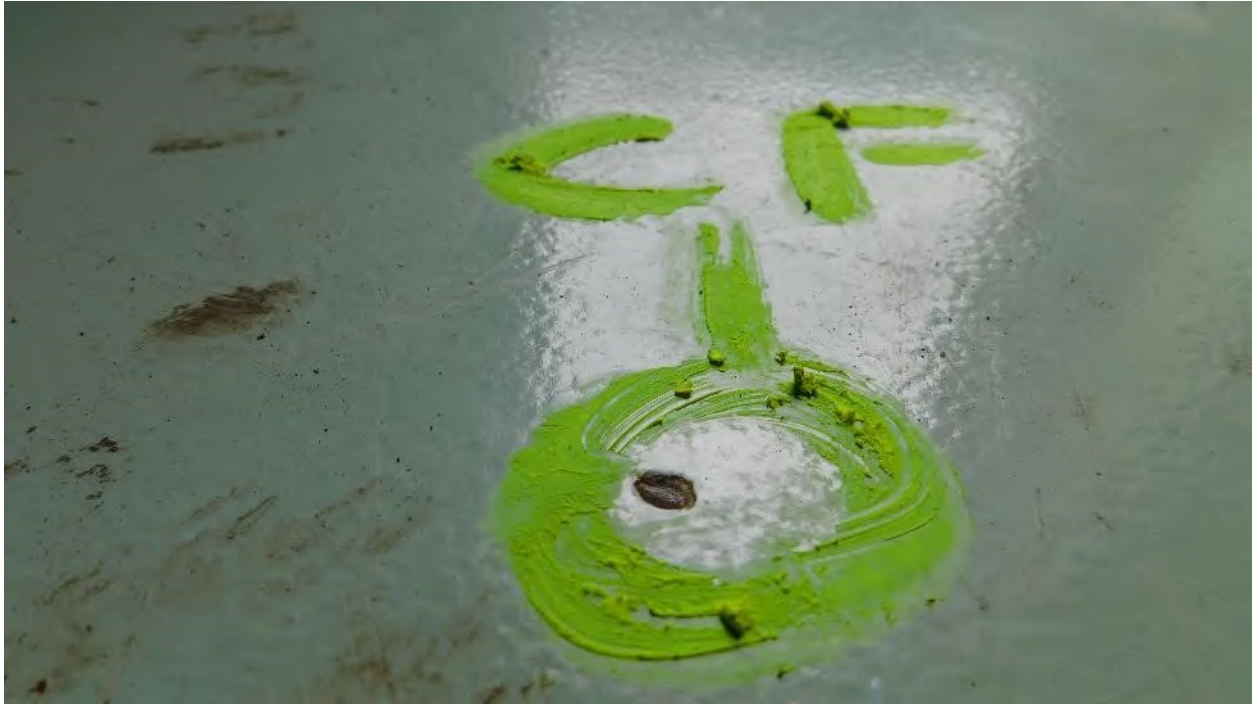
Photograph 23: Bottom Plate Coating Failure Detail

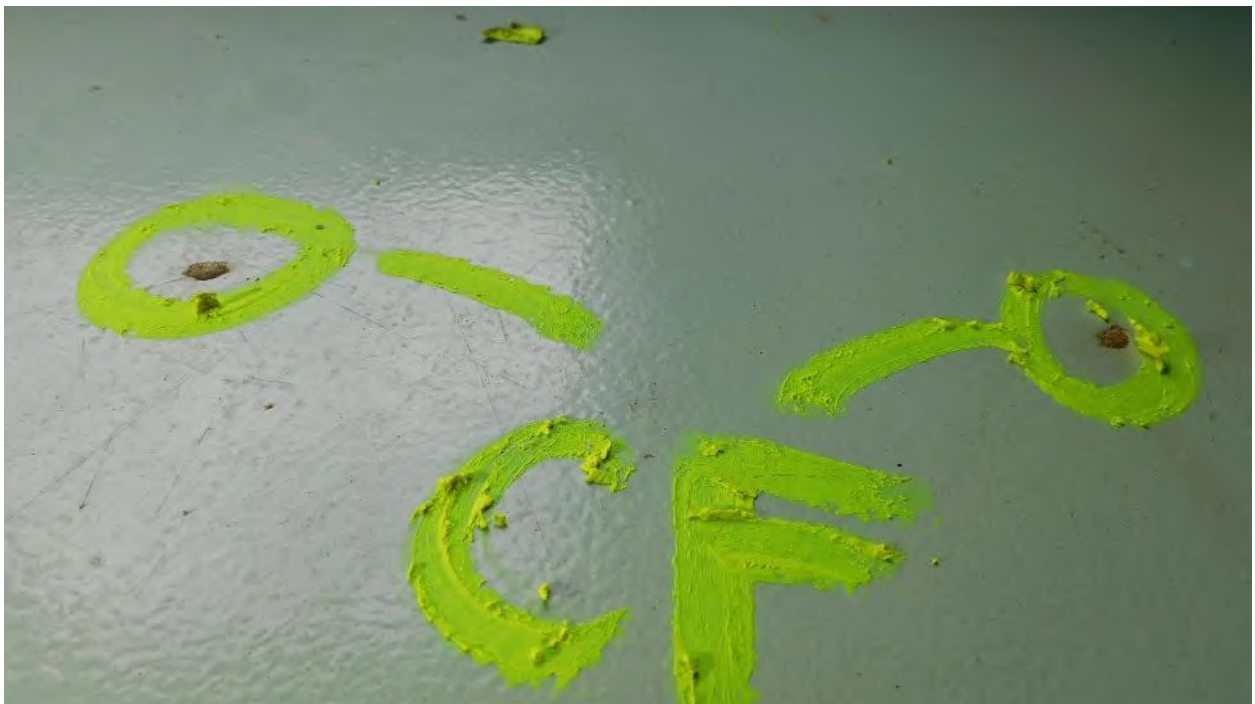
Photograph 24: Bottom Plate Coating Failure Detail

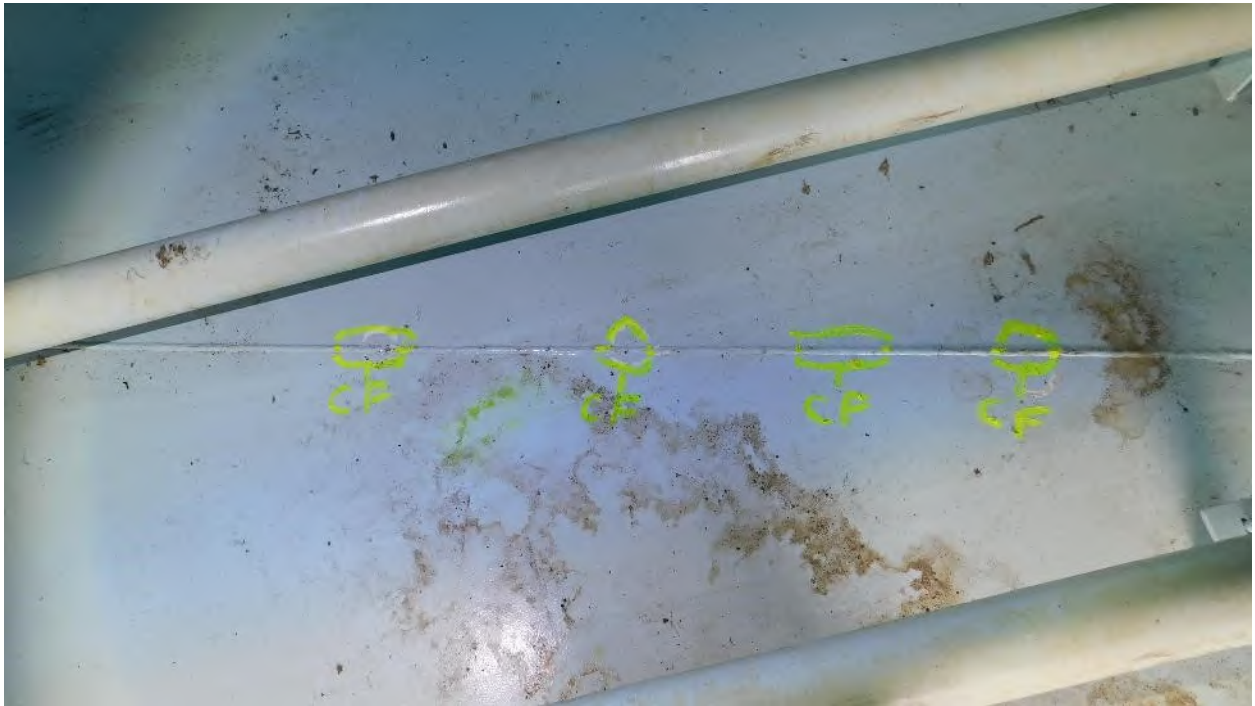
Photograph 25: Bottom Plate Weld Coating Failure Overview

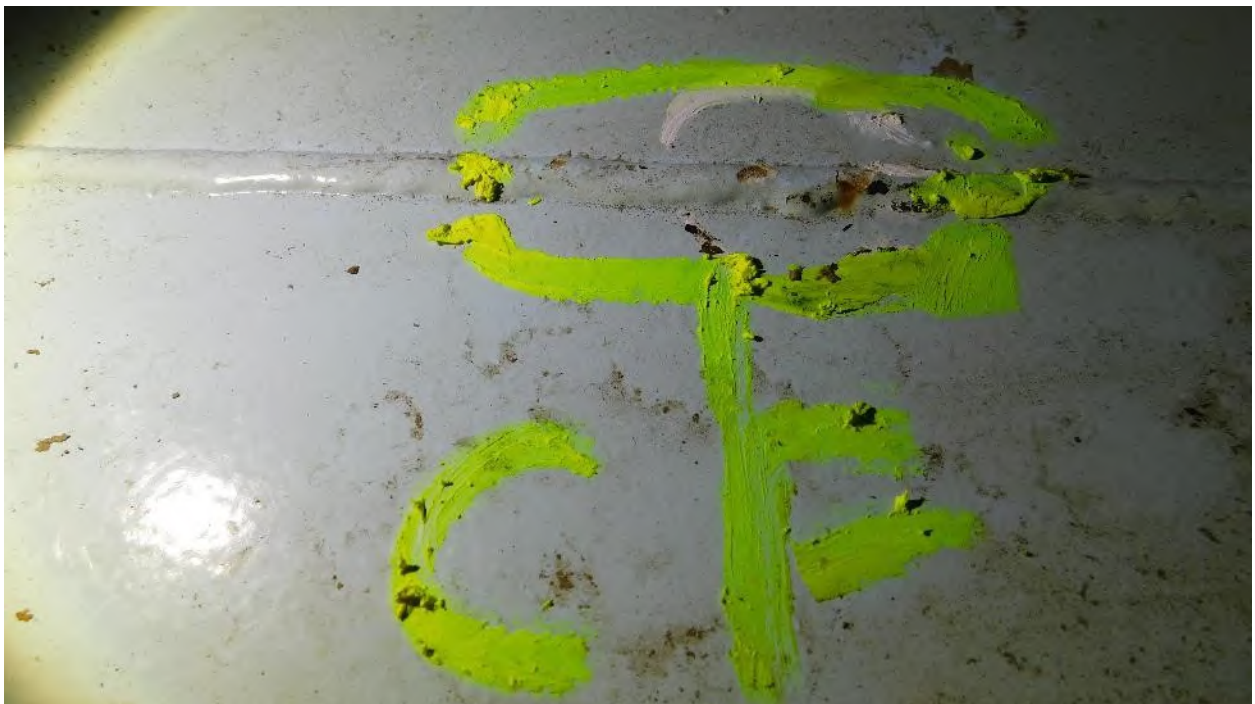
Photograph 26: Bottom Plate Weld Coating Failure Detail

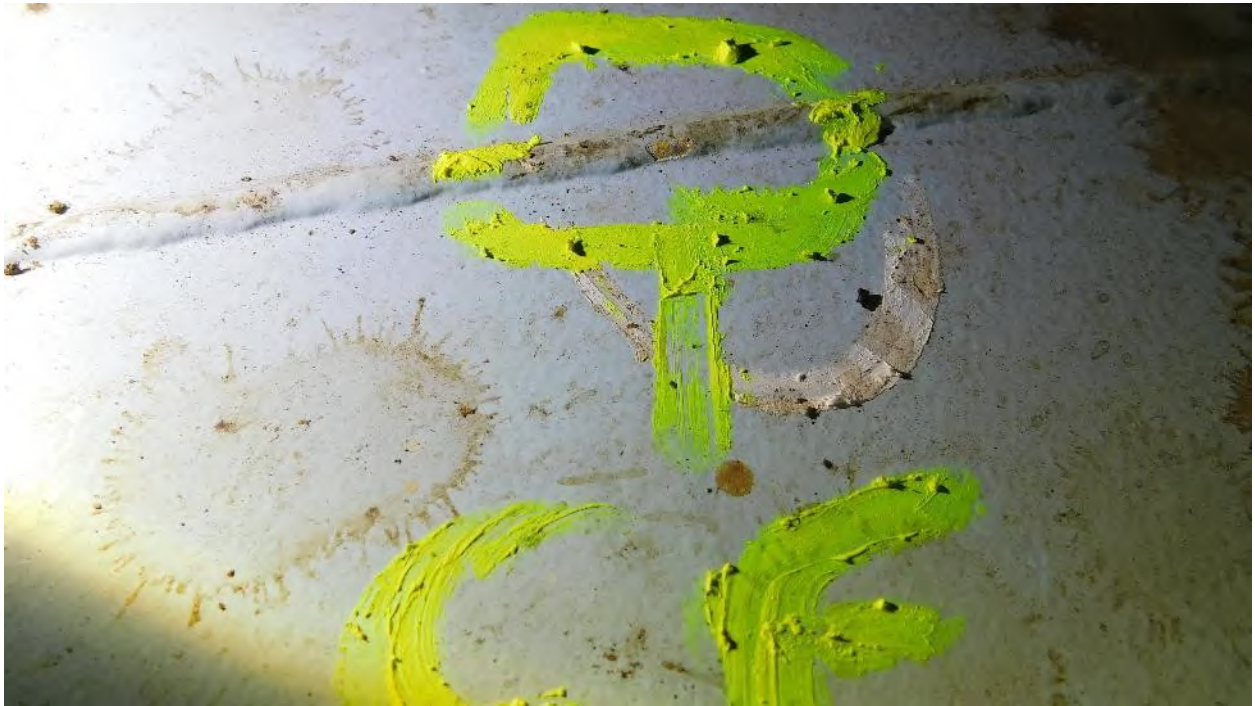
Photograph 27: Bottom Plate Weld Coating Failure Detail

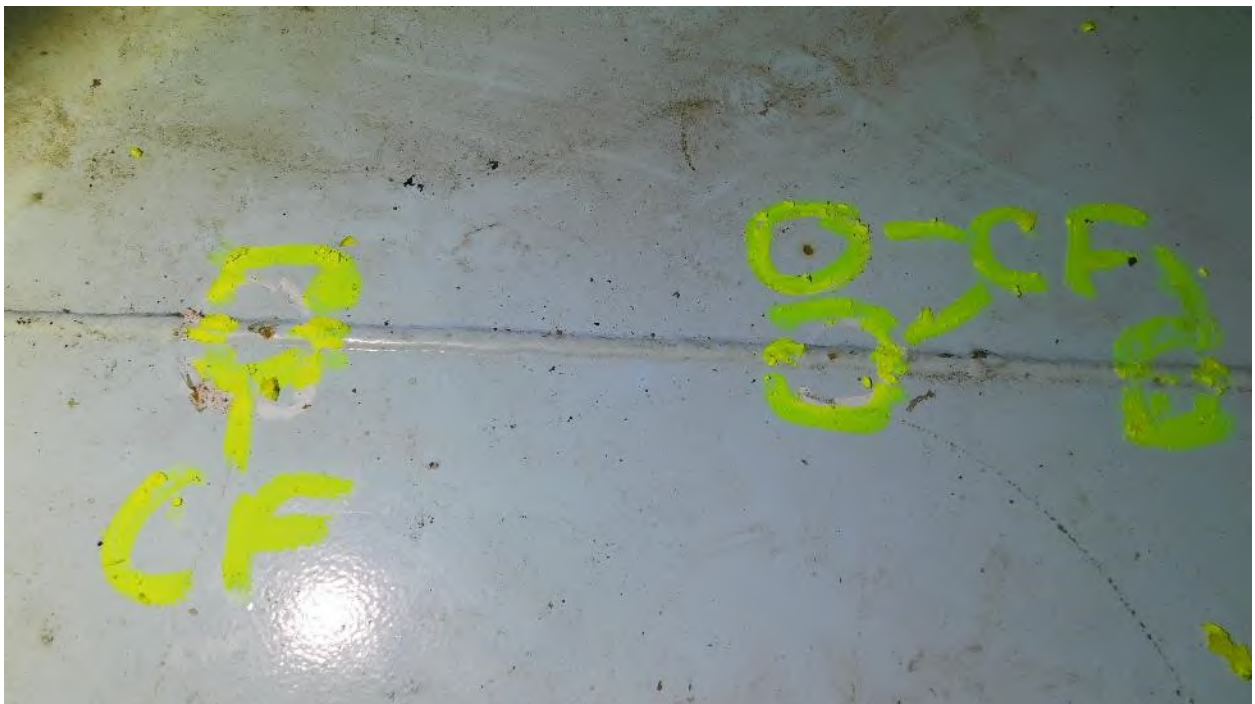
Photograph 28: Bottom Plate Coating Failure Overview

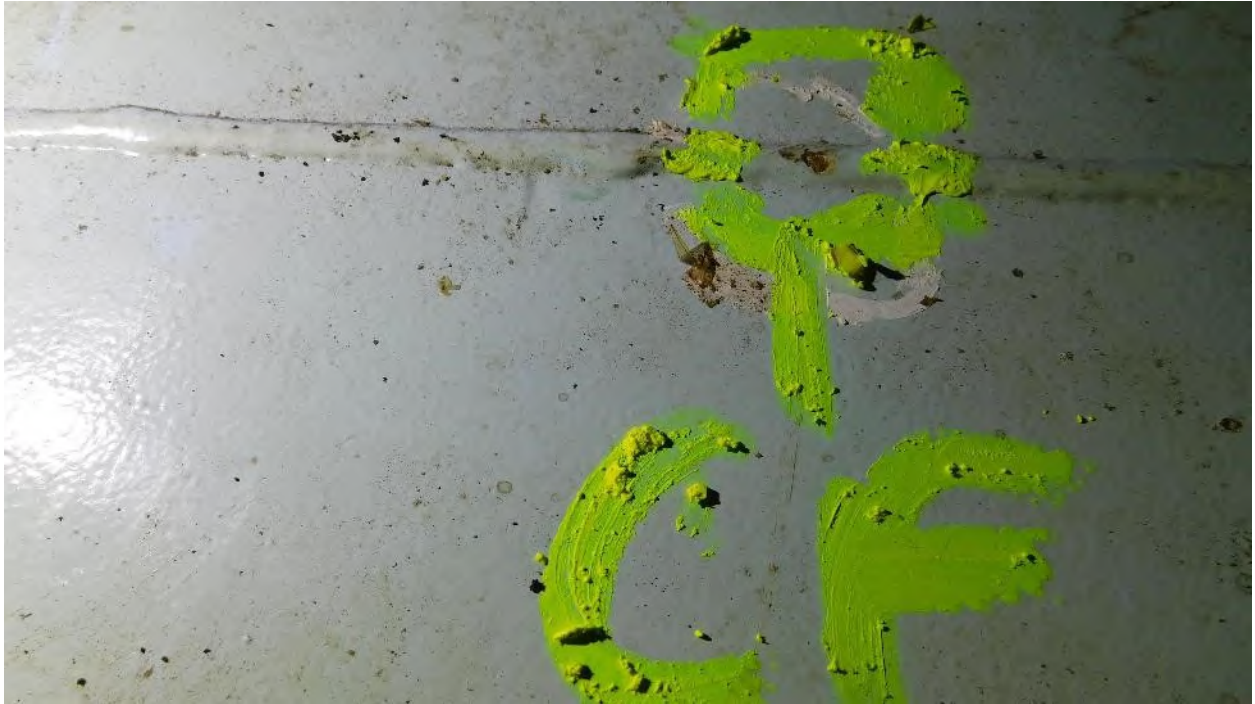
Photograph 29: Bottom Plate Weld Coating Failure Detail

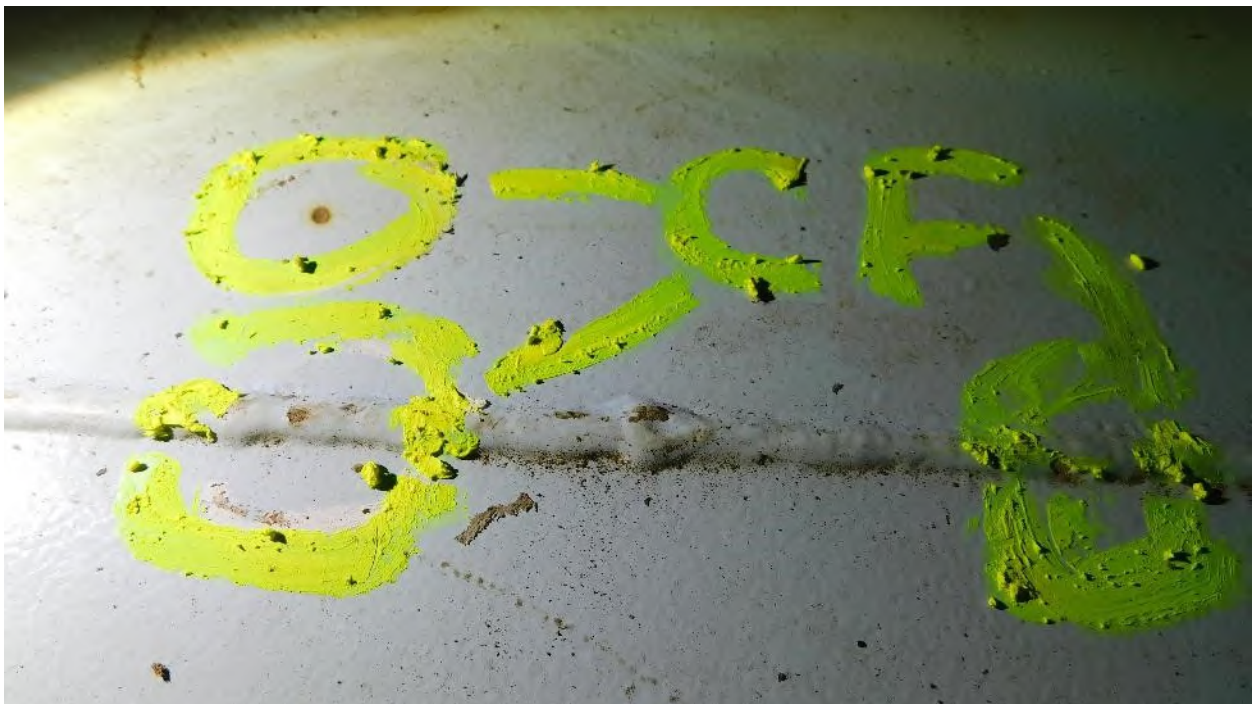
Photograph 30: Bottom Plate Coating Failure Detail

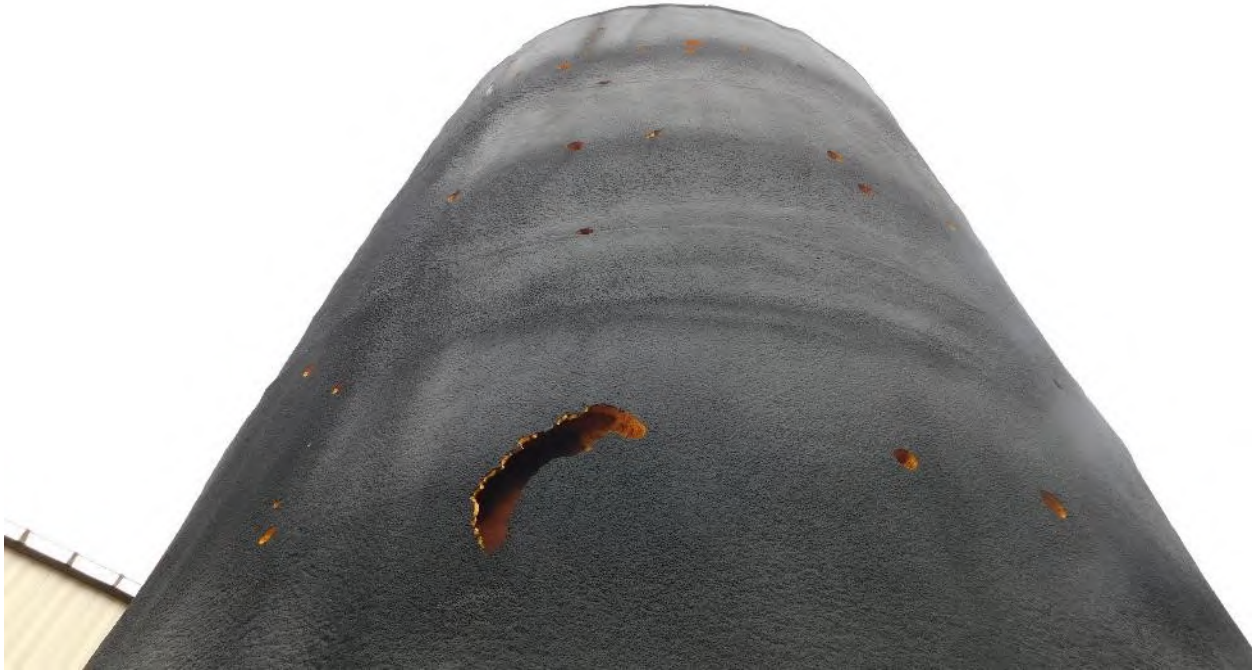
- 1.3.1 Externally, the shell plate was visually examined from ground level. The tank was observed to be foam insulated. Multiple minor areas of insulation damage were observed throughout the shell.
- 1.3.2 Internally, the shell plate was visually examined from ground level. The entire shell was observed to be epoxy coated and in acceptable condition.
- 1.3.3 Random ultrasonic thickness (UT) measurements were taken on bottom portion the first course. Sixteen (16) measurements were recorded per plate. No significant material loss was observed. The minimum thickness reading found was 0.180 inch utilizing the echo-to-echo technique with a nominal thickness of 0.188 inch. Refer to Table A – Manual UT Readings – First Course for additional details.
- 1.3.4 Refer to Tank Shell Photographs for additional details on the items listed above.

Photograph 34: External Shell Overview – General Minor Insulation Damage

- 12.3.1 Consideration should be given to repairing all areas of insulation damage throughout the shell.

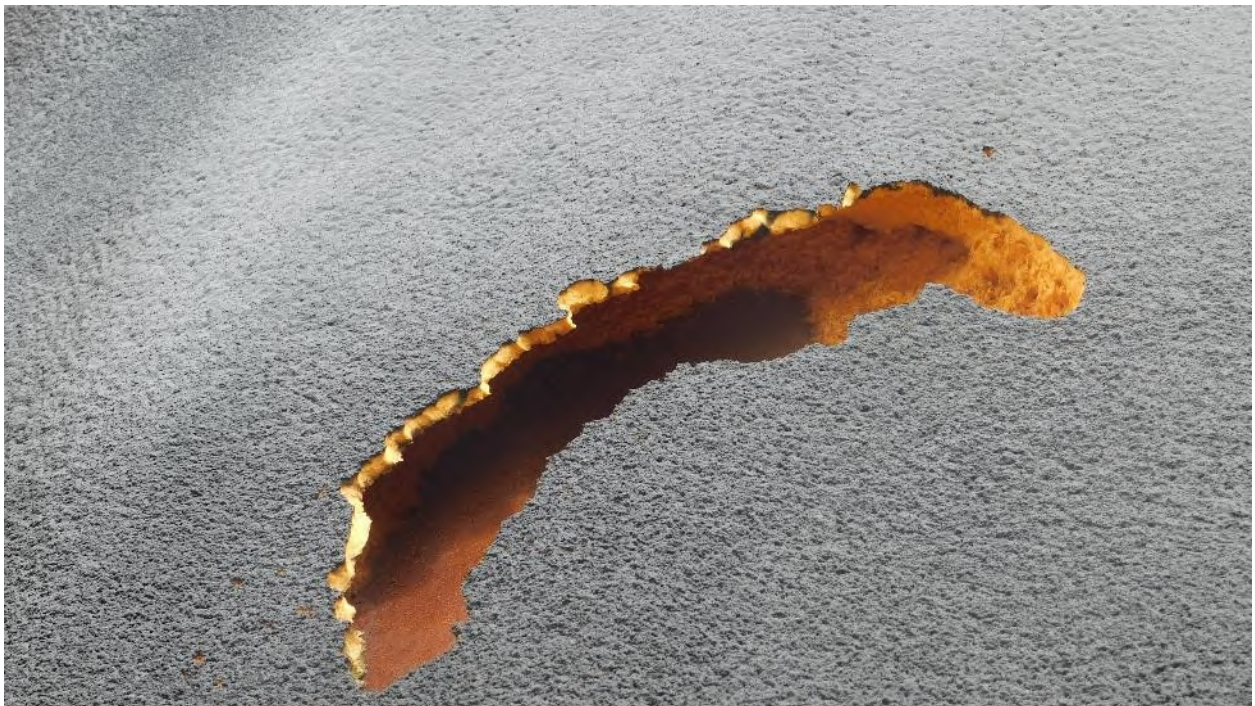
Photograph 35: External Shell Overview – Insulation Damage

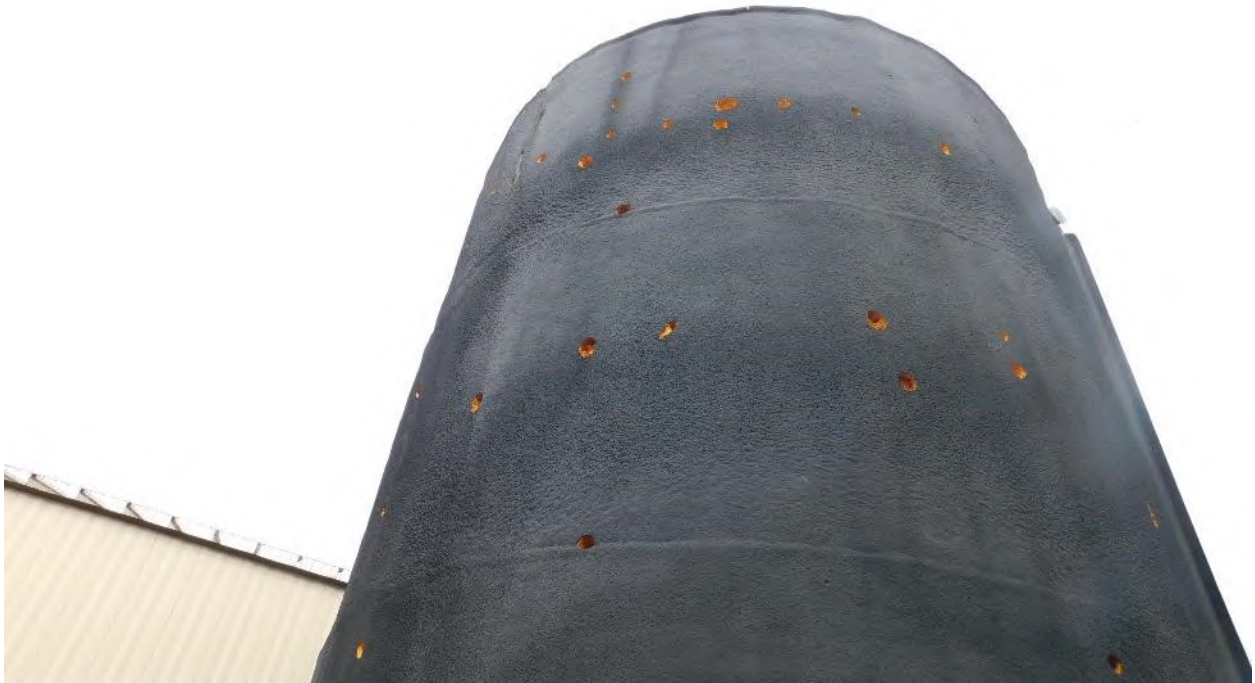
Photograph 36: External Shell Overview – General Minor Insulation Damage

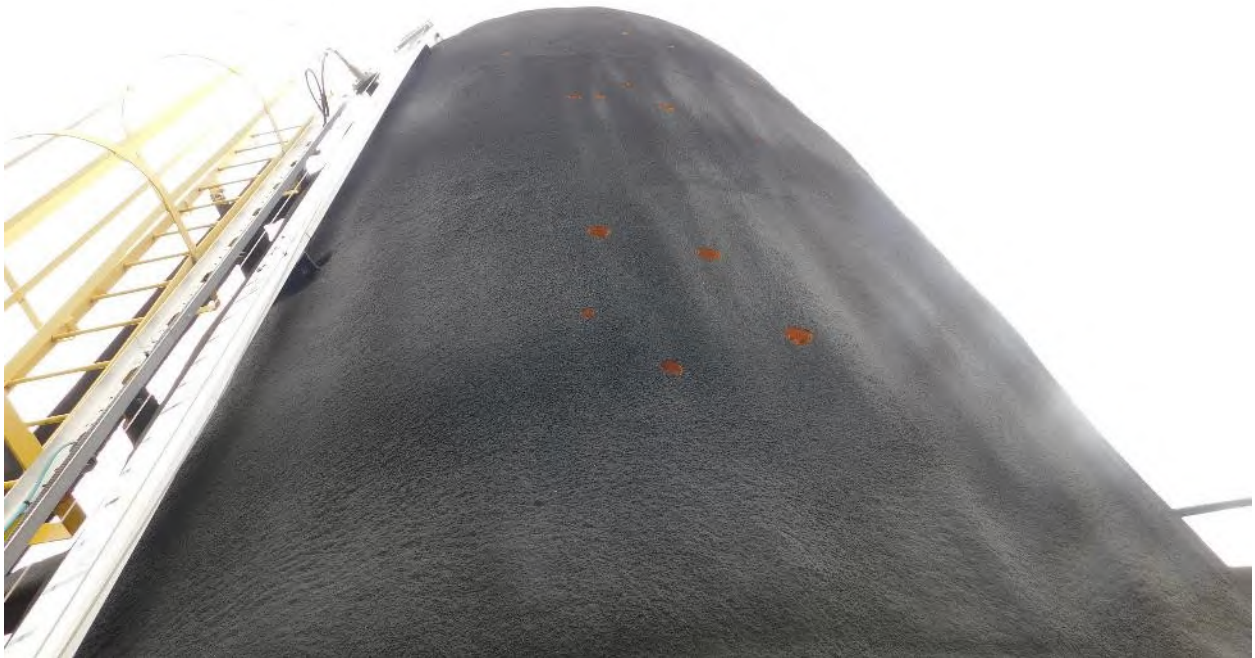
Photograph 38: External Shell Overview – General Minor Insulation Damage

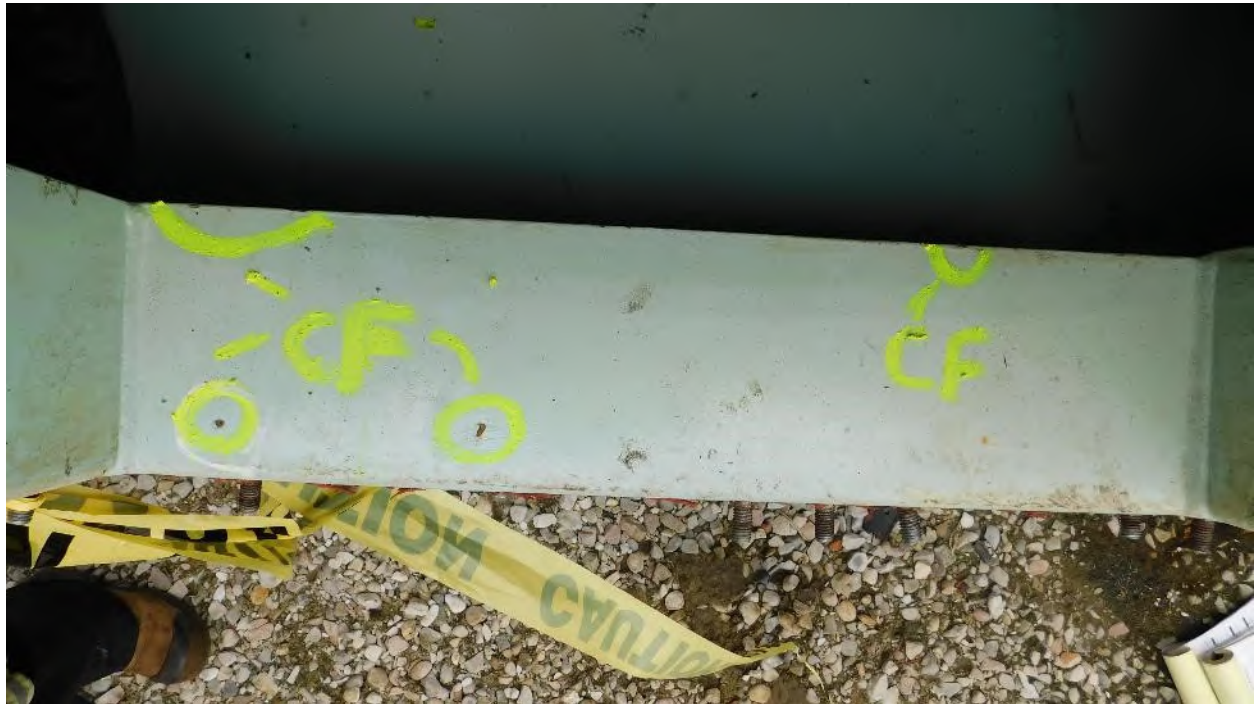
- 1.4.1 A visual examination was performed on the shell penetrations and attachments.
- 1.4.2 Internally, six (6) coating failures were observed on the manway neck and four (4) on the manway cover.

Photograph 53: Manway Coating Failure Overview

- 12.4.1 It is recommended to repair all coating failures observed inside the manway neck and on the cover.

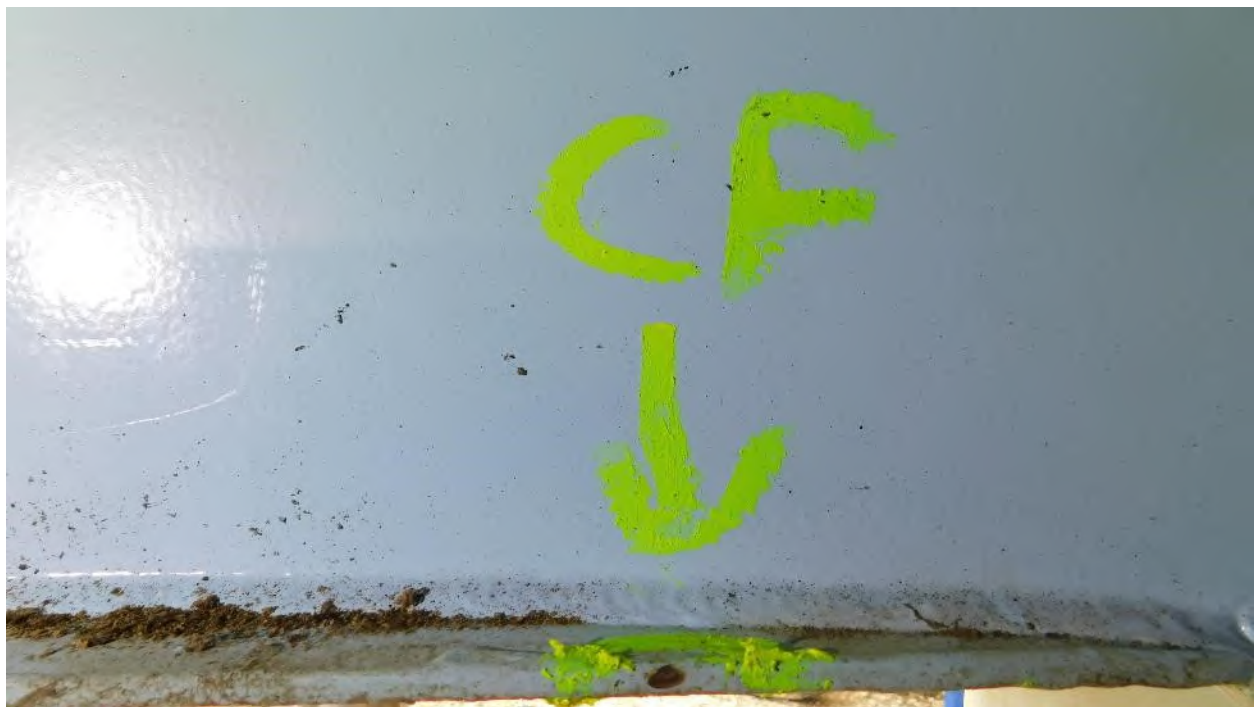
Photograph 54: Manway Coating Failure Detail

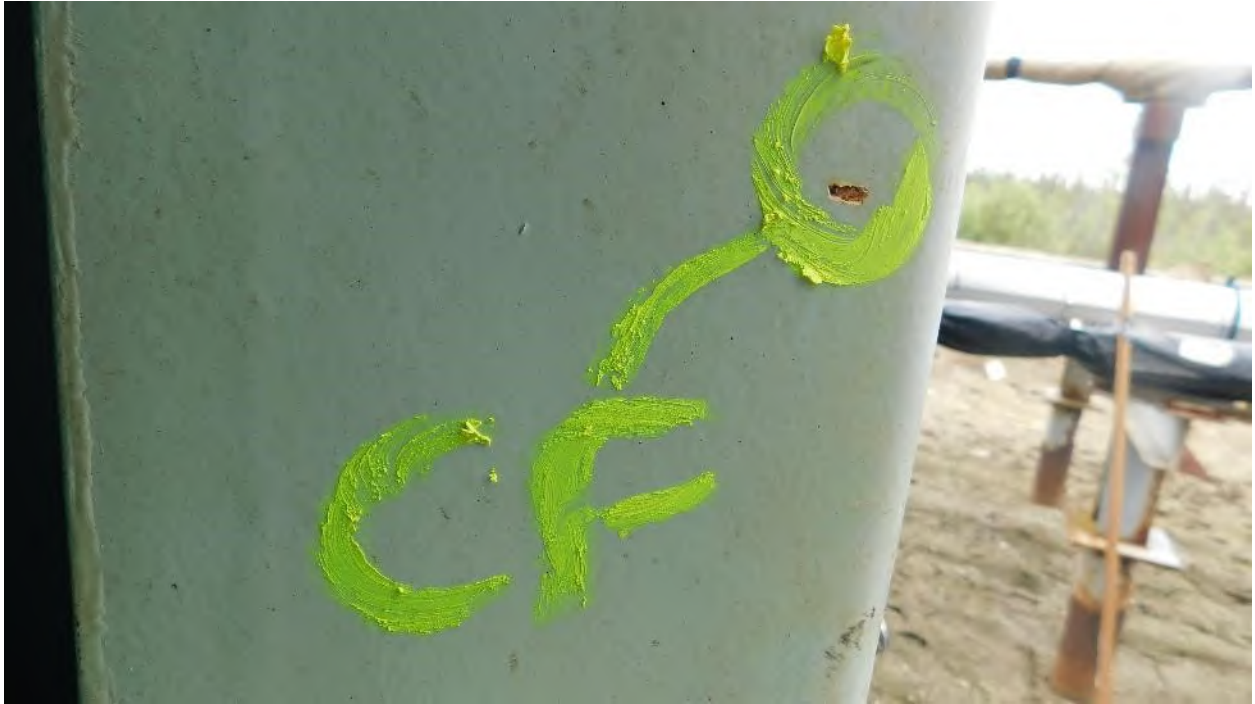
Photograph 55: Manway Coating Failure Detail

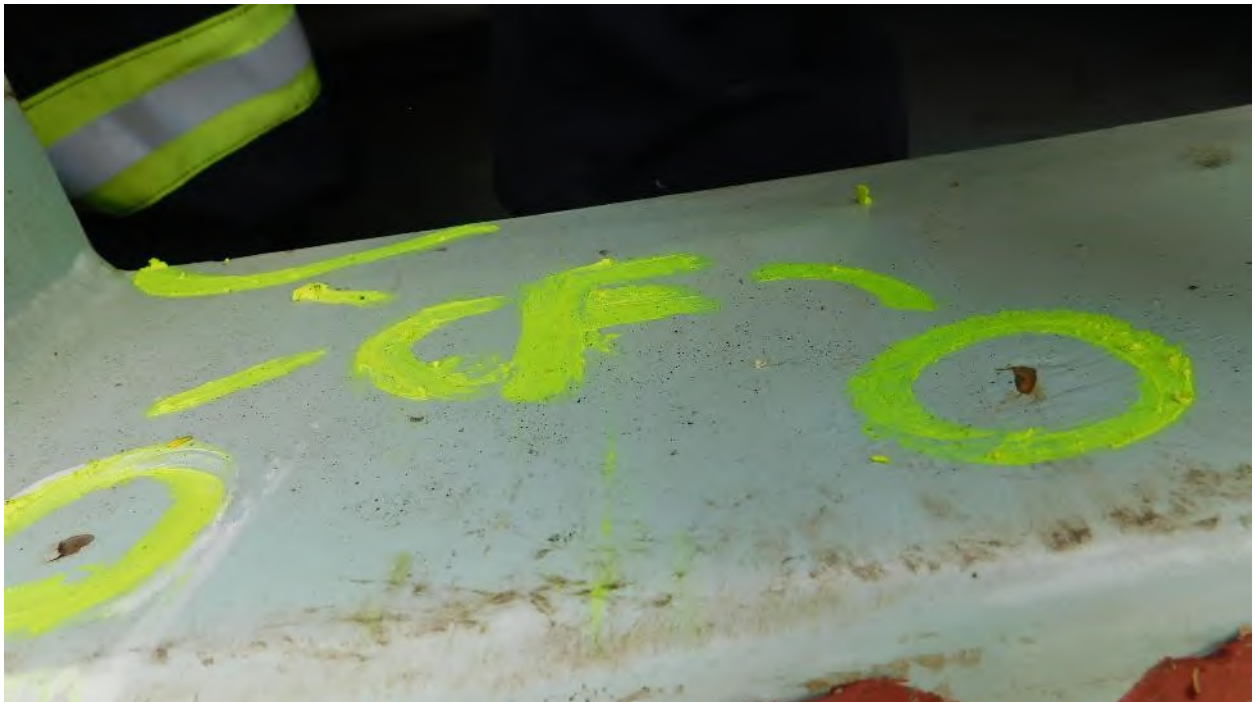
Photograph 56: Manway Coating Failure Detail

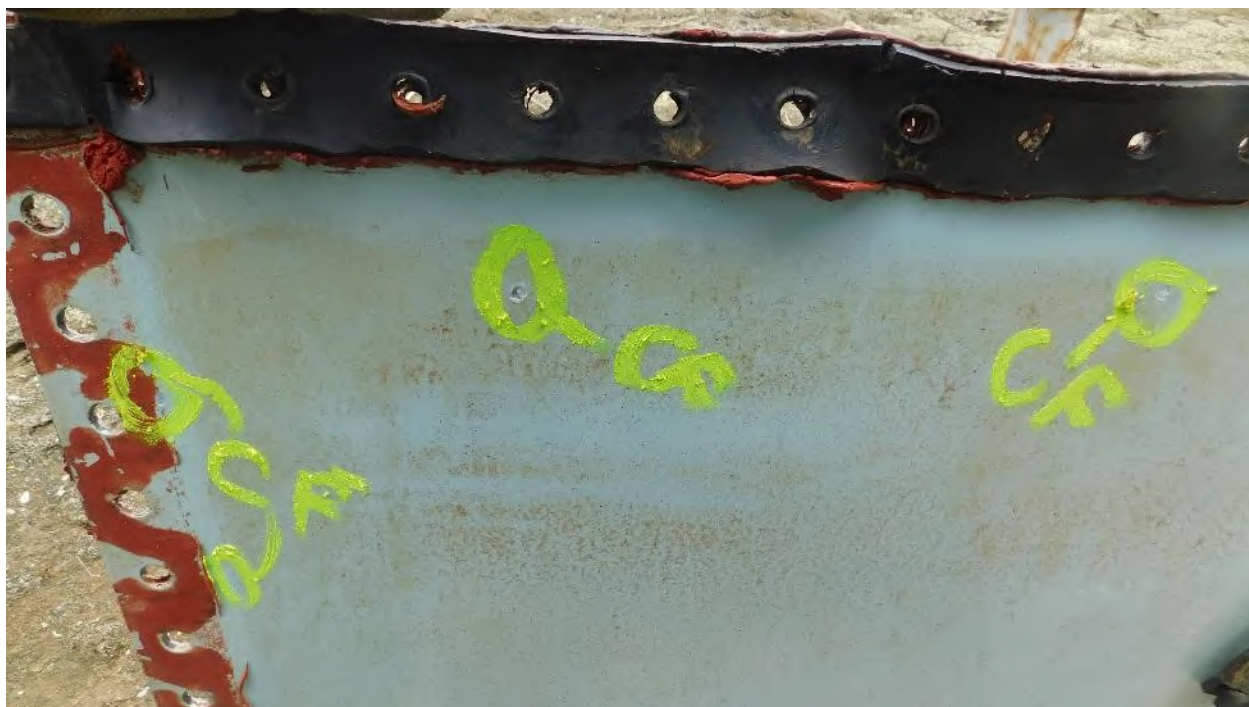
Photograph 63: Manway Cover – Coating Failure
