API 653 ABOVE GROUND STORAGE TANK INTERNAL AND EXTERNAL INSPECTION REPORT

TANK SERIAL # STTK-QI-T1-15643

DATE: JULY 8 / 2025

NEXTGEN JOB # 18248

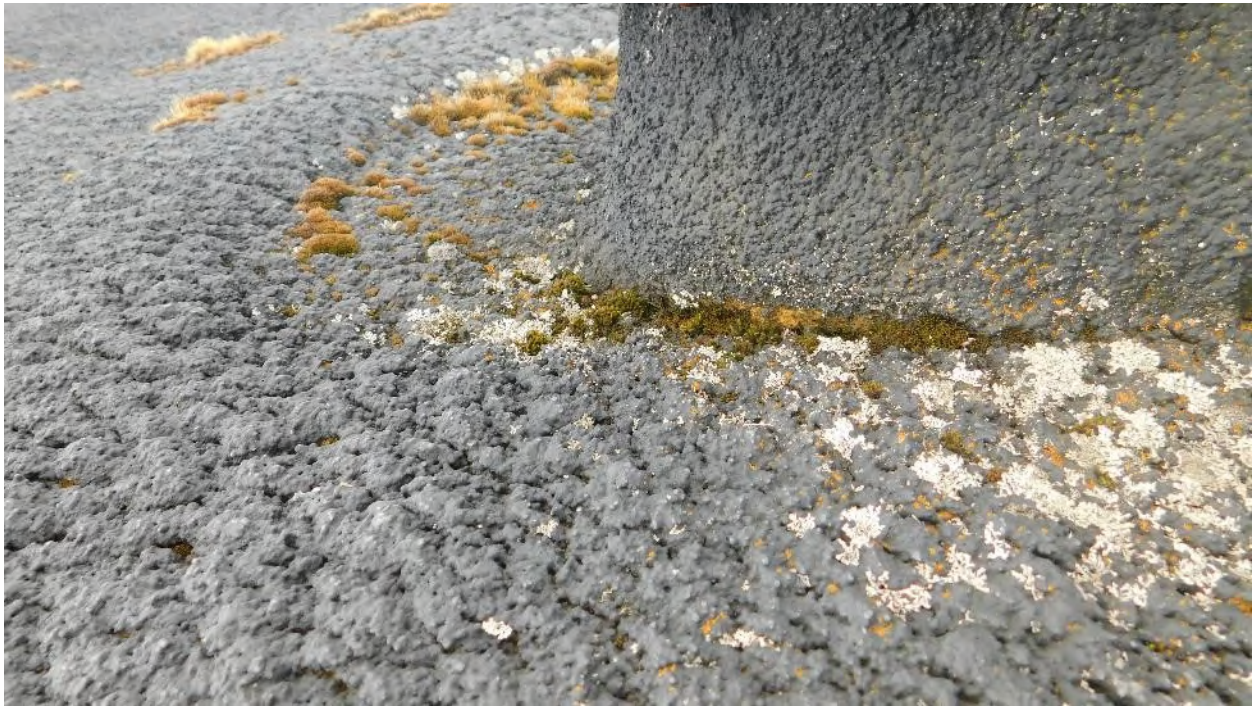
Photograph 68: Gauge Hatch Neck Detail – Moss Growth

- 12.5.1 It is recommended to remove the moss growth from the fixed roof and around the nozzles and investigate the cause of accumulated water in these areas to prevent insulation degradation.
- 12.5.2 It is recommended to install a safety gate / chain at the entrance to the platform.

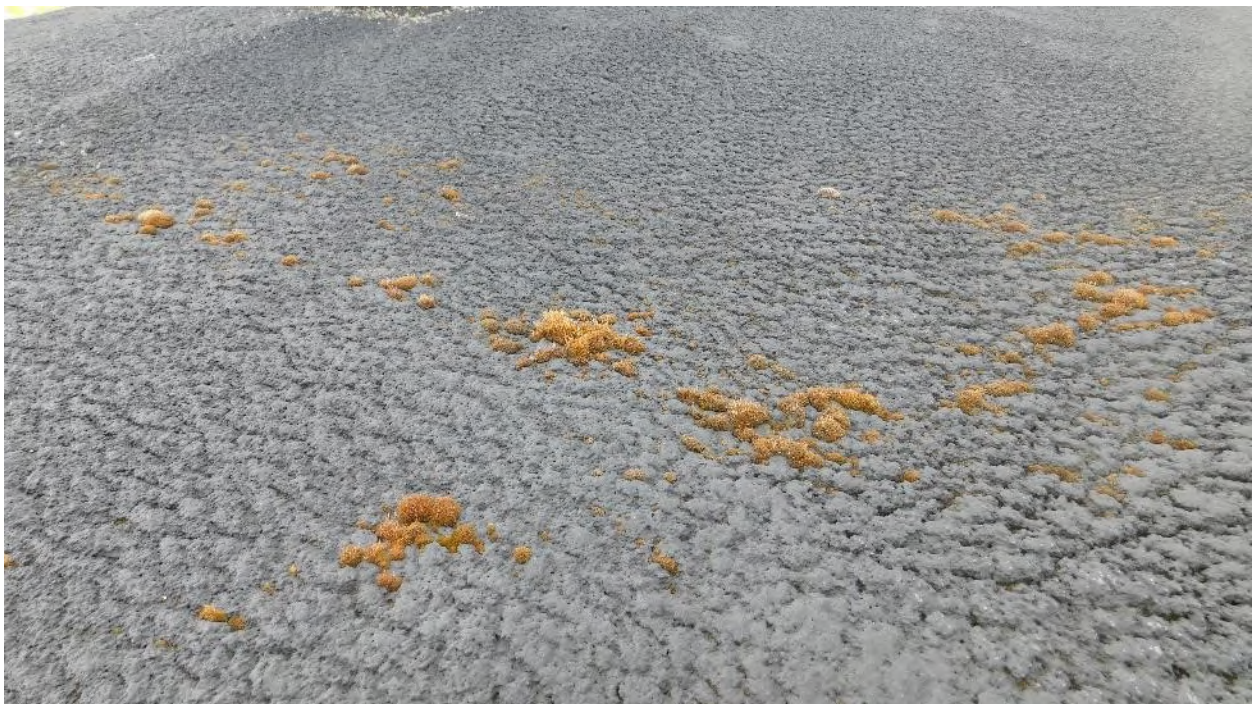
- 1.5.1 A visual examination was performed on the fixed roof from the vertical ladder.
- 1.5.2 The fixed roof was observed to be foam insulated and in acceptable condition. Moss growth was observed throughout the fixed roof.
- 1.5.3 The gooseneck vent was observed to be in acceptable condition with a clean mesh screen.
- 1.5.4 All nozzles and attachments on the fixed roof were observed to be insulated and in acceptable condition. Minor insulation damage and moss growth were observed around the nozzles.
- 1.5.5 No safety gate / chain was observed on the vertical ladder.
- 1.5.6 An internal visual examination of the fixed roof was performed from the bottom plate and was observed to be in acceptable condition.
- 1.5.7 Refer to Fixed Roof Photographs for additional details on the items listed above.

Photograph 69: Fixed Roof – Moss Growth

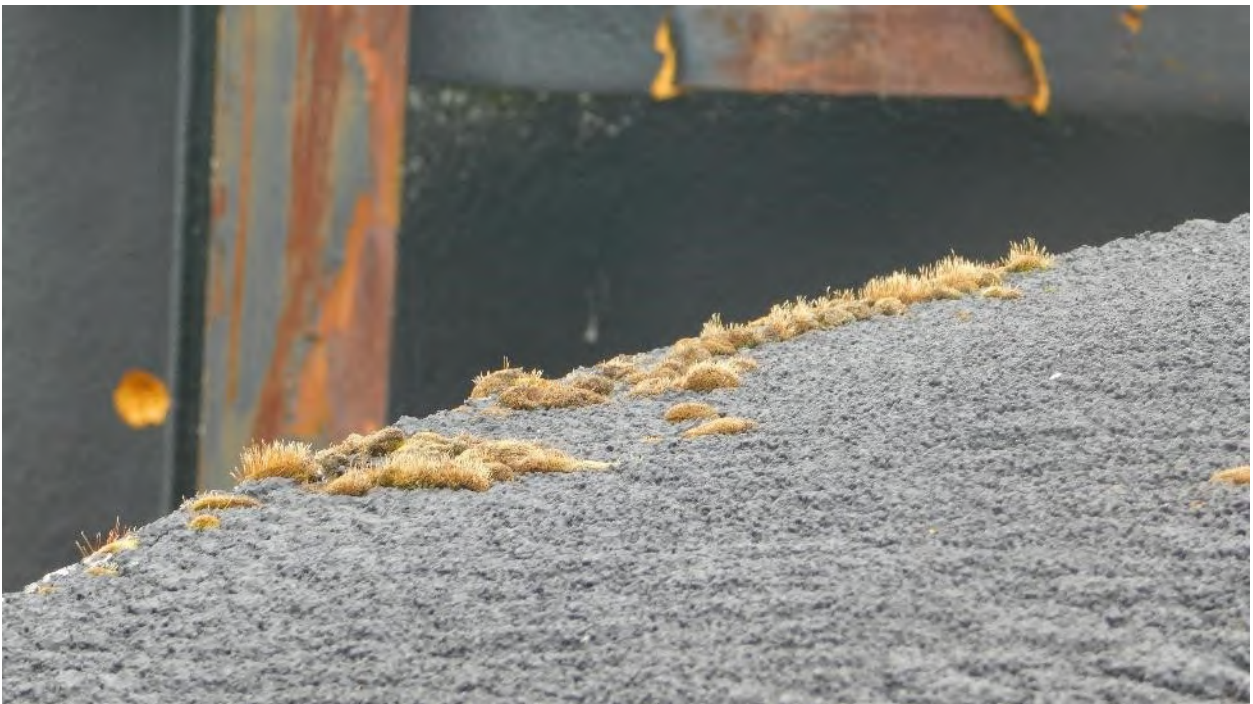
Photograph 73: Fixed Roof – Moss Growth
