## ULTRASONIC THICKNESS INSPECTION REPORT

40BBL TANK

TANK SERIAL #16220

### 40BBL TANK SERIAL #16220 THICKNESS TEST

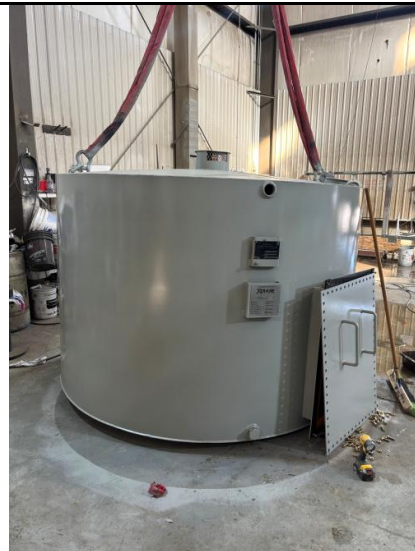
#### Overview 1

THICKNESS TESTING PERFORMED ON VESSEL ABOVE ON RANDOM SPOTS ON SHELL/ FLOOR AND ROOF AS PER CUSTOMER. RESULTS ARE RECORDED ON THE FOLLOWING PAGE.

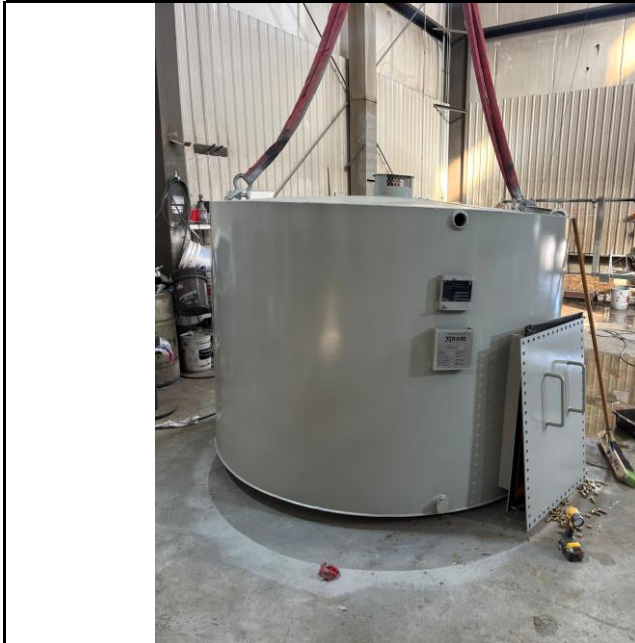
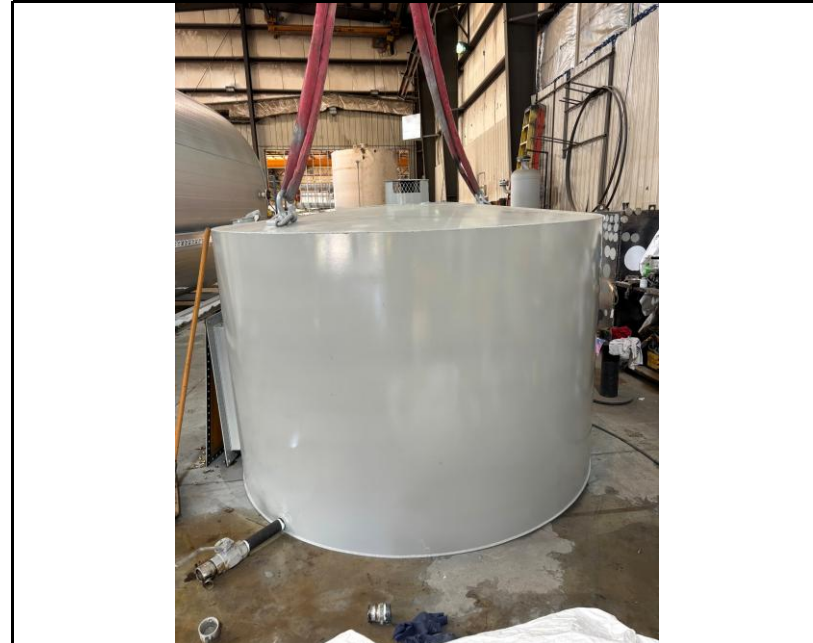
Information On Above: ↓ Material:> Carbon Steel Surface Condition:> Painted / Coated Information On Above: ↓ Material:> Carbon Steel Surface Condition:> Painted / Coated  
CML1-6 (SHELL)/ CML7-9 (ROOF)/ CML10-12 (FLOOR). RESULTS ARE RECORDED IN INCHES. CML1-6 (SHELL)/ CML7-9 (ROOF)/ CML10-12 (FLOOR). RESULTS ARE RECORDED IN INCHES.
