# API 510 PRESSURE VESSEL INSPECTION REPORT

| FACILITY: | Septimus Compressor Station | APPLUS JOB NO.: | 4051051 |
| VESSEL NAME: | Fuel Gas Scrubber | STATUS: | <input type="checkbox"/> In-service <input checked="" type="checkbox"/> Out of Service |

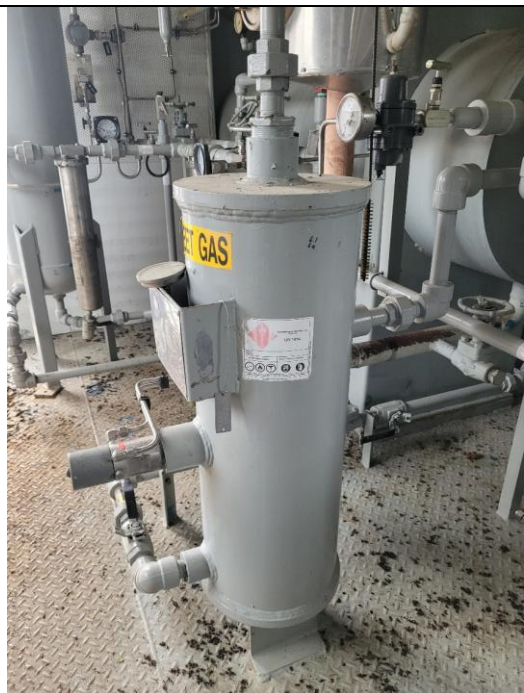
Vessel Overview

| DESCRIPTION | CONDITION | COMMENTS |
|---|---|---|
| <b>VISUAL EXTERNAL SUMMARY:</b> | Visual external inspection carried out – vessel is in good overall condition. Equipment has been out of service for several years. No corrosion or mechanical damage. No sign of leaks. No items of concern. PSV requires service.<br><br><b>Fit for Service</b> | |

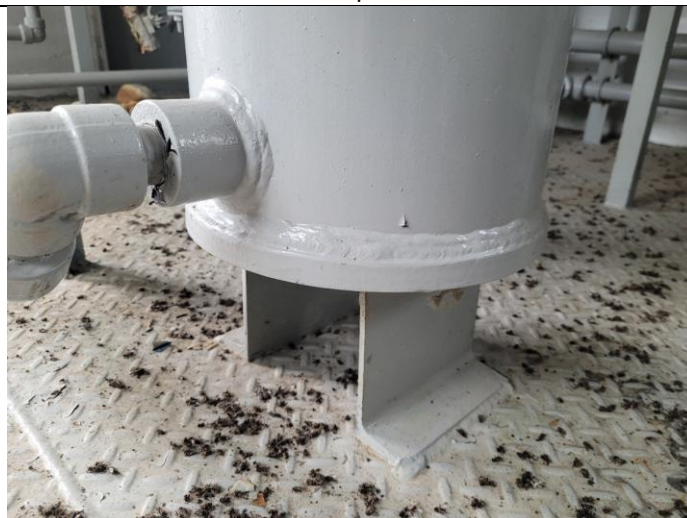
Base

| DESCRIPTION | CONDITION | COMMENTS |
|---|---|---|
| <b>Saddle/Skirt</b> Assess condition of paint, fire protection, concrete. Look for corrosion, buckling, dents, etc. Look at vessel surface area near supports. Verify no signs of leakage at attachment to vessel and attachment welds are acceptable. Ground wire attached? | Good | Flat base - paint is in good condition – no corrosion, buckling or dents. Attachment welds are acceptable – no sign of leaks.<br><br>Skid is grounded |

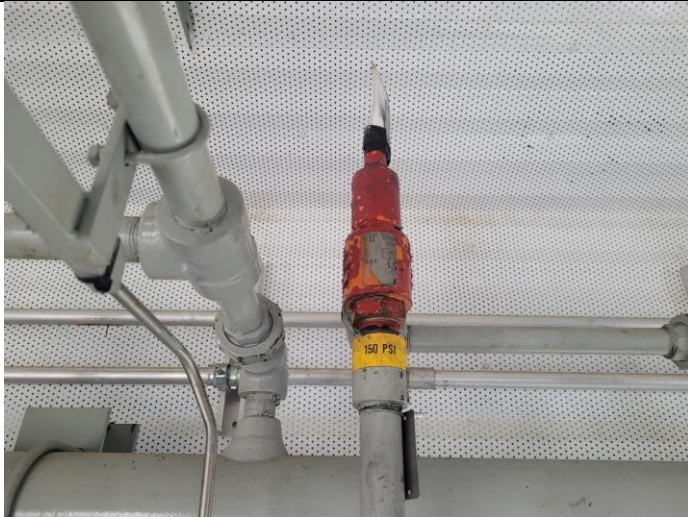
| DESCRIPTION | CONDITION | COMMENTS |
|---|---|---|
| <b>PSV</b> Ensure PSV is set at pressure at or below that of vessel. Discharge piping is same size as inlet to valve and is properly supported and routed. Ensure no block valves between PSV and vessel or if there are they are locked open. | | PSV is set at vessel MAWP – discharge piping is properly supported and routed – no block valve. PSV is due for service |
