# API 510 PRESSURE VESSEL INSPECTION REPORT

| FACILITY: | Septimus Compressor Station | APPLUS JOB NO.: | 4051051 |
| VESSEL NAME: | Glycol Flash Tank | STATUS: | <input type="checkbox"/> In-service <input checked="" type="checkbox"/> Out of Service |
| EQUIPMENT NO.: | V-2270 | INSPECTION TYPE: | <input checked="" type="checkbox"/> Regulatory <input type="checkbox"/> Inventory <input checked="" type="checkbox"/> VE <input type="checkbox"/> VI |

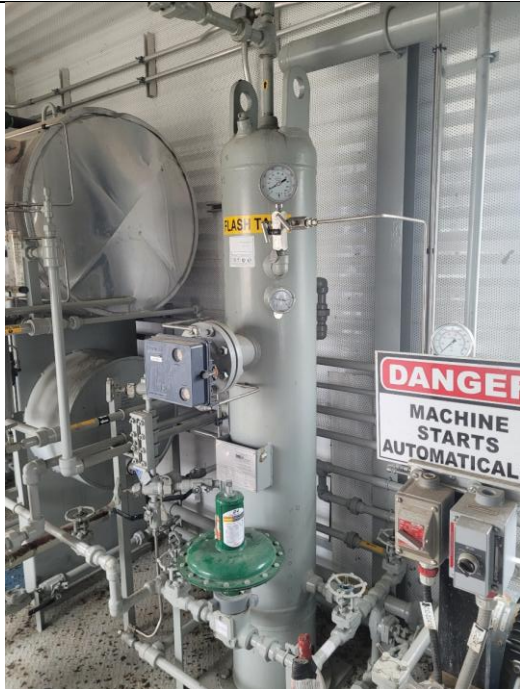
Vessel Overview

| DESCRIPTION | CONDITION | COMMENTS |
|---|---|---|
| <b>VISUAL EXTERNAL SUMMARY:</b> | Visual external inspection carried out – vessel is in good overall condition. Equipment has been out of service for several years. No corrosion or mechanical damage. No sign of leaks. No items of concern. PSV requires service. | |

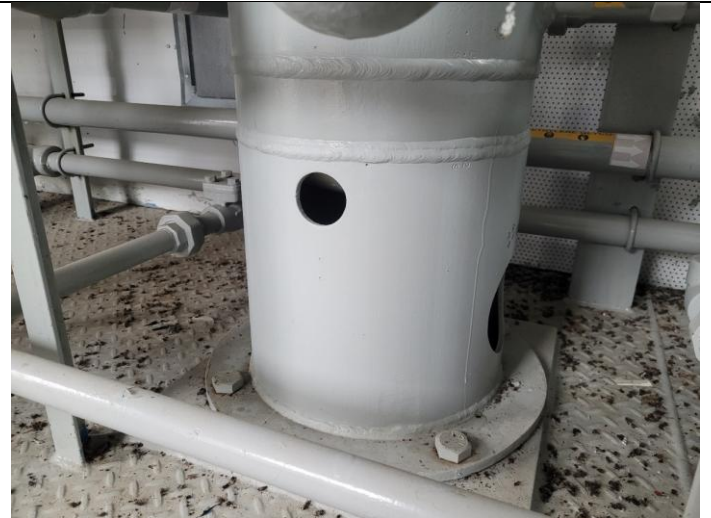
| DESCRIPTION | CONDITION | COMMENTS |
|---|---|---|
| <b>Saddle/Skirt</b> Assess condition of paint, fire protection, concrete. Look for corrosion, buckling, dents, etc. Look at vessel surface area near supports. Verify no signs of leakage at attachment to vessel and attachment welds are acceptable. Ground wire attached? | Good | Skirt – paint is in good condition – no corrosion, buckling or dents. Attachment welds are acceptable – no sign of leaks.<br><br>Ground wire attached to skid |

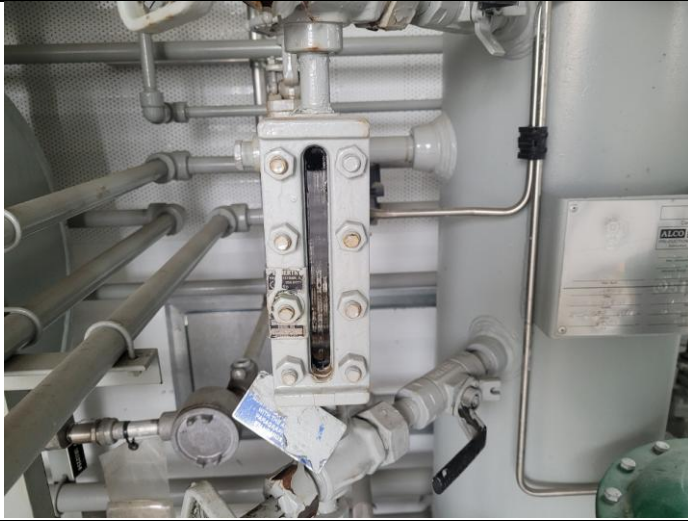
Sight Glass

| DESCRIPTION | CONDITION | COMMENTS |
|---|---|---|
| <b>Sight Glasses, Bridles, Auxiliary Equipment</b> Are sight glasses clean? Any leakage or concerning vibration? Ensure any added supports are intact. | Good | Sight glass is clean and well supported – no evidence of leaks |

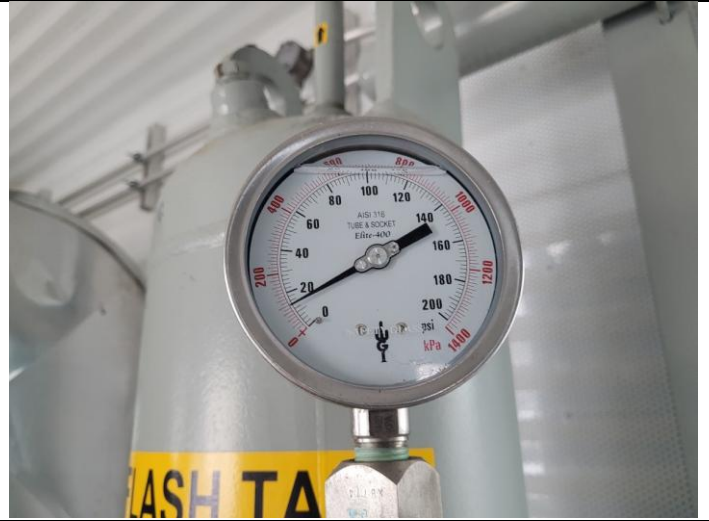
Pressure Gauge

| DESCRIPTION | CONDITION | COMMENTS |
|---|---|---|
| <b>Gauges</b> Ensure gauges are visible, working, no leakage, and suitable for range of MAWP/ Temp. | Good | Gauges are in good condition<br>Pressure gauge 0 – 200 PSI – not a suitable range for MAWP<br>Temperature gauge 0 – 250° F |

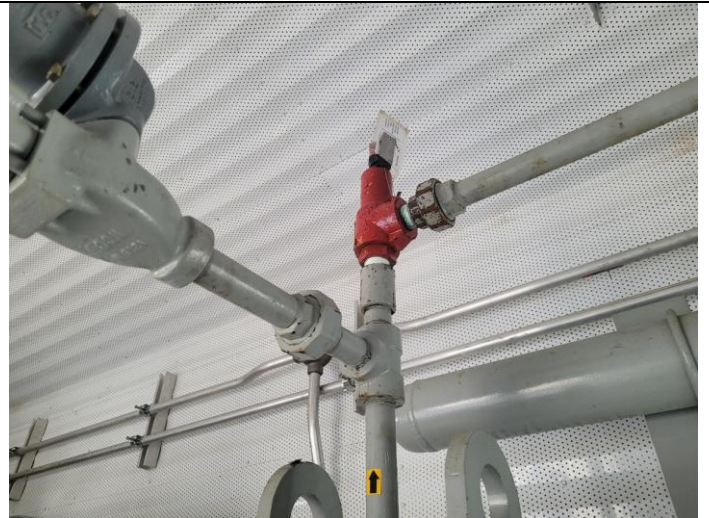
| DESCRIPTION | CONDITION | COMMENTS |
|---|---|---|
| <b>PSV</b> Ensure PSV is set at pressure at or below that of vessel. Discharge piping is same size as inlet to valve and is properly supported and routed. Ensure no block valves between PSV and vessel or if there are they are locked open. | | PSV is set at vessel MAWP – discharge piping is properly supported and routed – no block valve. PSV is due for service |
