API 510 PRESSURE VESSEL INSPECTION REPORT

CLIENT:	Tourmaline Oil Corporation	REPORT NUMBER:	
PROJECT:		INSPECTION DATE:	9/22/2025
FACILITY:	Septimus Compressor Station	APPLUS JOB NO.:	4051051
LOCATION / LSD:	09-36-81-19W6M	ORIENTATION:	<input checked="" type="checkbox"/> Horizontal <input type="checkbox"/> Vertical
VESSEL NAME:	Inline Recycle Separator	STATUS:	<input type="checkbox"/> In-service <input checked="" type="checkbox"/> Out of Service
EQUIPMENT NO.:		INSPECTION TYPE:	<input checked="" type="checkbox"/> Regulatory <input type="checkbox"/> Inventory <input checked="" type="checkbox"/> VE <input type="checkbox"/> VI

PROV. REG. NO.:	A0516853		CRN NUMBER:	R8682.2	
SERIAL NUMBER:	2004-7269-09		SIZE:	8.625" x 48"	
MANUFACTURER:	ALCO GAS & OIL PRODUCTION EQUIP.		CODE PARAMETERS:	ASME VIII, Div. 1	
YEAR BUILT:	2004		MANWAY ACCESS:	NO	
RADIOGRAPHY:	RT-1		HEAT TREATMENT:		
COATED:			CORR. ALLOWANCE:	0.125"	
SHELL THICKNESS:	0.594"/0.719"		SHELL MATERIAL:	SA-234 WPB/106B	
HEAD THICKNESS:	0.594"		HEAD MATERIAL:	SA-234	
TUBE THICKNESS:			TUBE MATERIAL:		
TUBE DIAMETER:			TUBE LENGTH:		
DESIGN PRESSURE:	SHELL:	1415 PSI	OPERATING PRESSURE:	SHELL:	
	TUBES:			TUBES:	
DESIGN TEMPERATURE:

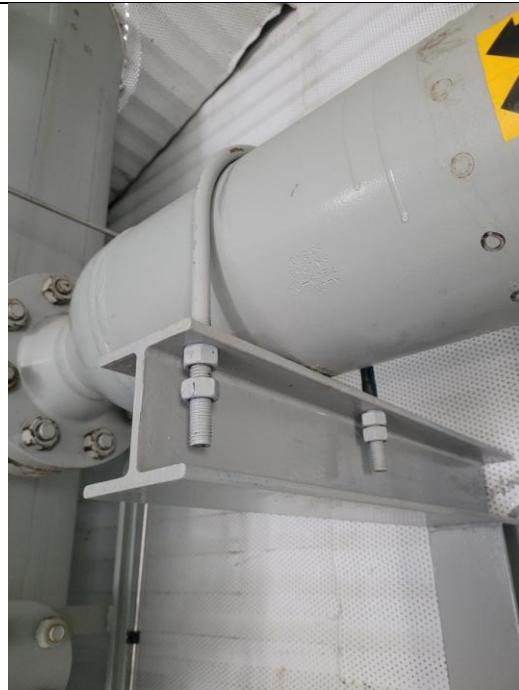
Anchoring

DESCRIPTION	CONDITION	COMMENTS
Insulation Verify sealed around manways, nozzles, no damage present, and there is no egress of moisture.	N/A	Vessel is not insulated
External Condition Assess paint condition, areas peeling, record any corrosion, damage, etc. (record location, size and depth of corrosion or damage)	Good	Paint is in good overall condition – no corrosion or mechanical damage – no bare metal.
Leakage Record any leakage at flanges, threaded joints, weep holes on repads, etc.	N/A	No evidence of previous leakage
Saddle/Skirt Assess condition of paint, fire protection, concrete. Look for corrosion, buckling, dents, etc. Look at vessel surface area near supports. Verify no signs of leakage at attachment to vessel and attachment welds are acceptable. Ground wire attached?	N/A	None – vessel is mounted inline
Anchor Bolts Hammer tap to ensure secure. Look for cracking in treads or signs of deformation.	N/A	Pipe clamps for vessel anchoring – secure

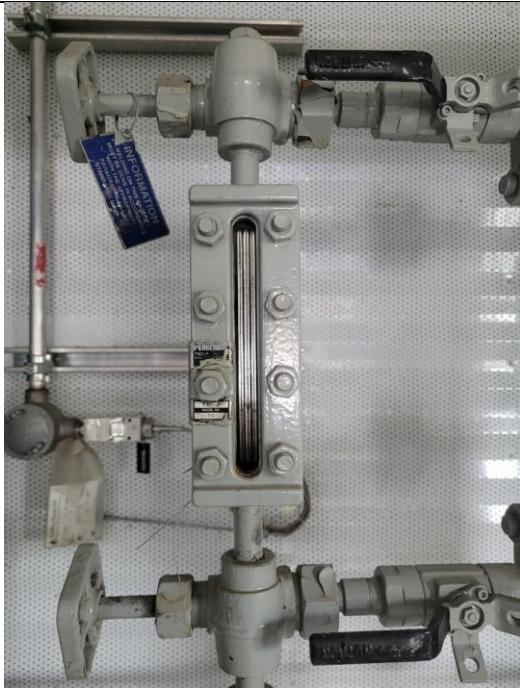
Sight glass

Sight Glasses, Bridles, Auxiliary Equipment Are sight glasses clean? Any leakage or concerning vibration? Ensure any added supports are intact.	Good	Sight glasses are clean and well supported – no evidence of leaks
PSV Ensure PSV is set at pressure at or below that of vessel. Discharge piping is same size as inlet to valve and is properly supported and routed. Ensure no block valves between PSV and vessel or if there are they are locked open.		PSV is set at vessel MAWP – discharge piping is properly supported and routed – no block valve. PSV is due for service
VISUAL EXTERNAL SUMMARY:	Visual external inspection carried out – vessel is in good overall condition. Equipment has been out of service for several years. No corrosion or mechanical damage. Sign of leaks. No items of concern. PSV requires service.	
	Fit for Service	
RECOMMENDATIONS:		
NCRs / CORRECTIVE ACTIONS / REPAIRS REQUIRED:		
SUMMARY OF NDE RESULTS:	Ultrasonic thickness testing carried out – no metal thickness detected below nominal minus corrosion allowance
