## API 510 PRESSURE VESSEL INSPECTION REPORT

CLIENT:	Tourmaline Oil Corporation	REPORT NUMBER:	
PROJECT:		INSPECTION DATE:	9/22/2025
FACILITY:	Septimus Compressor Station	APPLUS JOB NO.:	4051051
LOCATION / LSD:	09-36-81-19W6M	ORIENTATION:	<input type="checkbox"/> Horizontal <input checked="" type="checkbox"/> Vertical
VESSEL NAME:	Glycol Charcoal Filter	STATUS:	<input type="checkbox"/> In-service <input checked="" type="checkbox"/> Out of Service
EQUIPMENT NO.:		INSPECTION TYPE:	<input checked="" type="checkbox"/> Regulatory <input type="checkbox"/> Inventory <input checked="" type="checkbox"/> VE <input type="checkbox"/> VI

PROV. REG. NO.:	<b>V116560</b>		CRN NUMBER:	<b>R-9739.213</b>	
SERIAL NUMBER:	JI2007-134		SIZE:	10.75" x 48"	
MANUFACTURER:	JL FILTRATION INC.		CODE PARAMETERS:	ASME VIII, Div. 1	
YEAR BUILT:	2007		MANWAY ACCESS:	NO	
RADIOGRAPHY:			HEAT TREATMENT:		
COATED:			CORR. ALLOWANCE:		
SHELL THICKNESS:			SHELL MATERIAL:		
HEAD THICKNESS:			HEAD MATERIAL:		
TUBE THICKNESS:			TUBE MATERIAL:		
TUBE DIAMETER:			TUBE LENGTH:		
DESIGN PRESSURE:	SHELL:	3103 kPa	OPERATING PRESSURE:	SHELL:	
	TUBES:			TUBES:	
DESIGN TEMPERATURE:	SHELL:	121 °C	OPERATING TEMPERATURE:	SHELL:	
	TU

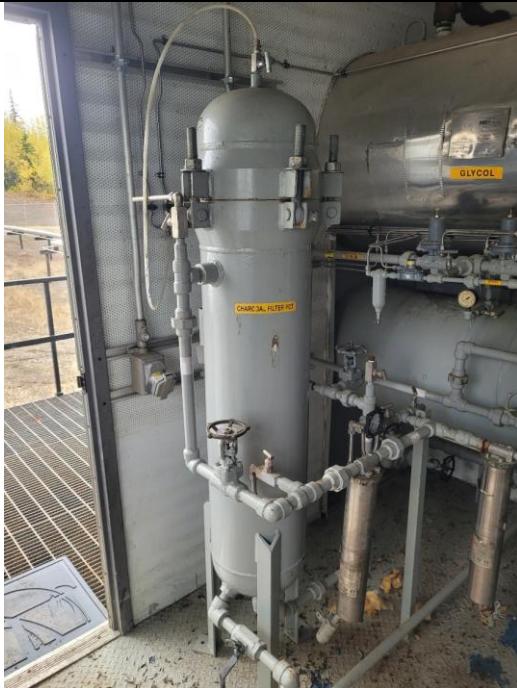
Vessel Overview

DESCRIPTION	CONDITION	COMMENTS
<b>Insulation</b> Verify sealed around manways, nozzles, no damage present, and there is no egress of moisture.	N/A	Vessel is not insulated
<b>External Condition</b> Assess paint condition, areas peeling, record any corrosion, damage, etc. (record location, size and depth of corrosion or damage)	Good	Paint is in good overall condition – no corrosion or mechanical damage – no bare metal.
<b>Leakage</b> Record any leakage at flanges, threaded joints, weep holes on repads, etc.	N/A	No evidence of previous leakage
<b>Saddle/Skirt</b> Assess condition of paint, fire protection, concrete. Look for corrosion, buckling, dents, etc. Look at vessel surface area near supports. Verify no signs of leakage at attachment to vessel and attachment welds are acceptable. Ground wire attached?	Good	Legs - paint is in good condition – no corrosion, buckling or dents. Attachment welds are acceptable – no sign of leaks.  Skid is grounded

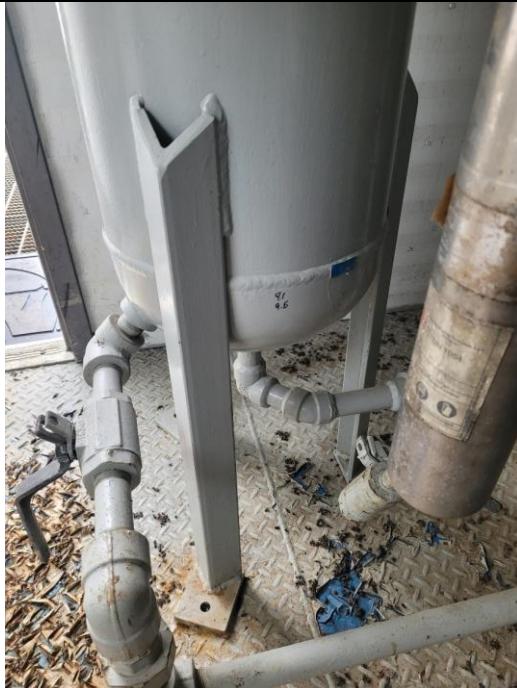
Support Legs

<b>Anchor Bolts</b> Hammer tap to ensure secure. Look for cracking in treads or signs of deformation.	Good	Securely welded to the skid deck
<b>Foundation</b> Check for cracks, spalling, etc.	N/A	Steel skid
<b>Ladder / Platform</b> Describe general condition, ensure support is secure to vessel, describe any hazards.	N/A	None
<b>Nozzle</b> Assess paint, look for leakage, and ensure stud threads are fully engaged. Record any damage, deflection, etc. Are nozzles gusseted?	Good	Paint is in good condition – no leakage. No damage or deflection
<b>Gauges</b> Ensure gauges are visible, working, no leakage, and suitable for range of MAWP/ Temp.	N/A	None
<b>External Piping</b> Ensure pipe is well supported. All clamps, supports, shoes, etc. in place. Look for evidence of structural overload, deflection, etc. Paint condition, external corrosion?	Good	Piping is well supported – all clamps, supports, and shoes are in place. No evidence of structural overload. Paint is in good condition – no corrosion

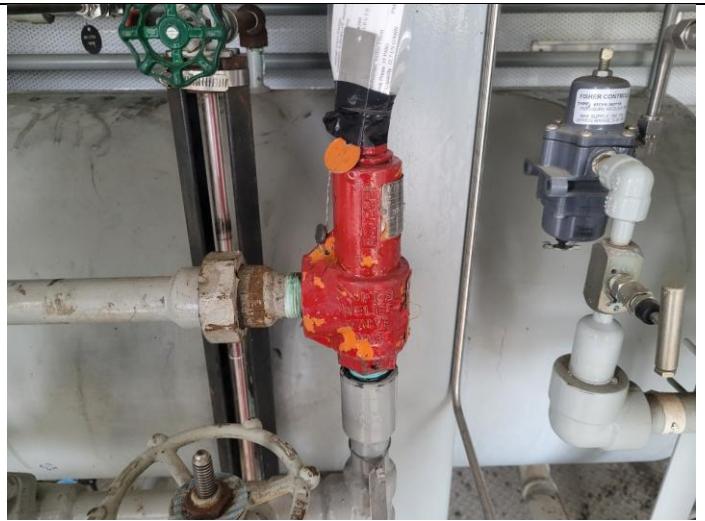
<b>Valving</b> Ensure no leaks are visible. Valves are properly supported and chained if necessary.	Good	No leaks – well supported
<b>Sight Glasses, Bridles, Auxiliary Equipment</b> Are sight glasses clean? Any leakage or concerning vibration? Ensure any added supports are intact.	N/A	None
<b>PSV</b> Ensure PSV is set at pressure at or below that of vessel. Discharge piping is same size as inlet to valve and is properly supported and routed. Ensure no block valves between PSV and vessel or if there are they are locked open.		PSV is set below vessel MAWP – discharge piping is properly supported and routed – no block valve. PSV is due for service
<b>VISUAL EXTERNAL SUMMARY:</b>	Visual external inspection carried out – vessel is in good overall condition. Equipment has been out of service for several years. No corrosion or mechanical damage. No sign of leaks. No items of concern. PSV requires service.
