API 510 PRESSURE VESSEL INSPECTION REPORT

CLIENT:	Tourmaline Oil Corporation	REPORT NUMBER:	
PROJECT:		INSPECTION DATE:	9/22/2025
FACILITY:	Septimus Compressor Station	APPLUS JOB NO.:	4051051
LOCATION / LSD:	09-36-81-19W6M	ORIENTATION:	<input type="checkbox"/> Horizontal <input checked="" type="checkbox"/> Vertical
VESSEL NAME:	Glycol Contactor	STATUS:	<input type="checkbox"/> In-service <input checked="" type="checkbox"/> Out of Service
EQUIPMENT NO.:	T-710	INSPECTION TYPE:	<input checked="" type="checkbox"/> Regulatory <input type="checkbox"/> Inventory <input checked="" type="checkbox"/> VE <input type="checkbox"/> VI

PROV. REG. NO.:	A0516851		CRN NUMBER:	R-8686.2	
SERIAL NUMBER:	2004-7269-01		SIZE:	20" x 40'	
MANUFACTURER:	ALCO GAS & OIL PRODUCTION EQUIP.		CODE PARAMETERS:	ASME VIII, Div. 1	
YEAR BUILT:	2004		MANWAY ACCESS:	NO	
RADIOGRAPHY:	RT-1		HEAT TREATMENT:	YES	
COATED:			CORR. ALLOWANCE:	0.125"	
SHELL THICKNESS:	0.930"		SHELL MATERIAL:	SA 516 70N	
HEAD THICKNESS:			HEAD MATERIAL:	SA 516-70N	
TUBE THICKNESS:			TUBE MATERIAL:		
TUBE DIAMETER:			TUBE LENGTH:		
DESIGN PRESSURE:	SHELL:	1415 PSI	OPERATING PRESSURE:	SHELL:	
	TUBES:			TUBES:	
DESIGN TEMPERATURE:	SHELL:	150 °F	O

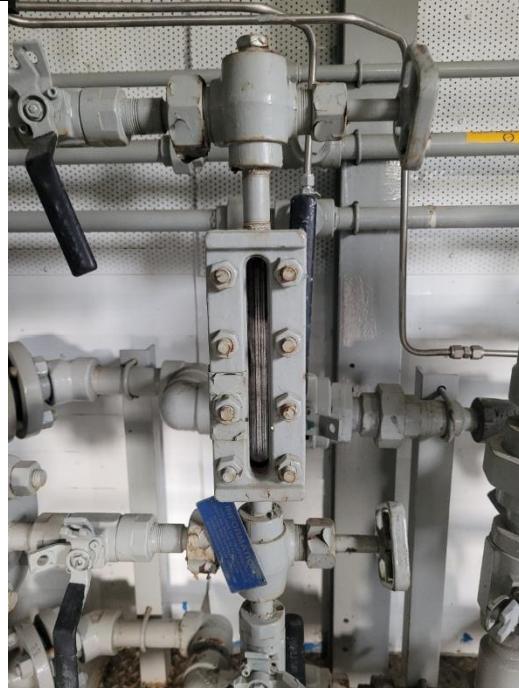
Sight glass

Valving Ensure no leaks are visible. Valves are properly supported and chained if necessary.	Good	No leaks – well supported
Sight Glasses, Bridles, Auxiliary Equipment Are sight glasses clean? Any leakage or concerning vibration? Ensure any added supports are intact.	Good	Sight glasses are clean and well supported – no evidence of leaks
PSV Ensure PSV is set at pressure at or below that of vessel. Discharge piping is same size as inlet to valve and is properly supported and routed. Ensure no block valves between PSV and vessel or if there are they are locked open.		PSV is set at vessel MAWP – discharge piping is properly supported and routed – no block valve. PSV is due for service
VISUAL EXTERNAL SUMMARY:	Visual external inspection carried out – vessel is in good overall condition. Equipment has been out of service for several years. No corrosion or mechanical damage. No sign of leaks. No items of concern. PSV requires service.
