**BOILERS AND PRESSURE VESSELS
REPAIR OR ALTERATION REPORT**

1. Name of Organization doing Repair/Alteration Bromley Mechanical Services, A Division of Argo Sales LP,
Address 925-23 Street S.W., Medicine Hat, Alberta, T1A 8R1 AQP No. & Expiry Date AQP-1009, February 25, 2028
2. Name of Owner Rare Oilfield Services Corp
Address 502 Mitchell Street North East, Redcliff, Alberta T0J 2P0
Location of Installation LSD: 15-35-021-07 W4

3. Boiler/Pressure Vessel Description Horizontal Treater CRN N8993.23
Manufacturer's Name Universal Industries Ltd., Serial No. 97-11-73

Fire Tube Repair

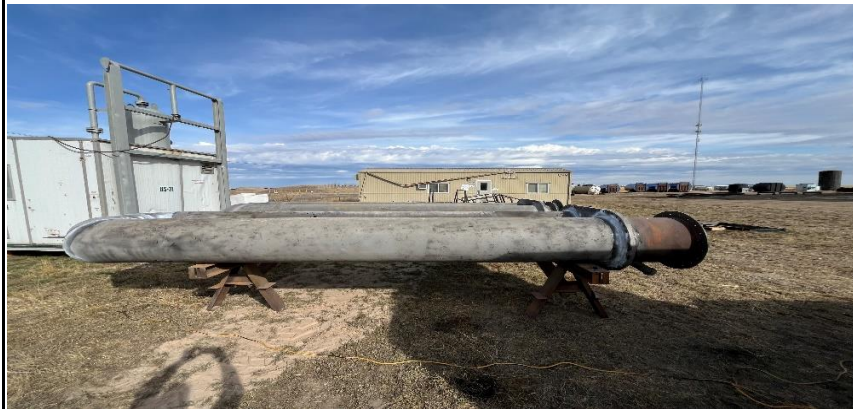
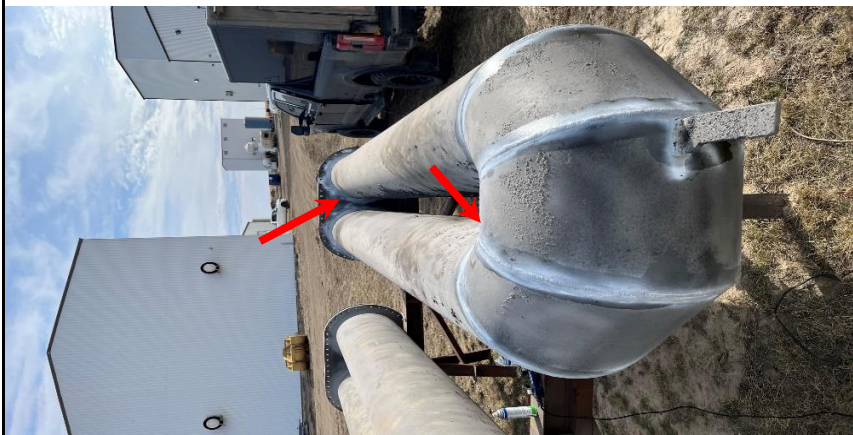
FIRE TUBE 'A'

Crack on pipe to mounting flange at the 9 to 12 O'clock position & crack on miter at the 9 O'clock position

LINEAR INDICATIONS FOUND ON AREAS INDICATED IN ABOVE PHOTOS

1. Baked out Fire Tube @ 750°F for 60 minutes.
2. Investigated indications on Fire Tube.
3. Removed all indications completely using a combination of grinding & MPI checks.
4. QCM inspected the prepared joint prior to welding.
5. Welded out the repairs & carried out NDE (RT) & (MPI).
6. Final inspection by AI/QC.
7. Signed off Travel Sheet & AB40.

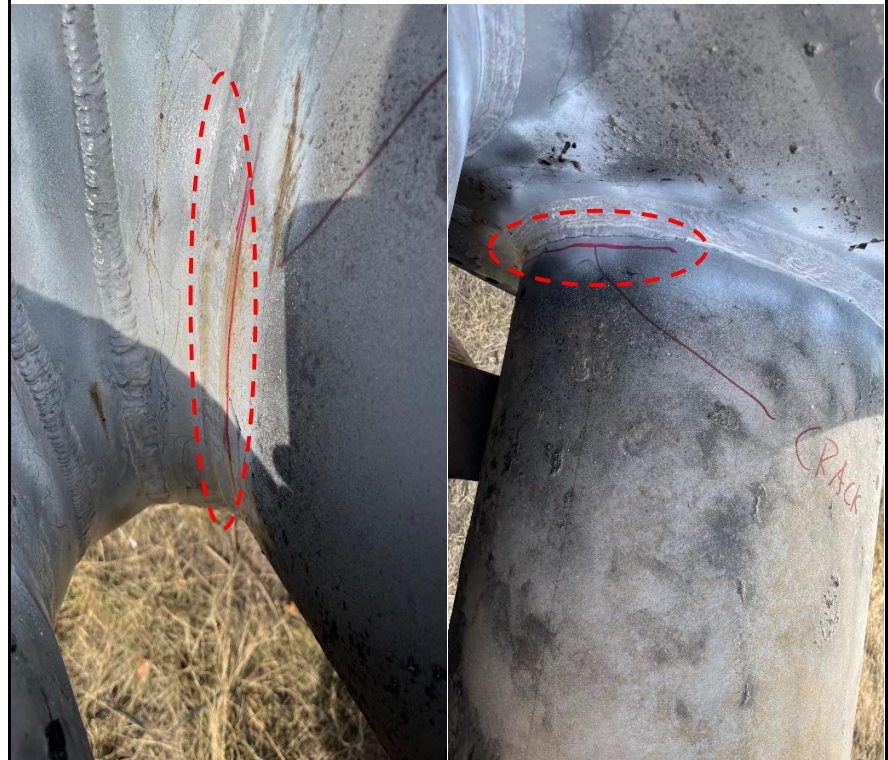
FIRE TUBE 'A' INDICATION

LINEAR INDICATIONS FOUND ON AREAS INDICATED IN ABOVE PHOTOS

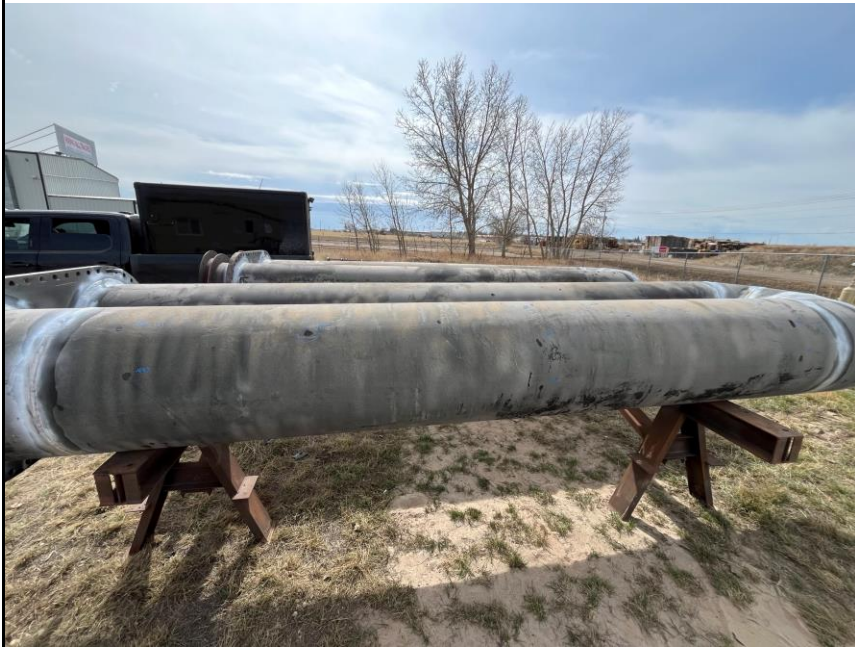
FIRE TUBE 'B'

NO RELEVANT INDICATIONS FOUND AT TIME OF INSPECTION

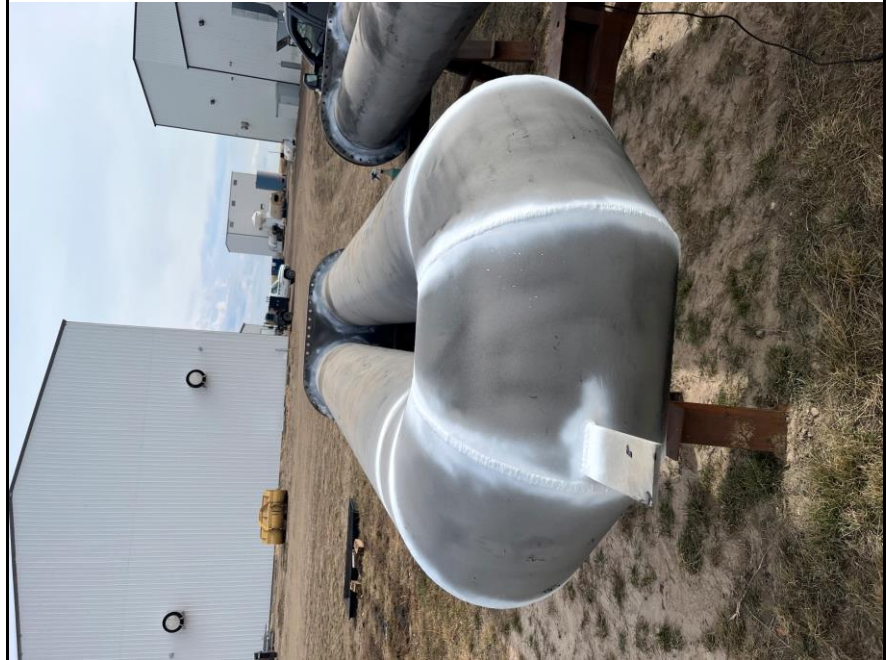
FIRE TUBE 'B'

NO RELEVANT INDICATIONS FOUND AT TIME OF INSPECTION
