Reference: **Fiber scope inspection of 2 NASH vacuum pumps in Kingsey Falls, Qc Canada**

**Inspection Date:** November 1st 2017

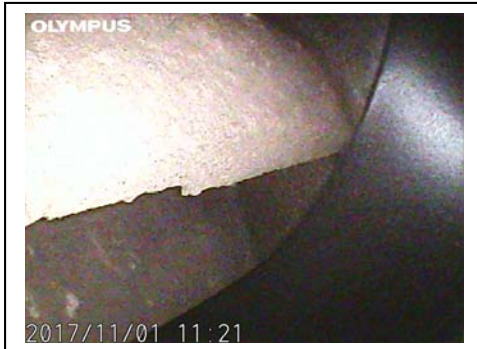
Rotor blade OD is eroded. Head shroud is acceptable.

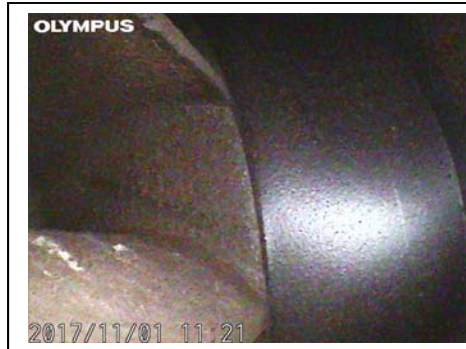
This unit is not cladded. All internal components are cast iron.

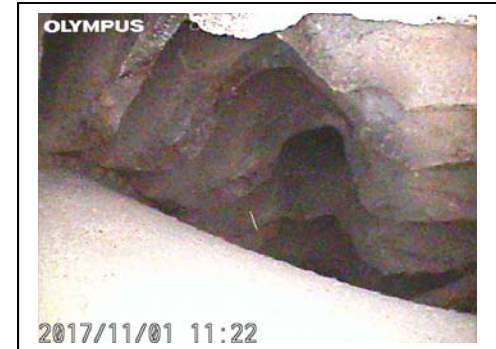
Rotor tapers are completely eroded.

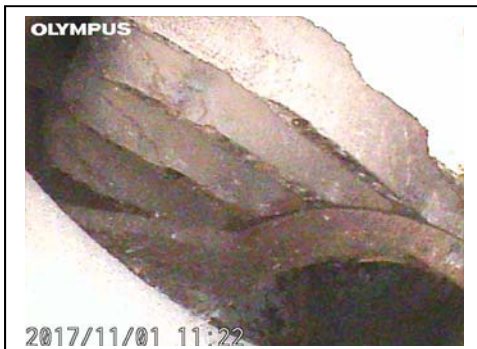
From another angle, eroded tapers, cone edge at the discharge is also worn.

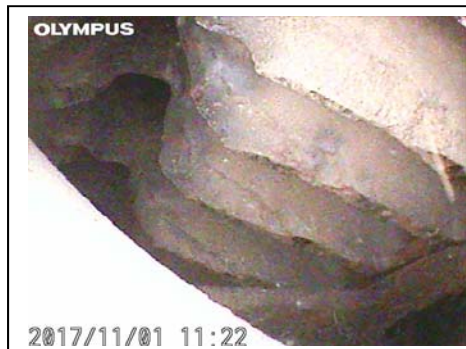
We can clearly see the extent of the erosive wear of all rotor blades.

Although I was only able to inspect the idle end since the drive end plug was seized, this unit has advanced wear on the rotor and cone edges. Unit is 100% cast iron and has seen better days...!!!

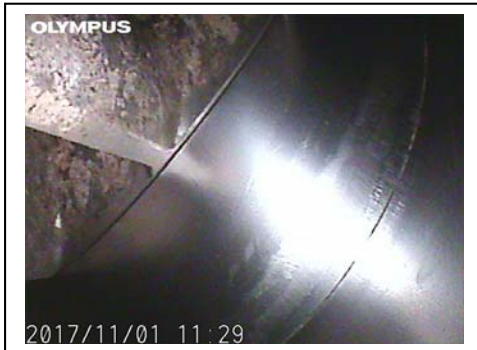
Drive end: below in the compression area, all surfaces are smooth and clean. Head shroud to rotor clearance is tight.

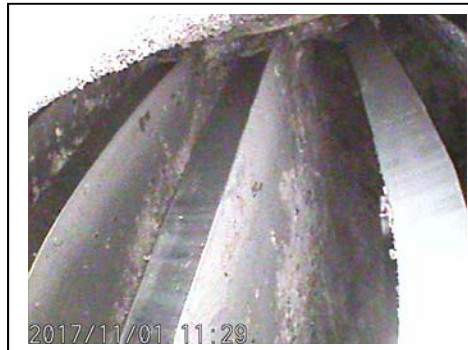
Drive end: Viewed here are three rotor blade tapers; all are square, even and true. Rotor is Stainless Steel cast.

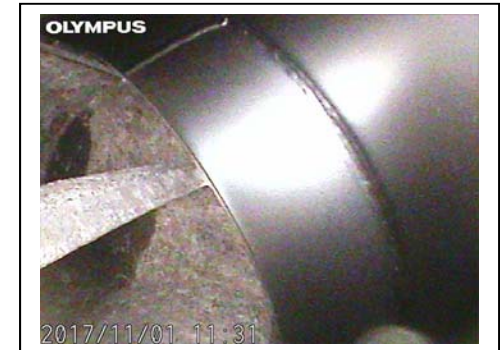
Drive end: Seen here towards the center shroud, tight measurement and smooth surfaces.

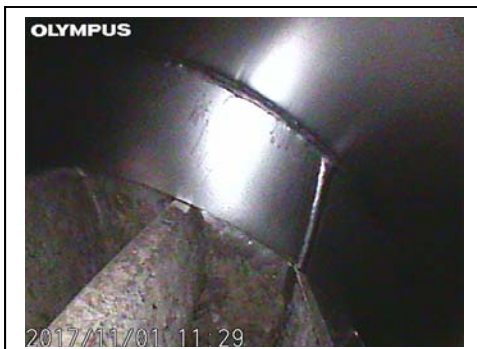
Idle end: Head shroud, body liner and rotor viewed here at the head. All good..!!!!

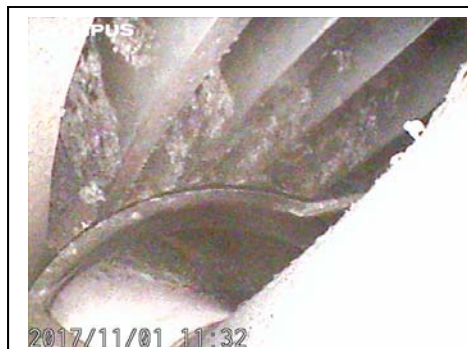
Idle end: Rotor is in near new condition.

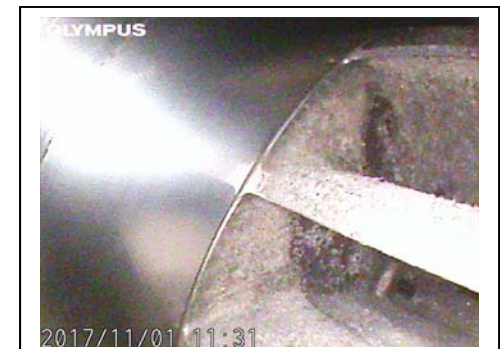
Idle end: close-up view of the center shroud to rotor clearance; very tight measurement.
