# FIELD SERVICE REPORT

Customer Name	Graphic Packaging	Purpose of Visit	Polydisk Thickener Inspection
Location	Middletown OH	Valmet SO #	N176593-001
Contact Name	Jamie Buchheit	Customer PO#	4505379393
Valmet Rep	Jimbo Doucette	Equipment	12'-6" x 17 Polydisk 3000
Dates On-Site	May 18 & 19, 2021	Serial #	SD-349
JOB DESCRIPTION		Date of Report:	June 14, 2021

Graphic Packaging / Middletown OH  
May 18 & 19, 2021

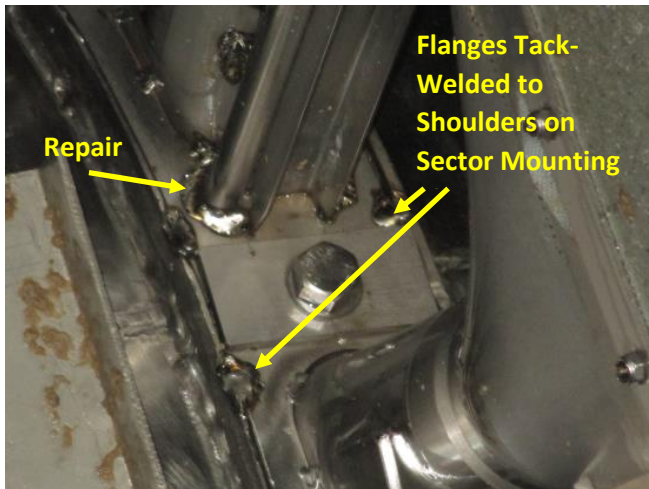
The first broken tie-rod had broken welds at the base. The mill maintains a stick welder at the back end of the Polydisk with some 316L welding rod. The mechanic re-welded the base of the tie-rod to the holder flange. (See photo below left.)

**Tie-Rod Re-Welded to Flange**

3. Sector holder fasteners should be installed with 242 Blue Loctite and torqued to 100 ft-lb.
4. Consider adding deflector plates to the missing disc locations to prevent stock from accumulating and rotting on top of the chutes.

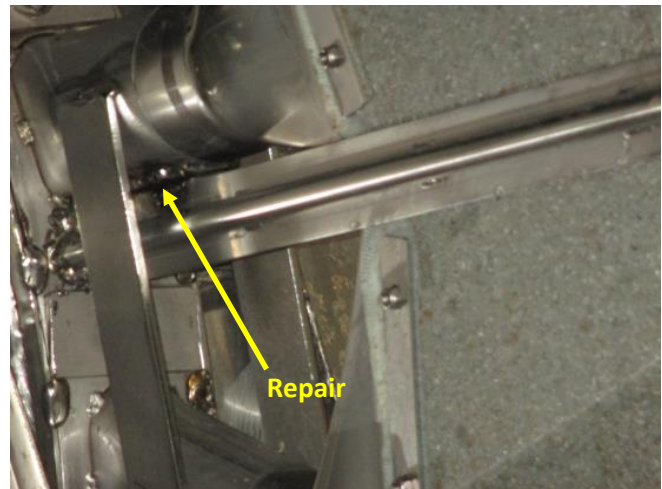
**Tie-Rod Re-Welded to Receiver Tube**

The trailing edge of one sector had come out of the channel in the trailing tie rod. This was because the trailing tie-rod had broken away from the receiver tube and dropped downwards. The mechanic re-welded the tie-rod to the receiver tube. (See photo above right.)

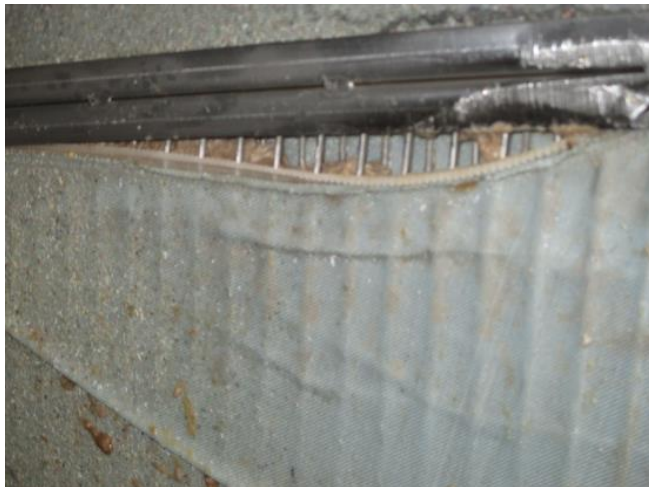
One segment was replaced because the zipper on the bag had pulled apart. It was observed that the bag was installed with its zipper on the sector's leading edge. This allows drag forces during operation to pull at the zipper. Filter bags should be installed with the zipper on the trailing edge (the edge with the round outlet).

**Split Zipper**

1. Review safety policies for working on the Polydisk. Consider requiring the vat to be sniffed prior to going inside to make weld repairs.
2. When re-bagging the sectors, take care to locate the zipper on the trailing edge next to the filtrate outlet, and be sure to replace the O-ring.

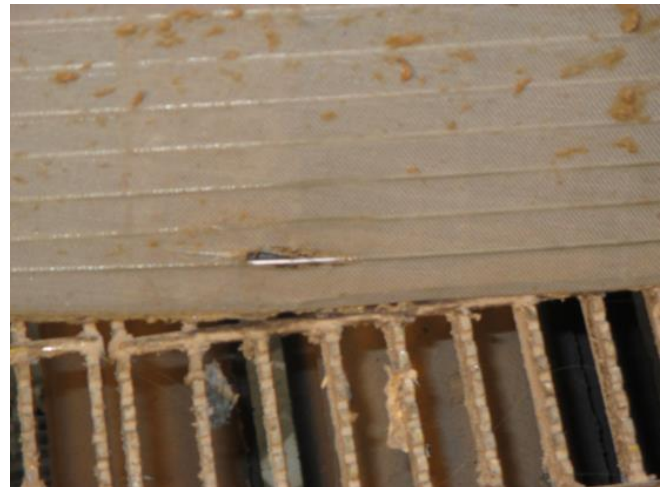
**Hole in Bag**

Another sector was replaced because it had a hole in the bag on the non-drive side near the OD. Most of the disc assemblies have bent tie-rods that lean away drive end. This puts the disc OD on the non-drive end very close to the chute walls, intensifying friction and drag force on the synthetic fabric.

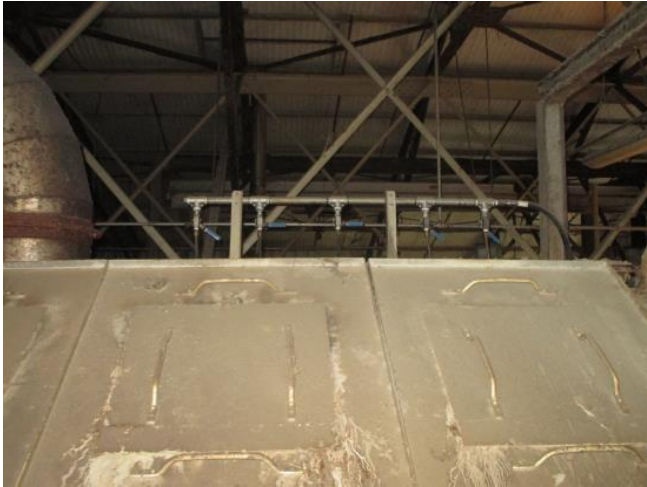
The OEM sluice shower header is not connected to a water source and the original sluice showers have been removed. At the back end of the machine, the mill has installed external sluice showers that pierce the top of the hood to lubricate the last five sluice pans. The sluice pan between discs 16 and 17 was intentionally removed by the mill because stock would pile up on it. This means that stock will now pile up on the centershaft and be carried by shaft rotation back to the feed side of the vat. Another pile of stock had formed on the narrow sluice pan at the drive end.

**External Sluice Showers**

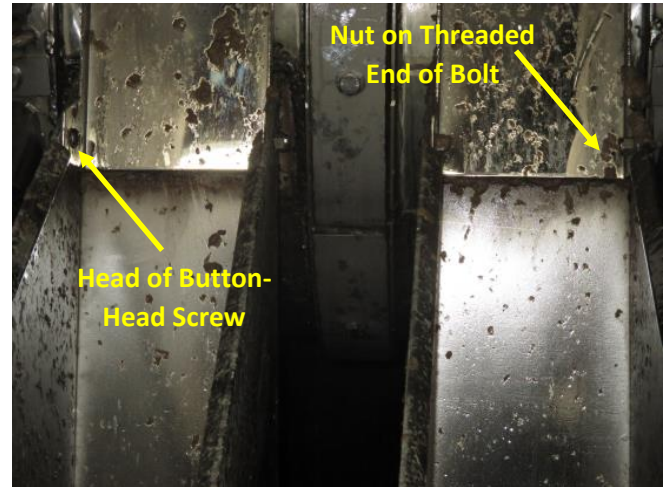
**Sluice Pans**

The sluice pans are secured with two button head bolts. Button head bolts were used by Beloit to minimize the projection of the bolt head into the sluice pan and therefore minimize the potential for pulp mats to hang up on the bolt heads. Unfortunately, the bolts on all but one sluice pan are installed with the nut and the threaded end of the bolt projecting over the sluice pans. It is recommended that the missing sluice pan be re-installed and the bolts on all sluice pans should have the button head inside the sluice pan.

5. Re-install the missing sluice pan between discs #16 & 17 with the head of the button head screw on the inside of the pan to minimize the potential for pulp to become hung up on the fastener. Reverse the other button head screws that are installed with the nut inside the sluice pan.

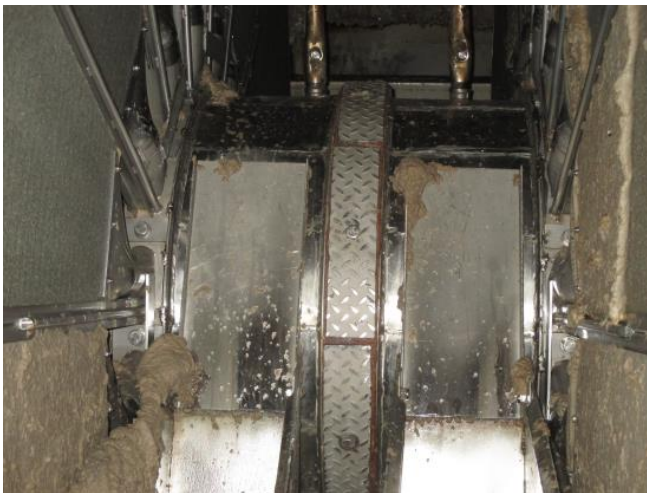
**Centershaft Covers.** The shaft openings at the missing disc locations are covered with plates made by the mill. Each rolled plate covers two shaft openings and is secured by a single bolt in the middle. Some cover plates are made of diamond plate (see photo at left). It is unknown whether the gasket underneath the plates is a single piece of rubber going around the centershaft or individual gaskets, whether a single gasket going around the centershaft makes more than one winding. These gaskets and covers are a potential source of fiber and vacuum leaks.

The OEM covers for the centershaft had a single length of rubber gasket going around the shaft

twice, clamped with a two-piece belly band bolted together at the ends. This ensured there were no openings in the gasket that could leak.

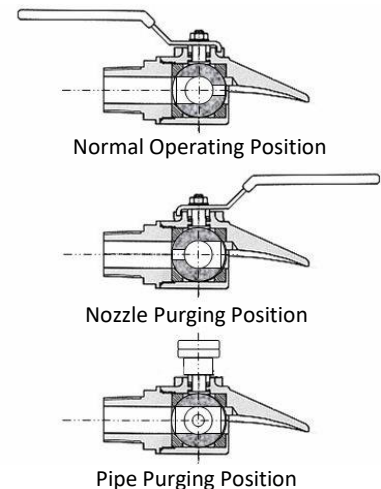
**Knock-Off Showers.** The mill is using Decker Blaster spray nozzles for the knock-off. These are a flat spray nozzle with an internal ball that can be reversed so header pressure can clear a plugged orifice. The ball can also be rotated half-way to clear the shower pipe of debris. (See sketch at right).

The deflector in the nozzle assembly is machined to make a well-defined fan when the ball is in the operating position. When reversed to the orifice clearing position, the fan is more poorly defined.

When the ball is in the pipe purging position, there is no fan – just a brute force blast of water at a much higher flow rate than that produced in the operating position. Guess which ball position the operators use.

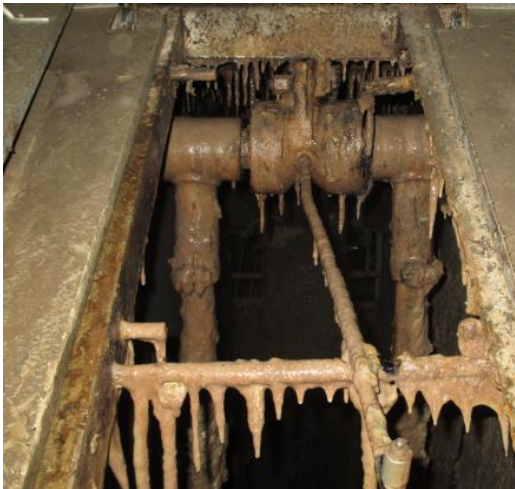
**Oscillating Cleaning Showers.** The discs in the Polydisk has are cleaned by two oscillating showers, one at each end of the machine. The two independent shower headers are supported by a common hanger bearing assembly in the center of the filter. The customer has connected a grease lubrication line to the bearing assembly (see photo below left). The headers looked to be well centered with the ends of the bearing housing, though the one at the drive end of the machine may have dropped a bit.

**Hanger Bearing**

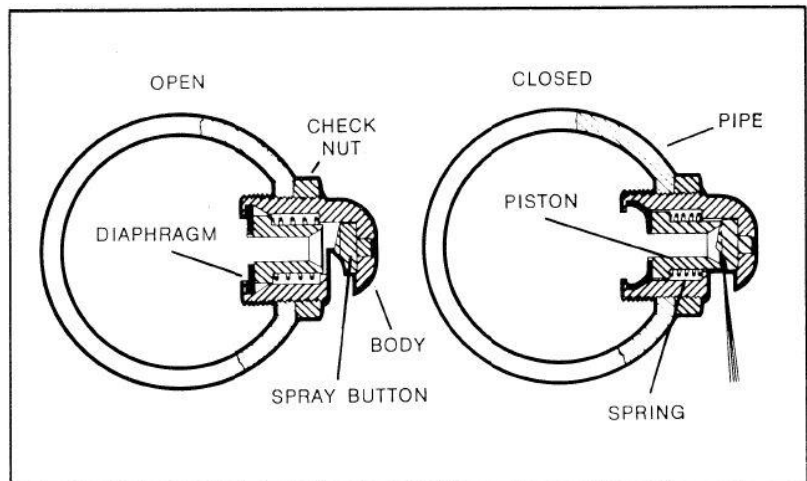
**Self-Purging Nozzles**

The oscillating shower uses self-purging nozzles. These have an internal spring-loaded piston that retracts when shower water pressure drops, and a rubber diaphragm that compresses the spring and moves the piston against the shoer button when pressurized. When the piston is retracted, the nozzle orifice is equivalent to a 1/4" diameter. In the few seconds it takes pressure on the diaphragm to become great enough to compress the spring, the enlarged orifice gets flushed out by the shower water. (See schematic above right).

Purging of the nozzles is accomplished by periodically shutting off the shower water until the shower pipes drain, then turning the water back on. Timers and a control valve are recommended to automate this process, purging the nozzles three times an hour for 20-40 seconds. Sometimes fiber in the shower water leaks past the diaphragm and collects between the diaphragm and the piston, preventing the piston from retracting when shower pressure drops. Then the nozzle needs to either be replaced or disassembled and cleaned. The nozzles can also be rebuilt with replacement springs and diaphragms.

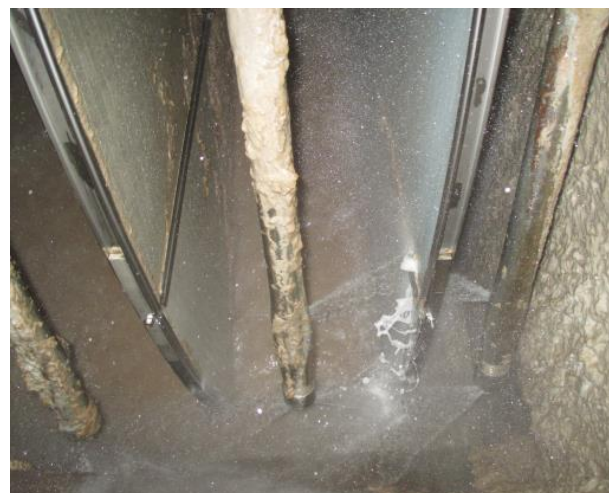
The oscillation travel as currently adjusted swings the shower pipes out past the disc OD (see photo at right). Presumably the travel was set this way to allow the deflected fan from the side nozzle to reach all the way to the disc OD.

This causes the bottom nozzle spray (and some of the side nozzle spray) to blow past the discs and is unnecessary. The knock-off showers clean the outer 4-6" of the disc surface with every revolution of the disc.

Most bottom nozzles are rotated inward at a 45-60° angle from the perpendicular with the disc surface, presumably to reduce the amount of spray that blows past the disc OD. However, this greatly increases the distance the water must travel to contact the disc and severely diminishes its impact as a cleaning shower.

It is recommended that the cleaning showers be jogged to their outermost position. Then, with someone holding onto one of the shower pipes, the clamp in the oscillation mechanism that grasps the header should be loosened until the pipes start to fall back into the vat. The pipes should be positioned about 2" from the disc OD and the clamp re-tightened. Then the bottom shower nozzles should be re-positioned to put their spray fans perpendicular to the disc surface.

6. Replace or rebuild the plugged and partially plugged cleaning shower nozzles. Lodging #17 buttons are recommended. Adjust the swing of the showers so shower pipes stop a couple inches from the disc OD and the nozzles do not spray past the disc OD. The spray fans on the bottom nozzles should be perpendicular to the disc surface to shorten the distance the spray must travel and maximize its impact. Use timers as needed to purge the nozzles three times an hour for 30 seconds or so --- however long it takes for the shower pipes to drain. Also, the cleaning showers need more water pressure to be effective.

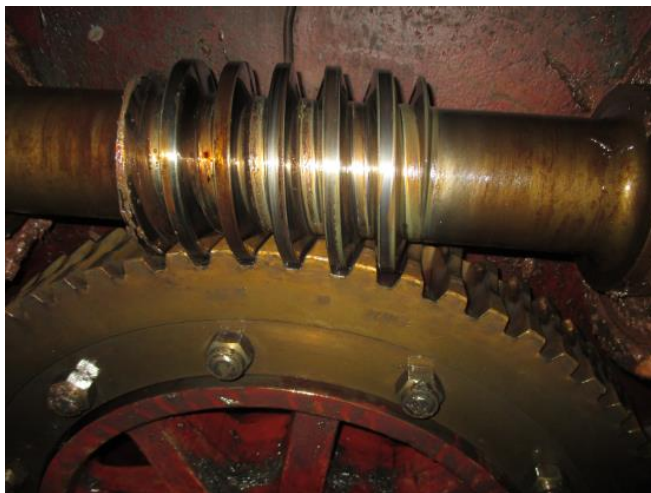
**Worm Drive.** When work on the disc assemblies and knock-off showers was finished, the oil was drained from the worm drive and the gearbox cover was removed for inspection. The gearcase internals had no indications of water, rust or bronze filings, with only relieved grease from the bearings in the bottom of the housing. Wear on the worm and ring gear teeth was minimal, and the worm was fully engaged with the ring gear. The ring gear hub was well centered with the main bearing housing behind it.

**Worm and Ring Gear**

With no evidence of filtrate leakage from the vacuum valve and the worm drive in excellent condition, there is no need to rebuild the valve. Rebuilding it as a preventative maintenance task risks creating a leak where there is none.

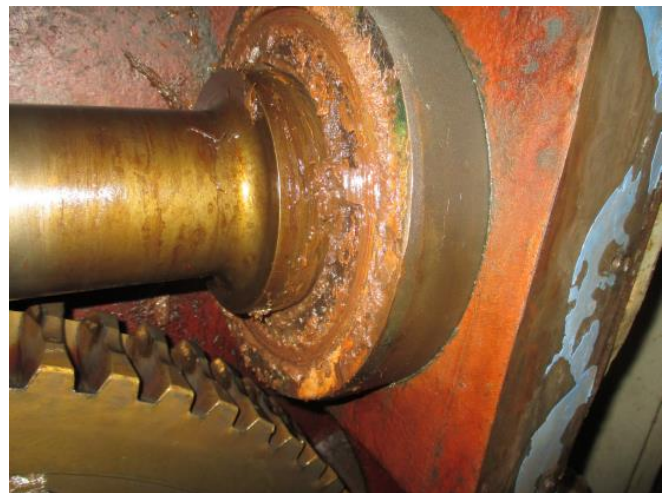
**Worm Input Shaft Bearing**

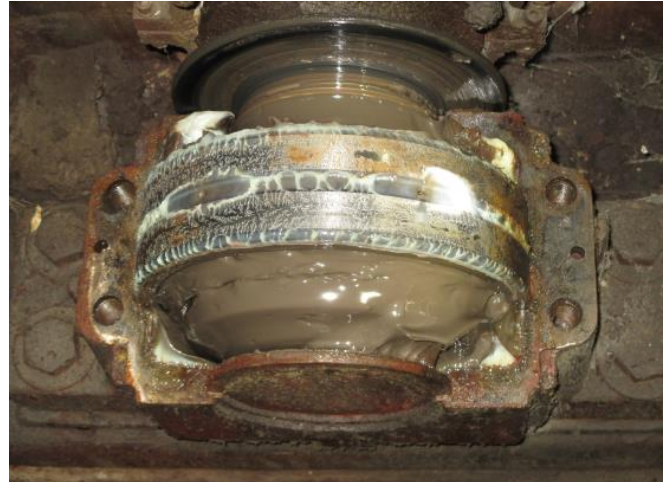
**Rear Bearing.** The cap was removed from the pillow block bearing at the back end of the Polydisk. There was no evidence of corrosion or water in the grease (see photo at right), and the cap was put back on.
