BORESCOPE INSPECTION REPORT

GAS TURBINE ENGINE
CENTAUR 50
COLD END DRIVE

Engine Rating
6201SA GSC

Inspection Date
Tuesday, January 21, 2020

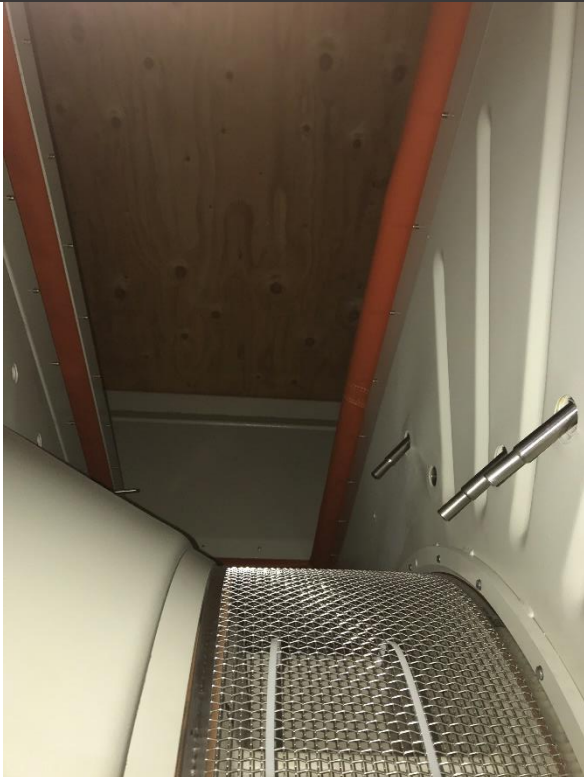
Access location Description	Picture	Inspection for	Severity / Comments
A Air Inlet Duct

a)Potential FOD b)Corrosive Pitting c)Cracks d)Excessive fouling	Normal Condition

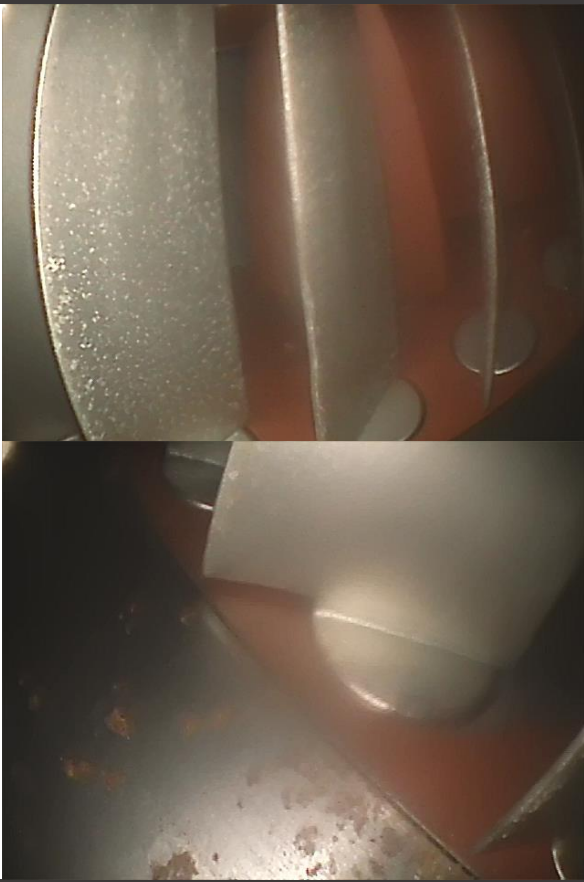
Access location Description	Picture	Inspection for	Severity / Comments
A IGV

a)Nicks and dents. Qty and size b)Excess of fouling c)Corrosive pitting. Affected area	Minor Corrosion
A 1st Stg Compressor Blades

The Engine appears to be in serviceable condition at this time. Minor corrosion/oxidation was observed in the forward and aft sections of the compressor as well as the second stage turbine blades, this is due to the turbine being stored for over four years in a harsh environment.

Please continue to monitor engine condition and preservation status if continued storage is required.

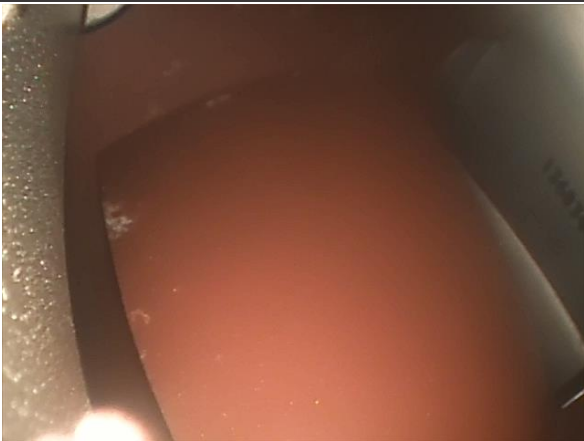
a)Nicks and dents. Qty and size b)Excess of fouling c)Corrosive pitting. Affected area d)Tip rub. Gap width, metal curl	Minor Corrosion

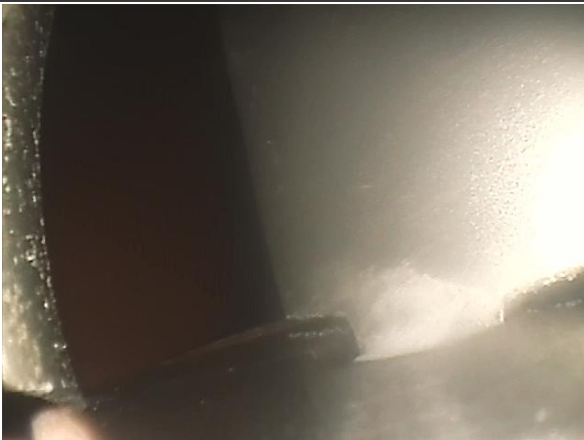
Access location Description	Picture	Inspection for	Severity / Comments
A 2nd Stg Compressor VGV

A borescope image showing the interior of a compressor. The view is somewhat dark and grainy, with a bright light source illuminating a curved, metallic surface. There are some small, dark spots visible on the surface.	a)Nicks and dents. Qty and size b)Excess of fouling c)Corrosive pitting. Affected area	Normal Condition
A 2nd Stg Compressor Blades

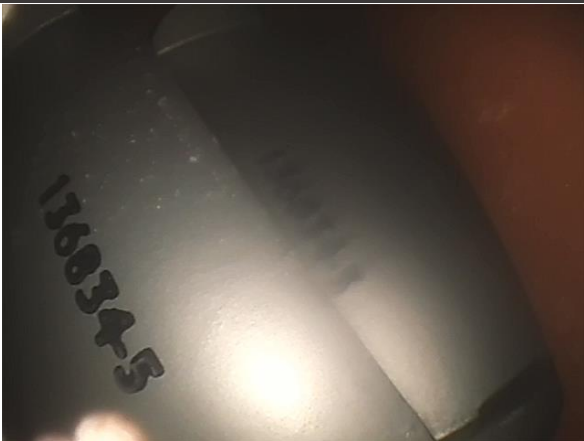
A borescope image showing the interior of a compressor. The view is dark and grainy, with a bright light source illuminating a curved, metallic surface. There are some small, dark spots visible on the surface. The number '13634-3' is visible on the left side of the image.	a)Nicks and dents. Qty and size b)Excess of fouling c)Corrosive pitting. Affected area	Normal Condition

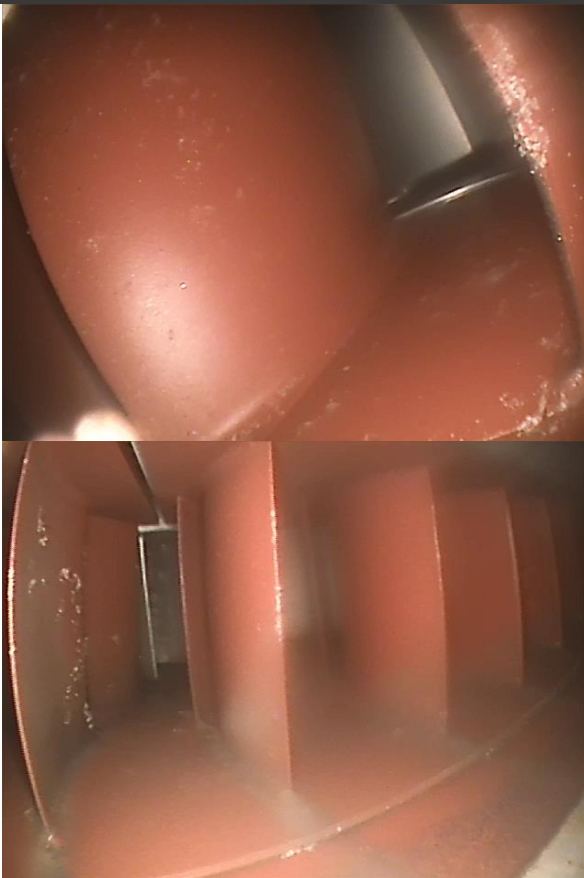
Access location Description	Picture	Inspection for	Severity / Comments
B Compressor Exit GV

<p>a)Nicks and dents. Qty and size</p> <p>b)Excess of fouling</p> <p>c)Corrosive pitting. Affected area</p>	<p>Minor</p> <p>Corrosion</p>

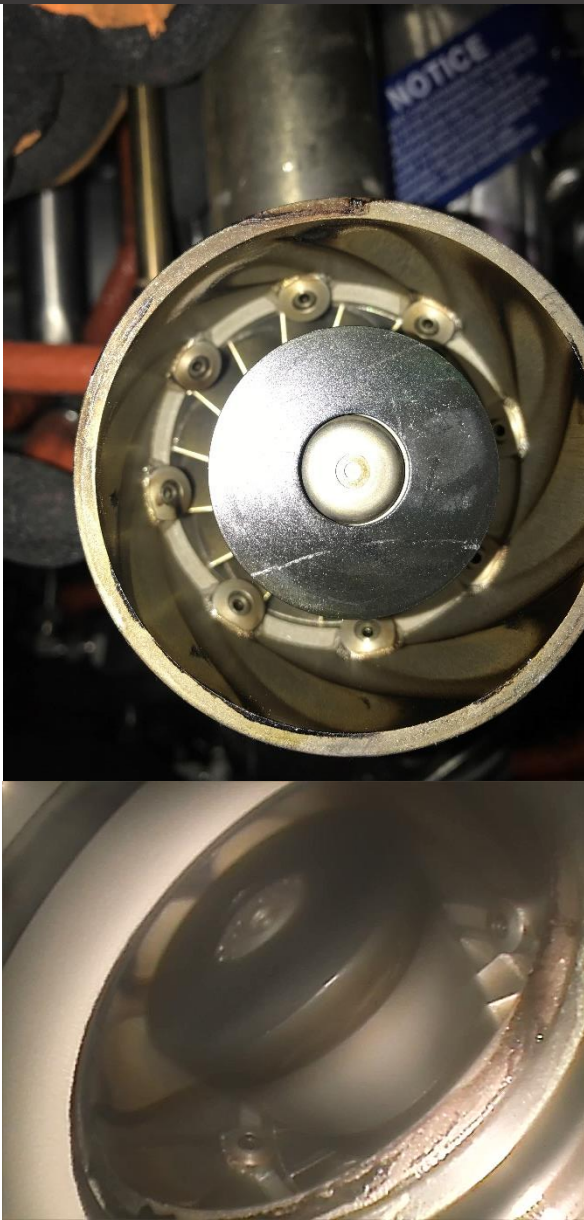
Access location Description	Picture	Inspection for	Severity / Comments
B Injectors

a)Pilot Center Erosion b)Fuel hole contaminated or blocked c)Cracks, Qty & Size d)Liquid: broken spoke	Normal Condition

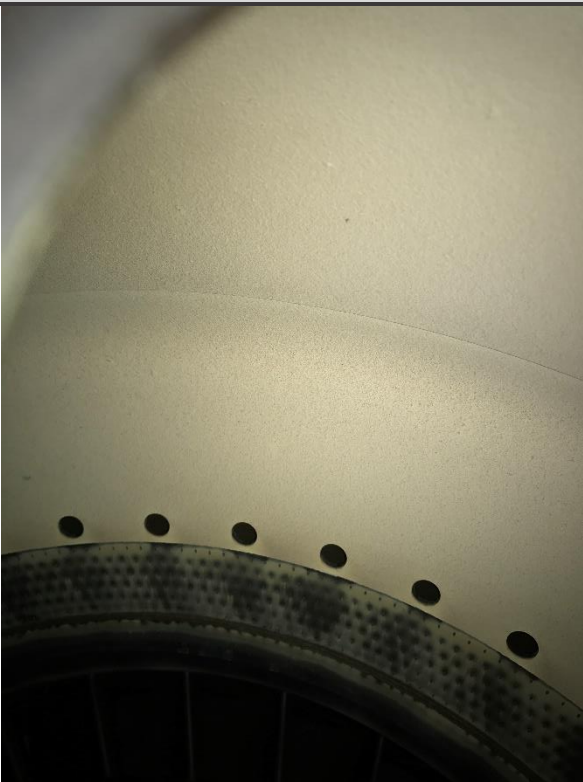
Access location Description	Picture	Inspection for	Severity / Comments
B Combustor Interior

a)Cracks, Qty, length, orientation b)Thermal Erosion c)Hot Spots d)Buckling or warpage	Normal Condition
B Torch Tube

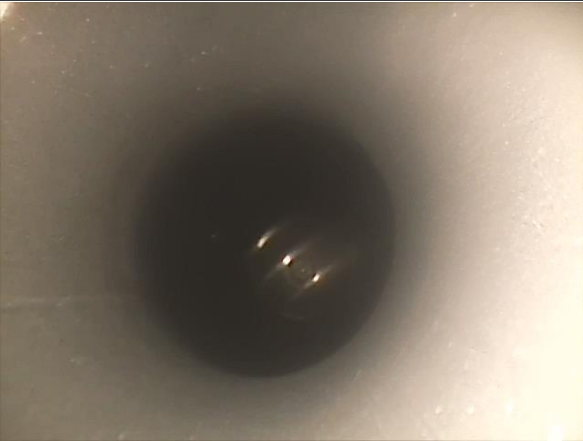
a)Thermal erosion	Normal Condition

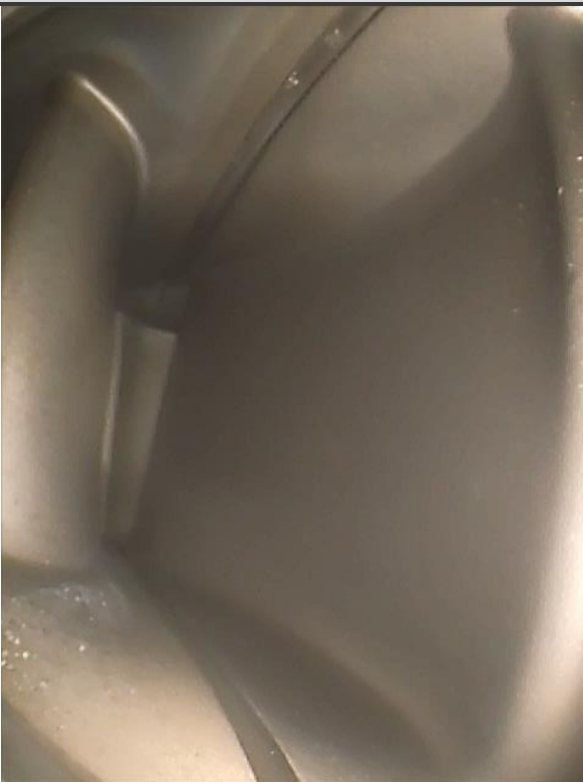
Access location Description	Picture	Inspection for	Severity / Comments
B 1st Stg Turbine Nozzles

a)Cracks, Qty, length, orientation b)Thermal Erosion. Depth, Area c)FOD, Area	Normal Condition
B 1st Stg Turbine Blades

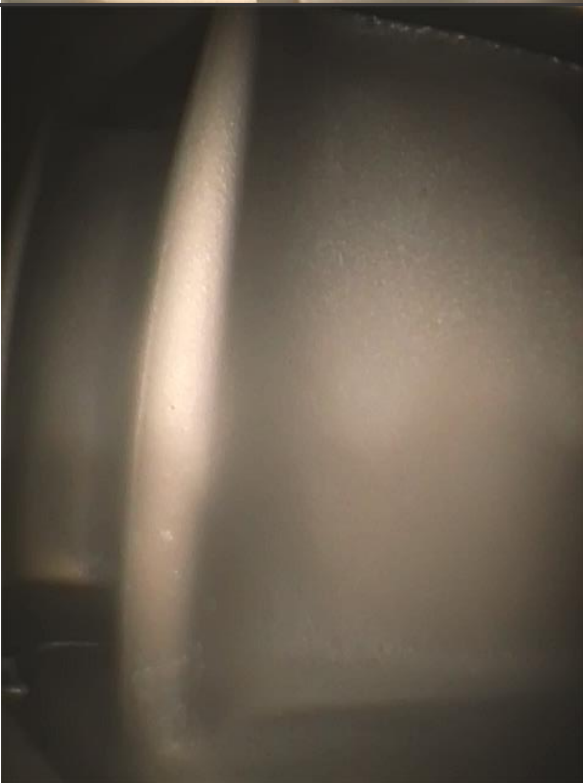
a)Cracks, Qty, length, orientation b)Thermal Erosion. Depth, Area c)FOD, Area d)Tip rub, Gap width	Normal Condition

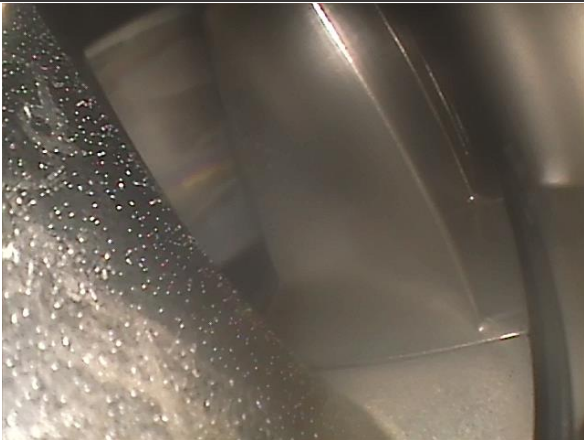
a)Cracks, Qty, length, orientation b)Thermal Erosion. Depth, Area c)FOD, Area d)Tip rub, Gap width	Minor Corrosion
D 3rd Stg Turbine Nozzles

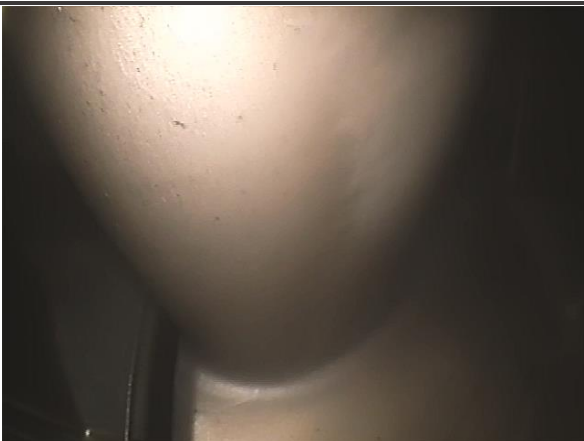
a)Cracks, Qty, length, orientation b)Thermal erosion, Depth, Area c)FOD, Area	Normal Condition

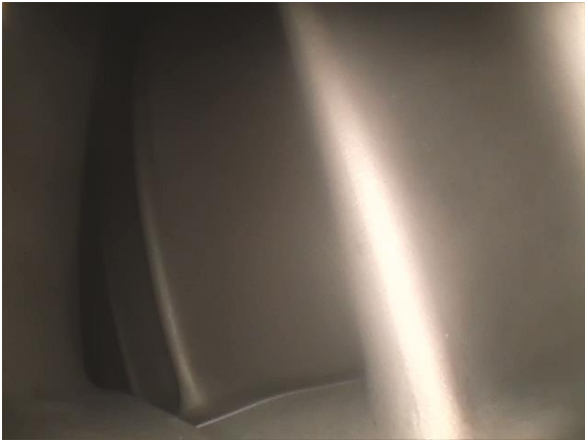
Access location Description	Picture	Inspection for	Severity / Comments
D 3rd Stg Turbine Blades

a)Cracks, Qty, length, orientation b)Thermal Erosion. Depth, Area c)FOD, Area d)Tip rub, Gap width	Normal Condition
VG IGV

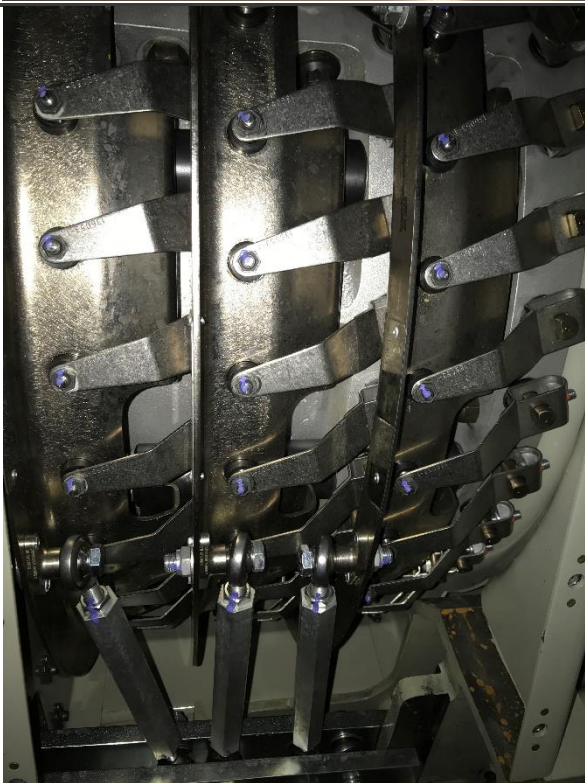
a)Cracks b)Lever arms bent c)Grommet out of position on unison ring d)Corrosion	Normal Condition

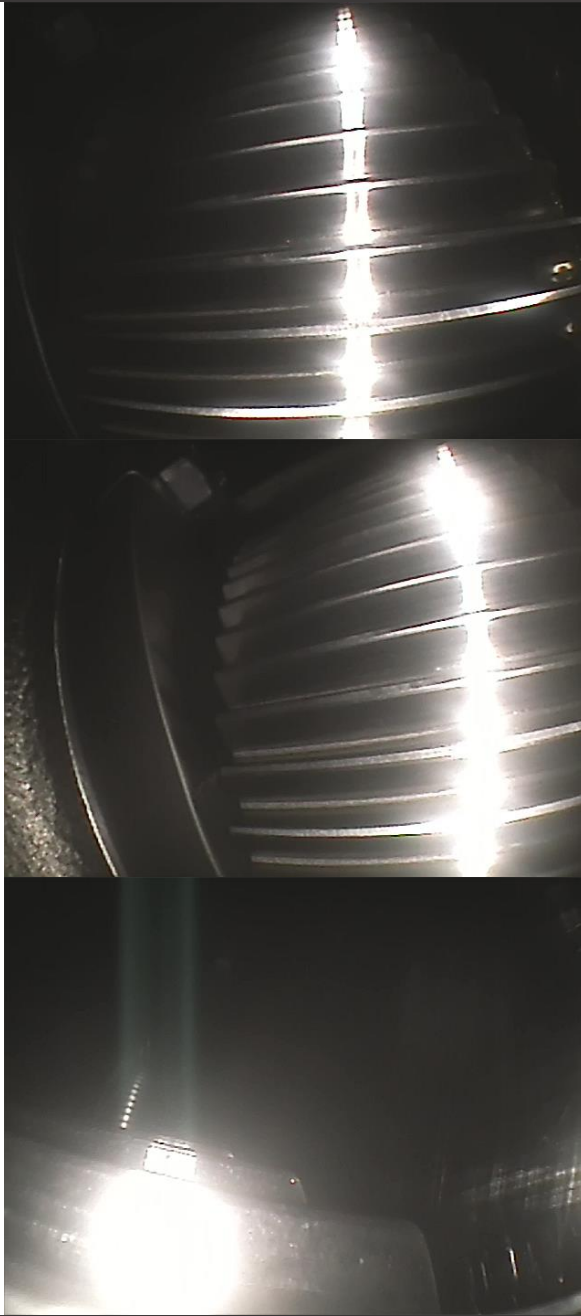
Gearbox

Normal Condition
