MURCO RIG 58 SURVEY

18780953-REP
January 16, 2023

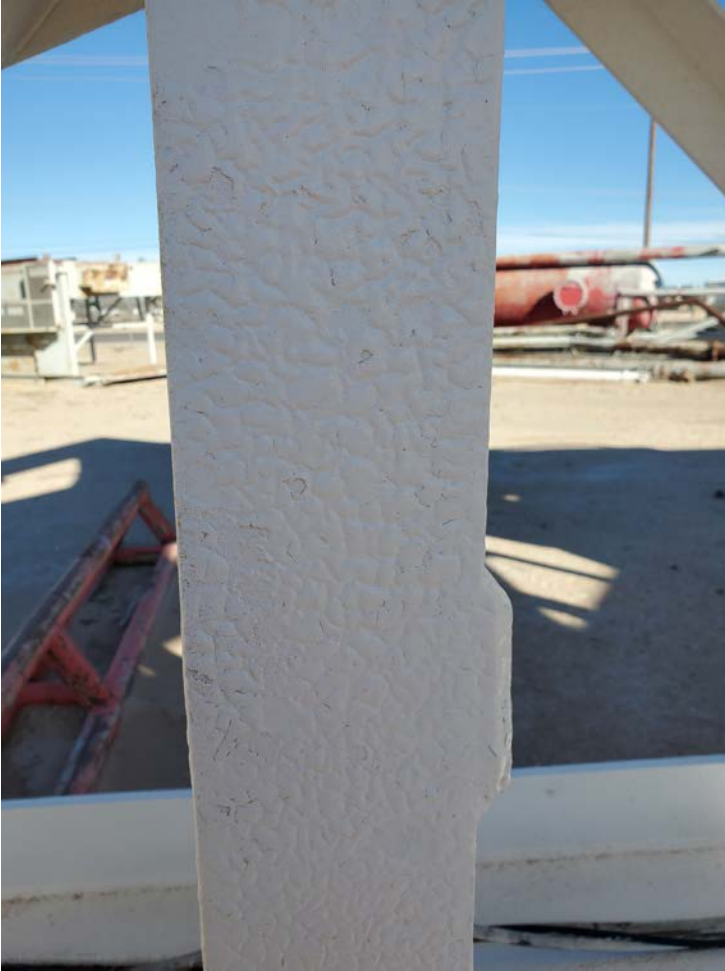
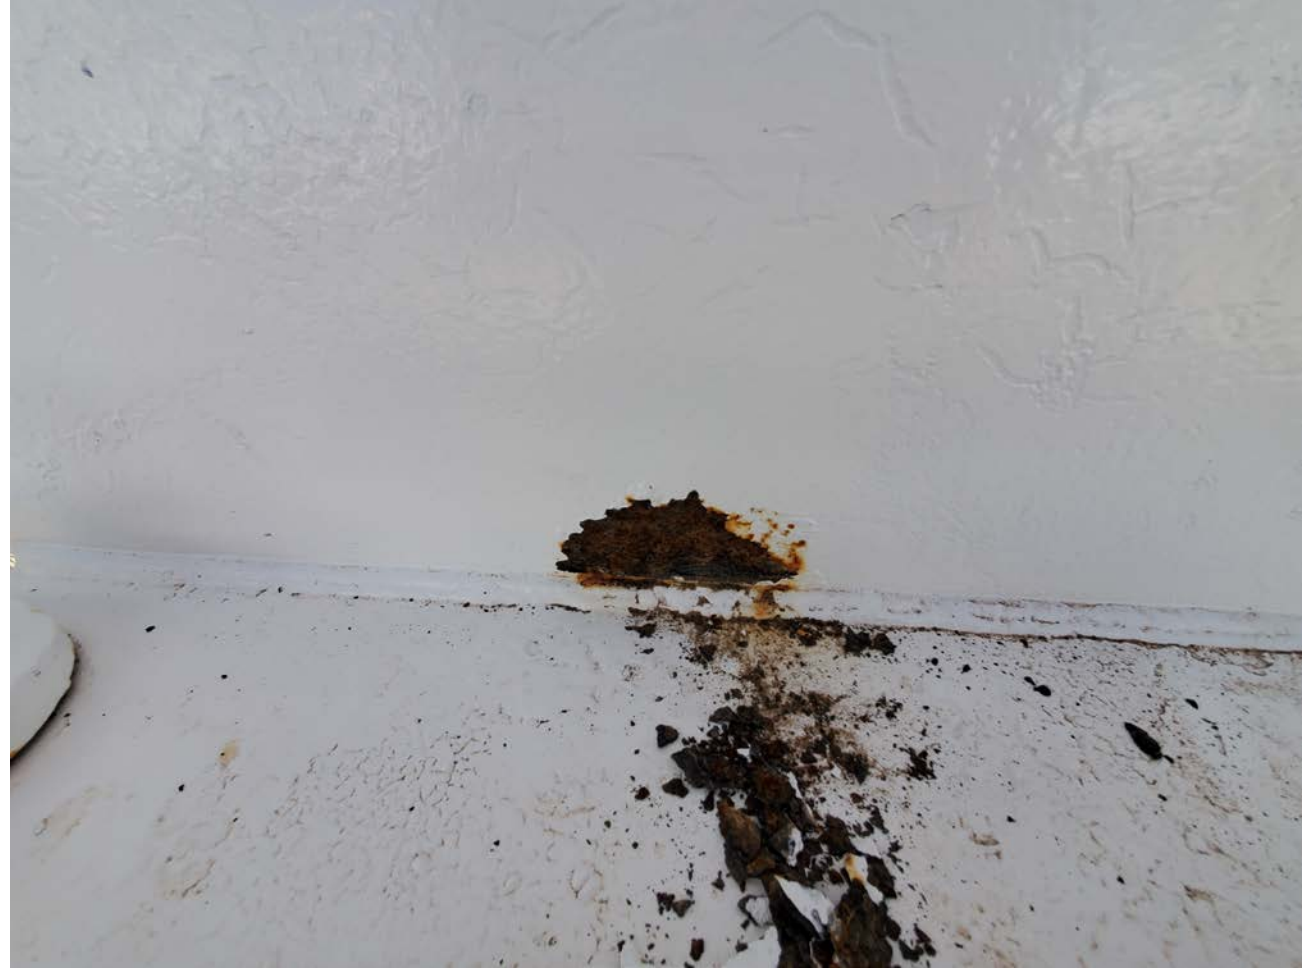
MAST PAINT

MAST HAD BEEN RE-TOP COATED WITH A FEW MINOR RUST SPOTS. (THIS WAS AT TOP MAST SECTION)

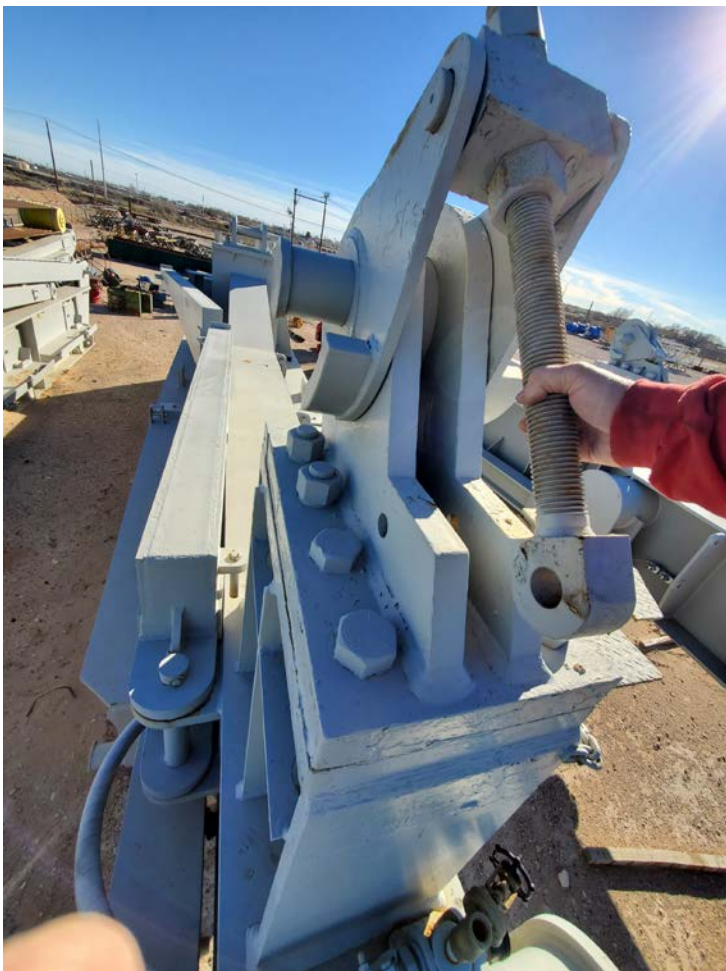
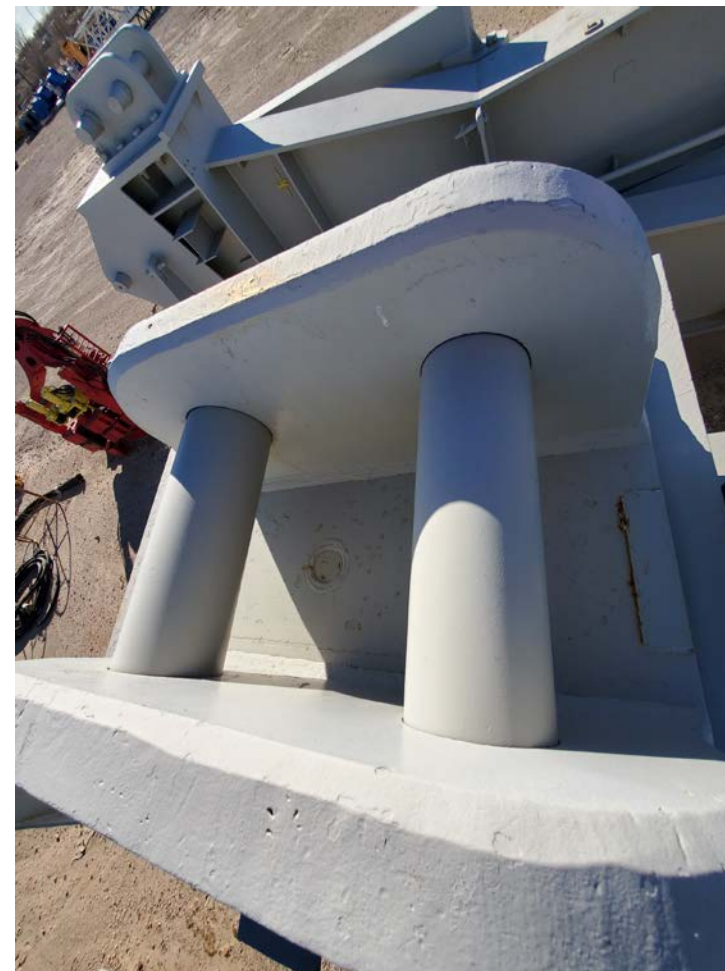
MAST SHOES

BOTH WERE MISSING THE ADJUSTMENT ROD PIN

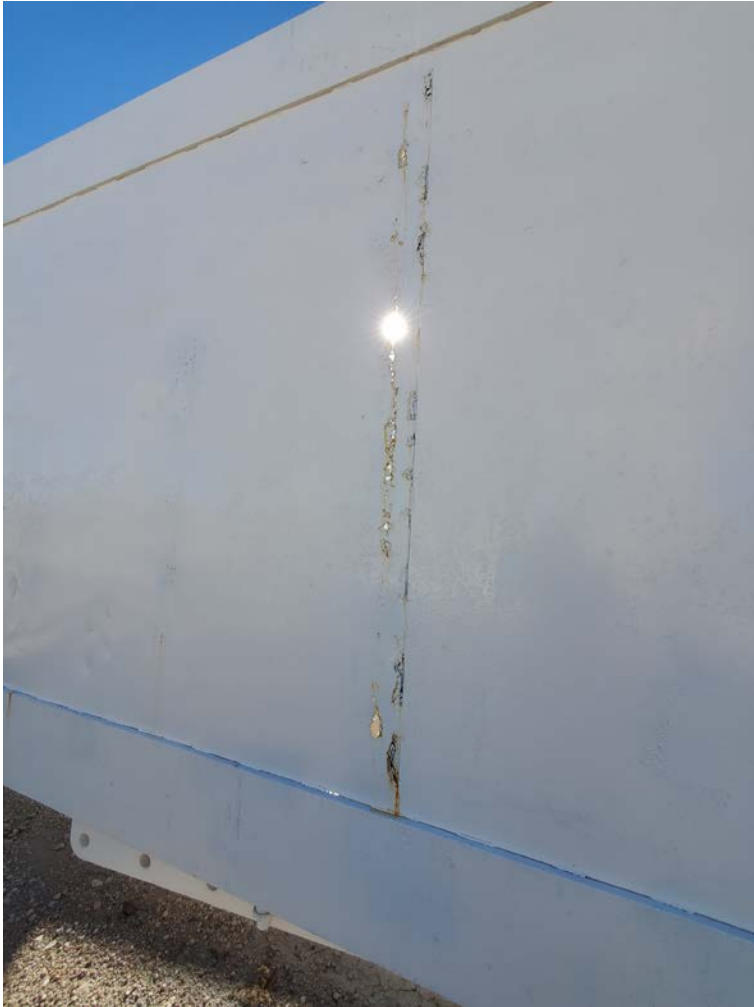
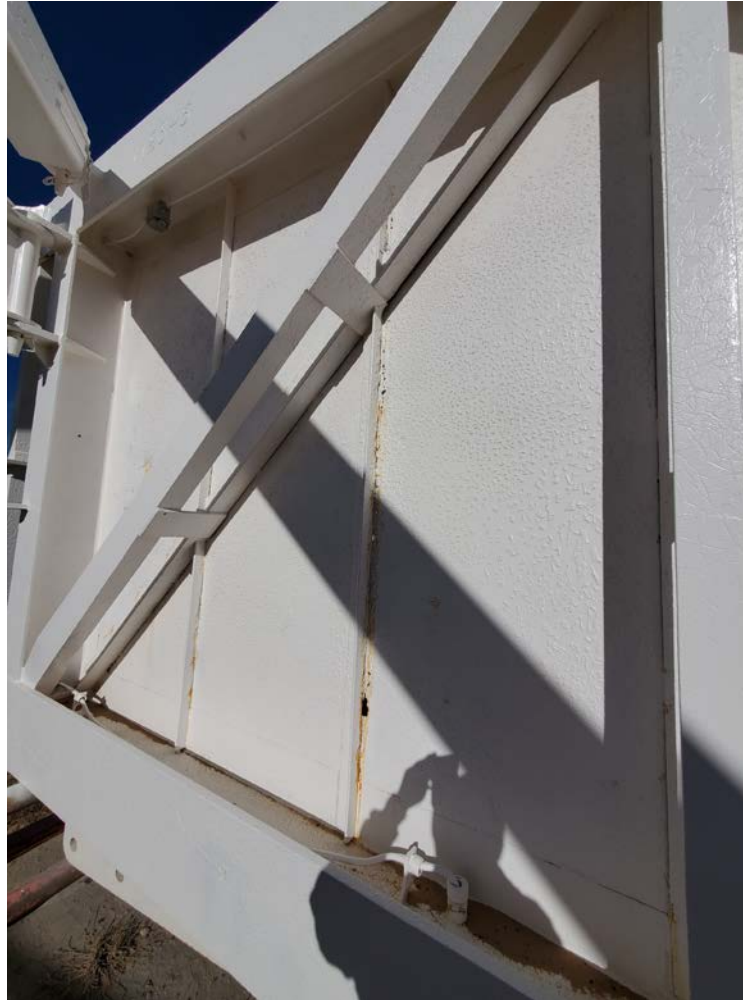
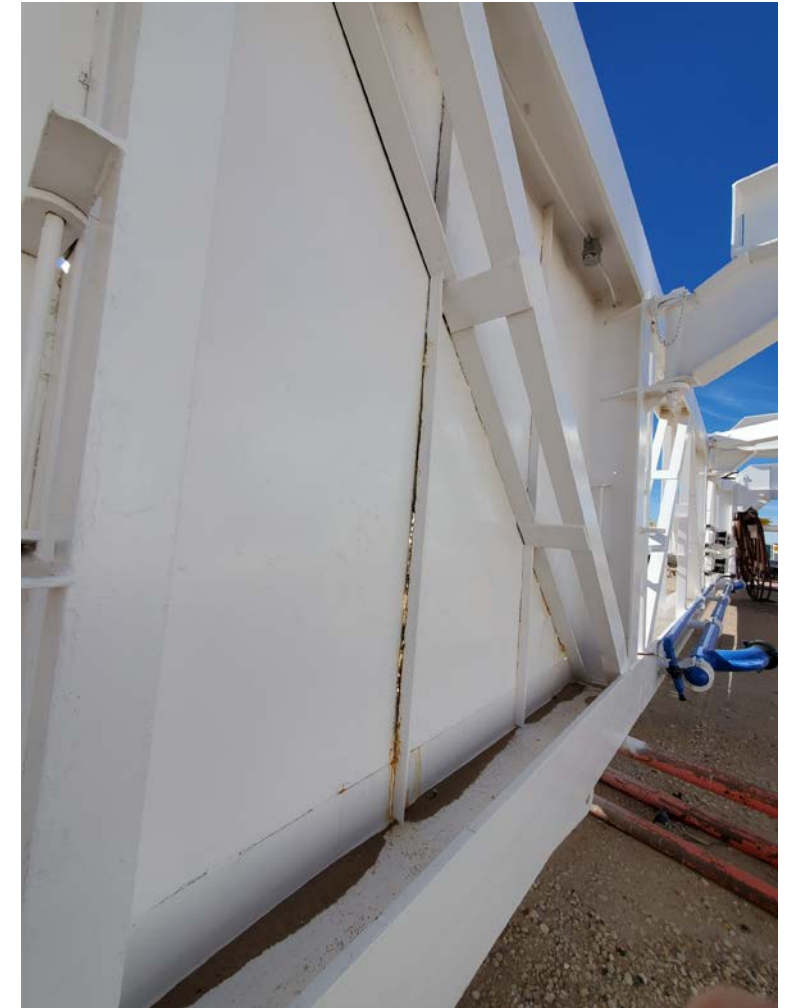
UPPER INTERMEDIATE WINDWALL DAMAGE

NO DAMAGE TO MAIN MEMBERS ONLY SHEETING

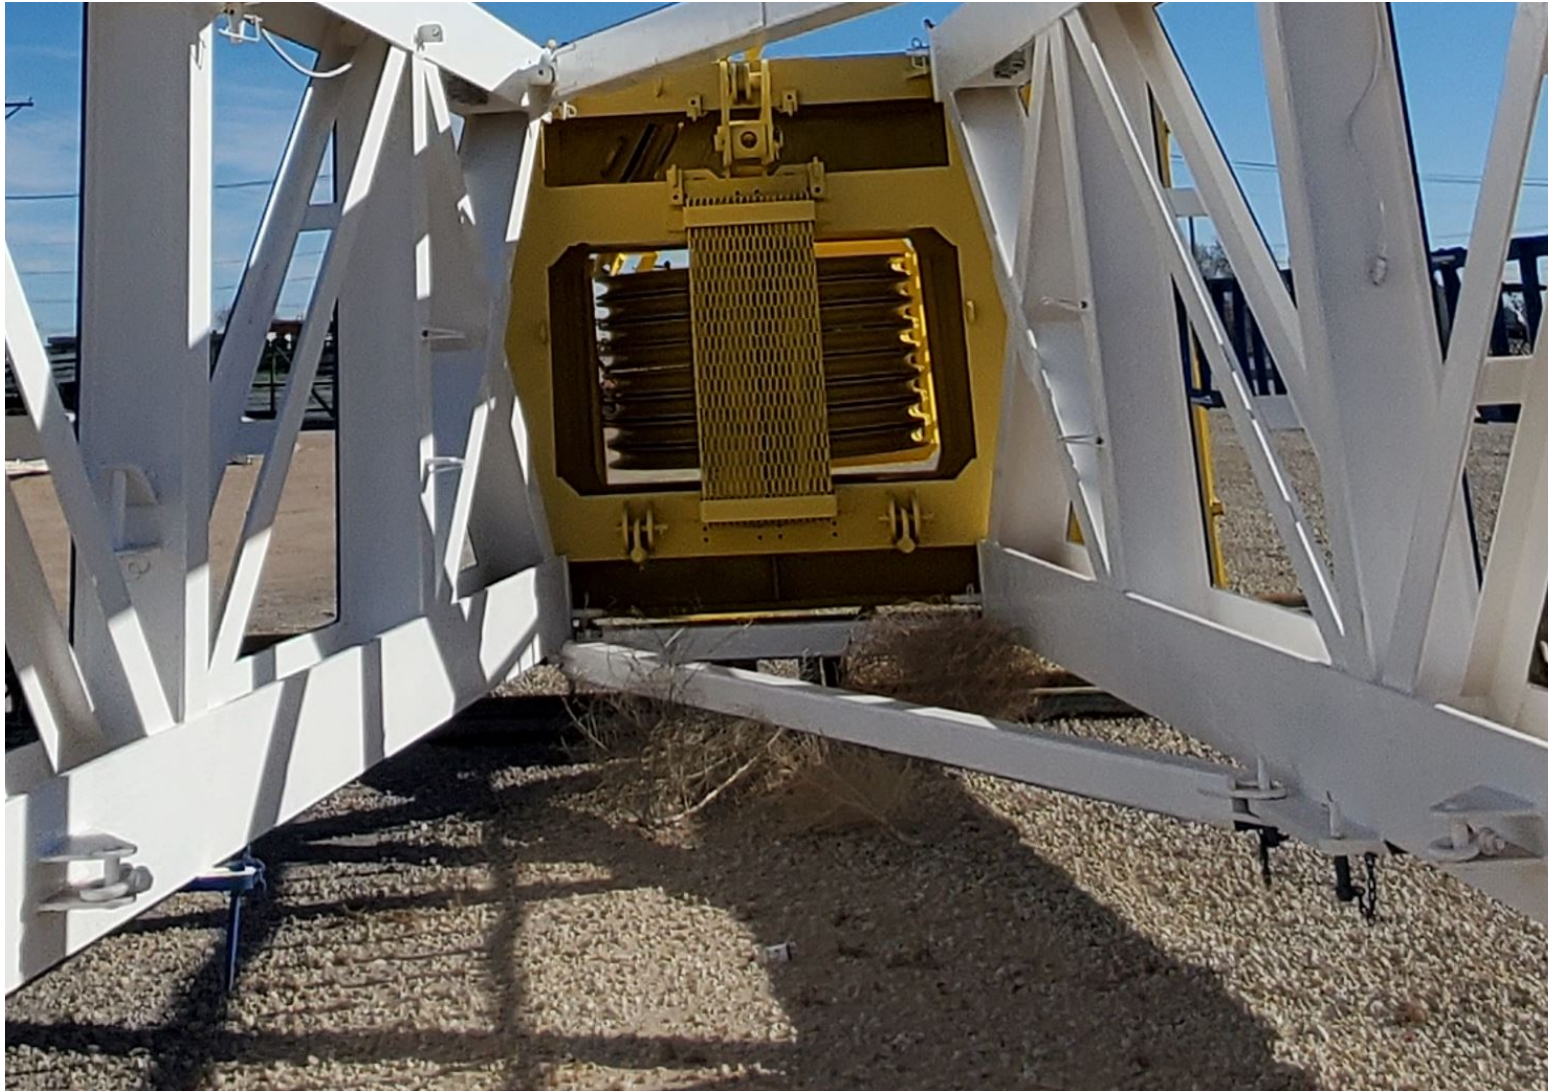
TOP MAST SECTION MISSING GIRT

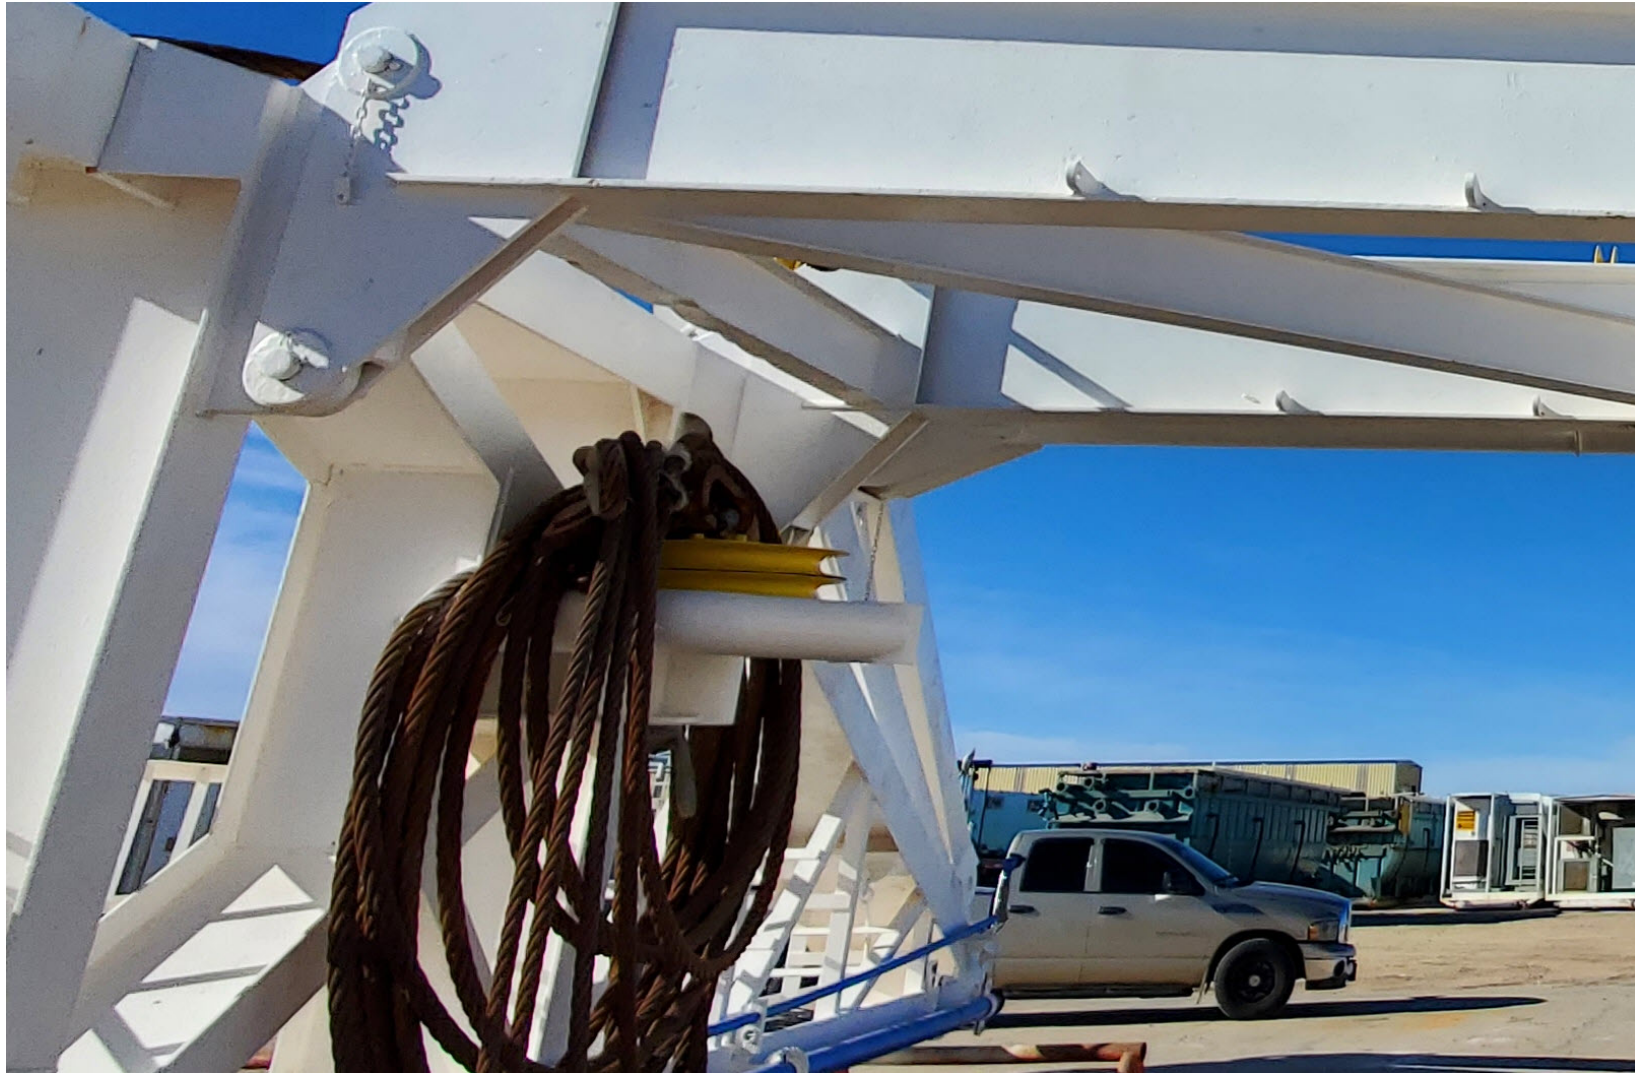
BOTTOM MAST SECTION SPREADER DAMAGE

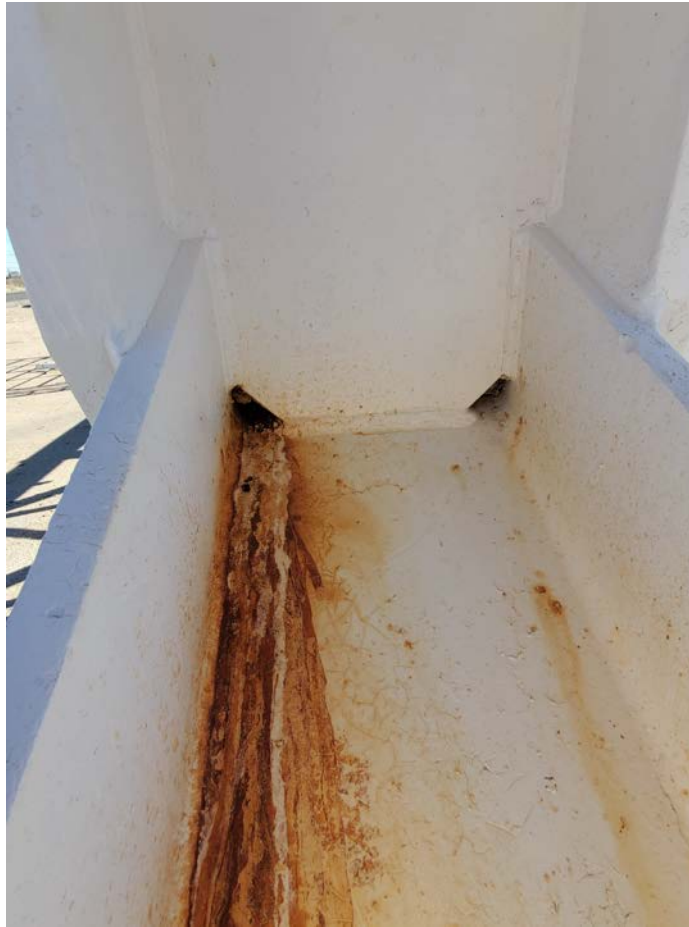
A-FRAME ODS

BLEEDING RUST BUT COULD NOT SEE ANY DAMAGE AND COULD NOT CHECK IT AS IT IS A CLOSED SECTION

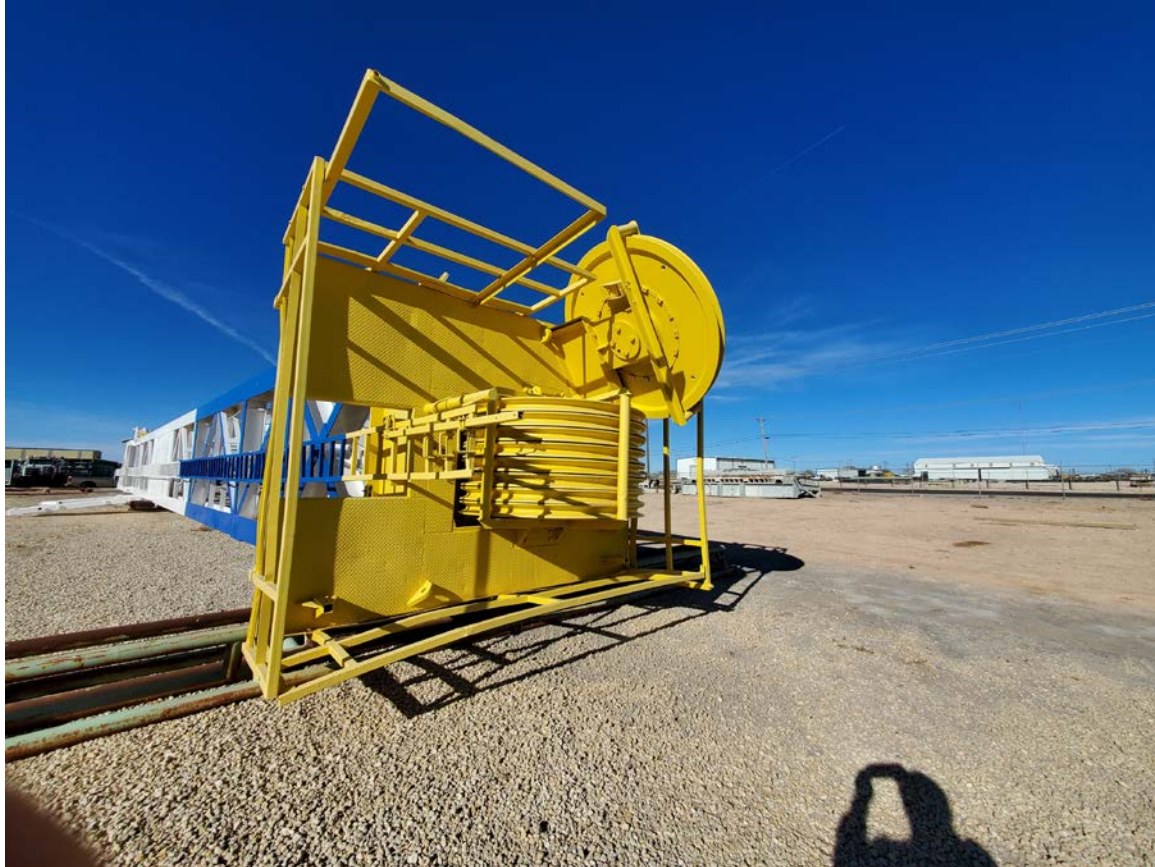
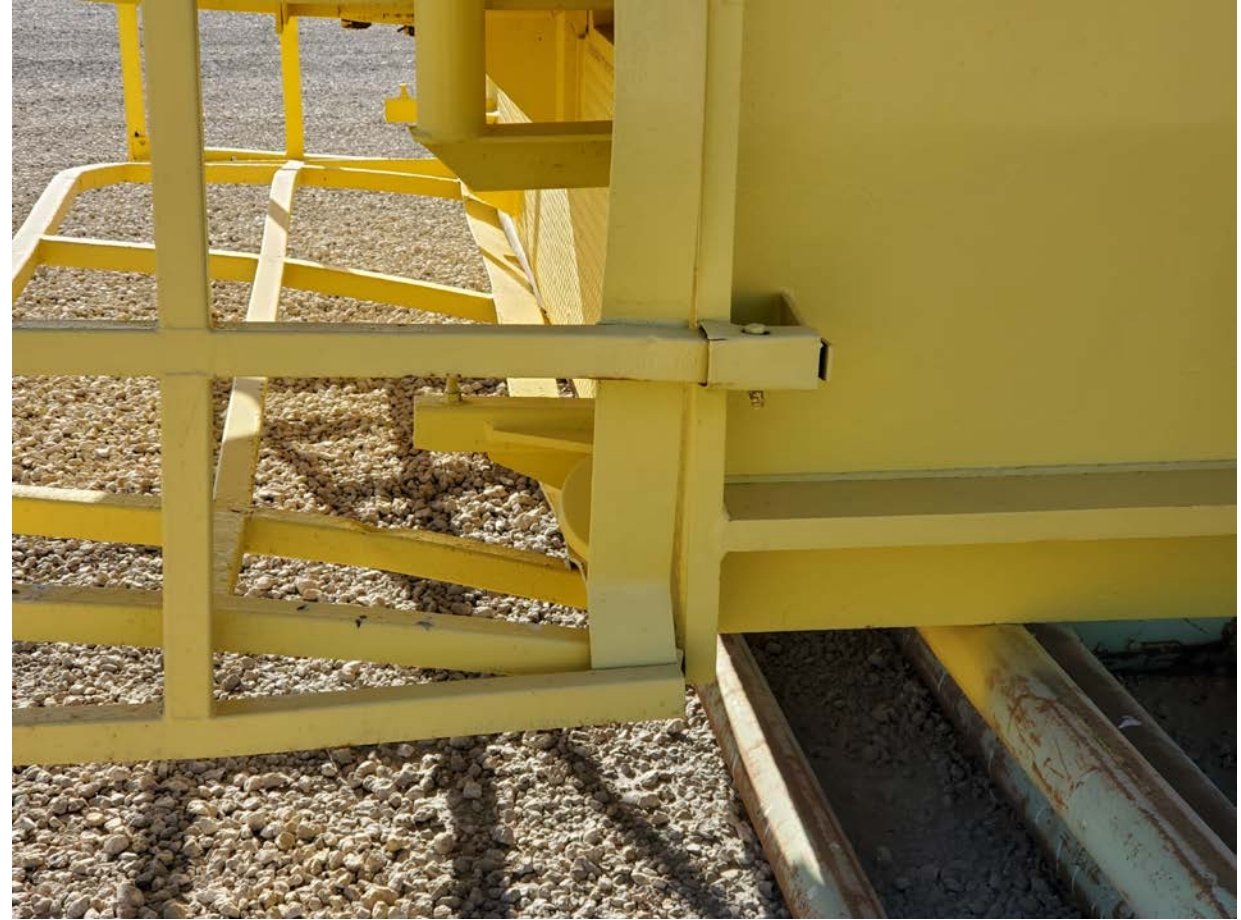
CROWN HANDRAIL DAMAGE

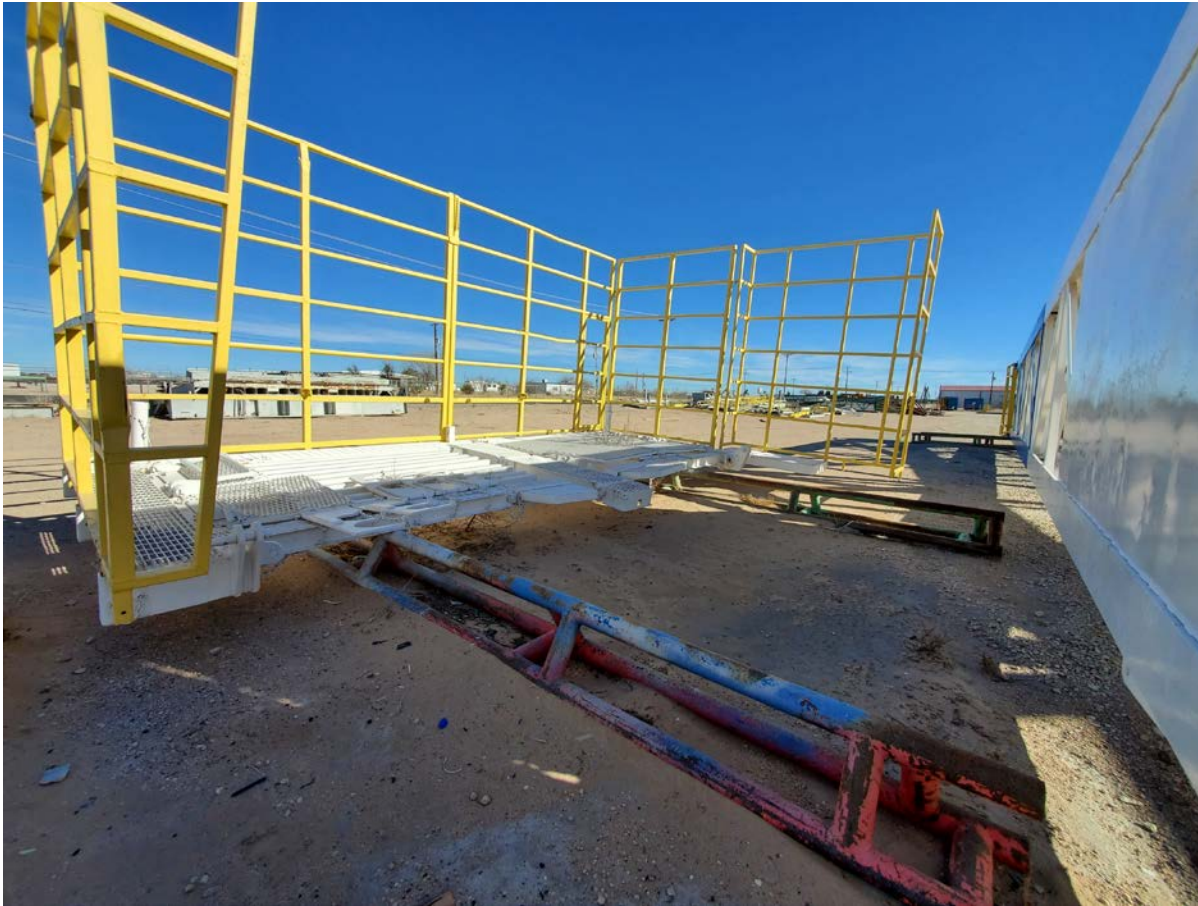
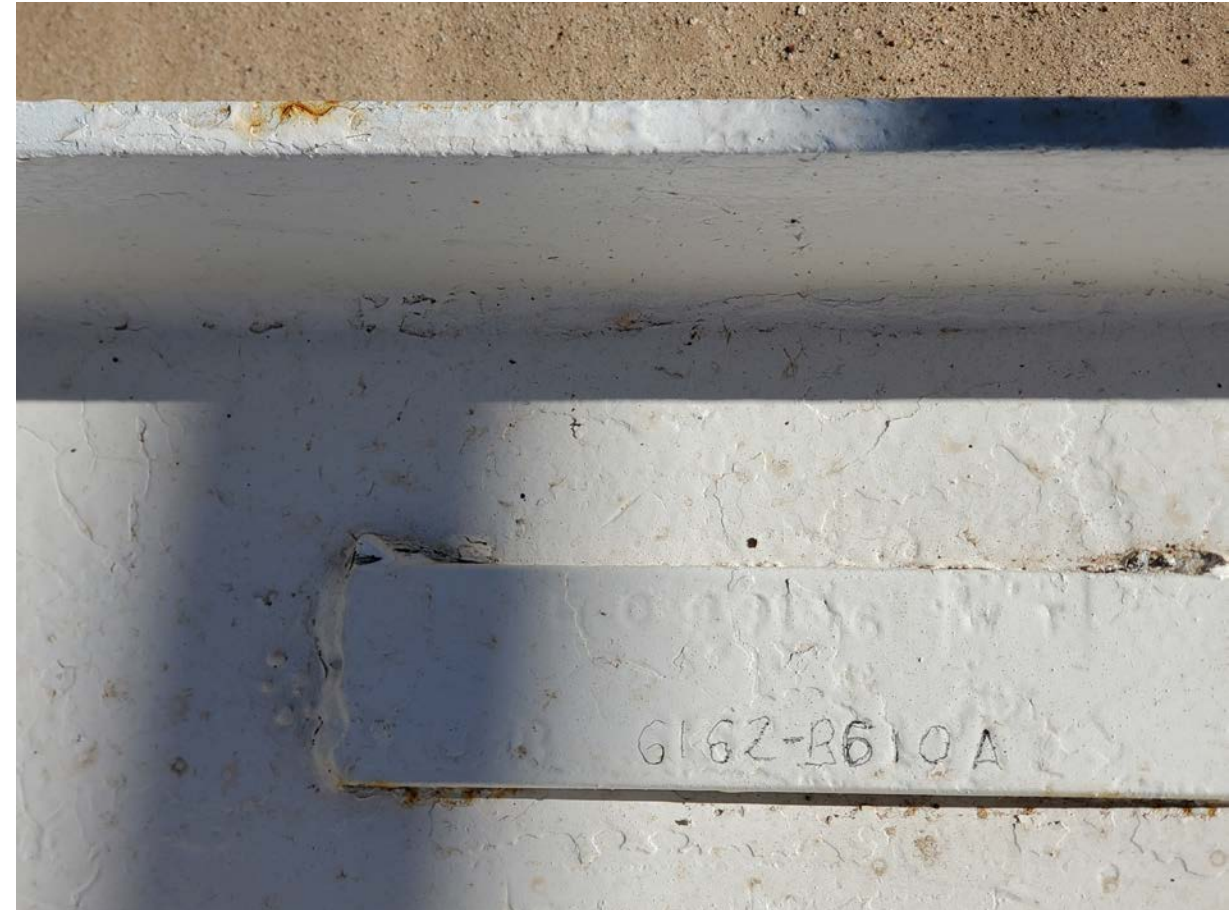
RACKING BOARD W/12' WINDWALL & KNEE BRACES

RACKING BOARD IS CONFIGURED FOR 270 STANDS OF DP NOT THE ORIGINAL 400 STANDS

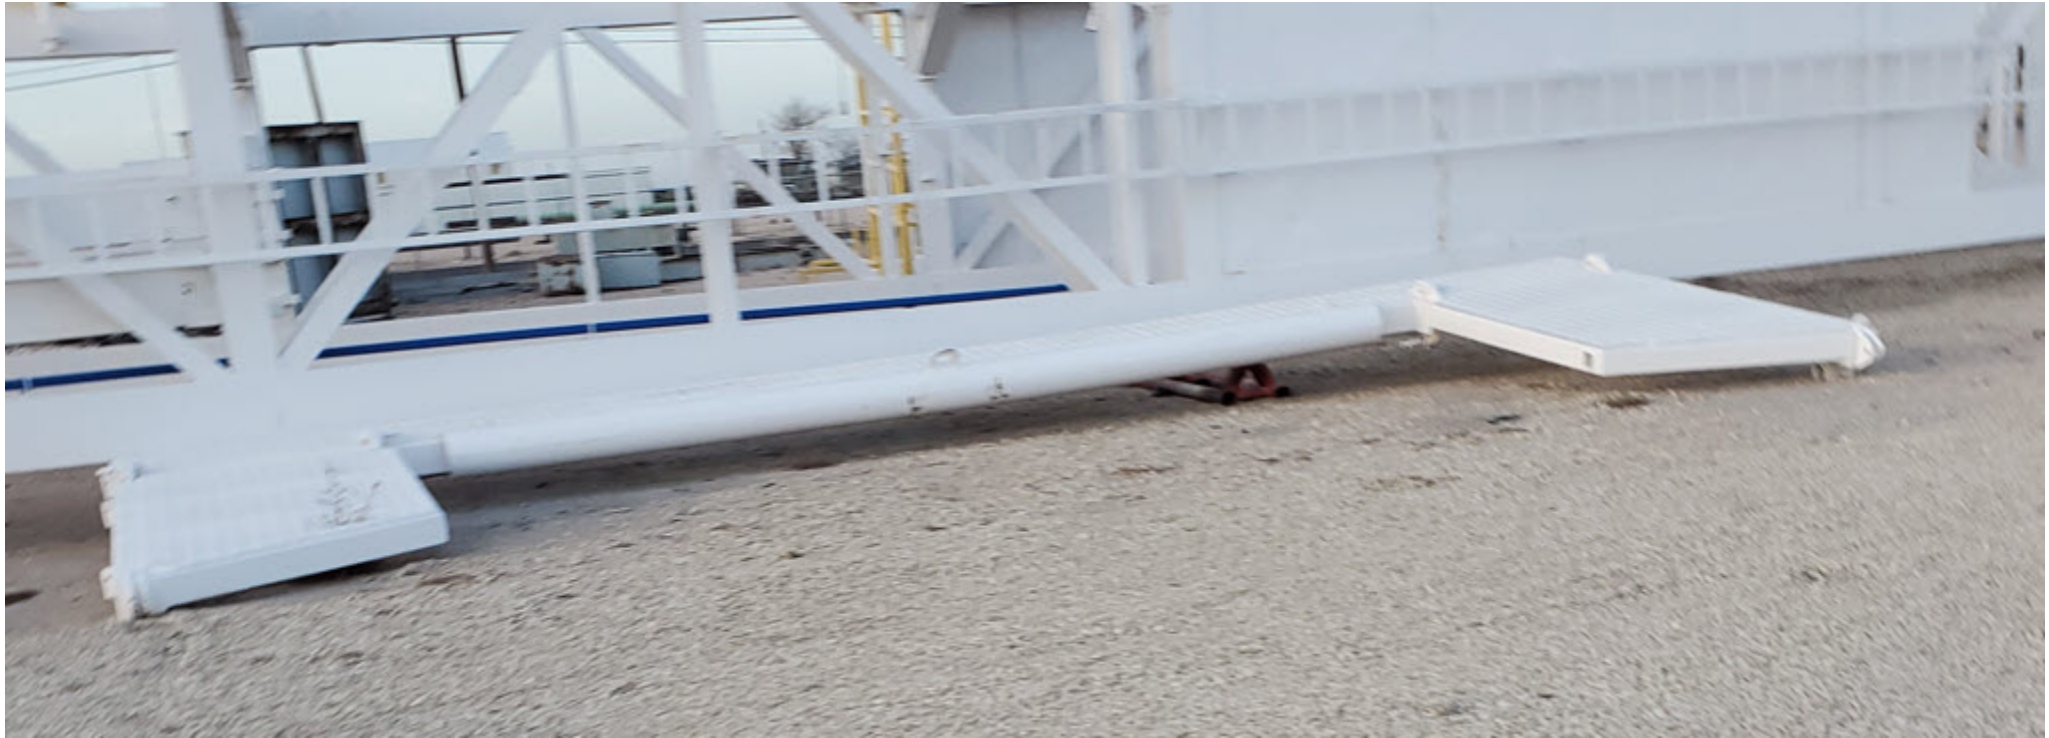
TUBING BOARD

HANDRAILS ARE MISSING. KNEE BRACES ARE NOT OEM AND NOT PER NOV DRAWINGS

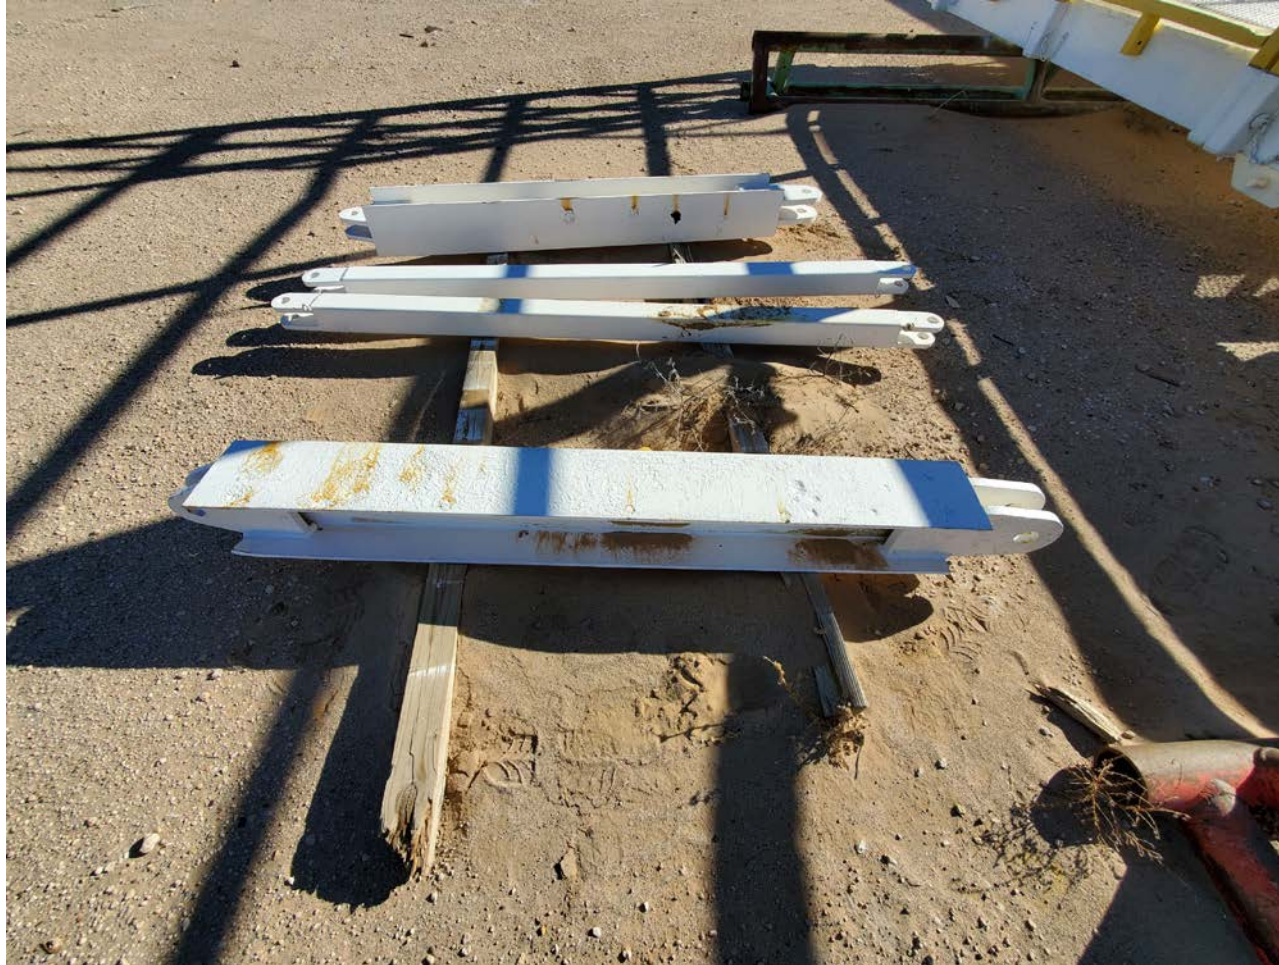
RACKING & TUBING BOARD KNEE BRACES

RACKING BOARD KNEE BRACES ARE OEM; TUBING BOARD BRACES ARE NOT OEM OR PER NOV DESIGN

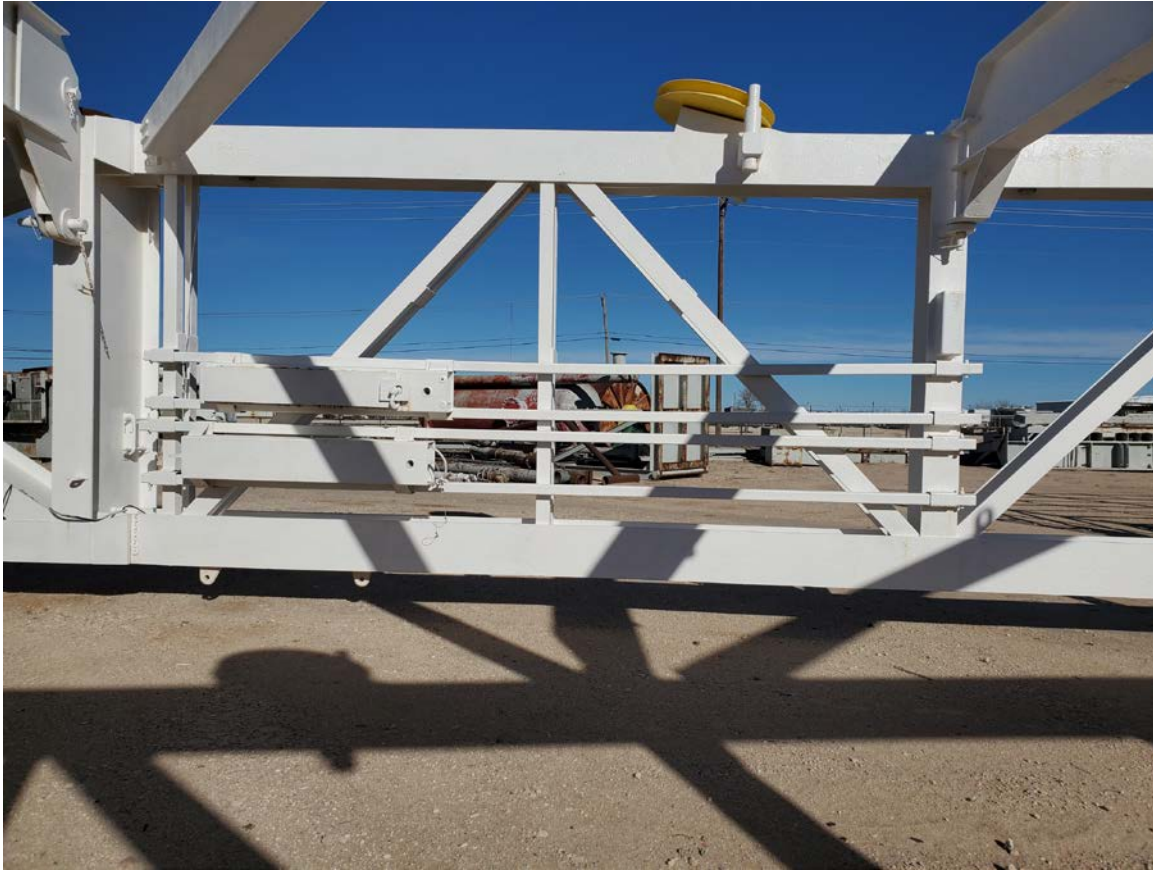
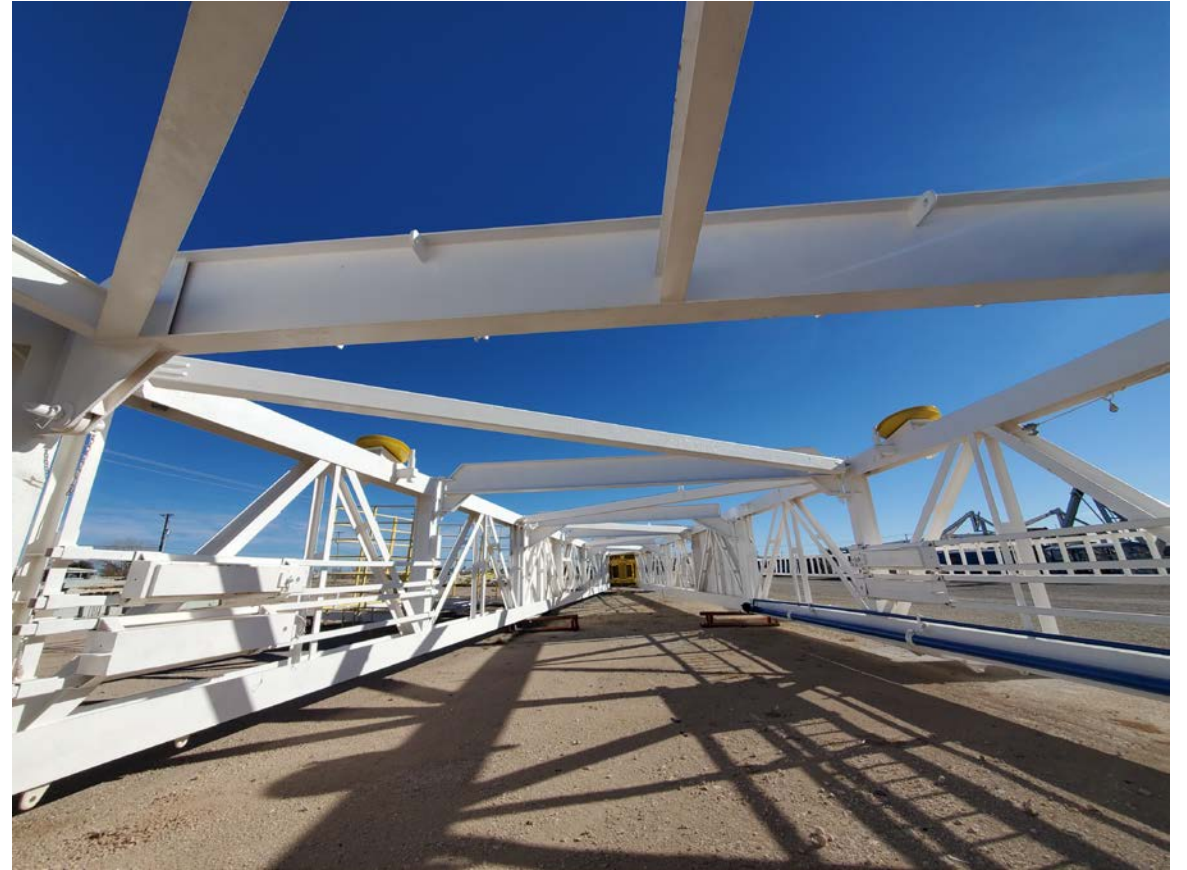
TONG COUNTERWEIGHTS

ALL 4 BUCKETS ARE THERE BUT NOT THE RIGGING

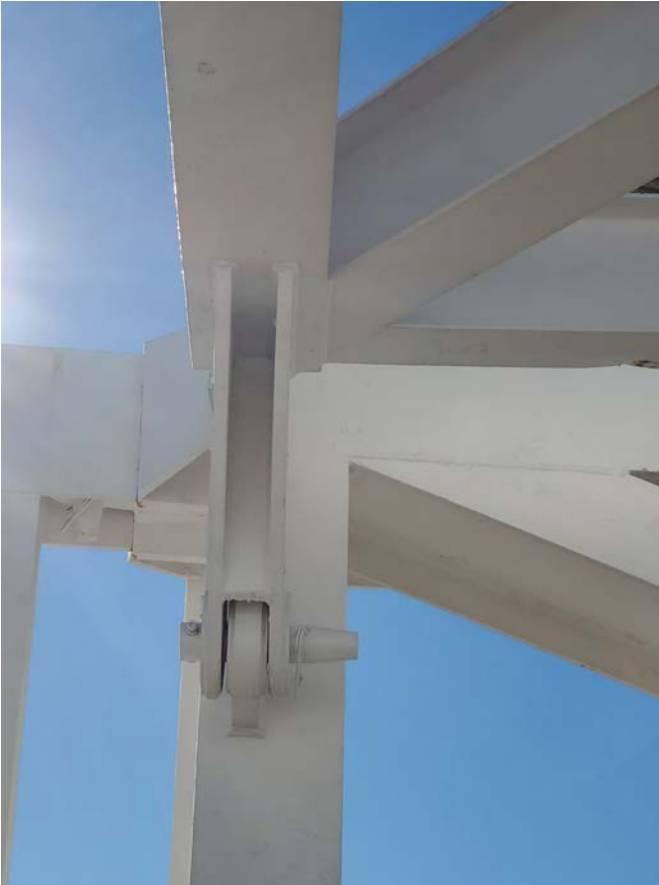
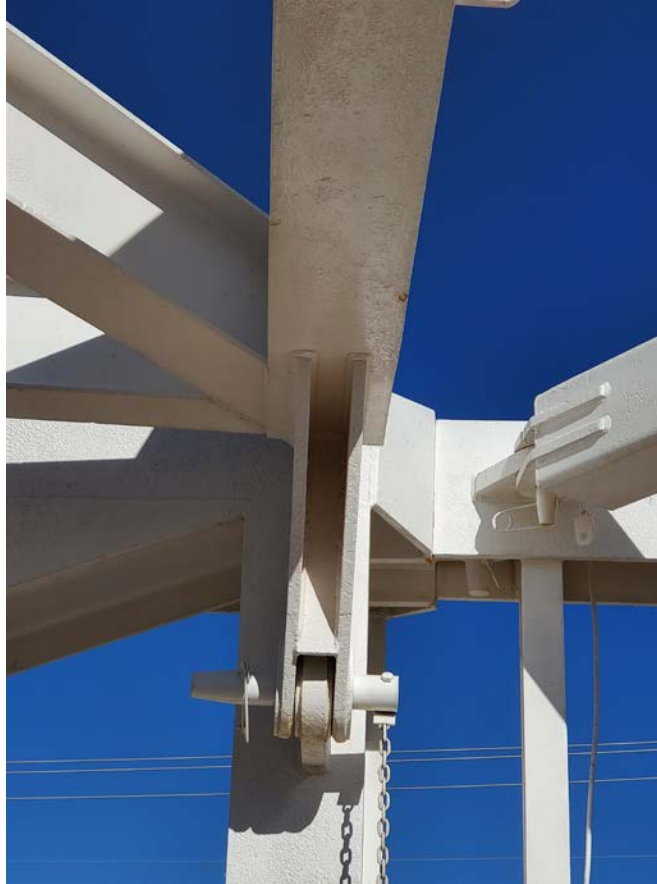
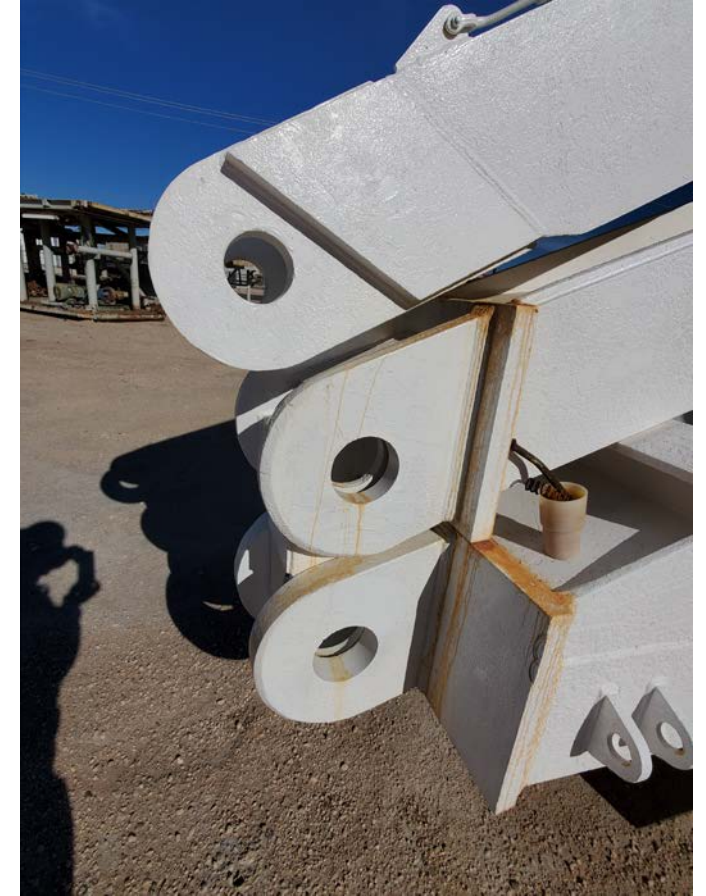
MAST PINS

ALL PINS WERE THERE BUT I COULD NOT DETERMINE IF THEY WERE OEM OR NOT. PIN HOLES WERE TO SPEC.

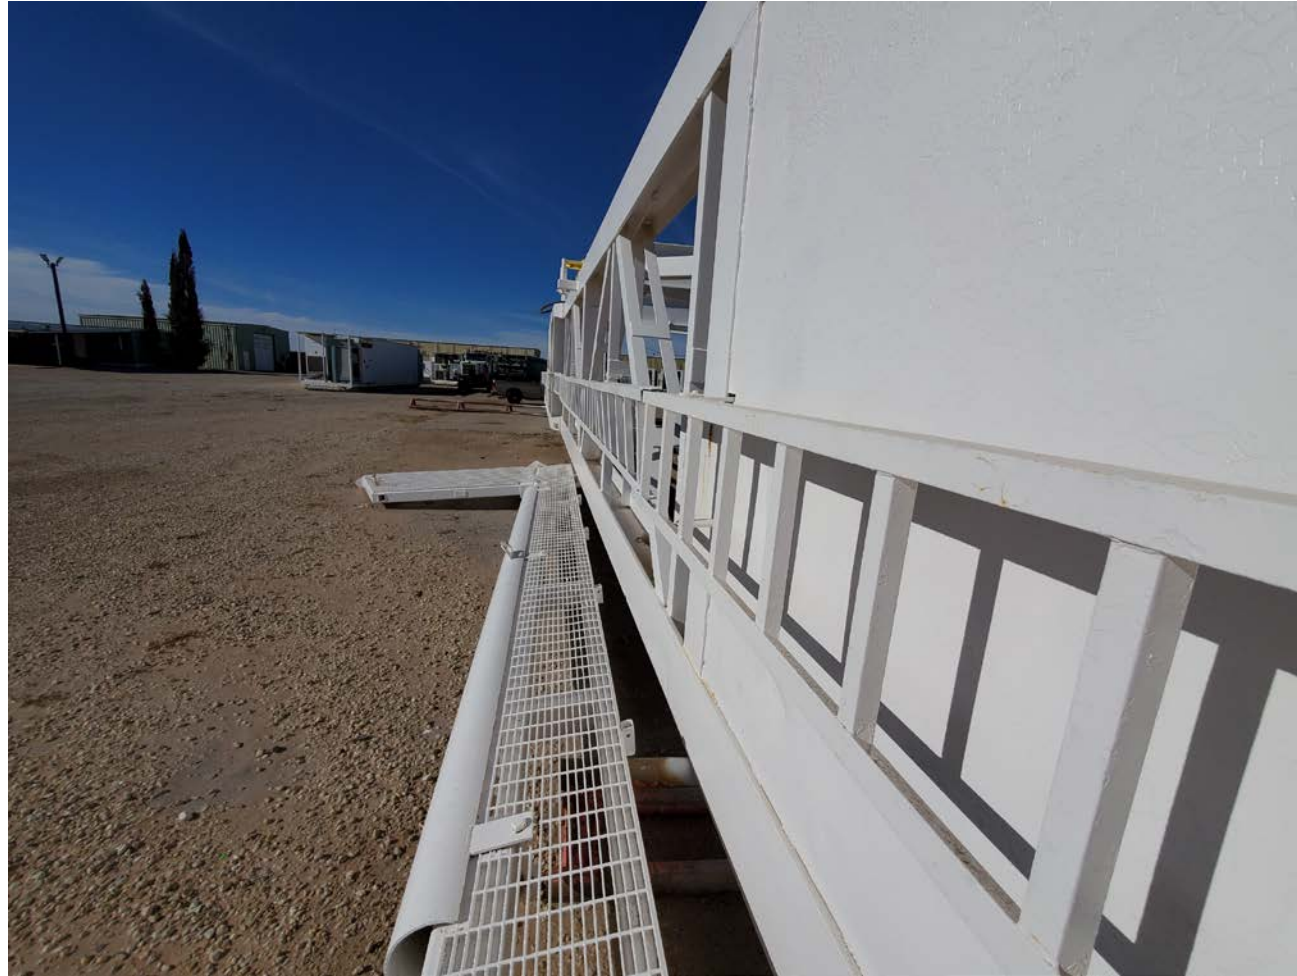
MAST LADDERS

LADDERS WERE IN GOOD CONDITION
