MURCO RIG 58 SURVEY

18780953-REP
January 16, 2023

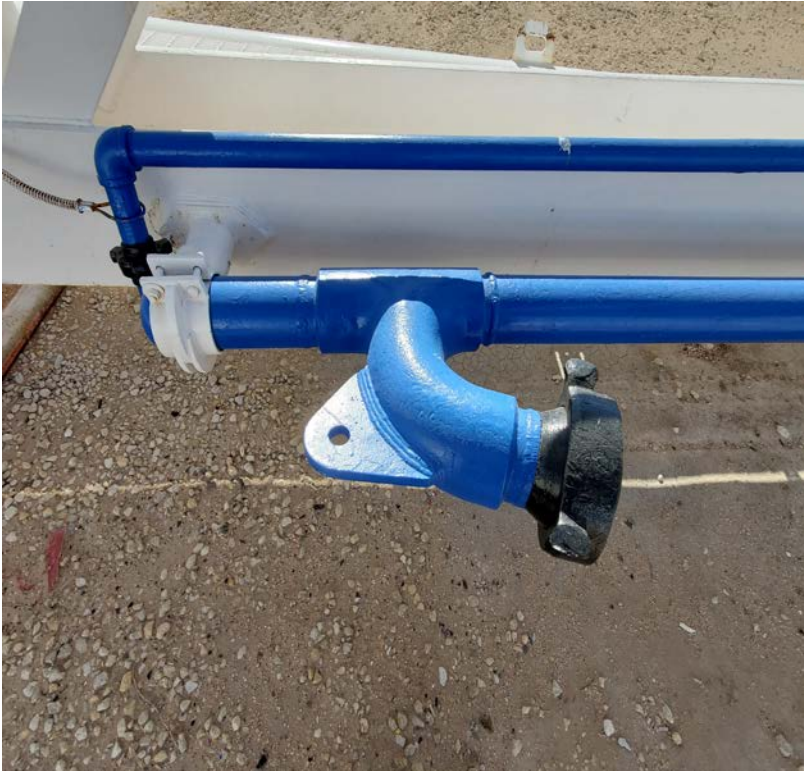
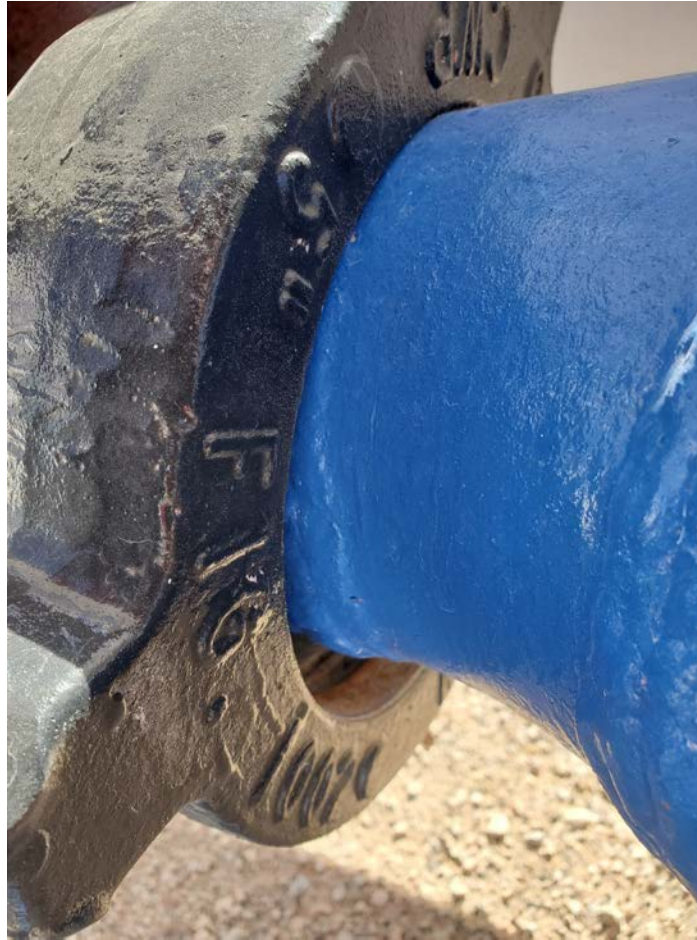
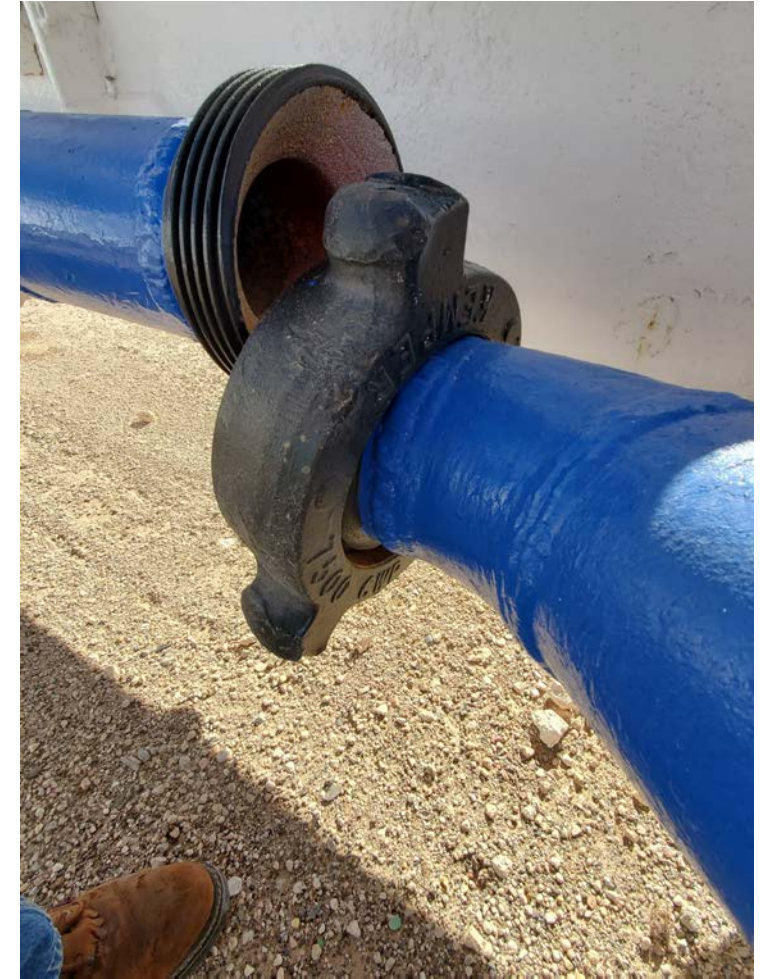
MAST STANDPIPE

SINGLE 5" ON DRILLERS SIDE DID NOT SEE A STP MANIFOLD

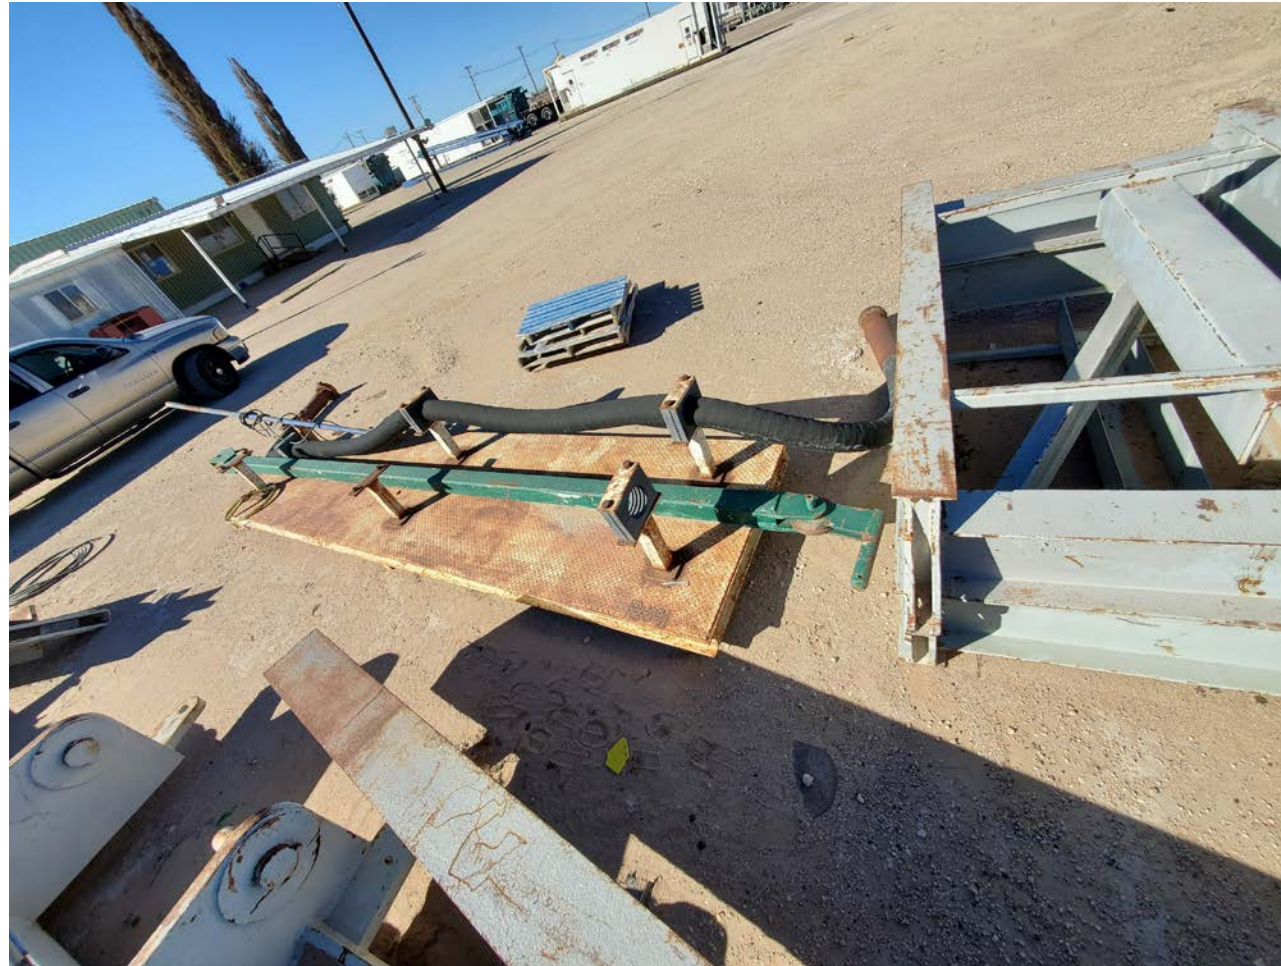
JIB BOOM

MISSING MAST BRACKETS AND SUPPORT LINE

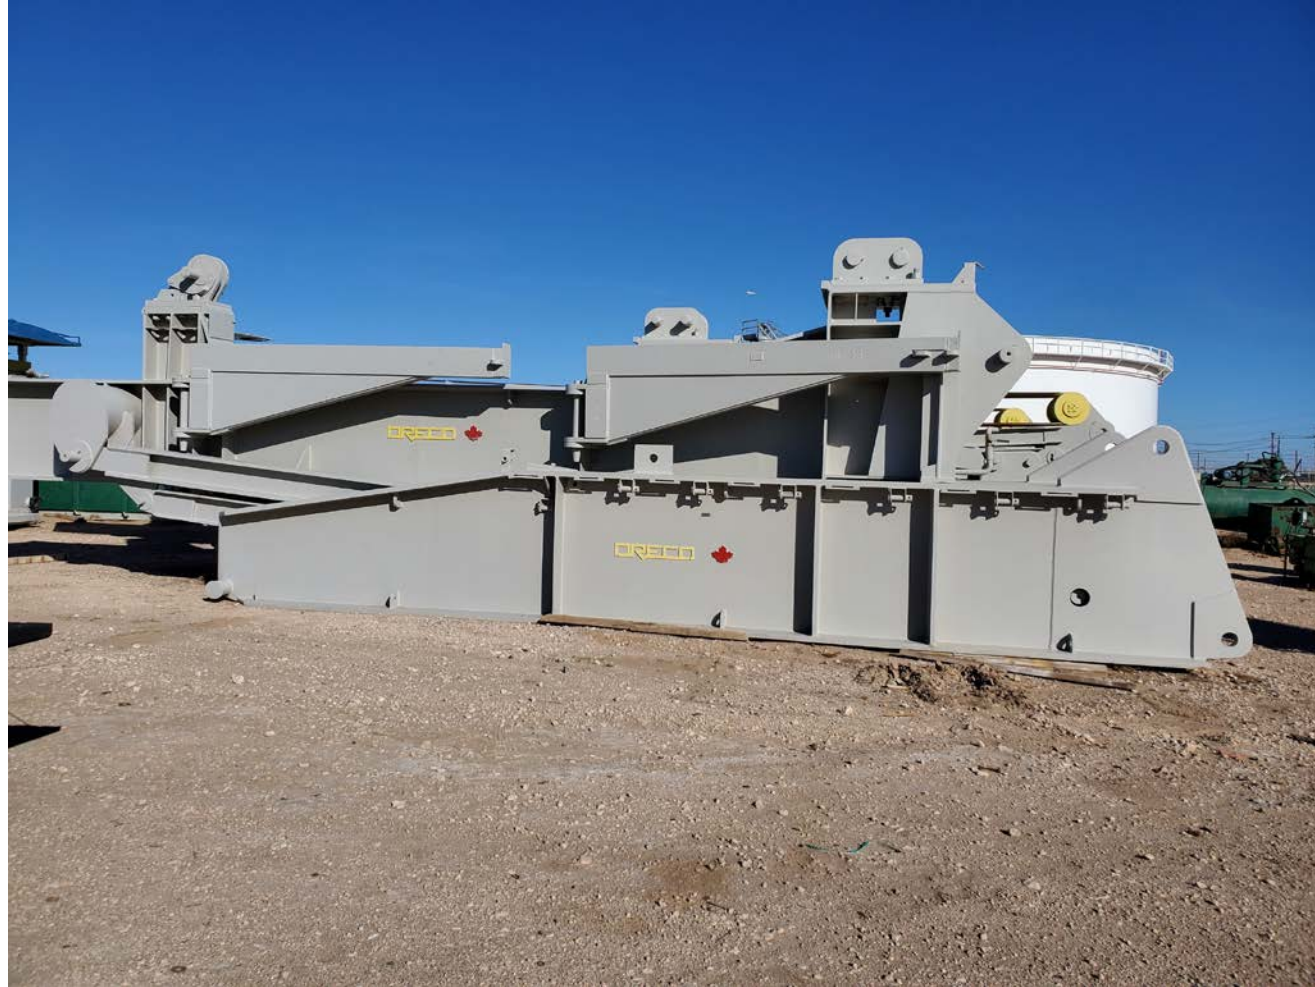
SUBSTRUCTURE

BASE AND ELEVATORS BOXES WERE STILL RIGGED UP IN THE SHIPPING POSITION

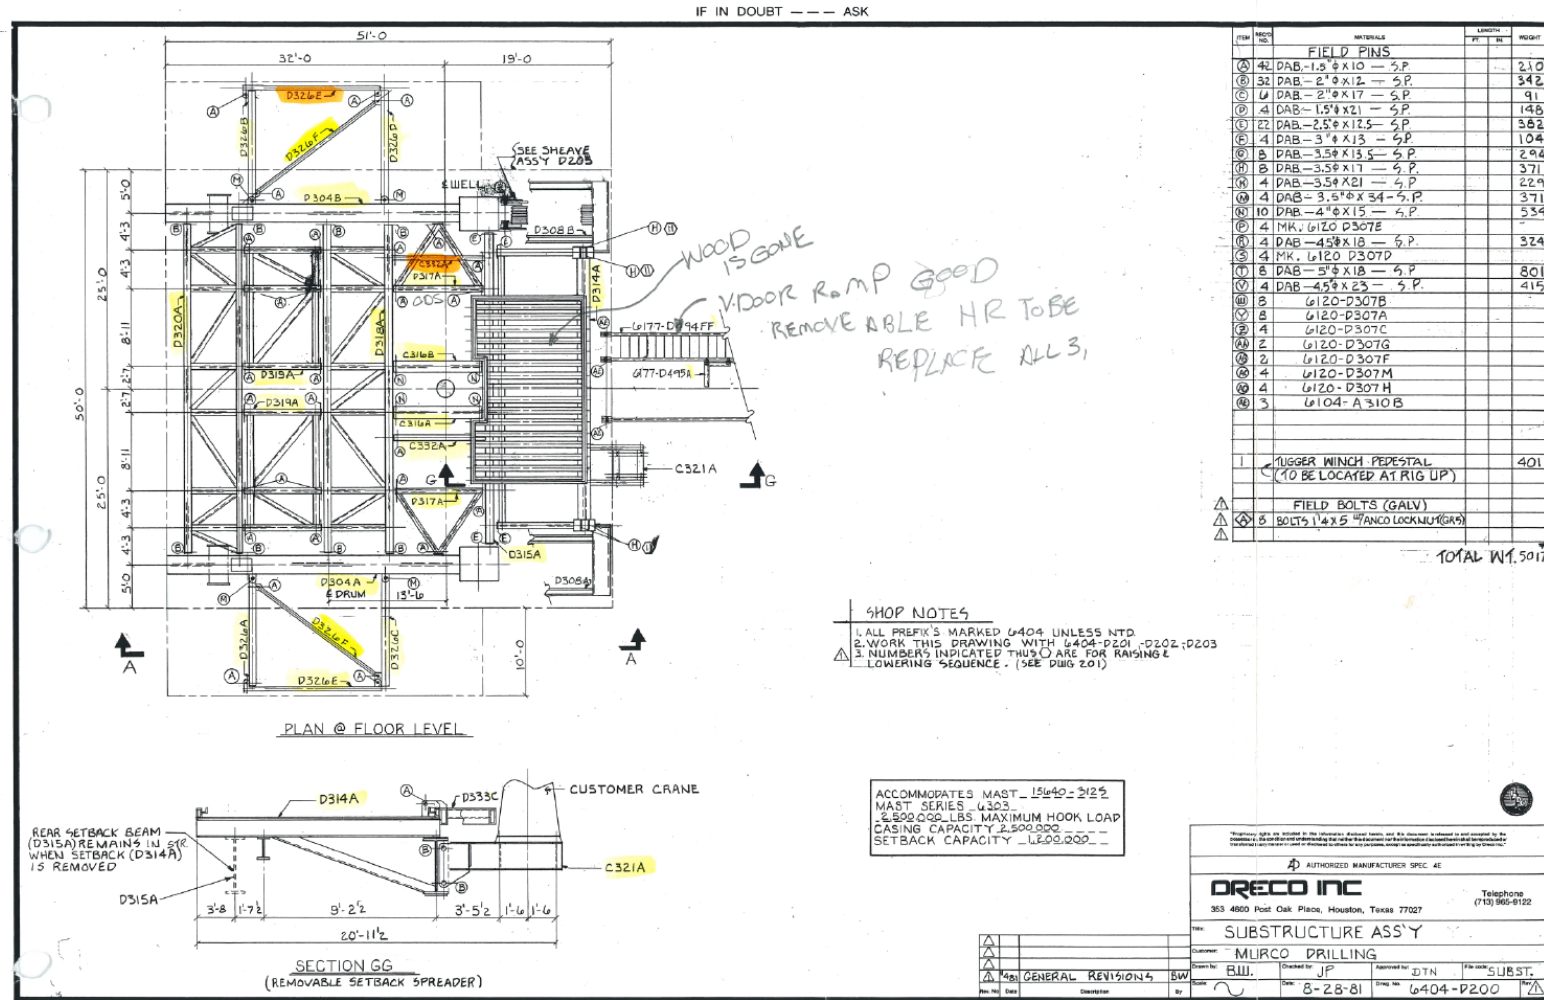
SUBSTRUCTURE ASSEMBLY

ITEMS IN ORANGE COULD NOT BE LOCATED (ASSUMED TO BE MISSING)

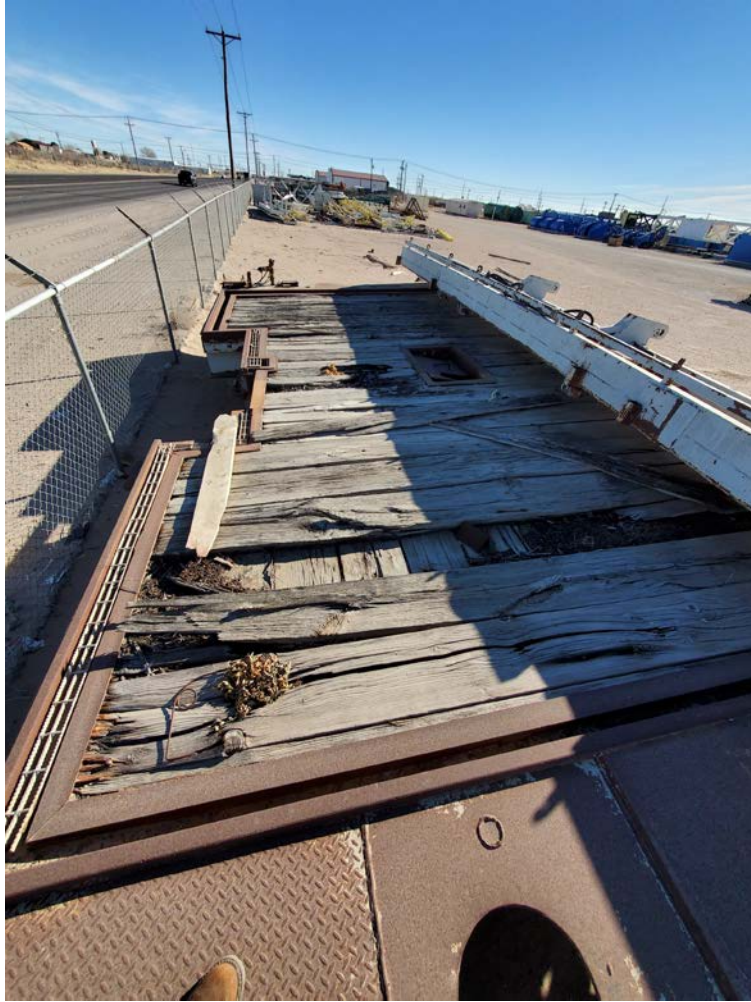
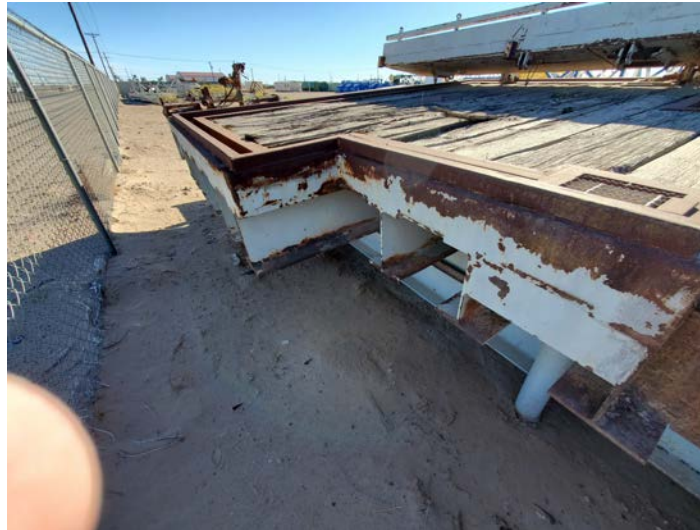
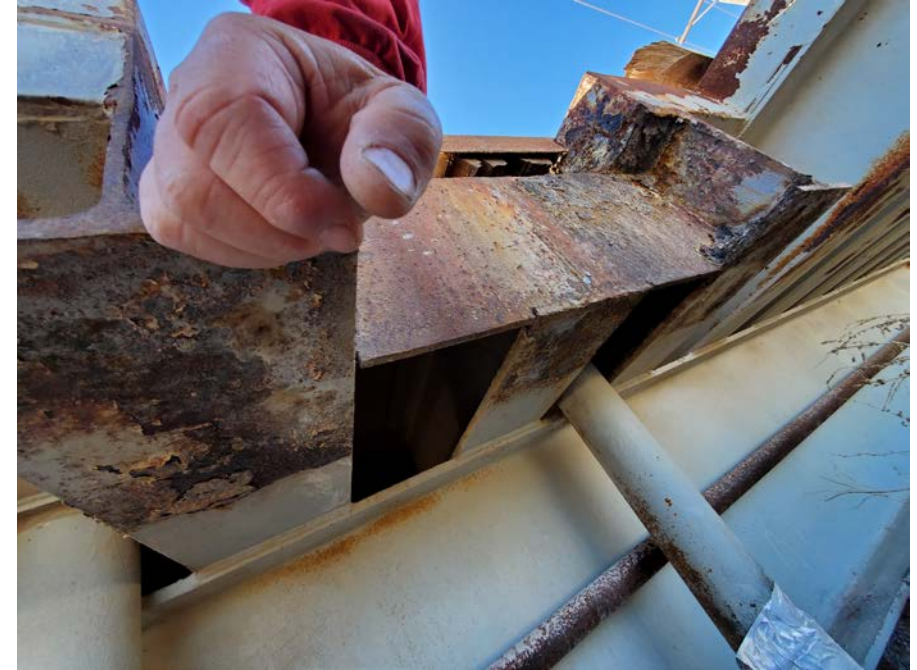
SETBACK SPREADER

WOOD NEEDS TO BE REPLACED AND MINOR SURFACE RUST

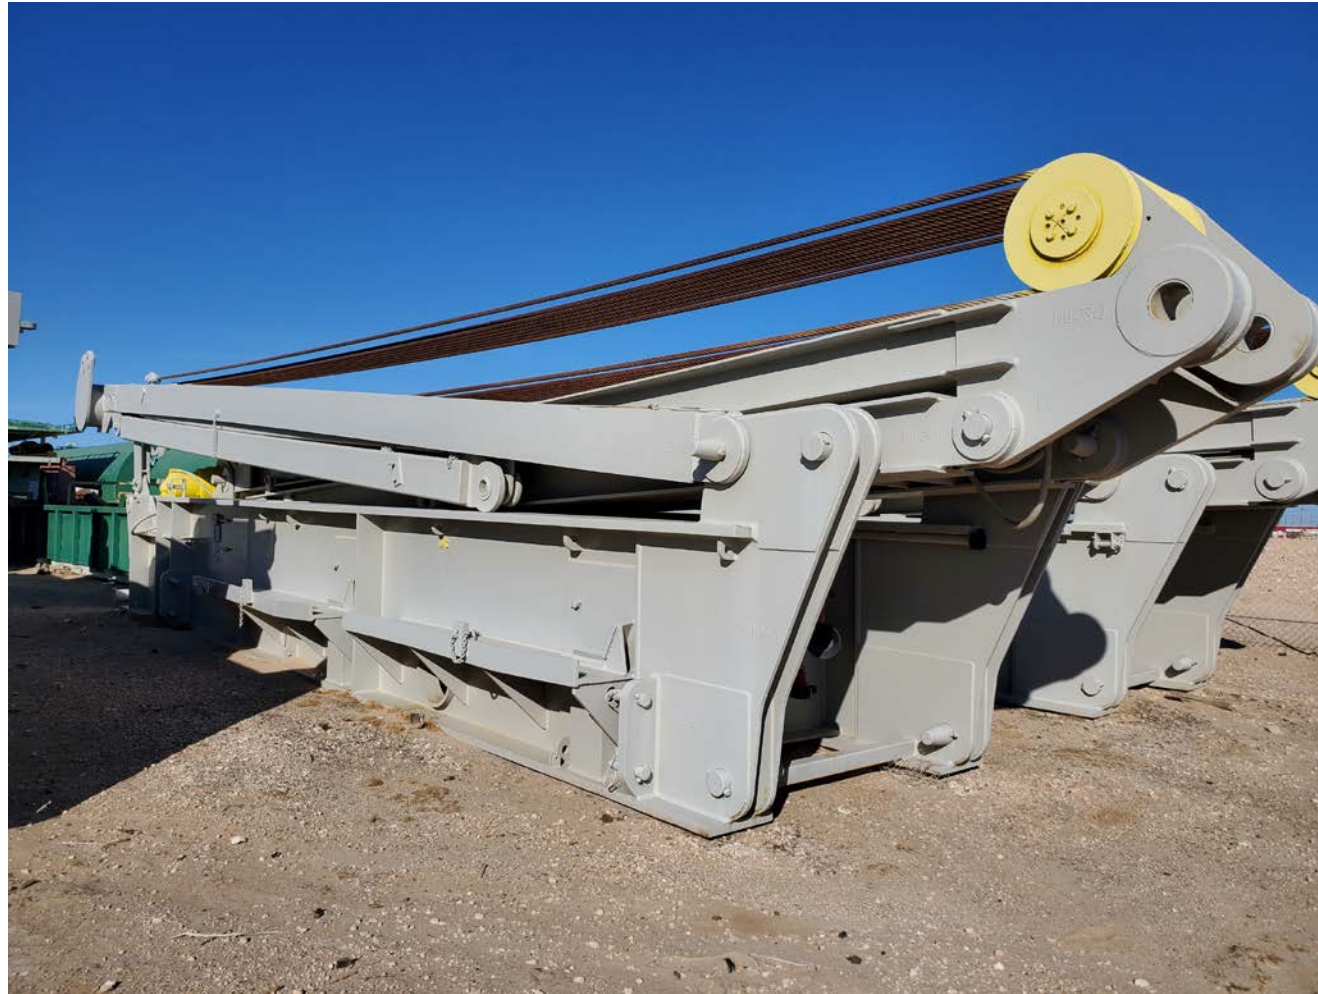
GIN POLE LEGS ARE BOWED UP AND THE COUNTER BRACES ARE BOWED DOWN AROUND A PIN IN THE CENTER. I CANNOT DETERMINE IF THE LEGS WILL BE LIKE THIS PERMANENTLY OR IF THEY WILL RETURN TO NORMAL AFTER THE LOAD IS RELEASED. THREE OF THE FOUR LEGS ARE JUST BOWED UP AND ONE IS BOWED UP AND TWISTED DUE TO AN INCORRECT PIN BEING USED AND THE PIN TAPER IS IN THE WAY. I FEEL LIKE THIS WAS CAUSED BY THE IMPROPER RIG DOWN OF THE GIN POLE LEGS.

- The substructure gin pole legs are bowed up and the counter braces are bowed down around a pin in the center. I cannot determine if the legs will be like this permanently or if they will return to normal after the load is released. Three of the four leg are just bowed up and one is bowed up and twisted due to a incorrect pin being used, and the taper is in the way. I feel like this was caused by the improper rig down on the gin pole legs.

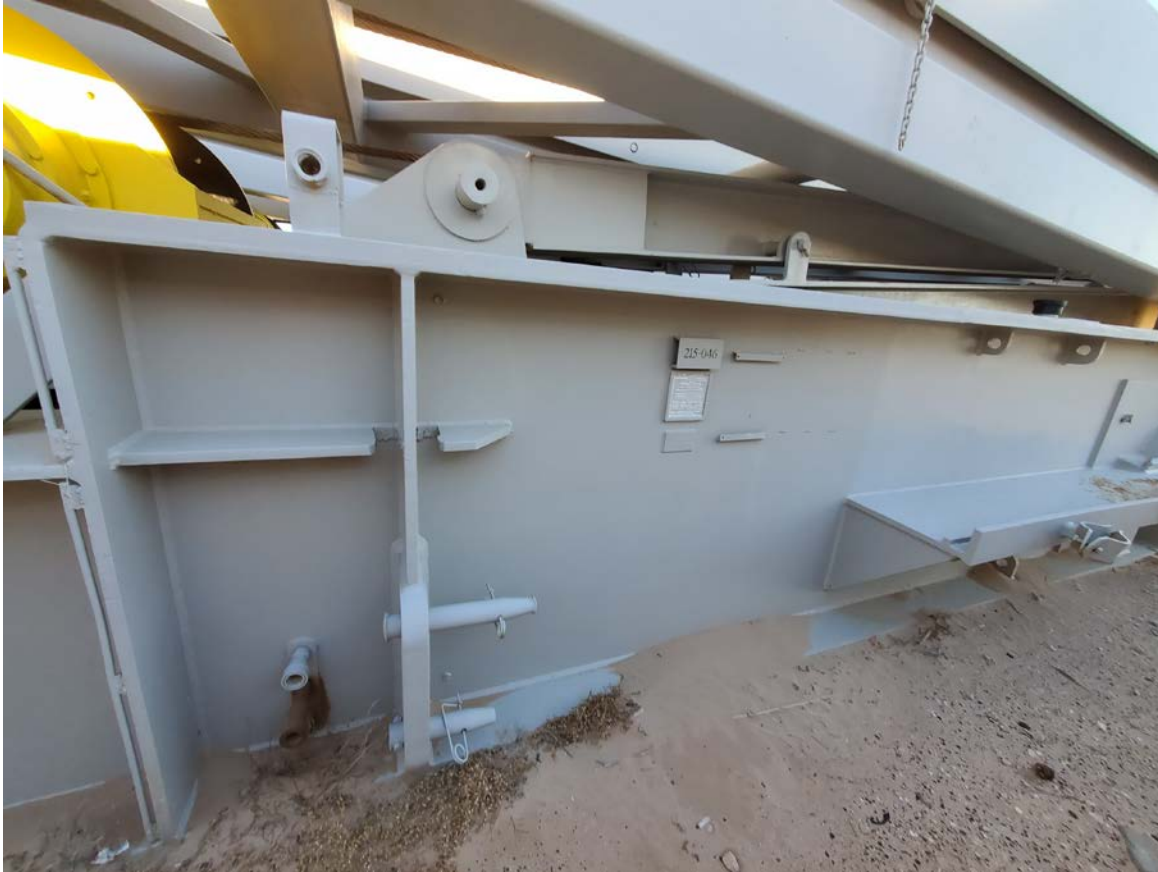
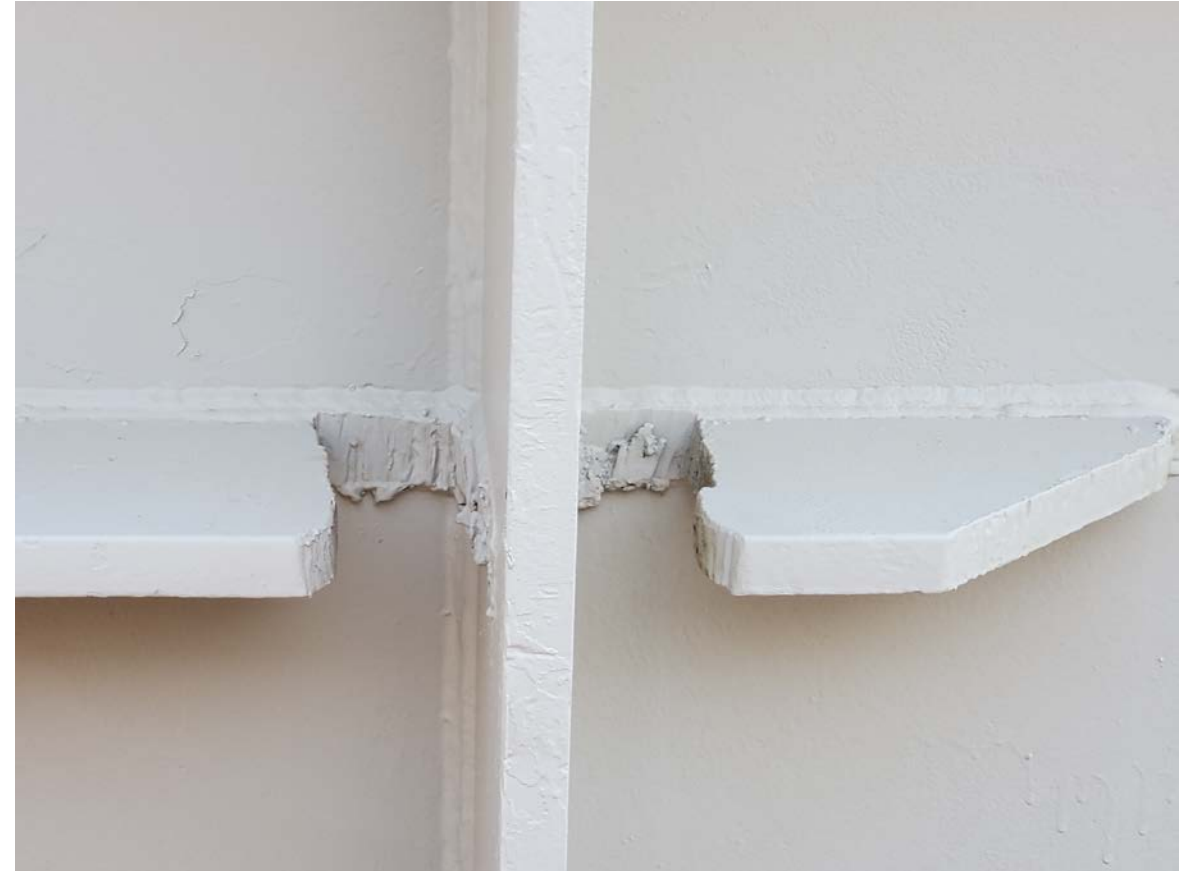
BASE BOX FIELD MODIFICATION

THE CUTOUT STIFFENER IS NOT PER PRINT NOR WAS IT APPROVED BY ENGINEERING. NOT SURE WHY THIS WAS MODIFIED BUT I CAN ASSUME IT WAS FOR RIG-UP,

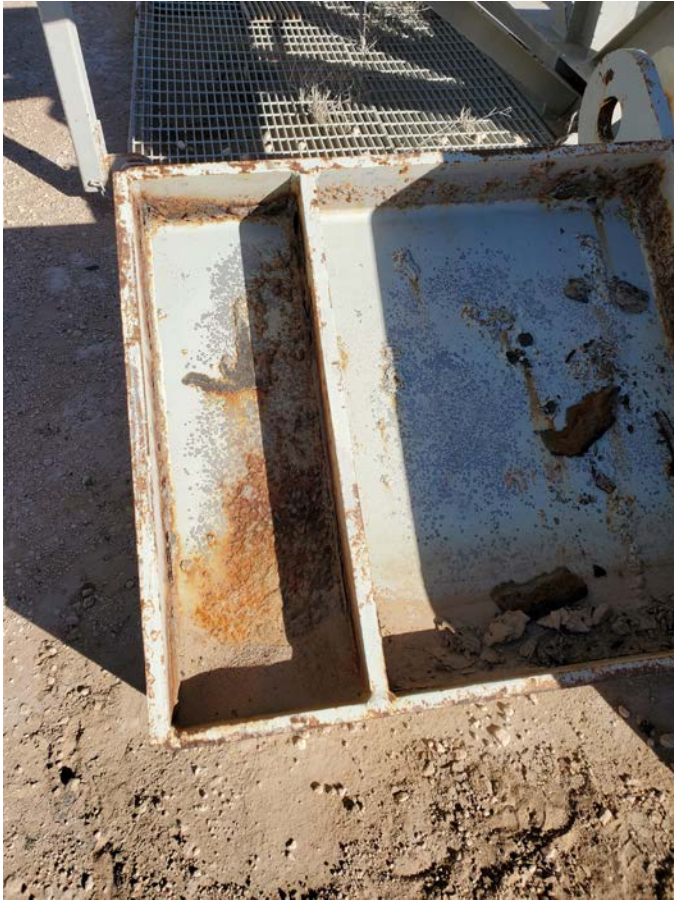
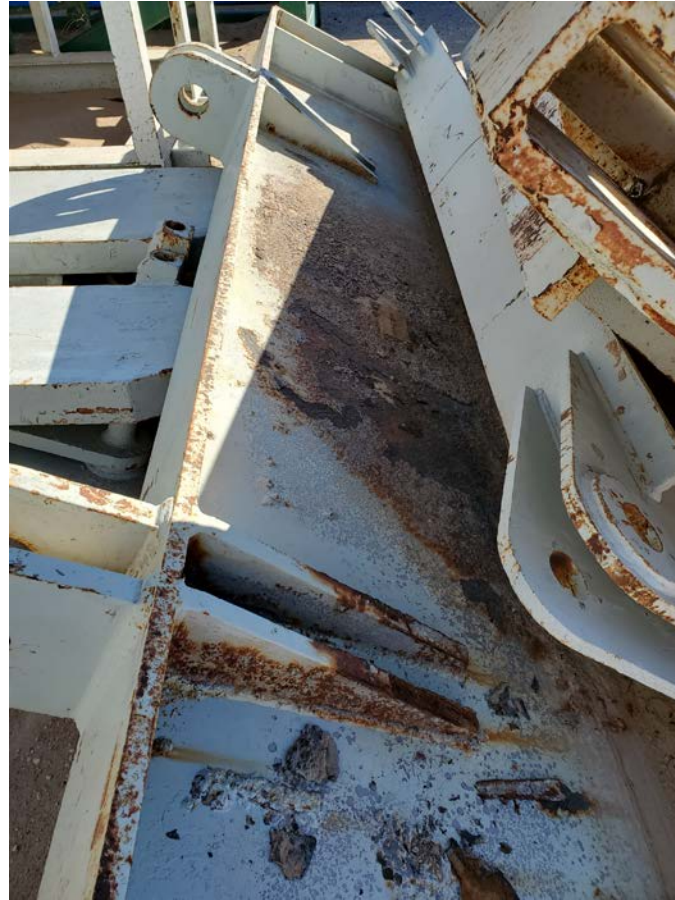
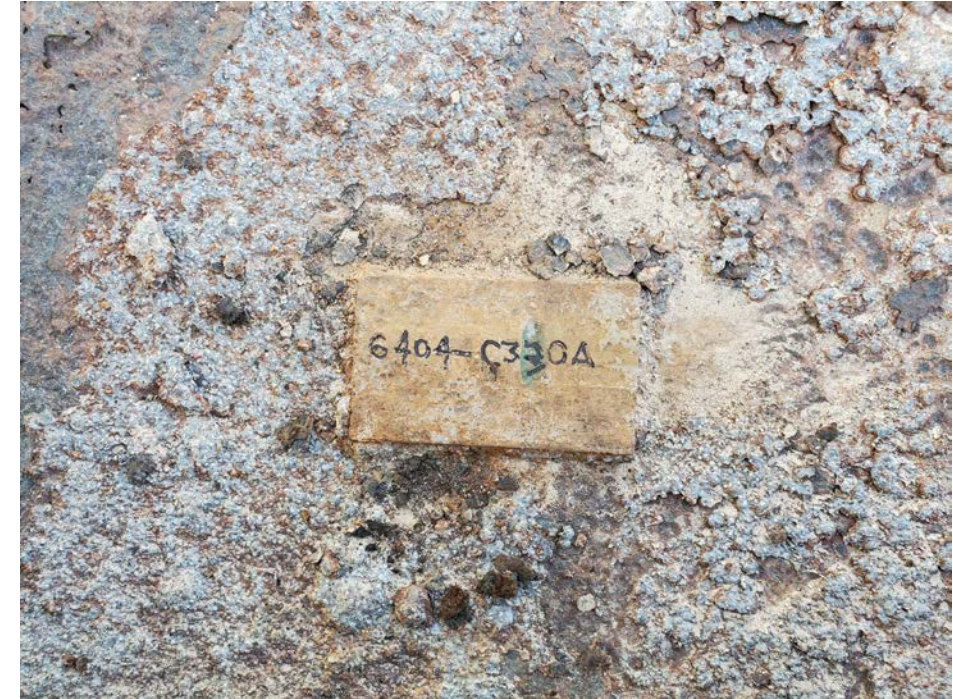
SUBSTRUCTURE JACKING BEAM

2 CAME WITH RIG ORIGINALLY BUT ONLY ONE WAS FOUND. SHOULD BE BLASTED AND INSPECTED
