Cleveland  
Pump  
Repair &  
Services, LLC

December 21, 2011

# **RockTenn Coshocton 1307 Ingersoll Rand 4x11 DA-8 Boiler Feed Pump S/N 1281126, PO 00575247 Inspection Report**

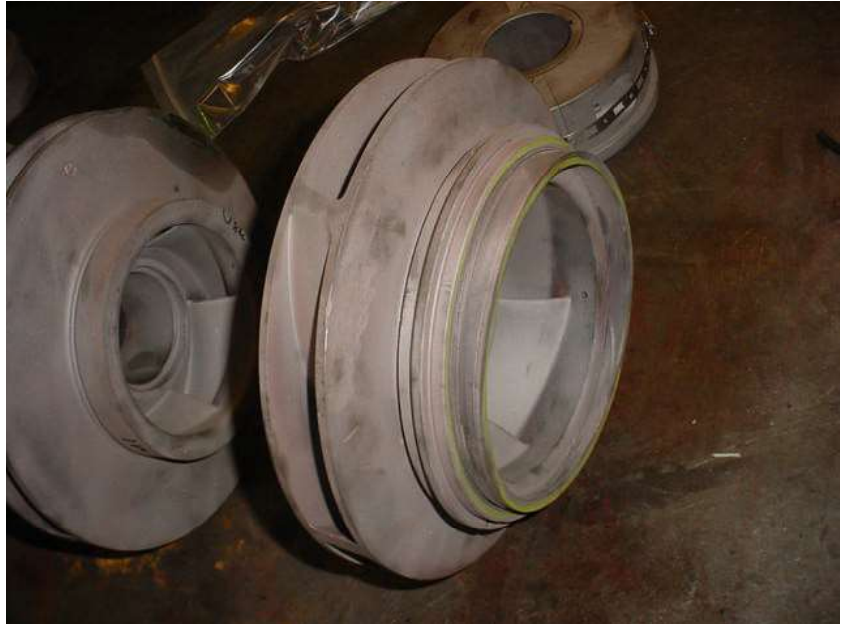
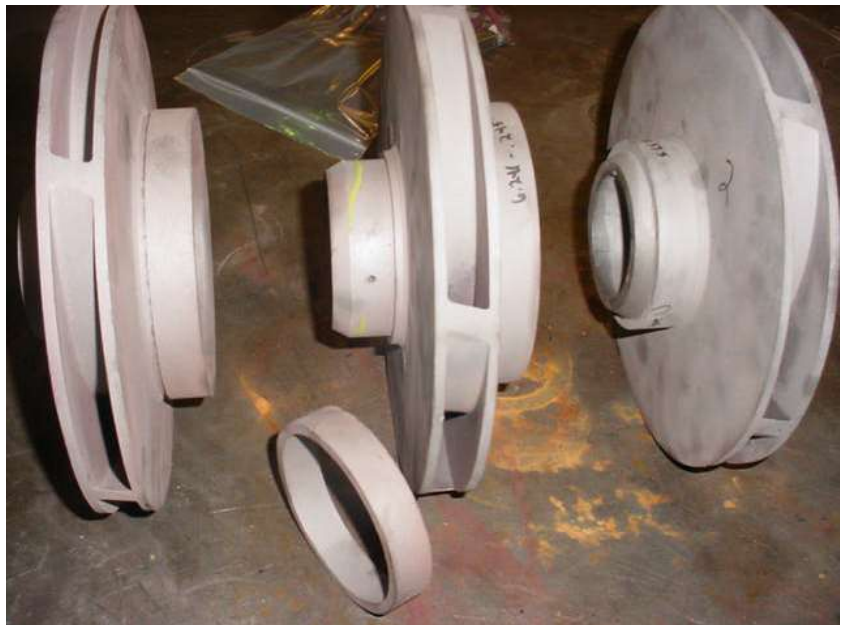
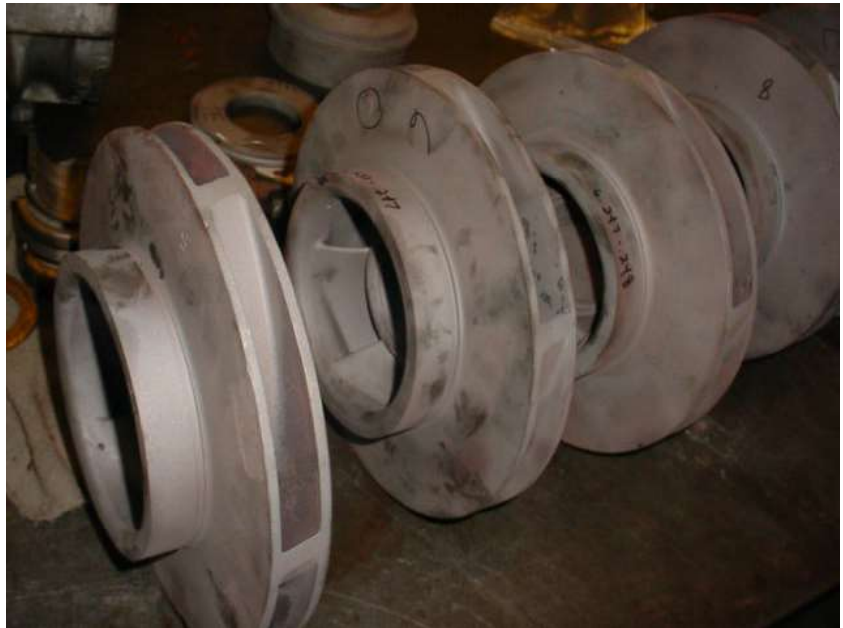
- A. The pump with coupling half was received.
- B. During our inspection process, the following conditions were noted:
1. Impellers (8) Photos 1 - 3
    - a. All hubs have wear rings.

- b. The 1<sup>st</sup> stage front hub is seized to its mating case ring.
    - c. #3 Back hub ring was loose.
    - d. All bores are out of round and have excessive interference to their shaft fits.

- e. Inlet – exit vanes are in relatively good condition.
  2. Case rings Photos 4 – 6
    - a. The 1<sup>st</sup> stage ring is seized to the impeller.

1. Impellers – 8
  - A. Removed the seized wear/case ring from the front hub.
  - B. Remove all wear rings and record fit sizes.
  - C. Repair and hand dress vanes as required.
  - D. Install new wear rings and finish machine.
  - E. Prep chrome plate and finish grind the bores to obtain the correct shaft fits.
  - F. Individually balance to 2 w/n specification.
  - G. Clean for reassembly.
2. Case rings, radial (7)
  - A. Machine bores to true-up to a common size.
3. Channel rings (6)
  - A. Machine bores to true-up to a common size.
4. Center bushing (1)
  - A. Machine bore to true-up to a common size.

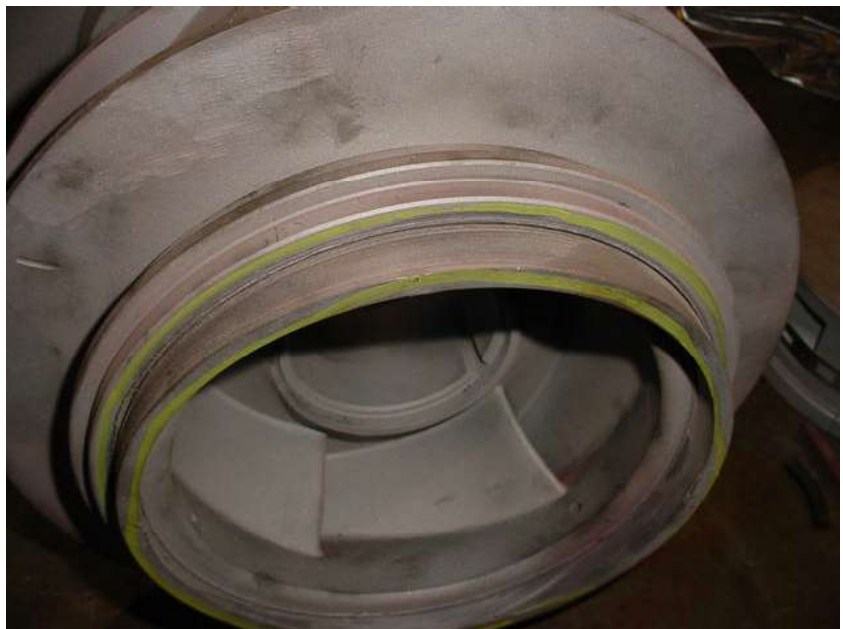
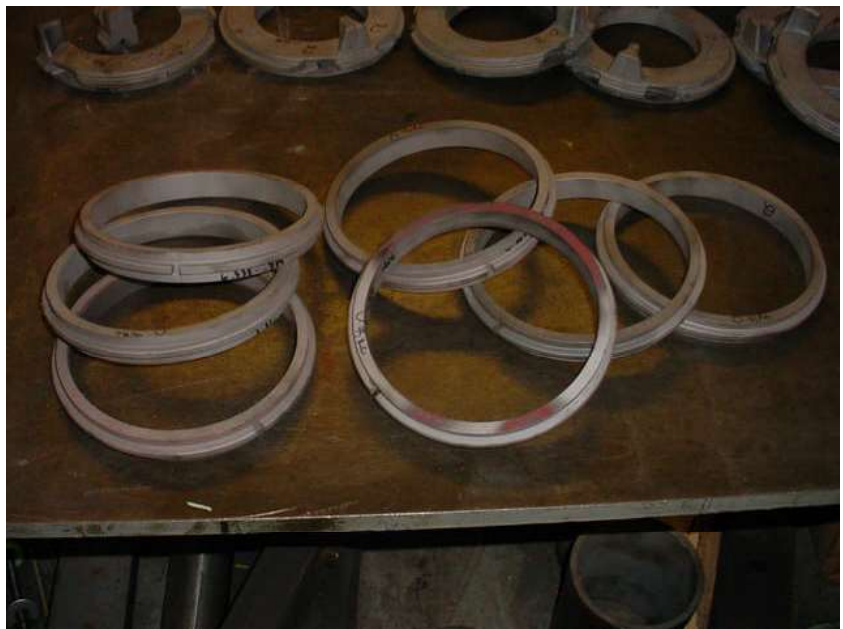
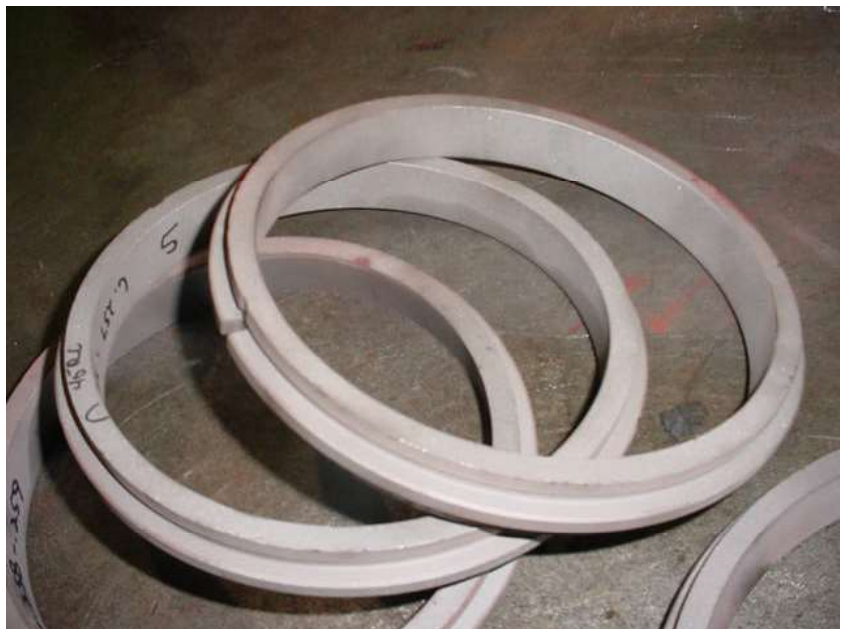
- b. The seven (7) radial rings have rub/wear indications in the bore.
    - c. The ODs are slightly out of round.
  3. Channel rings (6) Photos 7 – 9

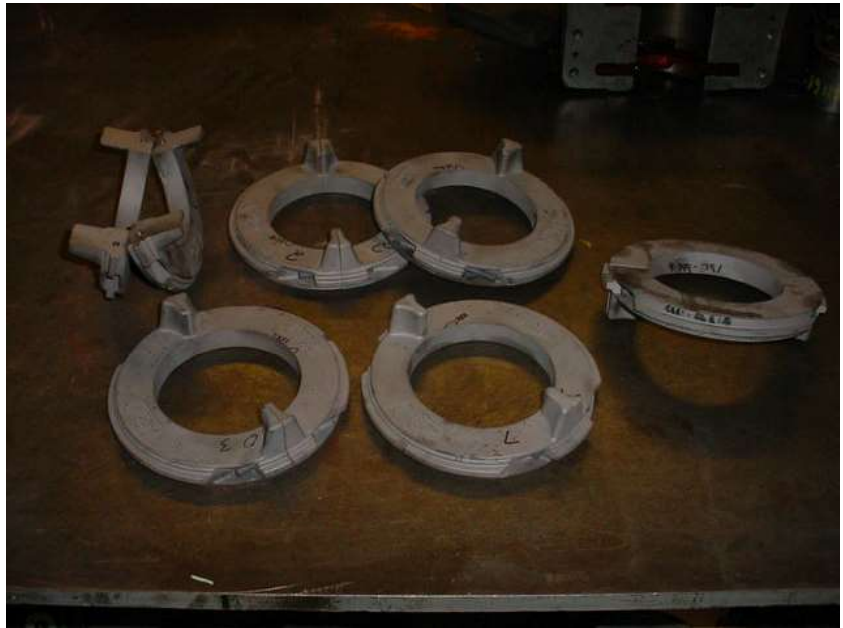
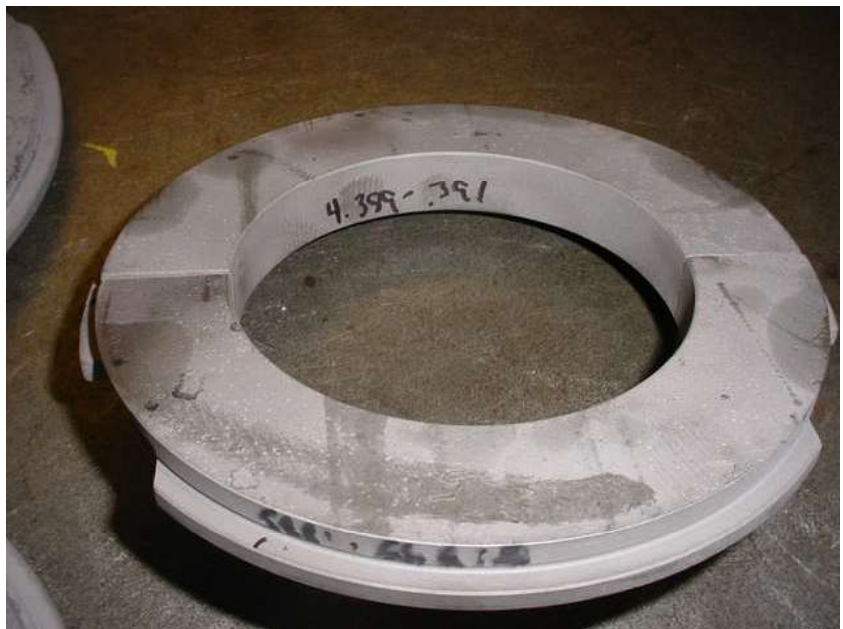
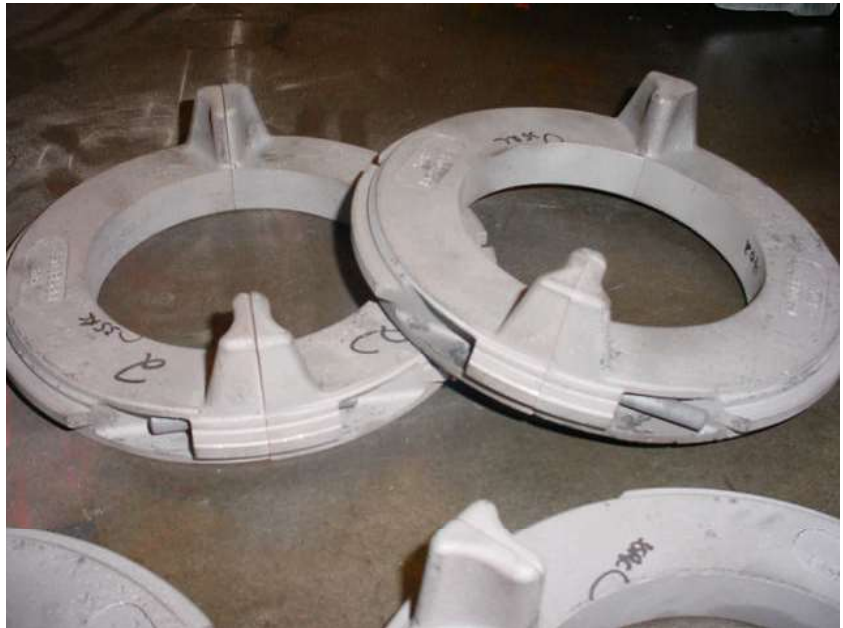
- a. Components are of the split design.
    - b. Bores have rub/wear indications.
    - c. OD fits are within specification.
  4. Center bushing and sleeve (1) Photo 10

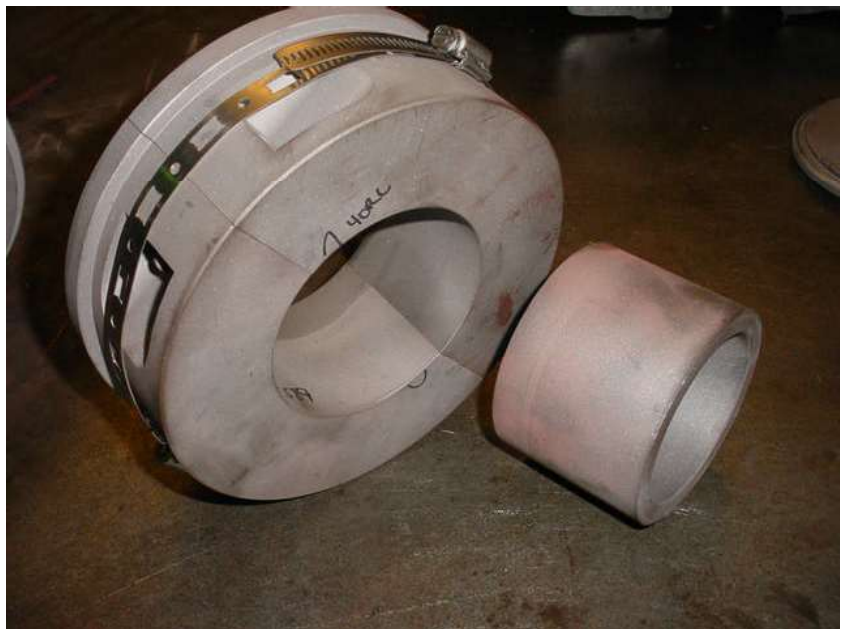
PHOTO #10

- a. There are minor wear indicators.
    - b. Running clearance has increased to .020 - .029.
  5. Throttle bushing and sleeve (1) Photo 11
    - a. Minor wear indicators

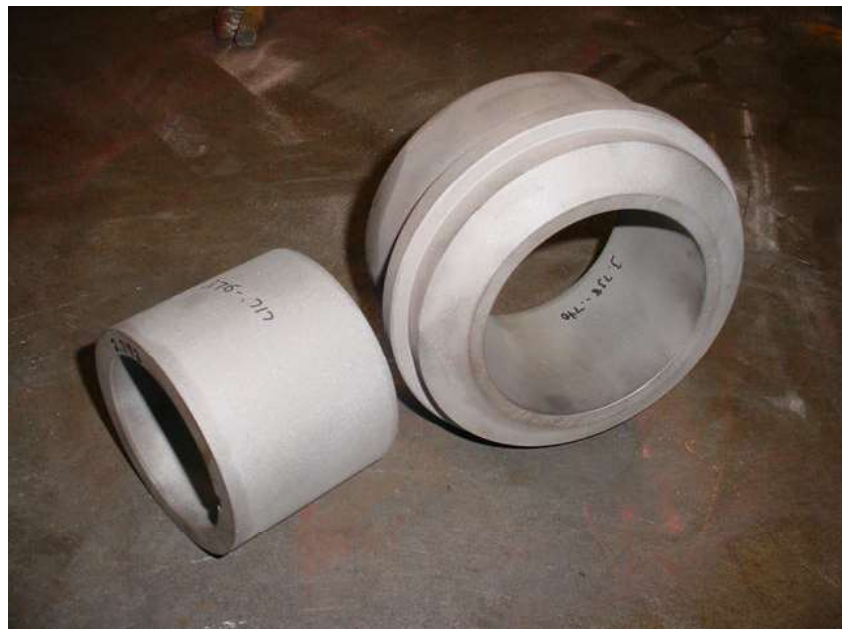
PHOTO #11

- b. Running clearance has increased to .021 - .025.
  6. Stuffing box bushings (2) No photo
    - a. Both are in good condition and reuseable.
  7. Bearing inserts Photo 12

5. Throttle bushing (1)
  - A. Machine bore to true-up to a common size.
6. Stuffing box bushings (2)
  - A. Clean and reuse.
7. Thrust bearing assembly.
  - A. Polish the shoes and thrust collar.

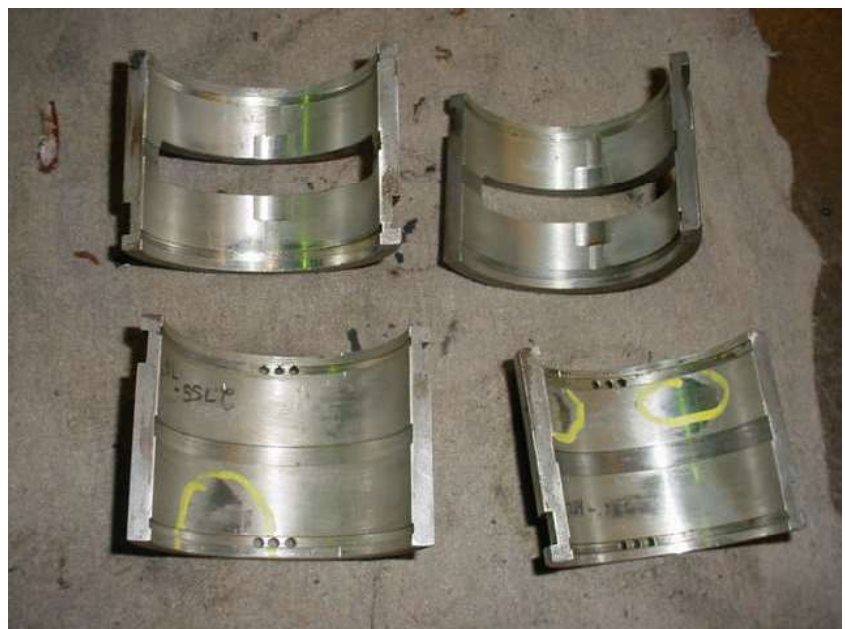
PHOTO #12

- a. Both sets are damaged and beginning to wipe.

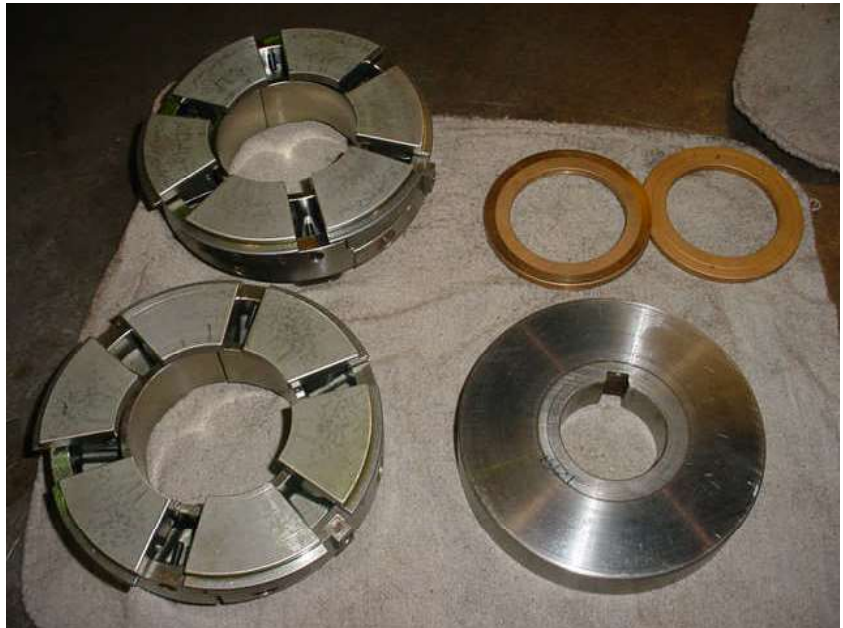
PHOTO #13

8. Thrust bearing assembly Photo 13
  - a. All components are in good condition.
9. Bearing housings Photos 14 – 15

- B. Clean all components for reassembly.
8. Bearing housings (2)
  - A. Stone fits and faces.
  - B. Thoroughly clean.
9. Laby seals (3)
  - A. Clean and reuse.

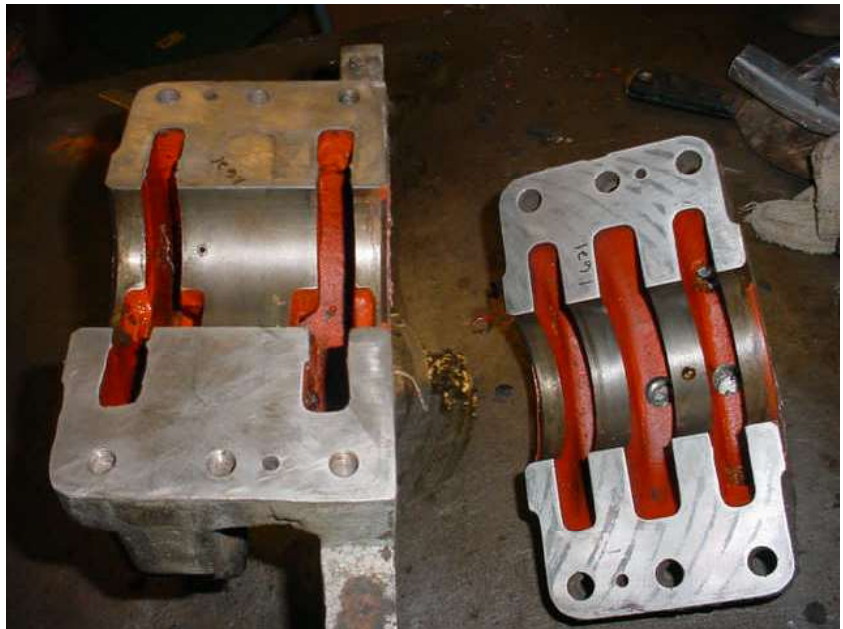
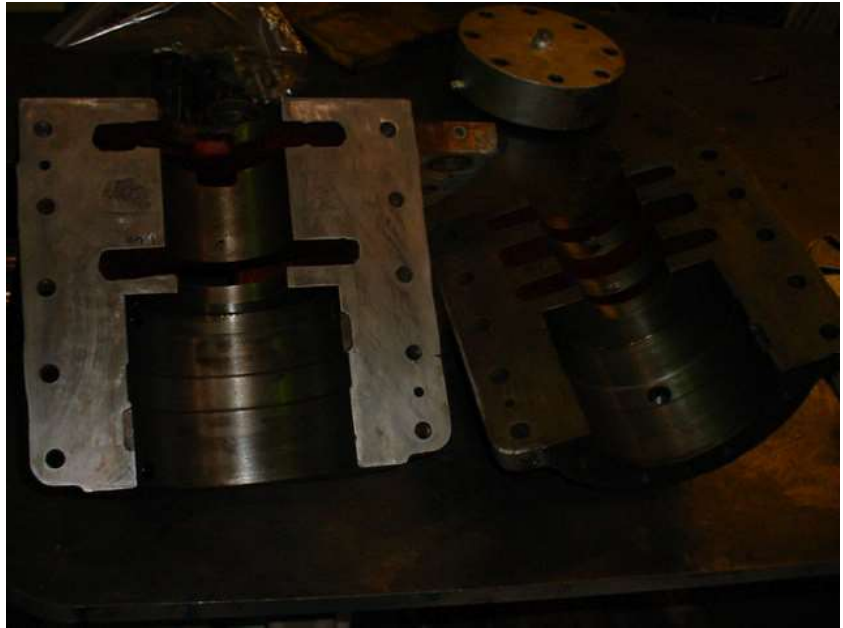
Note: During disassembly it was noted that there were no gaskets on the split lines. Dimensional data indicates that gaskets are required, as does the parts list.

- a. All fits and faces are in good condition.
10. Laby seals (3) No photo
  - a. All can be re-used
11. Casing Photos 16 – 17

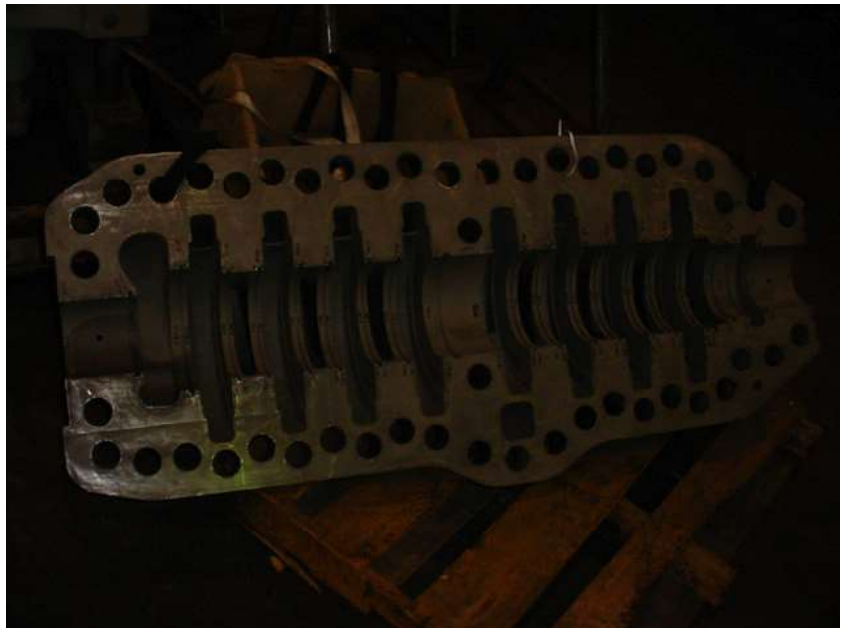
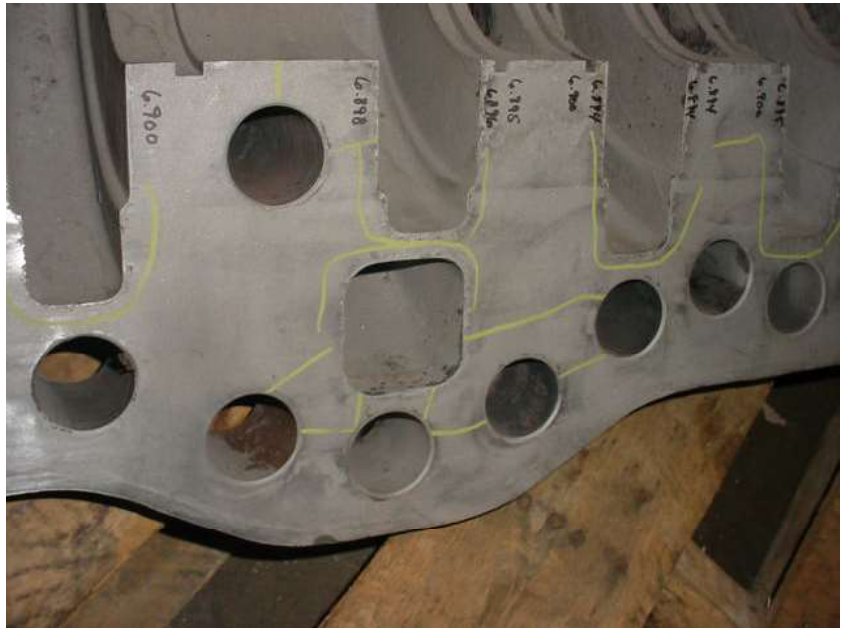
Note: By design, the DA pump cases are machined with a slight taper on the parting flanges. This, along with a specific torque procedure/pattern is required to insure proper sealing. The taper has been eliminated during a previous repair, the flanges are flat and there are lead indications thru to the stud holes.
12. Shaft Photos 18 – 20
  - a. T.I.R. is .005.
  - b. There are heavy gaul marks in areas from the excessive impeller bore interference.
  - c. Bearing fits are worn.

10. Casing
  - A. Remove all studs.
  - B. Grind the parting flanges to collapse the bores and establish the pinch taper.
  - C. Assemble and line bore all internal fits.

- D. Machine the mechanical seal and bearing housing mounting surfaces to clean-up.
  - E. Clean and deburr.
  - F. Replace anti-rotation pins as required.

- G. Retap and clean stud holes.
  - H. Make new gasket.
  - I. Thoroughly clean for reassembly.
11. Rebuild two mechanical seals.
12. Assemble rotor.
  - A. Record T.I.R.
