**FOX RIVER
HOUSATONIC, MASS. 01236**

SUCTION COUCH ROLL (NEW SHELL)

"AS SHIPPED REPORT"

September 16, 2005

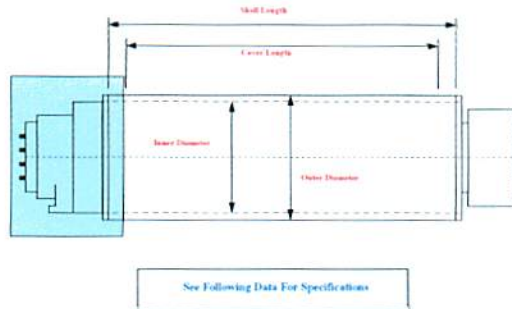
FRONT BEARING ASSEMBLY

[R] 8. Replaced front bearing cover plate seal, due to being worn out.

[R] 5. Replaced the front bearing with a customer supplied new one
