Final Report

Client name:	Verso paper - Duluth
Title:	Valve inspection
Job Number:	517700
Date:	5-14-15

JOB TYPE: *Valve inspection*

UNIT TYPE	Condensing Turbine
MODEL & RATING	Turbodyne/Dresser Rand
INSPECTION TYPE	Valve
TURBINE SERIAL NUMBER	37769
CONTROL SYSTEM	Woodward 505
LOAD TYPE	Generator
GEARBOX MODEL	Lufkin N2400C
GEARBOX SERIAL NUMBER	4595
STEAM CONDITIONS INLET PSI	820
INLET TEMPERATURE	720 F
TYPE OF OUTAGE	Planned
DATE UNIT OUT OF SERVICE	5-14-15
DATE UNIT RETURNED TO SERVICE	5-29-15

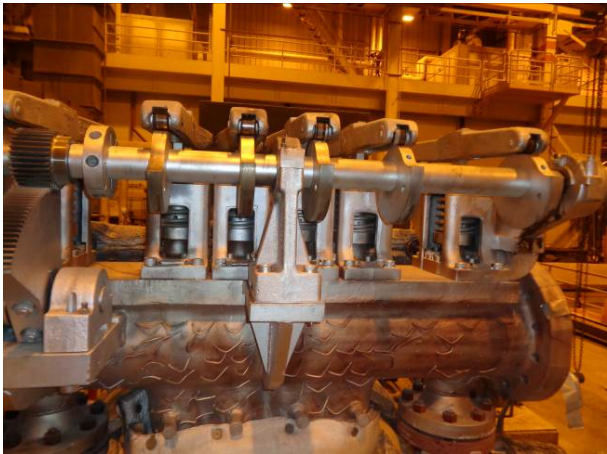
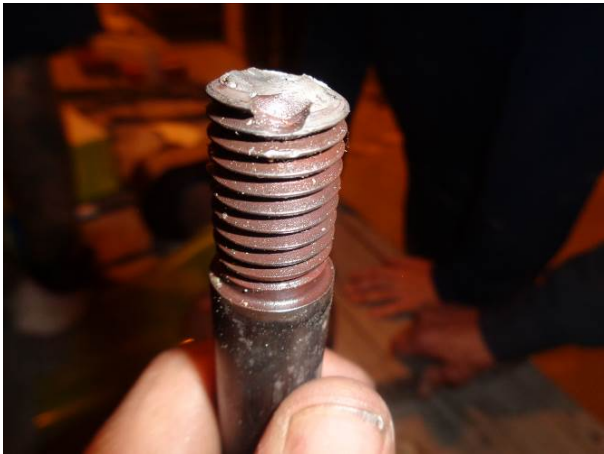
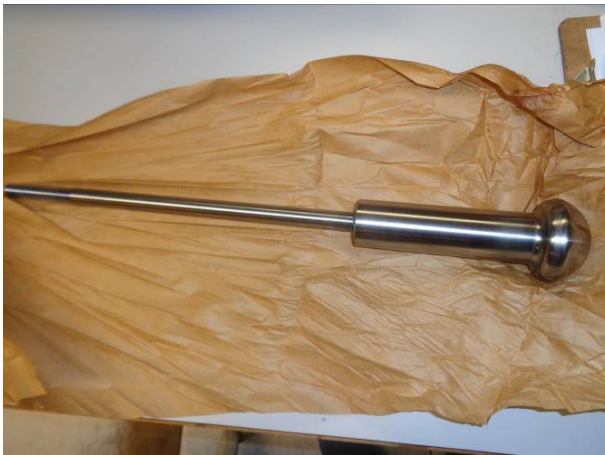
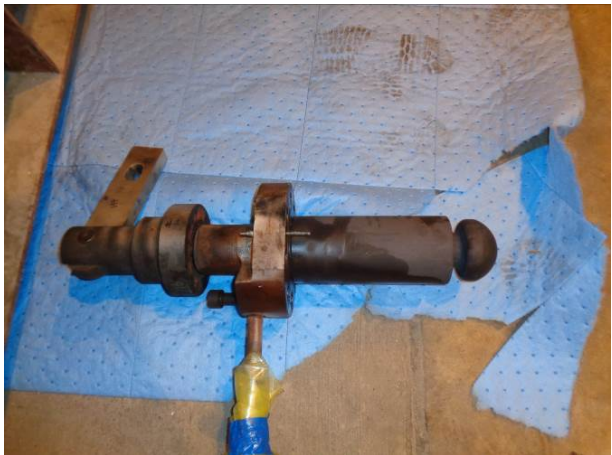
CONTROL VALVES

Disposition:			
Replaced with New Component: <u> X </u>	Replaced with Refurbished Component: <u> </u>	Repaired: <u> </u>	No Repair or Replacement: <u> </u>
Comments:			
During the removal of the valve stem from the cross heads one valve broke and one bent due to the stem being drilled too deep for the stem lock. Two new stems were made and installed. Two lower bushings were changed during the outage. All components were dye penetrant checked, blue contact checked, run outs documented, and clearances documented.

- ✚ Have new valve stems available on site prior to the start of the next outage.

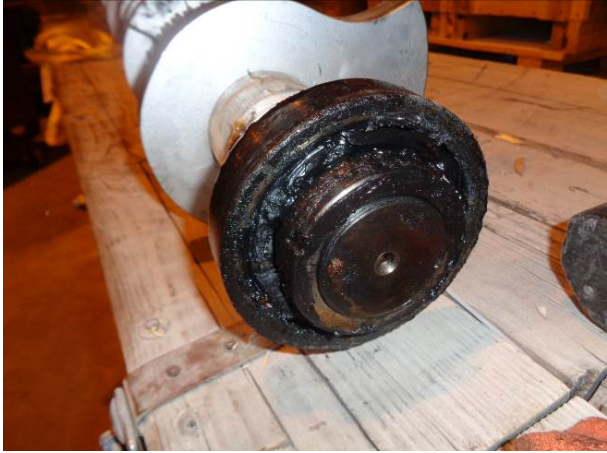
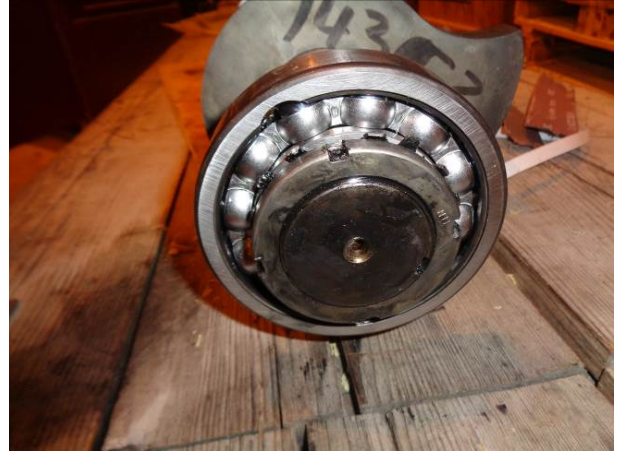
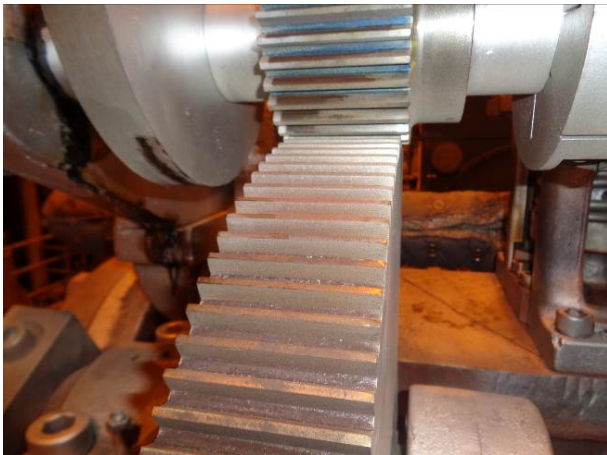
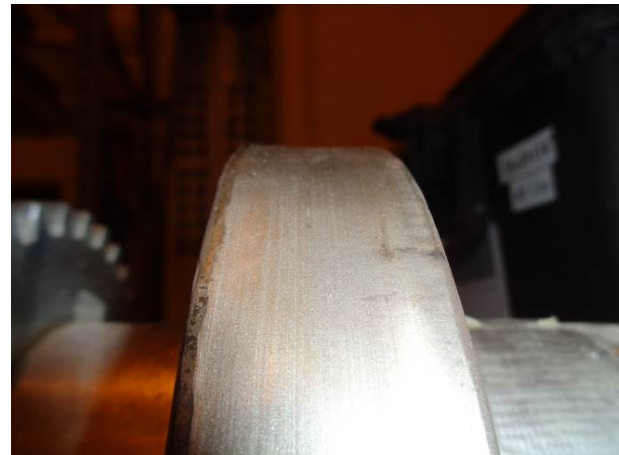
CAM SHAFT

Disposition:			
Replaced with New Component: <u> X </u>	Replaced with Refurbished Component: <u> </u>	Repaired: <u> </u>	No Repair or Replacement: <u> </u>
Comments:			
The sealed bearings on the cam shaft were replaced during the outage. The cam lobe for the # 6 valve had some wear and was replaced. The gear teeth were in good shape and no repair necessary.

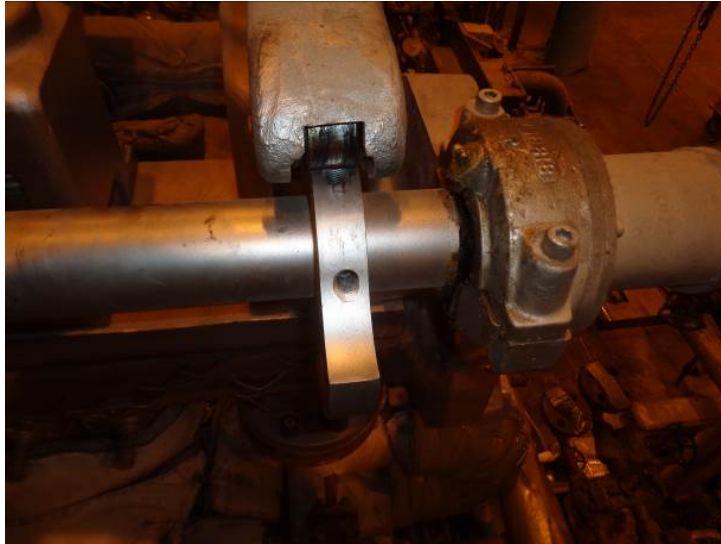
ROCKER ARM ROLLERS

Disposition:			
Replaced with New Component: <u>X</u>	Replaced with Refurbished Component: ____	Repaired: ____	No Repair or Replacement: ____
Comments:			
The rocker arm rollers were worn. The rollers were replaced with new ones.

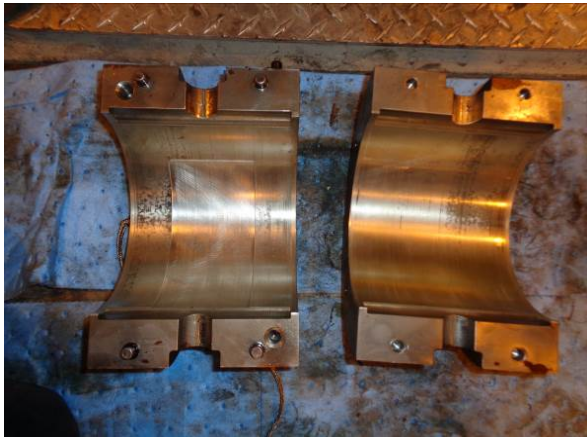
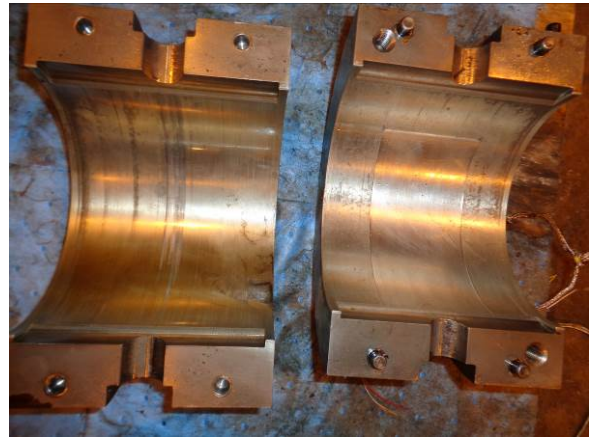
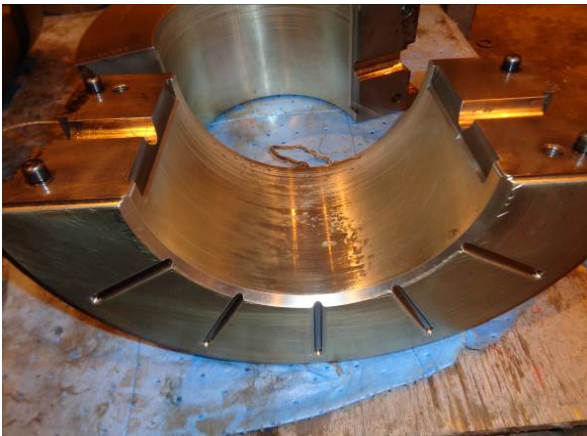
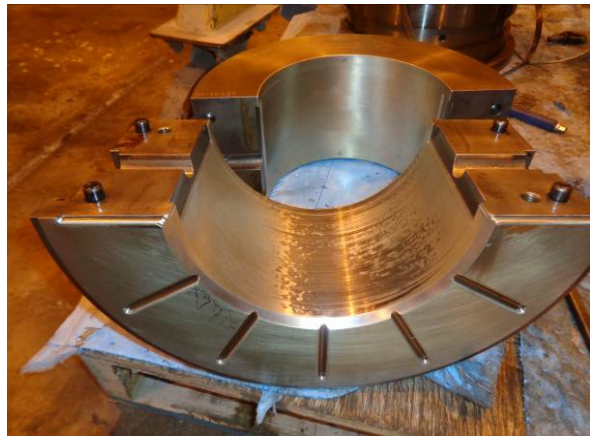
GEARBOX

Disposition:			
Replaced with New Component: <u> X </u>	Replaced with Refurbished Component: <u> </u>	Repaired: <u> </u>	No Repair or Replacement: <u> </u>
Comments:			
<p>The original scope was for a visual inspection of the gear box. During start up the unit tripped on high vibration in the low speed bearing. The gear box was opened up and a full inspection performed. All four bearings were replaced during the inspection. There was no apparent cause for the vibration. Later it was discovered that the coupling had too much grease causing the vibration.</p>

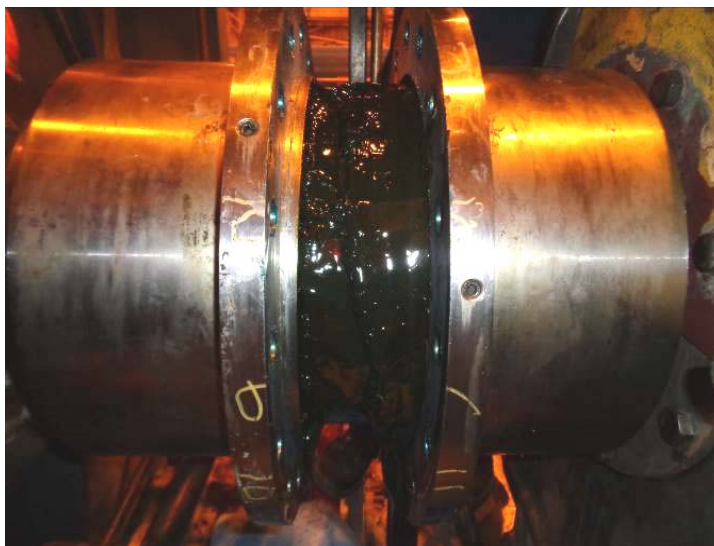
LOW SPEED COUPLING

Disposition:			
Replaced with New Component: <input type="checkbox"/>	Replaced with Refurbished Component: <input type="checkbox"/>	Repaired: <input type="checkbox"/>	No Repair or Replacement: <input checked="" type="checkbox"/>
Comments:			
The low speed coupling was separated and re-greased. The hubs were not able to separate enough to visually inspect gear teeth. During start up the unit tripped on high vibration due to too much grease. The coupling was separated and the correct amount of grease installed.

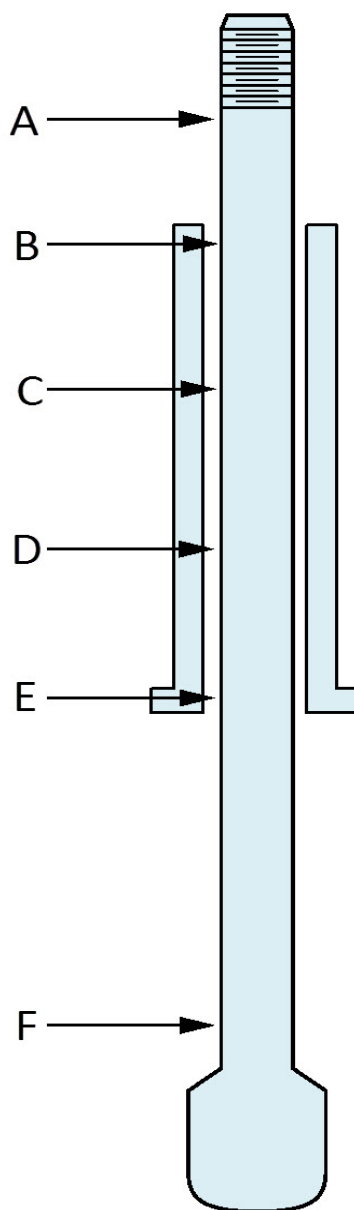
A	C	D	F	Max	Bowed?
Valve #1	4 Mils	1 Mils	0 Mils	0 Mils	4.0	
Valve #2	2 Mils	2 Mils	0 Mils	0 Mils	2.0	
Valve #3	3 Mils	3 Mils	0 Mils	0 Mils	3.0	
Valve #4	5 Mils	5 Mils	0 Mils	0 Mils	5.0	
Valve #5	1 Mils	1 Mils	1 Mils	1 Mils	0.0	
Valve #6	N/A	N/A	N/A	N/A	0.0	
STEM LENGTH:	21.750"		Inches			
MAX TIR per foot:			Mils/Ft			
Max Allowable TIR:			Mils

BEFORE CLEAN	AFTER CLEAN	BEFORE CLEAN	AFTER CLEAN
		B	B	E	E
VALVE #1	Bush. ID	.687	.687	2.126	2.126
	Stem OD	.681	.681	2.118	2.118
	Clearance	.006	.006	.008	.008
VALVE #2	Bush. ID	.690	.690	1.663	1.663
	Stem OD	.681	.681	1.651	1.651
	Clearance	.009	.009	.012	.012
VALVE #3	Bush. ID	.686	.686	1.662	1.662
	Stem OD	.681	.681	1.652	1.652
	Clearance	.005	.005	.010	.010
VALVE #4	Bush. ID	.690	.690	1.662	1.662
	Stem OD	.681	.681	1.652	1.652
	Clearance	.009	.009	.010	.010
VALVE #5	Bush. ID	.688	.688	.692	.692
	Stem OD	.681	.681	.681	.681
	Clearance	.007	.007	.011	.011
VALVE #6	Bush. ID	.691	.691	1.662	1.662
	Stem OD	.681	.681	1.652	1.652
	Clearance	.010	.010	.010	.010

6 stem broke during removal. # 3 stem bent during removal. Both will need to be replaced

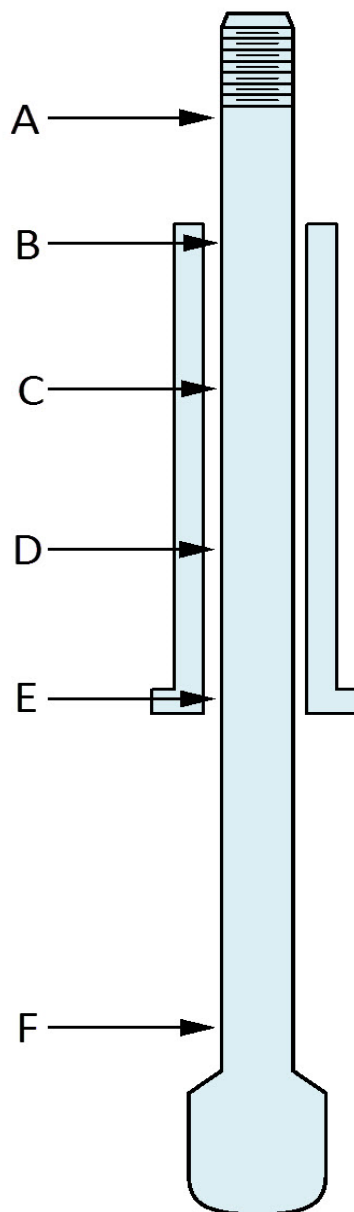
A	C	D	F	Max	Bowed?
Valve #1	4 Mils	1 Mils	0 Mils	0 Mils	4.0	
Valve #2	2 Mils	2 Mils	0 Mils	0 Mils	2.0	
Valve #3	0 Mils	0 Mils	0 Mils	0 Mils	0.0	
Valve #4	5 Mils	5 Mils	0 Mils	0 Mils	5.0	
Valve #5	1 Mils	1 Mils	1 Mils	1 Mils	0.0	
Valve #6	0 Mils	0 Mils	0 Mils	0 Mils	0.0	
STEM LENGTH:	21.750"		Inches			
MAX TIR per foot:			Mils/Ft			
Max Allowable TIR:			Mils

BEFORE CLEAN	AFTER CLEAN	BEFORE CLEAN	AFTER CLEAN
		B	B	E	E
VALVE #1	Bush. ID	.687	.687	2.126	2.126
	Stem OD	.681	.681	2.118	2.118
	Clearance	.006	.006	.008	.008
VALVE #2	Bush. ID	.690	.690	1.660	1.660
	Stem OD	.681	.681	1.651	1.651
	Clearance	.009	.009	.009	.009
VALVE #3	Bush. ID	.686	.686	1.662	1.662
	Stem OD	.680	.680	1.653	1.653
	Clearance	.006	.006	.009	.009
VALVE #4	Bush. ID	.690	.690	1.662	1.662
	Stem OD	.681	.681	1.652	1.652
	Clearance	.009	.009	.010	.010
VALVE #5	Bush. ID	.688	.688	.692	.692
	Stem OD	.681	.681	.681	.681
	Clearance	.007	.007	.012	.011
VALVE #6	Bush. ID	.691	.691	1.660	1.660
	Stem OD	.681	.681	1.652	1.652
	Clearance	.010	.010	.008	.008

3 & # 6 stems are new. New lower bushings were installed on # 2 & # 6 valves
