Andreas Wieder
From the Flensburg Chamber of Industry and
Commerce
Publicly appointed and sworn
Expert for wind turbines

**Condition report for the gearbox, winery PEAS 4375,6 with the serial number
170 102 909-001-2**

On Juli 26, 2025, a condition inspection with endoscopy was carried out at the winery
gearbox with the Serial number 170 102 909-001-2

Winergy PEAS 4375,6 SN 170 102 909-001-2

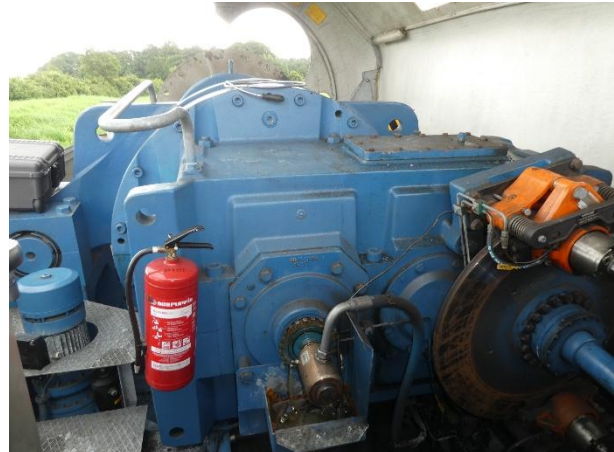
Exterior overview

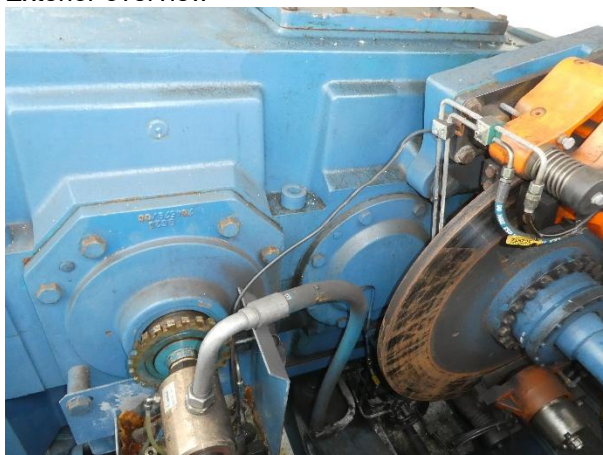
Exterior overview

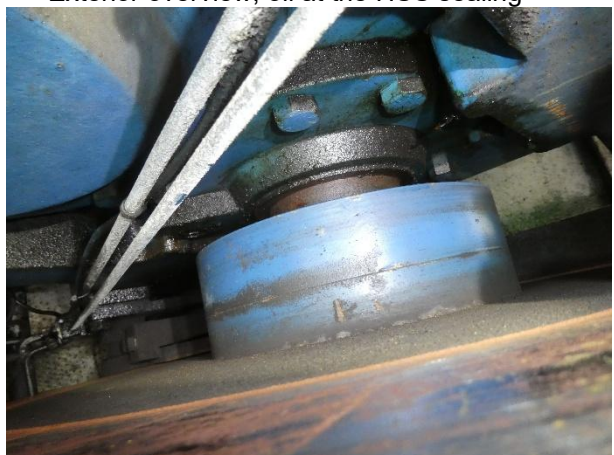
Exterior overview, oil at the HSS sealing

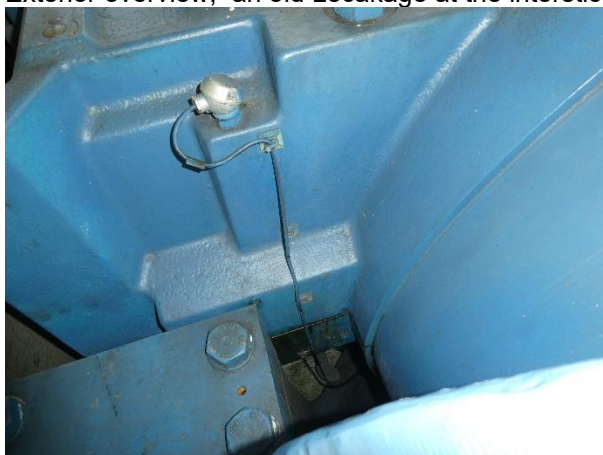
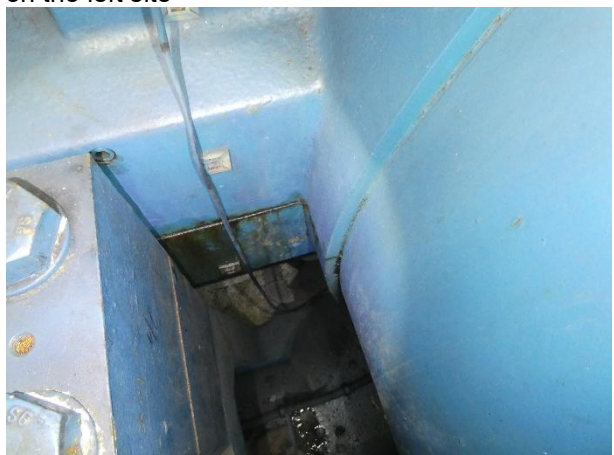
From the outside, the transmission looks clean and well maintained. Frictional
corrosion is present on the left side interstice of the spur gear housing.

Exterior overview, an old Lecakage at the interstice on the left site

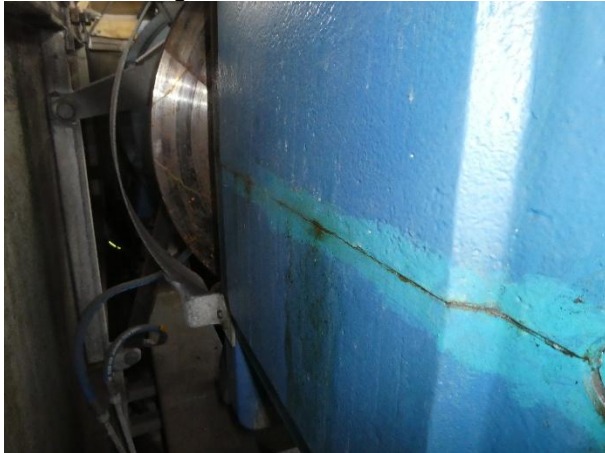
An old Leakage at the interstice on the left site

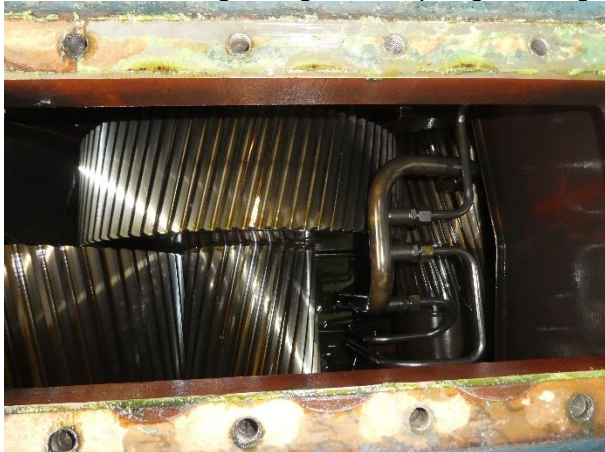
Overview of the gearing of the spur gear stage

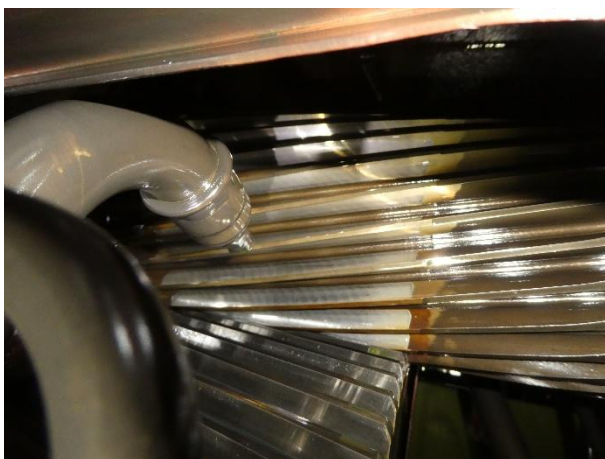
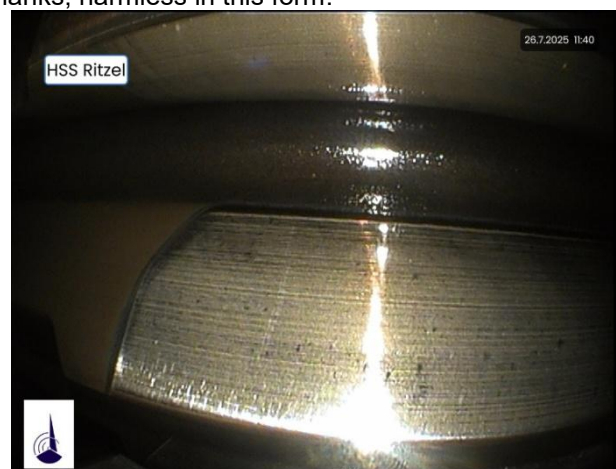
Pinion, HSS shaft, only slight scratches on the load flanks, harmless in this form.

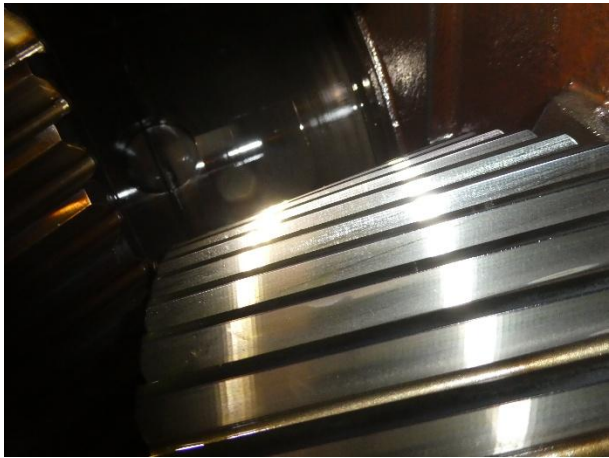
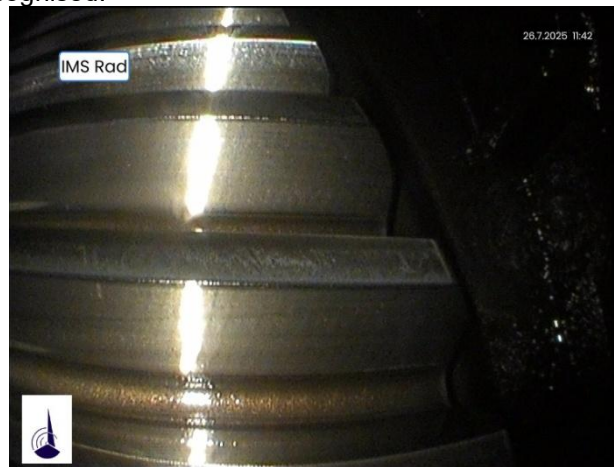
Wheel intermediate shaft, no abnormalities were recognised.

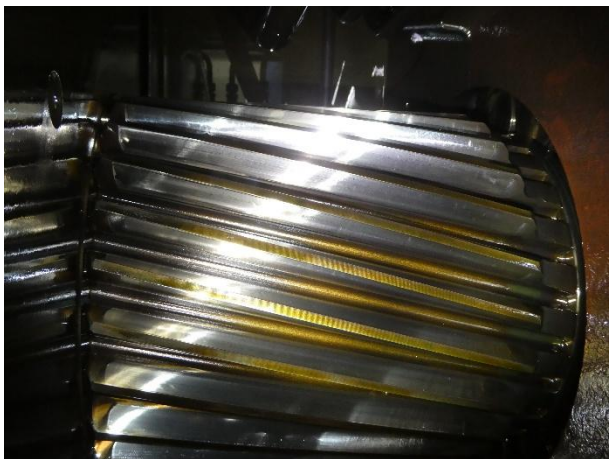
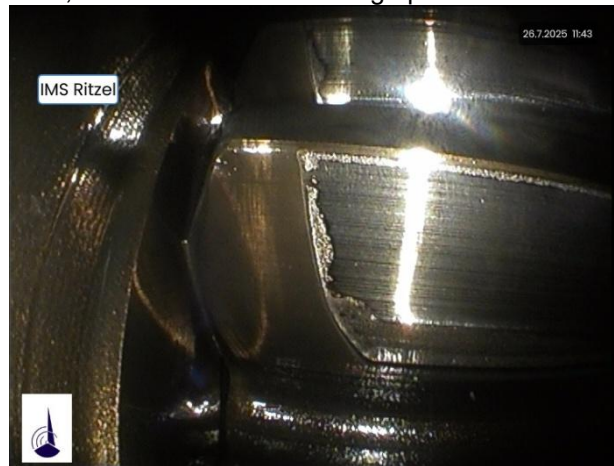
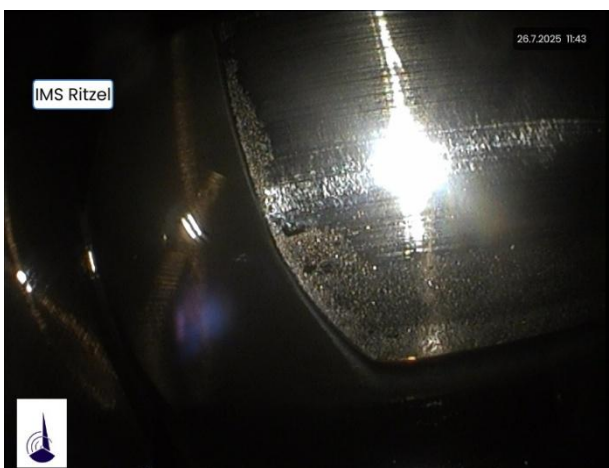
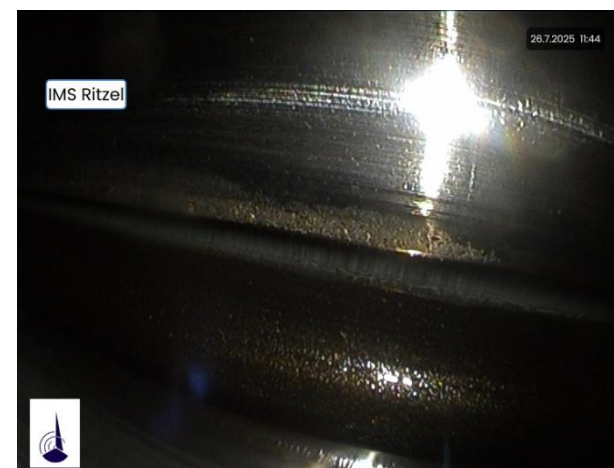
The load flanks of the gear teeth from the intermediate pinion and sun gear show lines
with micro pitting. All other gear teeth in the spur gear stage and in the planetary stage
show no abnormalities apart from a few slight scratches.

Pinion intermediate shaft, micropittings on the load flanks, this should observe during operations.

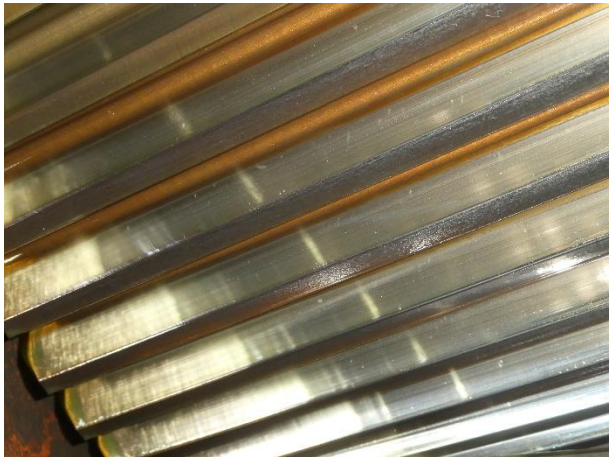
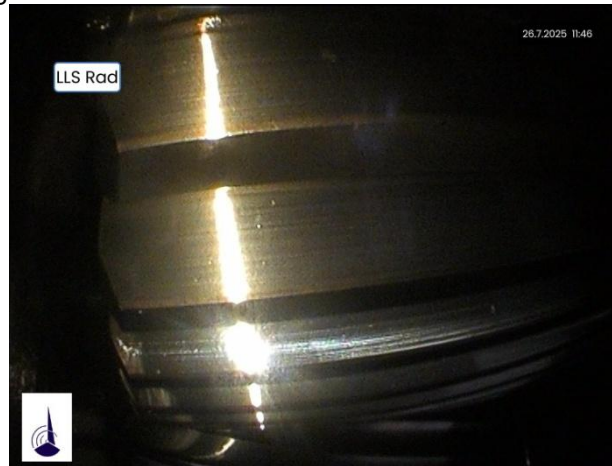
Wheel low speed shaft, no abnormalities were recognised.

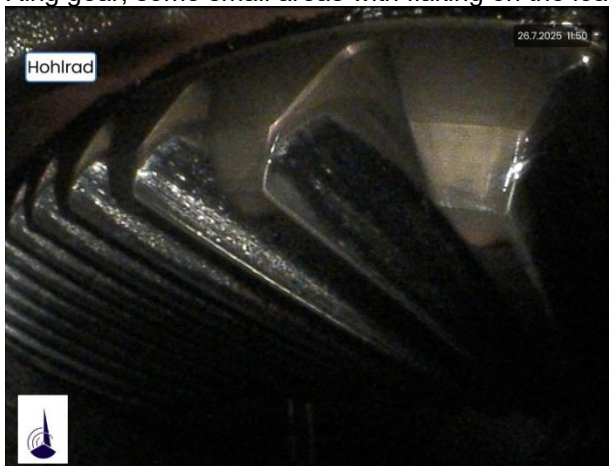
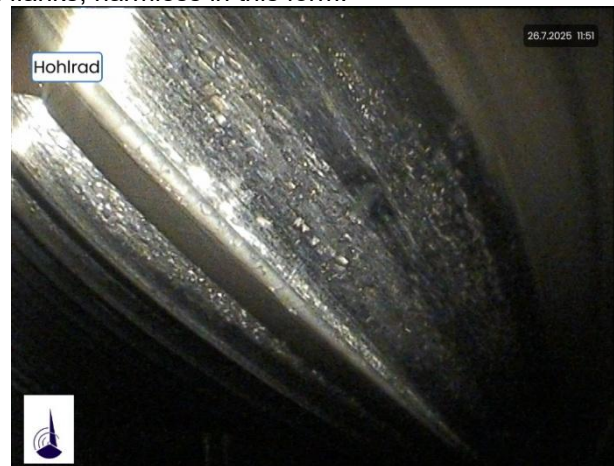
Ring gear, some small areas with flaking on the load flanks, harmless in this form.

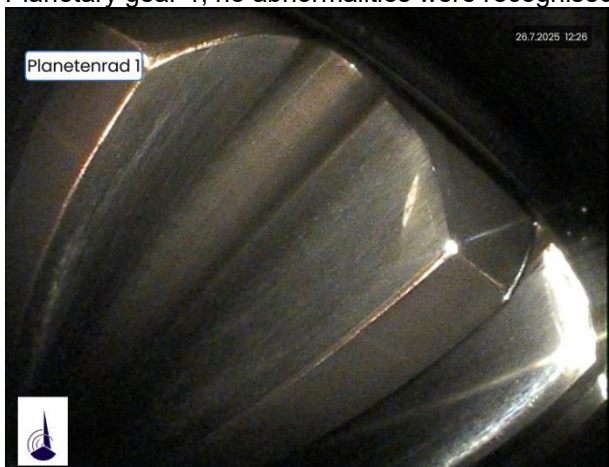
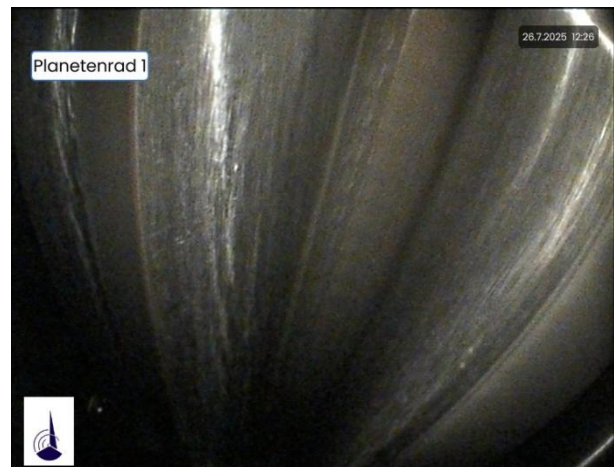
Planetary gear 1, no abnormalities were recognised.

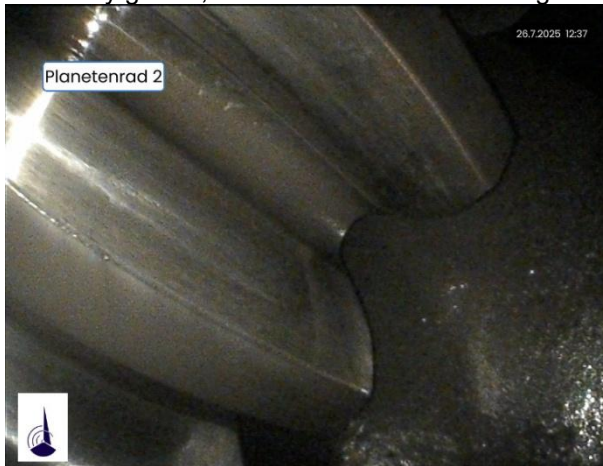
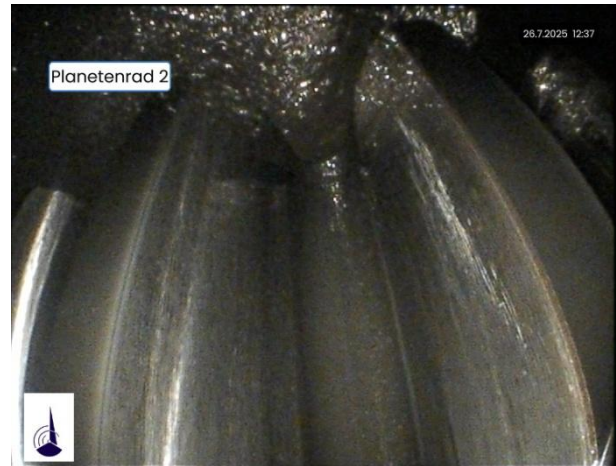
Planetary gear 2, no abnormalities were recognised.

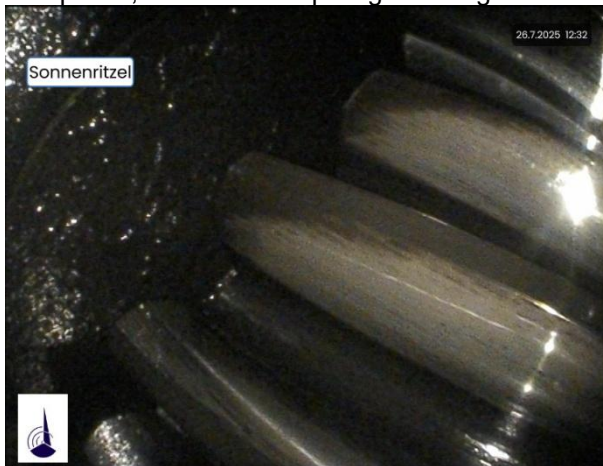
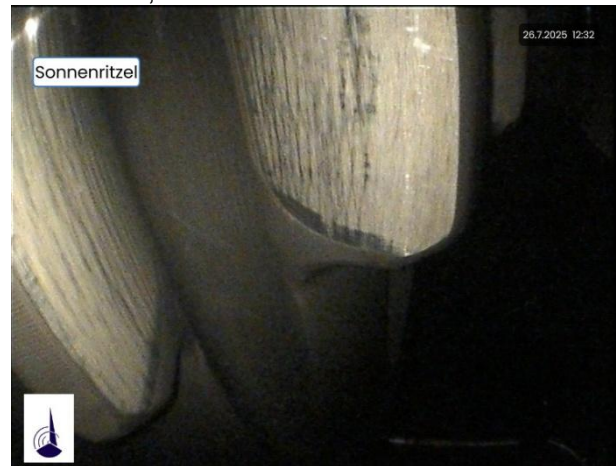
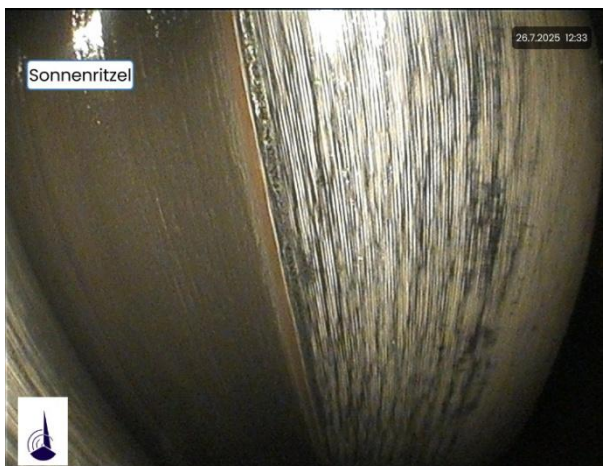
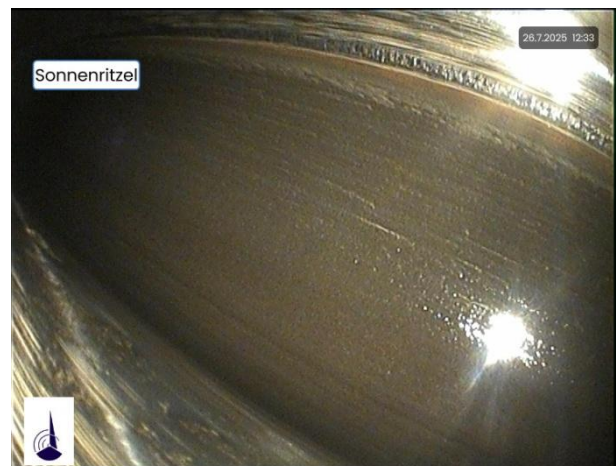
Sun pinion, a line of micropittings in the ground of the load flanks, harmless in this form

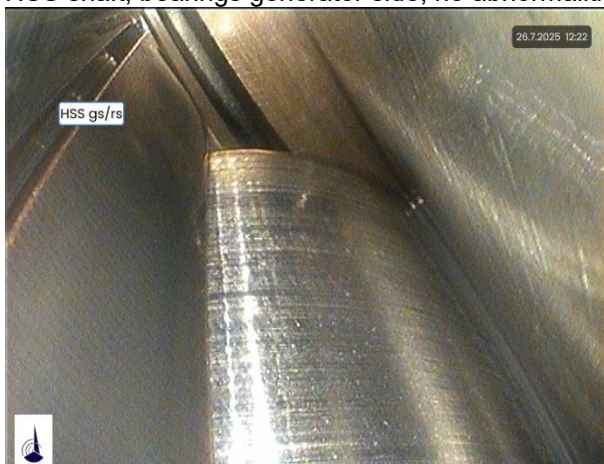
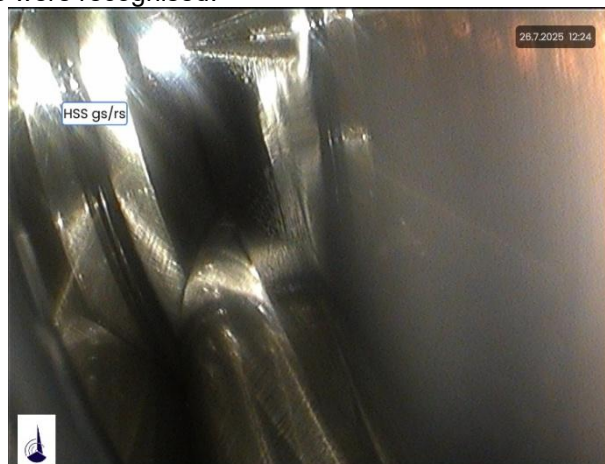
HSS shaft, bearings generator side, no abnormalities were recognised.

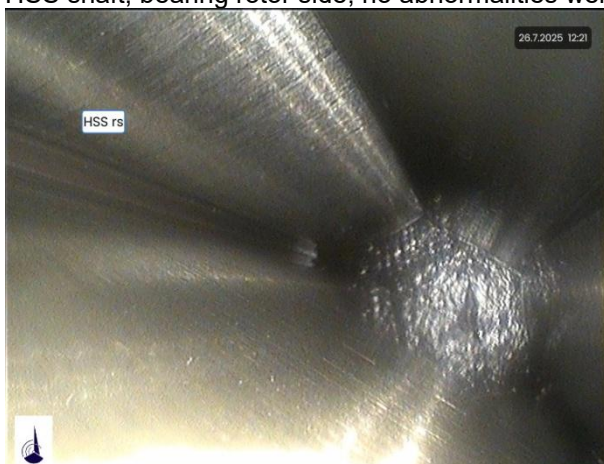
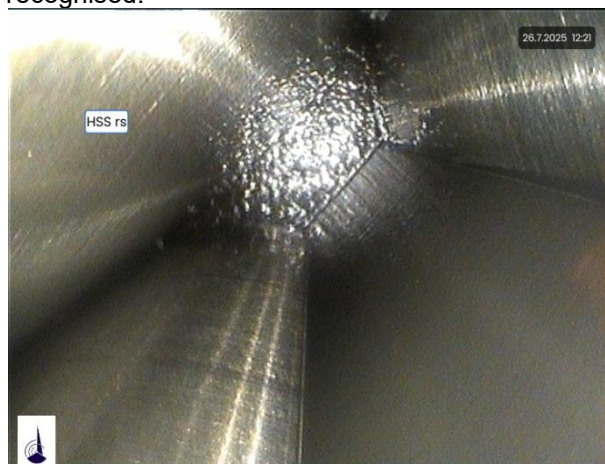
HSS shaft, bearing rotor side, no abnormalities were recognised.

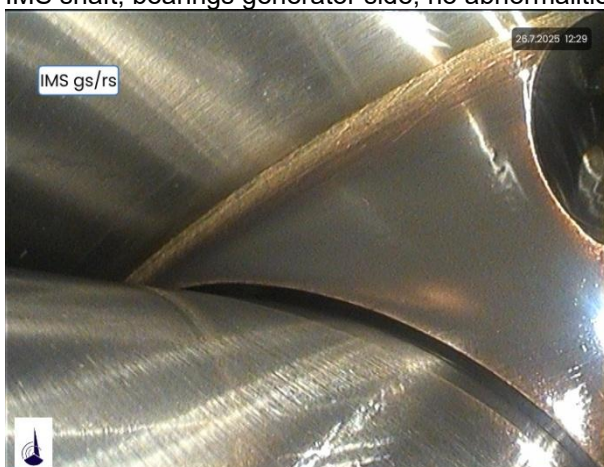
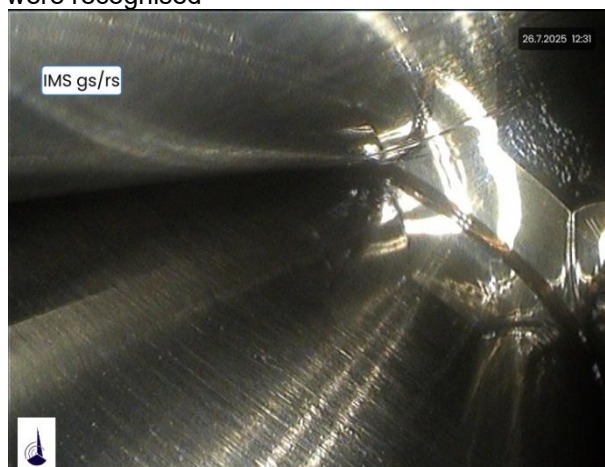
IMS shaft, bearings generator side, no abnormalities were recognised

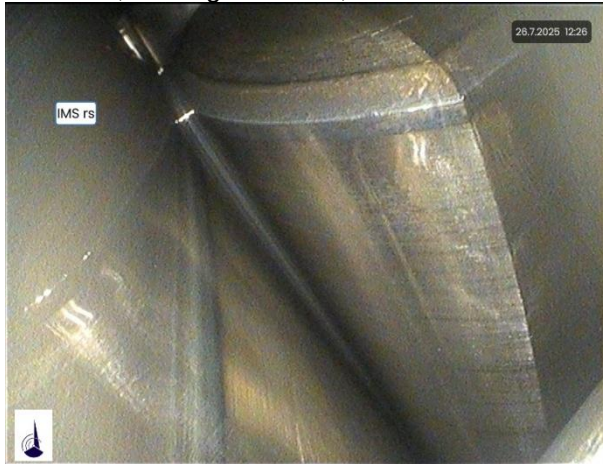
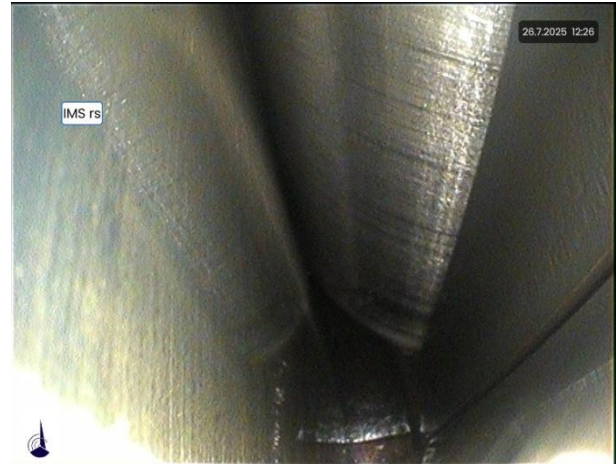
IMS shaft, bearing rotor side, no abnormalities were seen

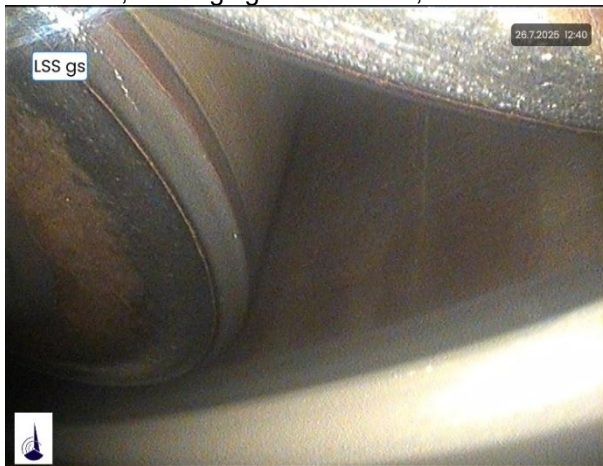
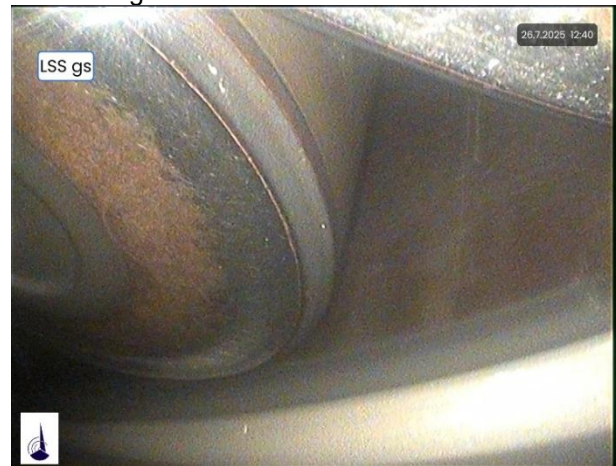
LSS shaft, bearings generator side, no abnormalities were recognised.

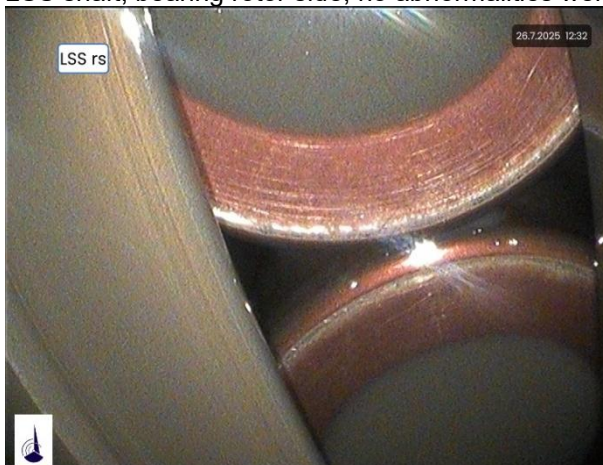
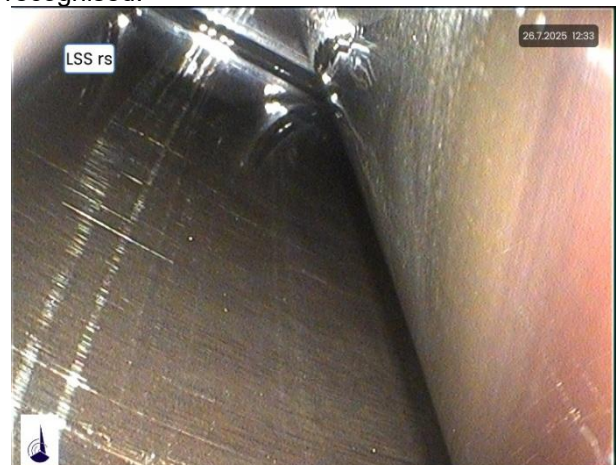
LSS shaft, bearing rotor side, no abnormalities were recognised.

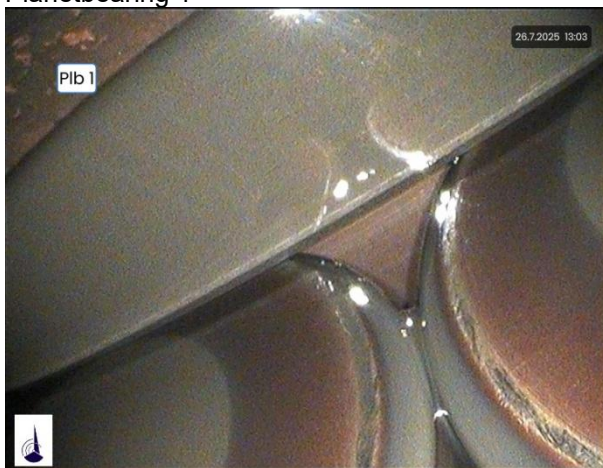
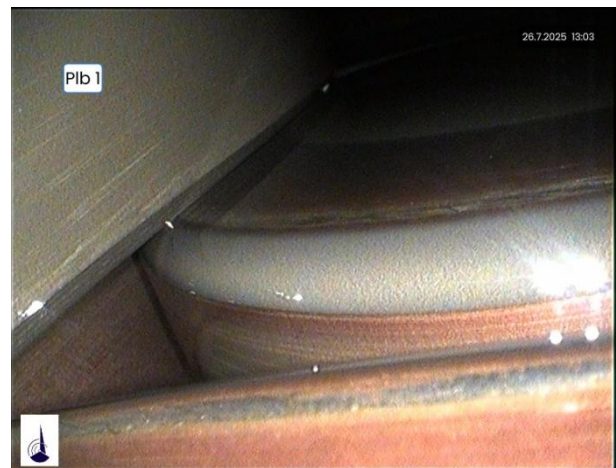
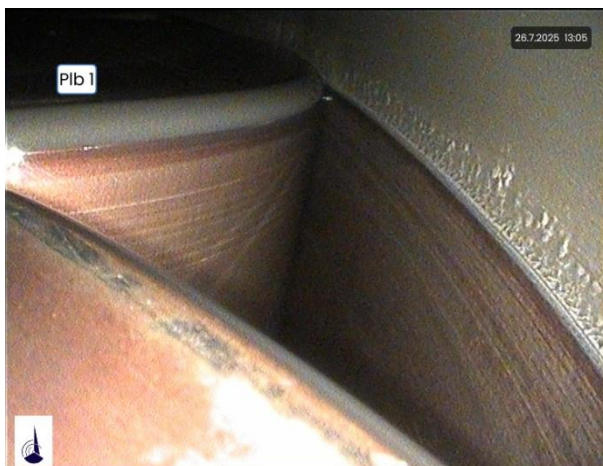
The planetary bearings of the 3 planets could be only limited seen.
Planetbearing 1
