LOW PRESSURE FEEDER

RECEIVING INSPECTION REPORT

JOB#: 50227827 DATE: 03/07/2012 INSPECTOR: B.L.Guy
SIZE: No 4 CUSTOMER: Lincoln P & T Lincoln, ME
S.H.#: 1144 KAMYR#: _____ MYRENS#: _____

LOW PRESSURE FEEDER REBUILD REPORT (REV.6-01/16/2008)

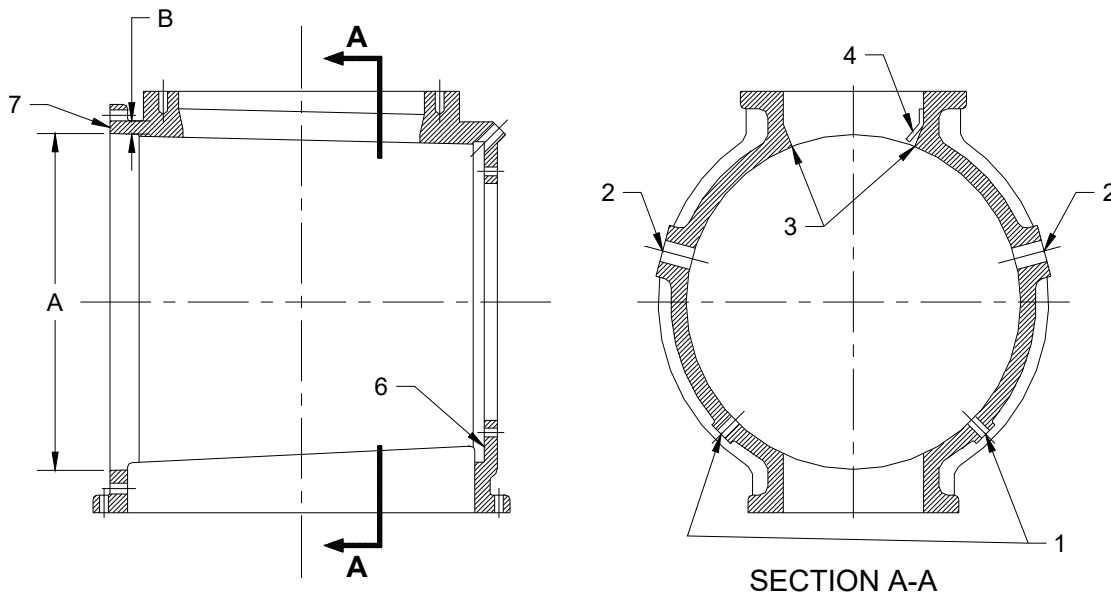
ROTOR HOUSING

A) BORE SIZE AS RECEIVED: 34 7/8"
CONDITION OF BORE: Fair

B) HOUSING WALL THICKNESS AS RECEIVED: 1 5/8" - 1 11/16"

2) EXHAUST PORTS: YES, 2 ea ,REPAIR

CONDITION: 1 side eroded bad, see pics

3) SHEAR EDGE OVERLAY: REQUIRED

POCKET TAPER: 3/4" in use

CONDITION: Worn

4) DOCTOR BLADE: REPLACE

CONDITION: Full length gussett

8) VISIBLE CRACKS: YES

CONDITION: See pics

9) TAPPED HOLES: REPAIR NUMBER & SIZE: 1 ea at adj. block on D/S. // 2 ea at T/S flange go thru into pocket // 2 ea T/S flange have badthreads. // 6 ea are "plug repaired" weld seams opening up, see pics

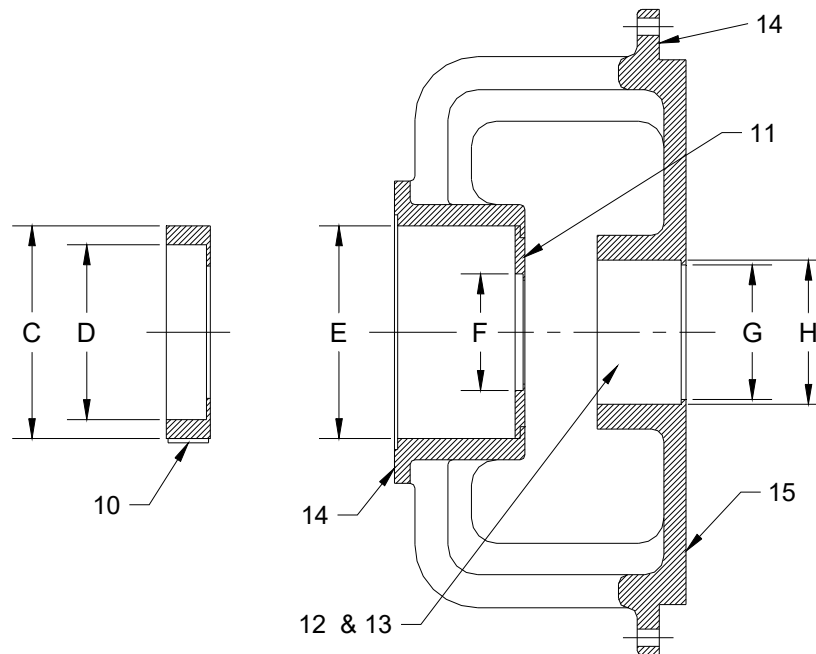
ADJUSTING SIDE END HEAD

<u>AS RECEIVED</u>	<u>CONDITION</u>	<u>AFTER REPAIR</u>
C) SLIDING MEMBER O.D.:	<u>15.391</u>	<u>OK</u>	_____
D) SLIDING MEMBER I.D.:	<u>11.812/.813</u>	<u>OK</u>	_____

E) BEARING HOUSING BORE:	<u>15.394/.395</u>	<u>OK</u>	_____
F) SEAL BORE:	<u>9.250</u>	<u>Minor erosion</u>	_____
G) WEAR RING I.D.:	<u>7.933/.939</u>	<u>S/S radial scoring, see pics</u>	_____
WEAR RING BORE:	<u>N/A</u>	<u>N/A</u>	_____

H) PACKBOX BORE:	<u>9.375</u>	<u>OK</u>	_____
10) KEY/KEYWAY:	<u>Both OK</u>	<u>CONDITION: N/A</u>	
11) SEAL ADAPTER PLATE:	<u>YES,OK</u>	<u>CONDITION: Head pattern is not modified</u>

12) PACKING GLANDS:	<u>YES,REPAIR</u>	<u>MAT'L: Stl</u>	<u>COMMENTS: Bore eroded out</u>
GLAND HARDWARE:	<u>REPLACE</u>	<u>DESCRIPTION: N/A</u>	
13) LANTERN RINGS:	<u>REPLACE</u>	<u>MATERIAL: Teflon</u>	<u>COMMENTS: Bore is worn</u>

17) TAPPED HOLES:	<u>REPAIR</u>	<u>NUMBER & SIZE: 4 ea 3/4"-10 @ pk box</u>	
18) CLEAN-OUT PORTS:	<u>N/A</u>	<u>COMMENTS: _____</u>	
GENERAL REMARKS:	_____

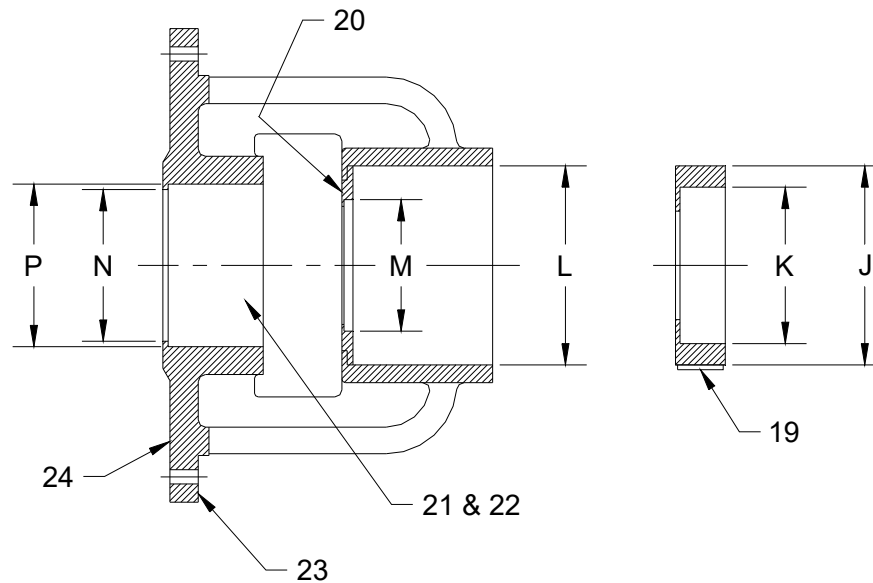
DRIVE SIDE END HEAD

<u>AS RECEIVED</u>	<u>CONDITION</u>	<u>AFTER REPAIR</u>
J) SLIDING MEMBER O.D.:	<u>13.128</u>	<u>OK</u>	_____
K) SLIDING MEMBER I.D.:	<u>11.418/.419</u>	<u>OK</u>	_____

L) BEARING HOUSING BORE:	<u>13.132/.134</u>	<u>Minor erosion, dings</u>	_____
M) SEAL BORE:	<u>9.252</u>	<u>OK</u>	_____
N) WEAR RING I.D.:	<u>7.933/.940</u>	<u>S/S, OK</u>	_____
WEAR RING BORE:	<u>N/A</u>	<u>N/A</u>	_____

P) PACKBOX BORE:	<u>9.3745</u>	<u>OK</u>	_____
19) KEY/KEYWAY:	<u>Both OK</u>	CONDITION: <u>N/A</u>	
20) SEAL ADAPTER PLATE:	<u>YES,OK</u>	CONDITION: <u>Headpattern is not modified</u>

21) PACKING GLANDS:	<u>YES,REPAIR</u>	MAT'L: <u>Stl</u>	COMMENTS: <u>Bore is eroded out</u>
GLAND HARDWARE:	<u>REPLACE</u>	DESCRIPTION: _____	
22) LANTERN RINGS:	<u>YES,REPAIR</u>	MATERIAL: <u>Teflon</u>	COMMENTS: <u>Bore is worn out</u>

26) TAPPED HOLES:	<u>REPAIR</u>	NUMBER & SIZE: <u>4 ea 3/4"-10 @ pk box</u>	
27) CLEAN-OUT PORTS:	<u>N/A</u>	COMMENTS: _____	
GENERAL REMARKS:	_____

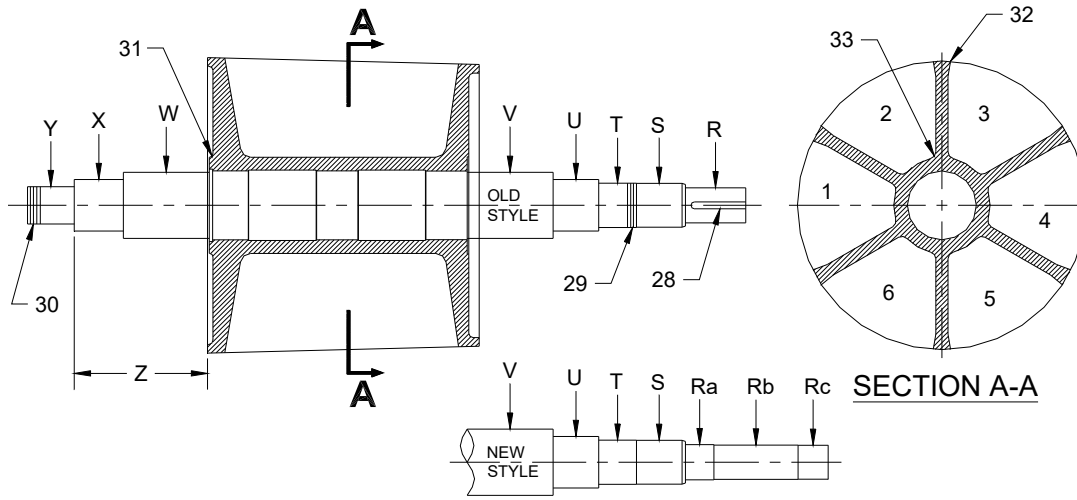
ROTOR & SHAFT ASSEMBLY

ROTOR: Fabricated

<u>AS RECEIVED</u>	<u>CONDITION</u>	<u>AFTER REPAIR</u>
R) DRIVE FIT DIAMETER:	<u>4.998</u>	<u>Linear scoring, see pics</u>	_____
Ra) INBOARD DRIVE FIT DIAMETER:	<u>N/A</u>	_____	_____
Rb) CLEARANCE DRIVE FIT DIAMETER:	<u>N/A</u>	_____	_____
Rc) OUTBOARD DRIVE FIT DIAMETER:	<u>N/A</u>	_____	_____

S) OUTBOARD SEAL FIT DIAMETER:	<u>5.314</u>	<u>OK</u>	_____
T) D.S. BEARING FIT DIAMETER:	<u>5.510</u>	<u>OK</u>	_____
U) INBOARD SEAL FIT DIAMETER:	<u>7.480</u>	<u>Eroded</u>	_____

V) D.S. WEAR SLEEVE DIAMETER:	<u>REPLACE</u>	<u>Worn</u>	_____
W) T.S. WEAR SLEEVE DIAMETER:	<u>REPLACE</u>	<u>Worn</u>	_____
X) T.S. SEAL FIT DIAMETER:	<u>7.480</u>	<u>Radial scoring</u>	_____

Y) T.S. BEARING FIT DIAMETER:	<u>4.919</u>	<u>OK</u>	_____
Z) BEARING SHOULDER TO FACE:	<u>17 3/8"</u>	<u>OK</u>	_____
28) KEYWAY: <u>1 1/4"X 5/8"X 8 3/8"</u>			<u>CONDITION:OK</u>

GENERAL REMARKS: Rotor is pinned in place

ACCEPTED: REJECTED: XXX REMARKS: Rotor - Cracks and pinholes in pocket corners and end plate to end ring welds.
