EthosEnergy

Client name:	VERSO, DULUTH MN
Title:	Unit 1, Minor Inspection
Job Number:	40-J12994
Date:	August 2018

EQUIPMENT TYPE: *Turbodyne/Dresser Rand*
Condensing Turbine
Single Flow

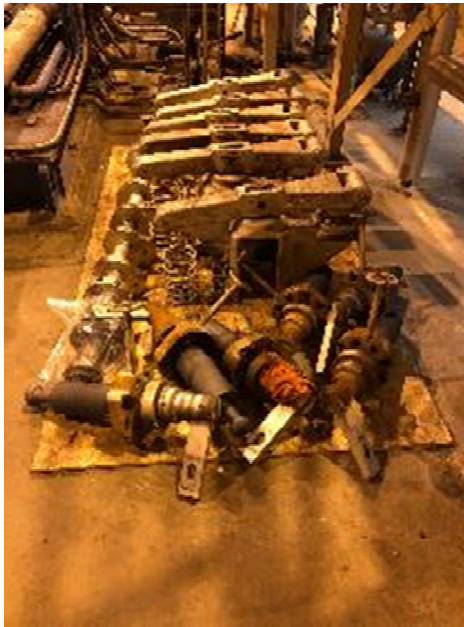
CONTROL VALVES / NON RETURN VALVES

The control valves were removed from the valve chest, and partially disassembled, it was decided by the customer not to remove the valve stems from the crossheads, because at a previous outage when removal had been attempted, two of the stems snapped off during disassembly. Limited visual inspection indicated that the bolt that pins the stems were inserted too deep, the threaded end that is inserted into the crosshead is only a 5/8" thread and inspection of a damaged stem from the previous outage showed that it had been drilled between 50 and 60 percent thru. The valve seats and discs were NDE inspected. All parts and bolting were cleaned. The control valves discs were contact blue checked. All six valves were at 100 percent contact at reassembly. Three of the leak off line trumpets were broken off. Replacements were fabricated on site by plant pipefitters and installed. The camshaft roller bearings were cleaned and greased prior to start up.

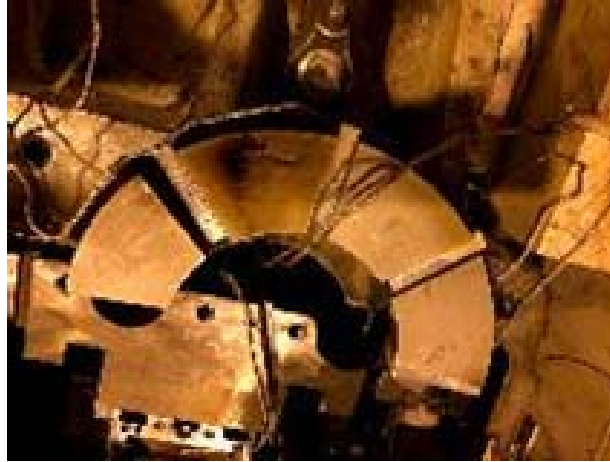
THRUST BEARING / THRUST RUNNER

Disposition:			
Replaced with New Component: ____	Replaced with Refurbished Component: ____	Repaired: ____	No Repair or Replacement: <u>X</u>
Comments:			
<p>The thrust bearing was disassembled, cleaned, inspected, and an NDE was performed on the active and inactive thrust pads, no defects were indicated, please refer to attached NDE Report. The cage, active and inactive plates, and shims were found slightly coated with an oil like varnish. All parts were cleaned with an industrial cleaning fluid. At reassembly all parts were coated with new turbine oil. A thrust bearing float or bump thrust check was performed prior to disassembly, the resulting bump was .013" within spec for this unit and repeatable 3 times. Spec for this unit is .010" to .015". A thrust bearing float or bump was performed at reassembly, the resulting bump was .013" which was within spec and repeated 3 times. Assistance was given to Bentley-Nevada pushing the rotor to the active and inactive sides for setting of the thrust probes for alarms and trips.</p>

- A set of bull and pinion gear bearings should be in stock for future outages.
- The thrust oil baffles on the governor end and the generator end should be replaced next outage.

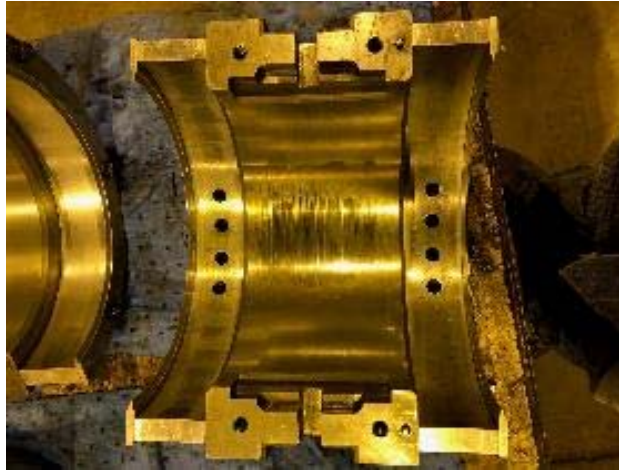
T1 BEARING

The T-1 Bearing and its respective journal was disassembled, cleaned, inspected, dimensionally checked and reassembled. T-1 bearing is a double tilt pad type bearing. The customer fabricated a mandrel on site to perform bearing clearance and contact checks. The clearance check showed .005" clearance and the contact check on all four pads was eighty percent or greater. NDE was performed on the bearing pads. All checks were acceptable. The T-1 Bearing and T-1 Journal were in good condition. All parts were cleaned with an industrial cleaning fluid. At reassembly all parts were coated with new turbine oil. Please see attached data sheets and NDE report.

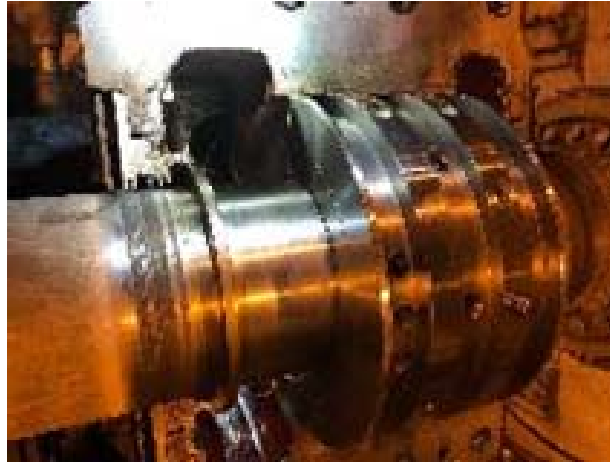
T2 BEARING

The T-2 Bearing and its respective journal was disassembled, cleaned, inspected, dimensionally checked and reassembled. T-2 bearing is a double tilt pad type bearing. The customer fabricated a mandrel on site to perform bearing clearance and contact checks. The clearance check showed .006" clearance and the contact check on all four pads was eighty percent or greater. NDE was performed on the bearing pads. All checks were acceptable. The T-2 Bearing and T-2 Journal were in good condition. All parts were cleaned with an industrial cleaning fluid. At reassembly all parts were coated with new turbine oil. Please see attached data sheets and NDE report.

- The T-2 Bearing Oil Deflectors governor end and generator end should be replaced next outage.
- A spare set of thrust shims active and inactive should be in stock for next outage.

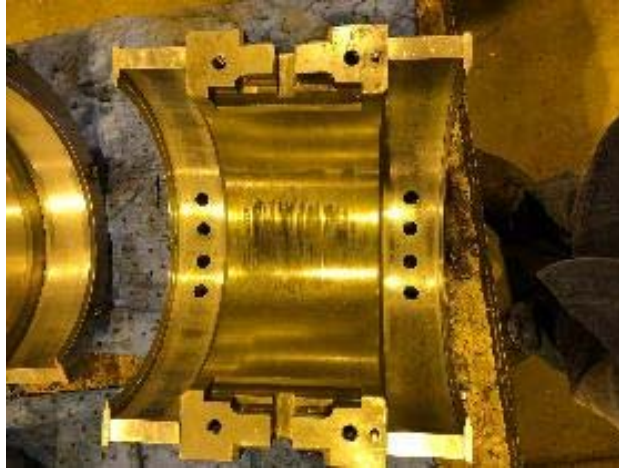
T3 BEARING

The Turbine End Bearing and its respective journal was disassembled, cleaned, inspected, dimensionally checked and reassembled. At reassembly a twist, tilt and pinch check were performed. An NDE check was performed on the bearing. All checks were acceptable. The Turbine End Bearing and Turbine End Journal were found in good condition. All parts were cleaned with an industrial cleaning fluid. At reassembly all parts were coated with new turbine oil. Please see attached data sheets and NDE Report.

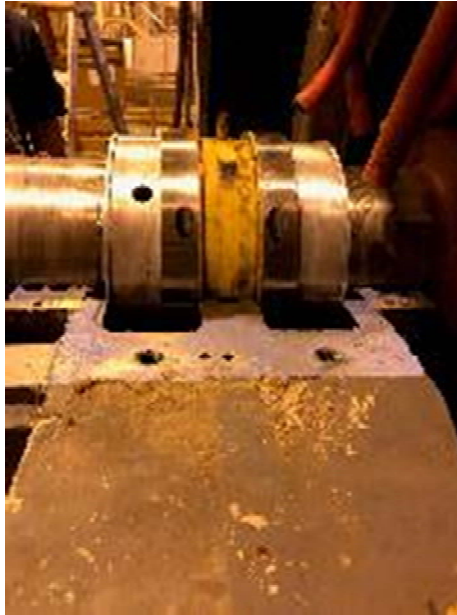
T4 BEARING

Disposition:			
Replaced with New Component: ____	Replaced with Refurbished Component: ____	Repaired: ____	No Repair or Replacement: ____X
Comments:			
Generator: Collector End Bearing			
<p>The Collector End Bearing and its respective journal was disassembled, cleaned, inspected, dimensionally checked and reassembled. At reassembly a twist, tilt and pinch check were performed. An NDE check was performed on the bearing. All checks were acceptable. The Collector End Bearing and Collector End Journal were found in good condition. All parts were cleaned with an industrial cleaning fluid. At reassembly all parts were coated with new turbine oil. Please see attached data sheets and NDE Report.</p>

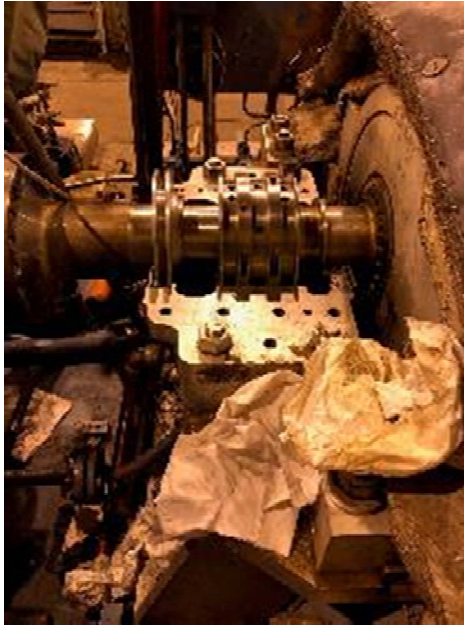
OIL DEFLECTORS AND AIR SEALS

The oil deflectors were removed from their respective bearings and standards, they were disassembled, cleaned, inspected, dimensionally checked and reassembled. All of the deflectors were found heavily coated with a heavy oily residue. The oil baffles at both ends of the thrust are slightly worn and should be replaced next outage. The front standard and T-2 turbine deflectors were all oversized, egg shaped and sprung, they are aluminium. The T-2 GE deflector was found installed upside down, the oil drain holes were in the top of the pedestal. The front standard and both T-2 oil deflectors should be replaced next outage. A replacement front standard oil deflector was in stock, when it was dimensionally checked the size was incorrect. The generator TE and CE Oil Deflectors Inboard and Outboard were acceptable when dimensionally checked, some of the teeth were worn and were sharpened. The Generator oil deflectors are bronze or brass, a spare set was found but they were only rough machined as full circles no horizontal joints were cut, bolt holes were cut but no dowel holes. All parts were cleaned with an industrial cleaning fluid. Please see attached data sheets.

- The T-1 Front Standard Oil Deflector is worn and should be replaced next outage. One was located in the station, when a dimensional check was performed, it was too small, it was the same size as the T-1 journal, it would have to be finish machined.

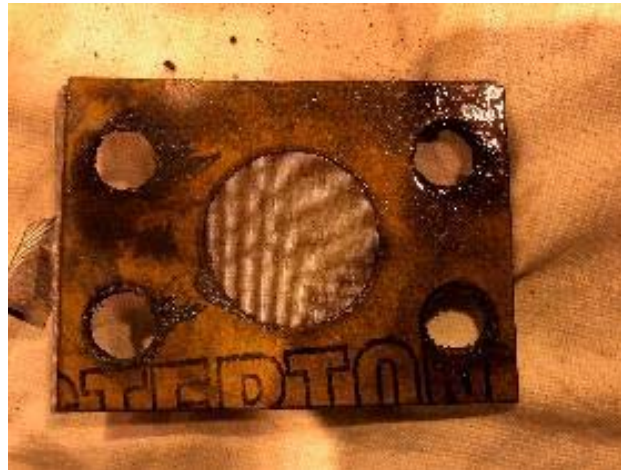
EHC / OIL LUBE PUMPS AND LUBRICATION SYSTEM

Prior to start up fine mesh screens were installed in the oil feed lines on the generator, gearbox, front standard, trip throttle valve, turbine bearings and hydraulic operator for flushing oil. The oil system was placed in service at 7:00 AM on July 31, 2018 no leaks were found, oil flushed for 4 hours. The oil pumps were shutdown at 11:00 AM, and all screens were inspected. Small particles of dirt were found, the screens were cleaned and reinstalled, the oil system back in service 12:00 PM 7/31/2018. The oil was allowed to circulate until 10 AM on 8/1/2018. The lube oil system was shutdown and the screens inspected. The screens were found clean, the lube oil system was restored to normal operating condition.

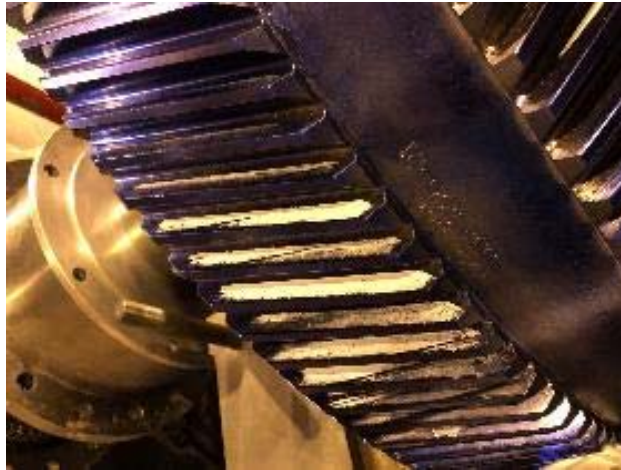
BULL AND TURNING GEAR ASSEMBLY

This unit has a Lufkin Reduction Gear, the upper half cover was unbolted and removed for bearing inspections. The upper half high and low speed bearing were removed. The pinion and bullgear were removed and the lower half bearings were removed. All of the Bearings and their respective journals were disassembled, cleaned, inspected, dimensionally checked and reassembled. At reassembly twist and tilt checks were performed. An NDE check was performed on the bearings. All checks were acceptable. The bullgear and pinion gear journals were found in good condition. All parts were cleaned with an industrial cleaning fluid. The following additional data was also recorded Gear Thrust .041", Gear End Float .061", Gear Backlash .020". At reassembly all parts were coated with new turbine oil. Please see attached data sheets and NDE Report.

- Lube Oil EBOP Testing should be performed annually.
- The bull and pinion (low speed and high speed) gears should be NDE inspected next outage.
- The gearbox horizontal joint studs should be replaced next outage as they were hour glassed from over torquing and stretching.

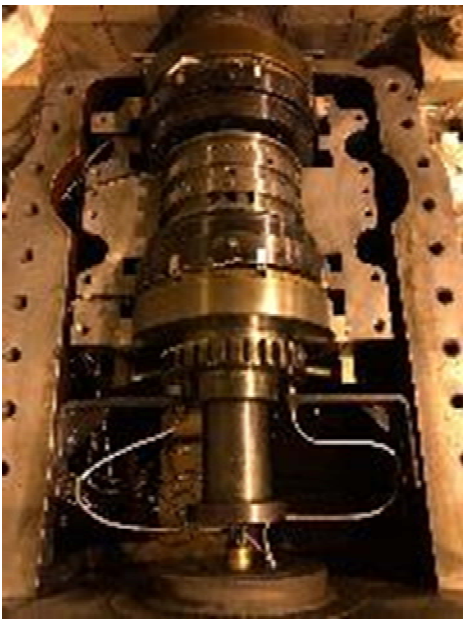
FRONT STANDARD

Disposition:			
Replaced with New Component: ____	Replaced with Refurbished Component: ____	Repaired: ____	No Repair or Replacement: ____
Comments:			
The T-1 journal bearing and thrust bearing were inspected. Please refer to Bearings and Oil Deflector Sections of Report for detailed information.

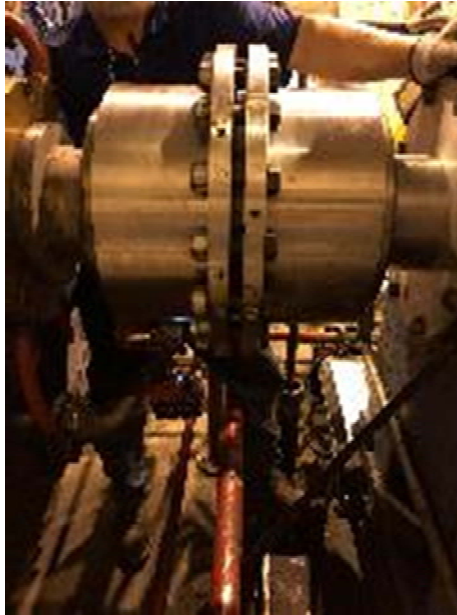
COUPLING & ALIGNMENT

Disposition:			
Replaced with New Component: ____	Replaced with Refurbished Component: ____	Repaired: ____	No Repair or Replacement: ____
Comments:			
<p>As left coupling alignment checks were recorded from the turbine to reduction gear and from the reduction gear to generator. No data as left could be located from any previous outages. The face alignment was well within spec per alignment drawings, the rims were just out of spec, a rim correction move would have had impact the face alignment, no corrections were made. The gearbox to generator coupling was greased 13 pounds of grease. The bolting on the turbine to gearbox coupling and the gearbox to generator coupling, were torqued to spec. turbine to gearbox small bolts 46 ft lbs, large bolts 56 ft lbs, gearbox to generator 250 ft lbs. Please see attached data sheets.</p>

- All the coupling bolts on the High Speed Coupling (Ameridrive Flex Coupling), should be replaced as a full set, they are worn and stretched from torqueing and retorquing.

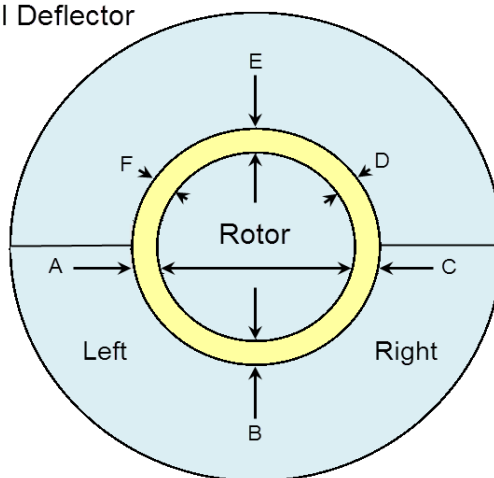
Oil Deflector Clearances AT RESSEMBLY, Turbine Deflectors all have excessive clearance, all were reused at reassembly.

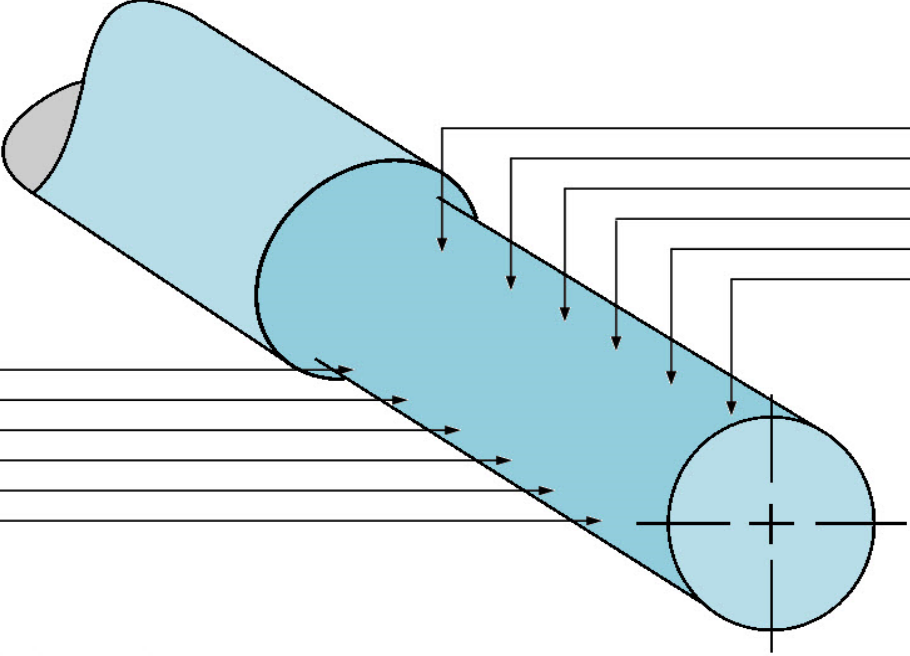
TE
End

COMMENTS The Generator Collector End Rotor Journal is in good condition, the journal was cleaned and strap lapped at reassembly.
--

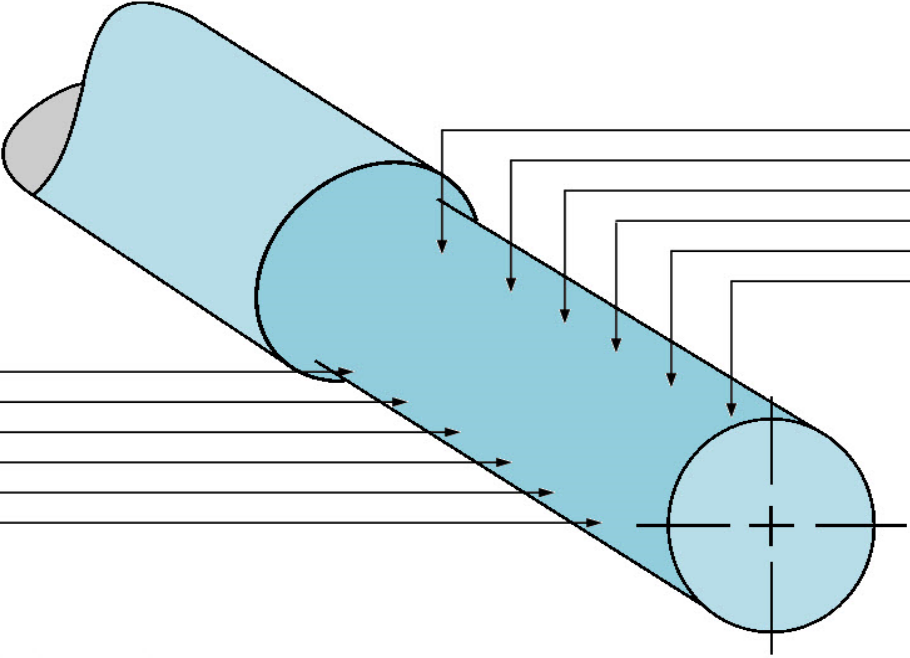
GE
End

COMMENTS
The Generator Turbine End Rotor Journal is in good condition, the journal was cleaned and strap lapped at reassembly.

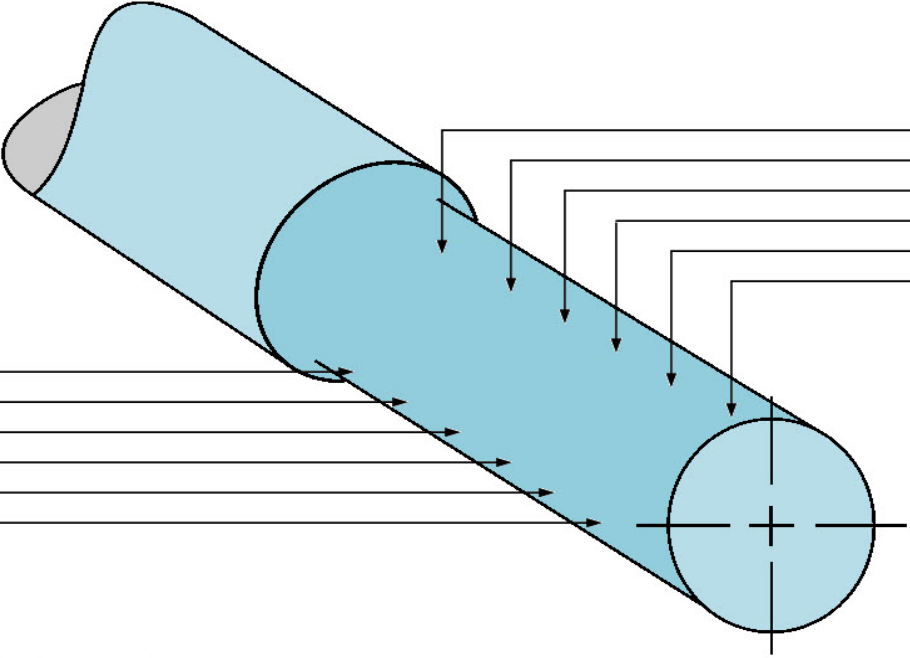
GE

COMMENTS HP-1 Rotor Journal is in good condition, the journal was cleaned and strap lapped at reassembly.

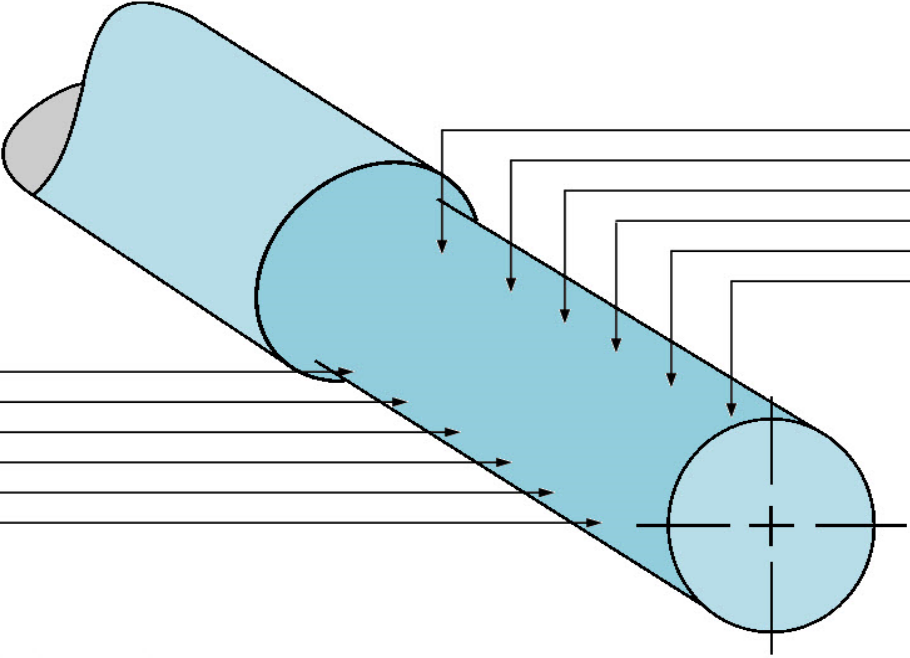
TE
End

LP-2 Rotor Journal is in good condition, the journal was cleaned and strap lapped at reassembly.

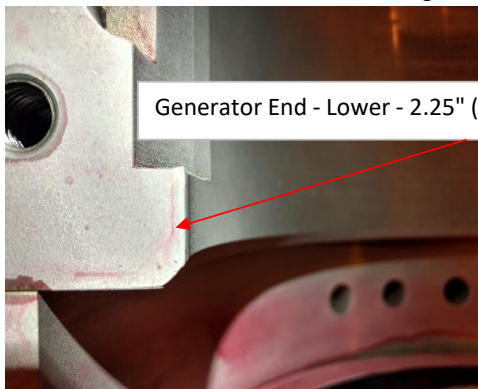
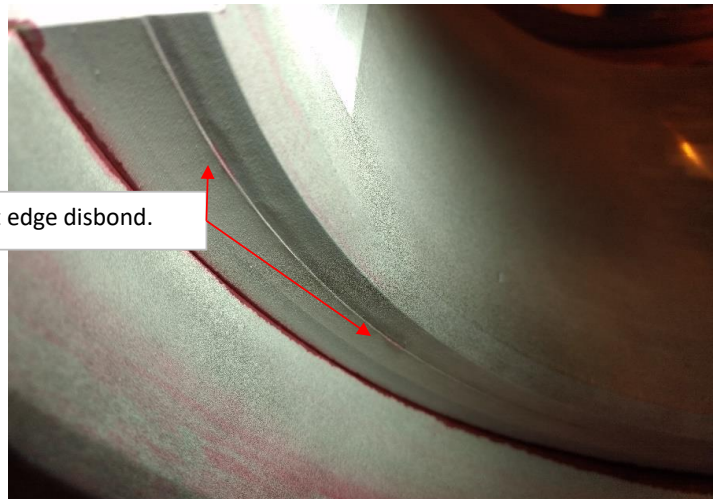
Generator End - Lower - 2.25" (5%) babbit edge disbond.

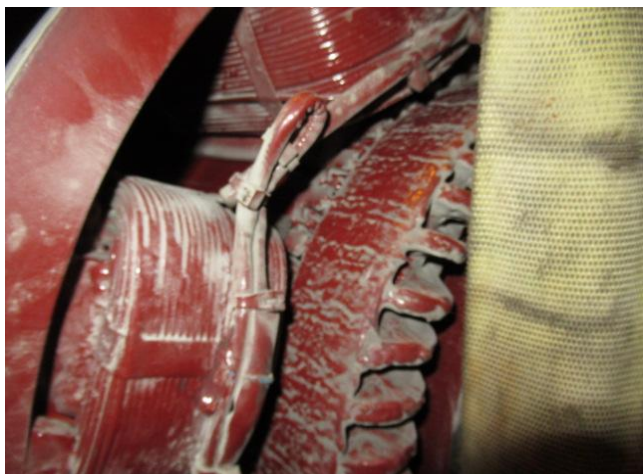
PMG contamination

PMG Rotor Condition: Dust can be cleaned next outage

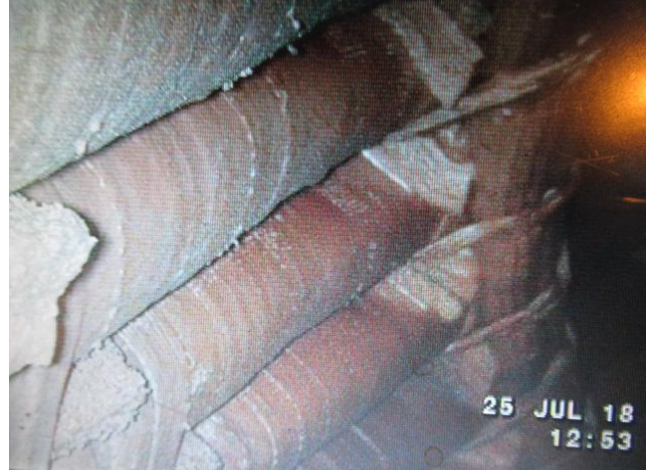
End windings contamination

Based on the limited testing, the unit temporarily meets operational expectations from an electrical standpoint. It is recommended that a thorough stator cleaning be performed during the next available outage schedule, and retest both stator and rotor for improvements. It is recommended to monitor the units condition in the future to look for trends

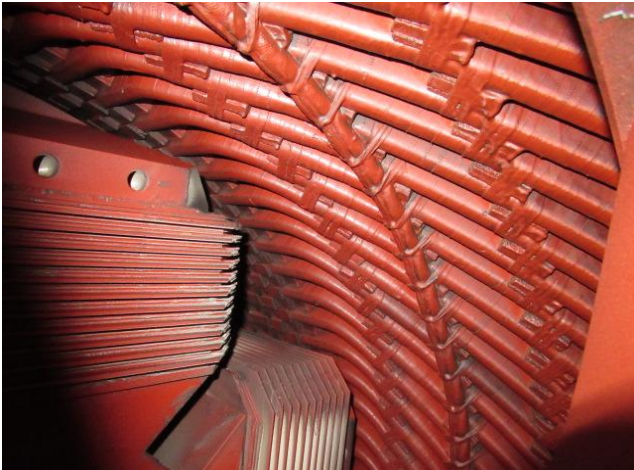
End windings contamination
