Pump Number	Pump Size	Test/Serial Number	Equipment Number	Service/ Application	Rated	Comments
2	CL-4002	174078560	1828	#1 PM Success Flow	90-95%	Position 1, grease lube, left side drive end discharge, double ext. shaft, driven by a Reliance motor 200 hp, 1190 rpm

Pump Number	Pump Size	Test/Serial Number	Equipment Number	Service/ Application		Rated		Comments
2 continued

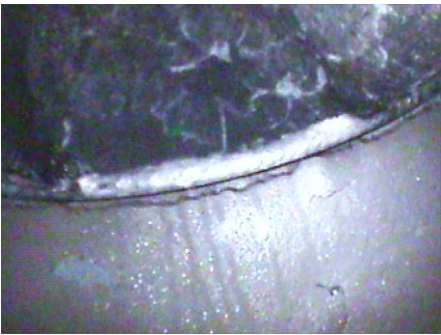
Drive end Rotor shroud clearance is good.

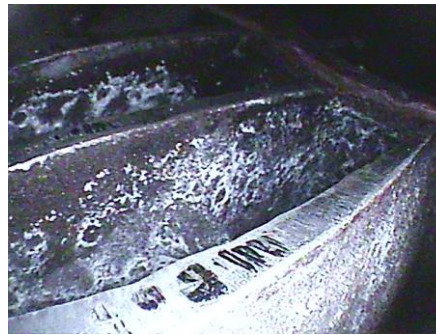
Drive end rotor taper is good.

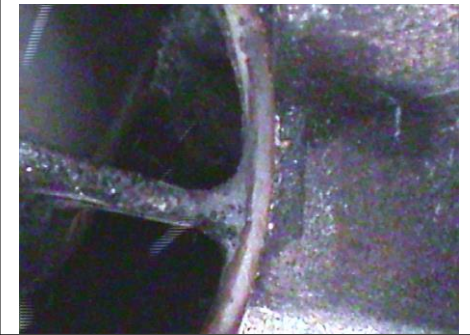
Drive end rotor taper clearance is good.

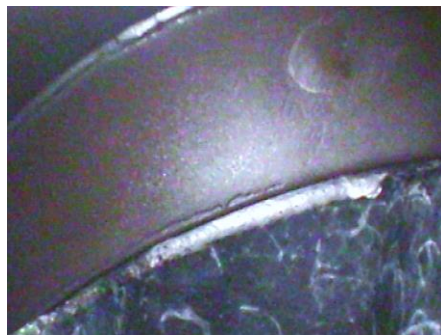
Idle end Rotor shroud clearance is good.

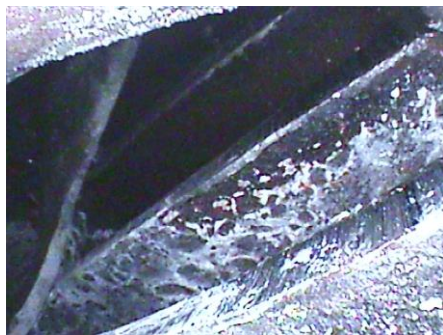
Idle end rotor taper is good.

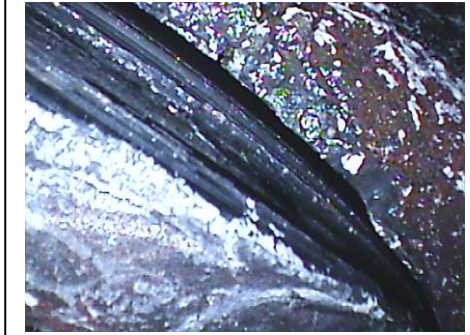
This pump was repaired by the Nash Cleveland Service Center in September of 2017. The body and cones are stainless steel clad. The rotor shrouds have been stainless steel rung. It appears there was contact between the rotor and cone tip on the idle end. The cladding appears to be peeled and the rotor tip is grooved. Besides this, the other clearances and internals looks good. Monitor wear with future visits.

Idle end rotor taper is grooved at the tip.

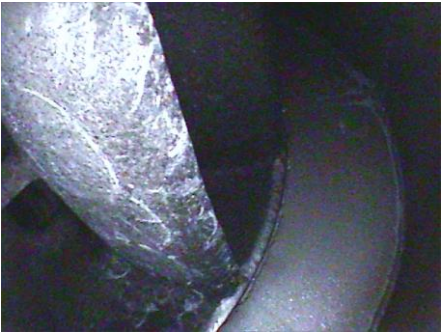
Outer Drive end Rotor Blades in good condition.

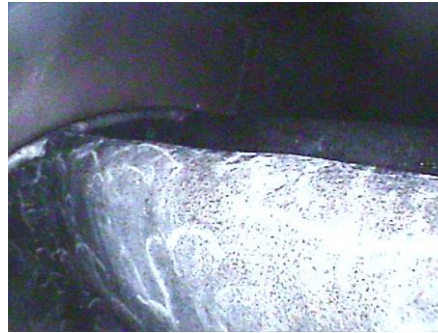
Outer Idle end Rotor Blades in good condition.

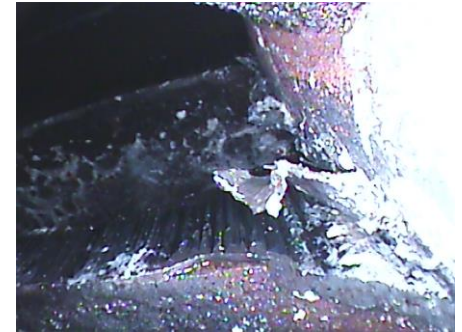
Idle end cone cladding peeled, rotor taper grooved at the tip.

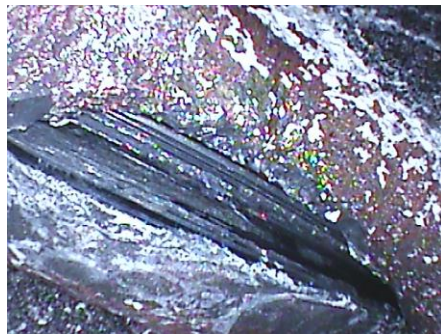
Idle end rotor taper at the tip is grooved.

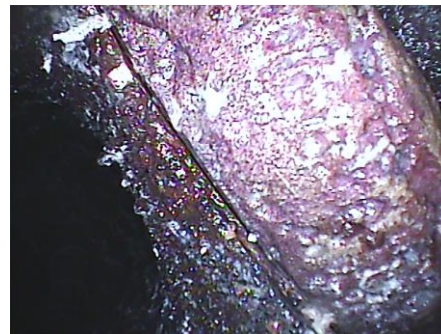
Drive end rotor taper clearance at the small diameter is good

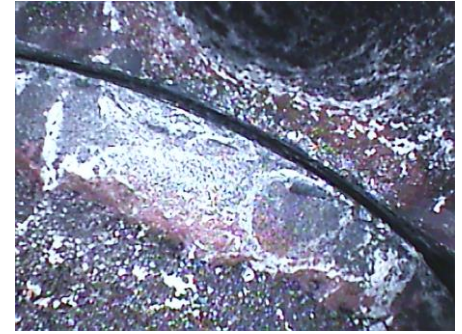
Idle end rotor taper clearance at the small diameter is excessive.
