Varian E500 HP

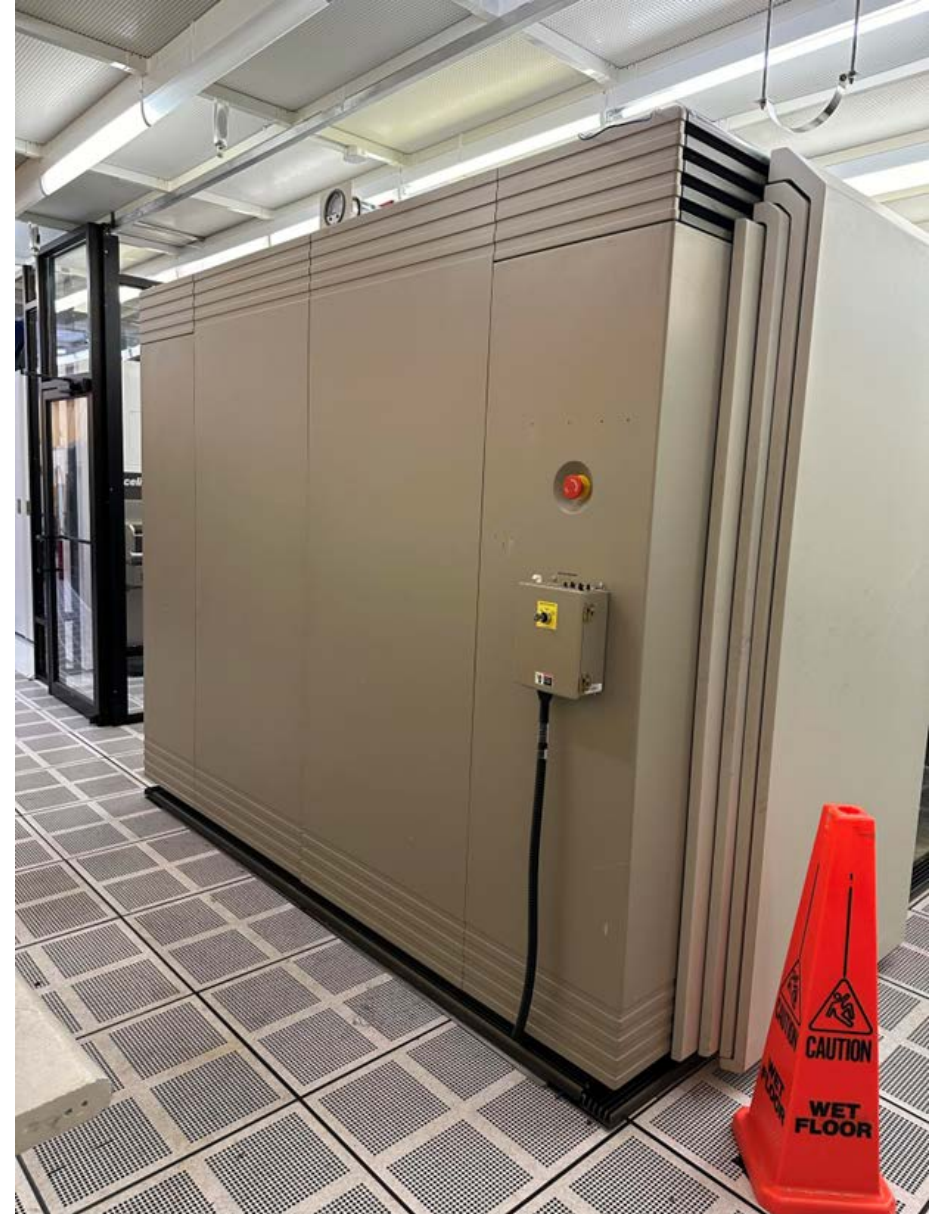
The tool was in good condition for its age.

There were a few small issues with some of the power cables for the internal lights. These were perished due to age.

Also, the terminal doors were sagging with age. This is common for these tools.

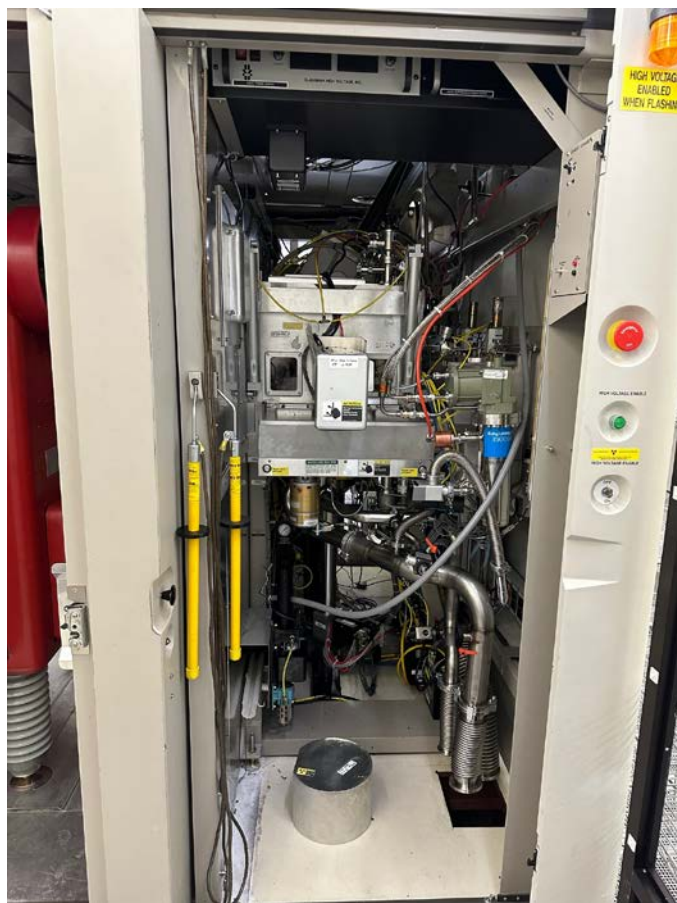
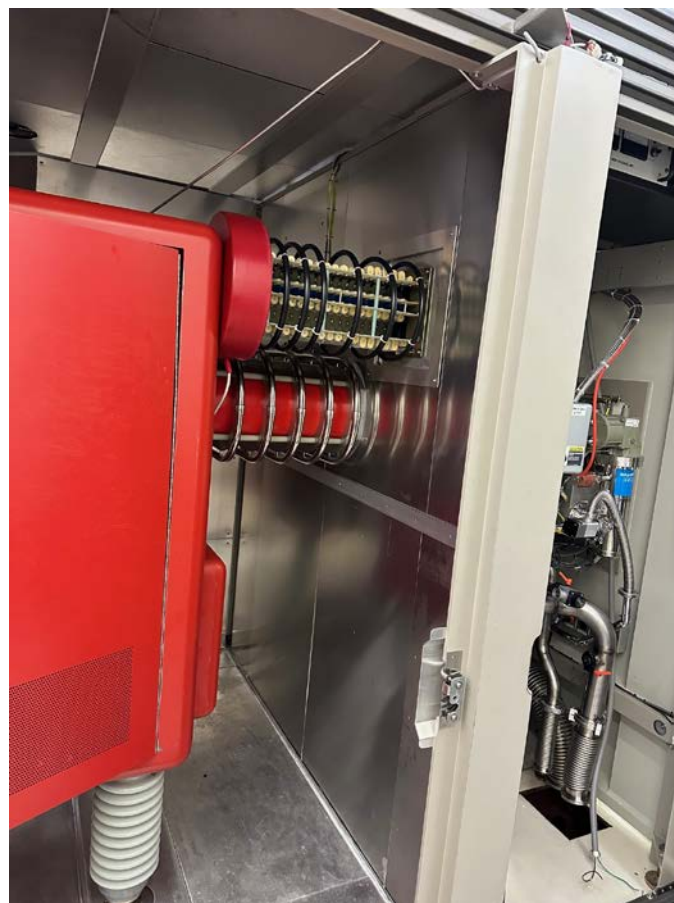
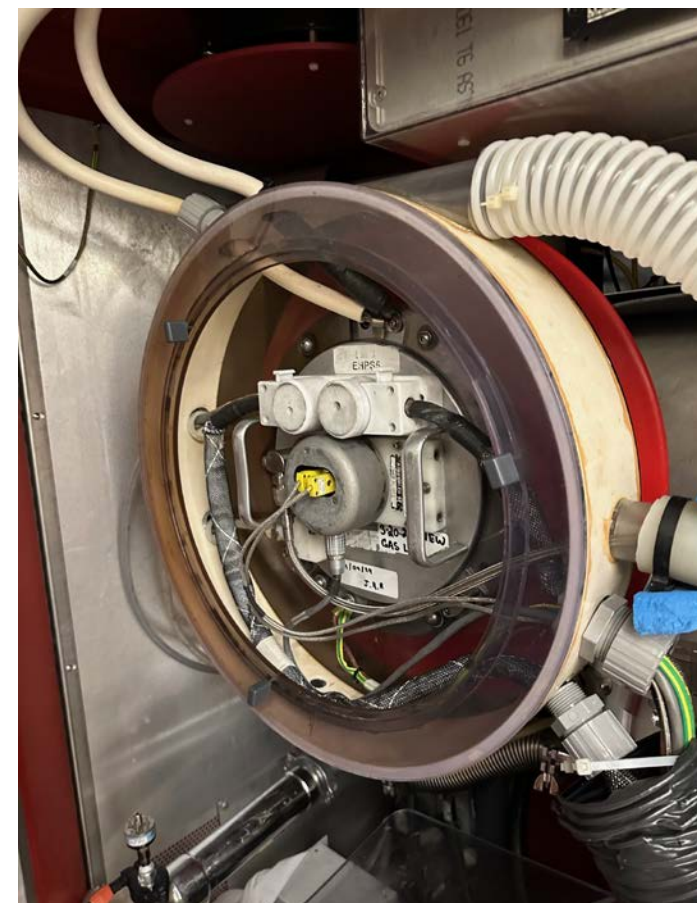
Picture showing
tool condition

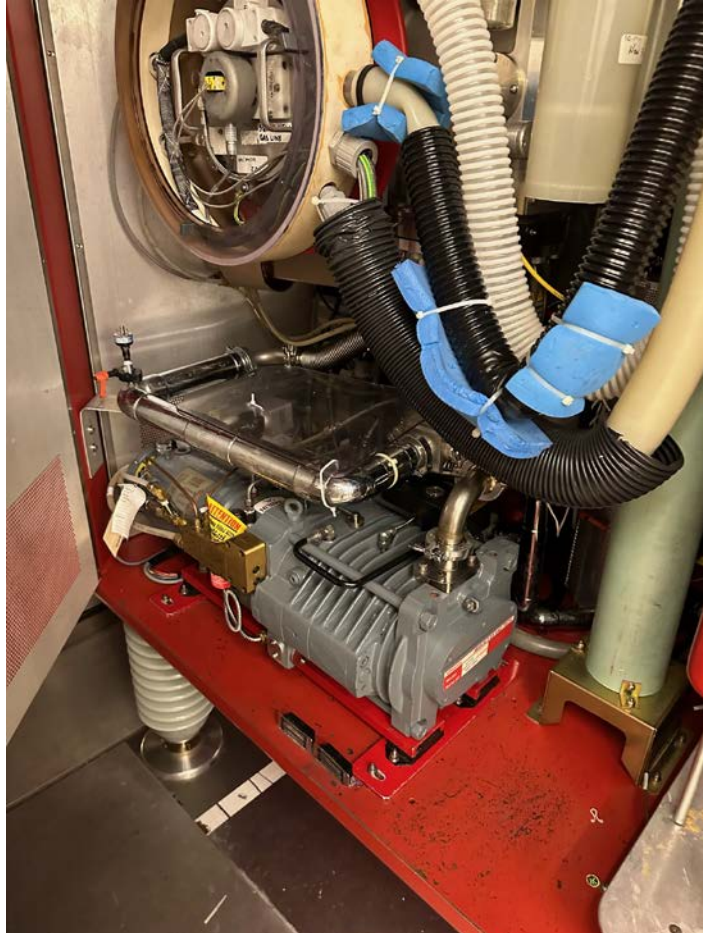
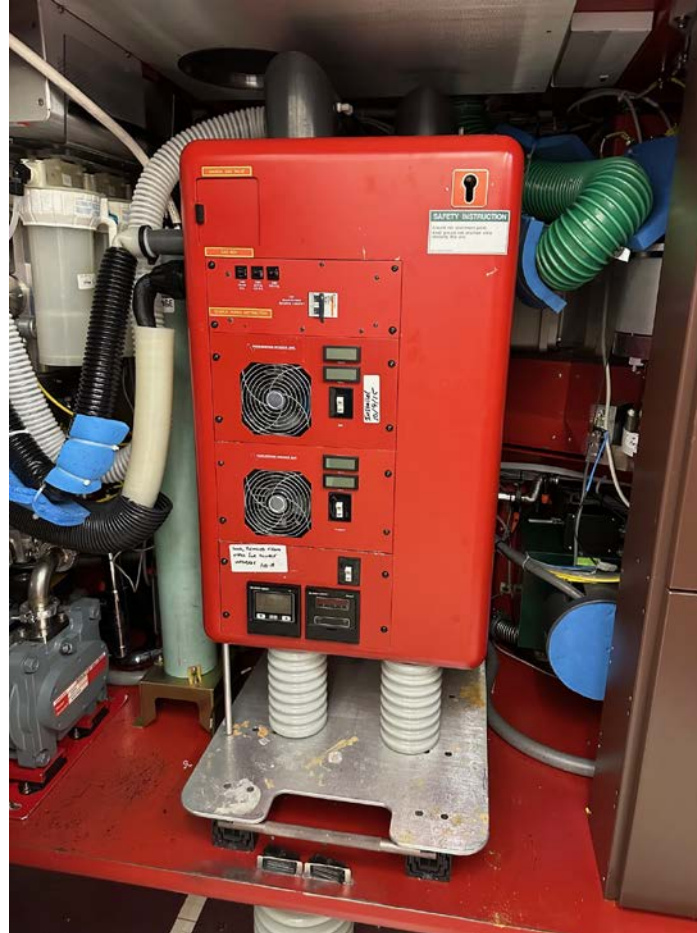
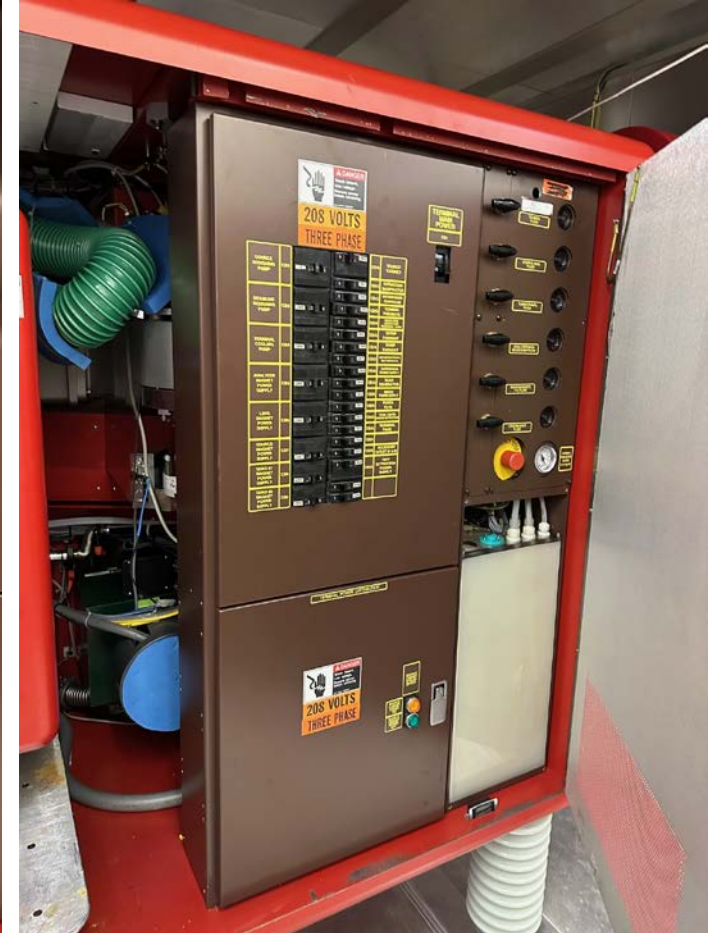
Picture showing
tool condition (2)

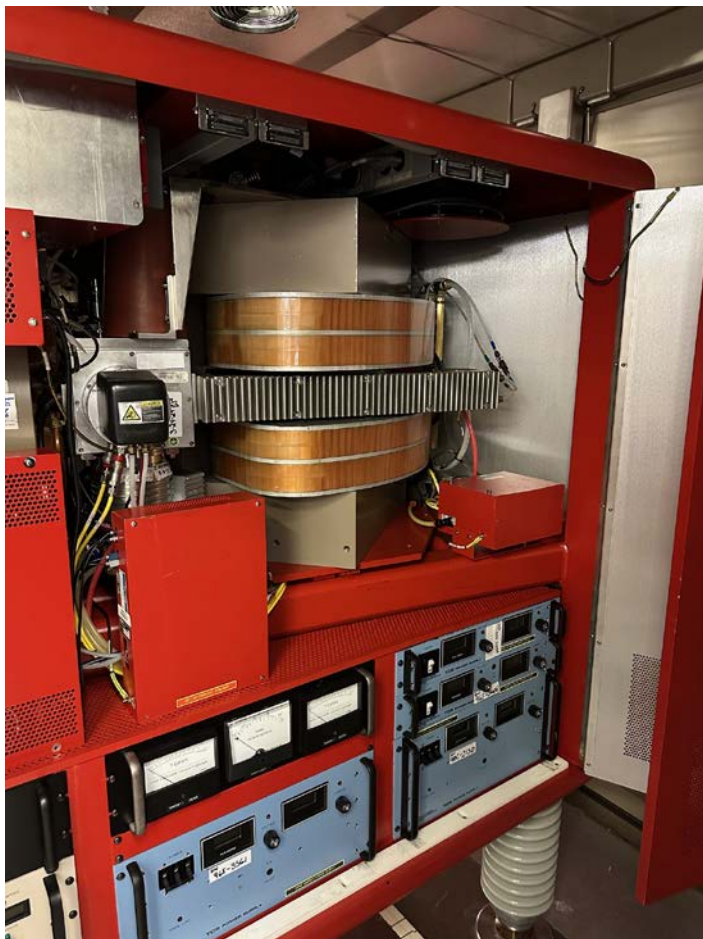
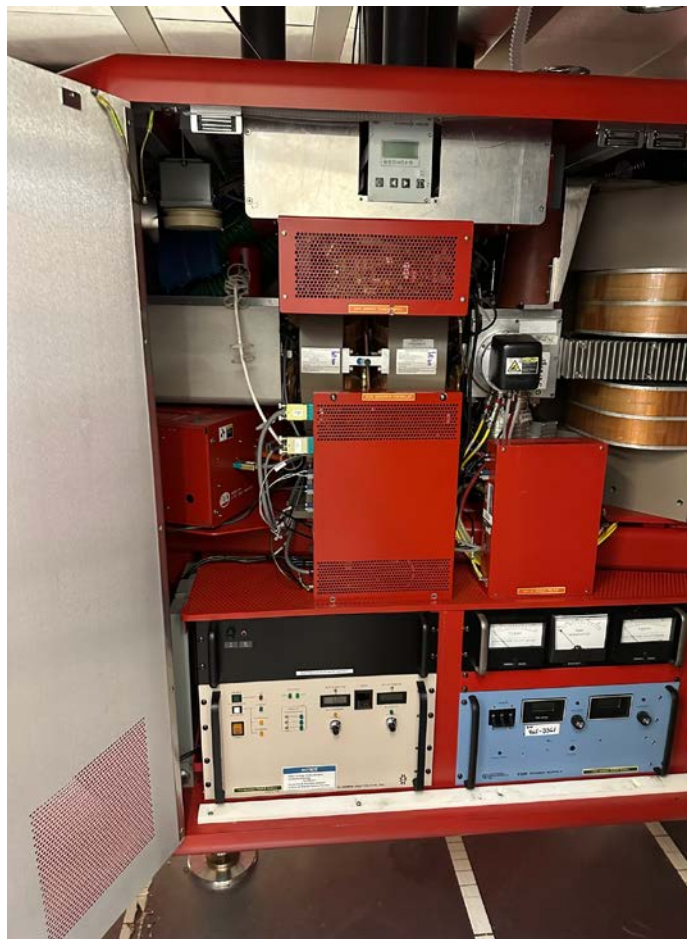
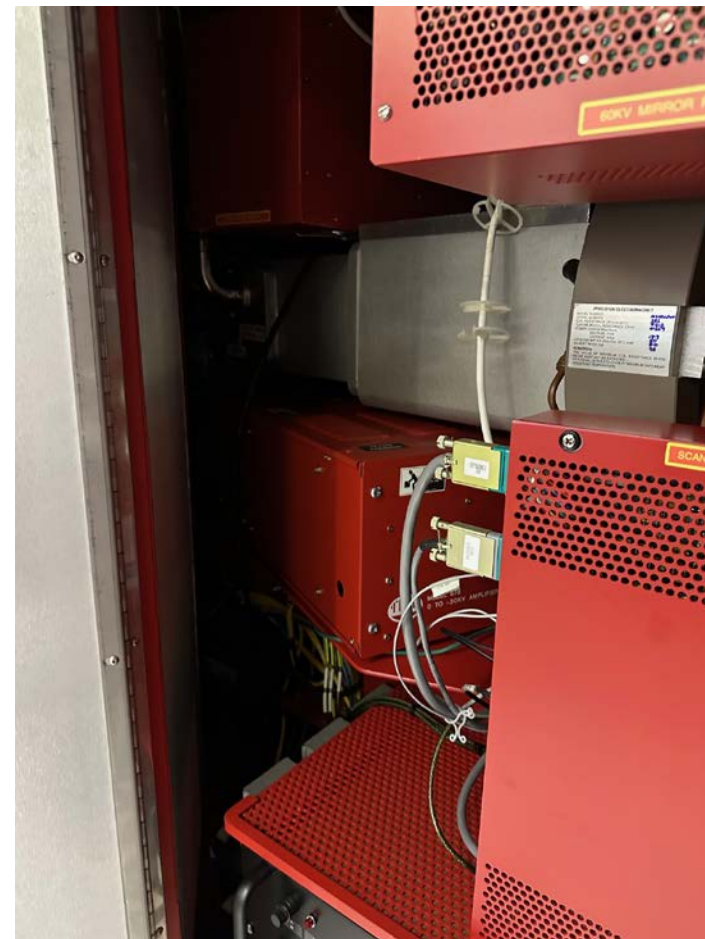
Picture showing
tool condition (3)

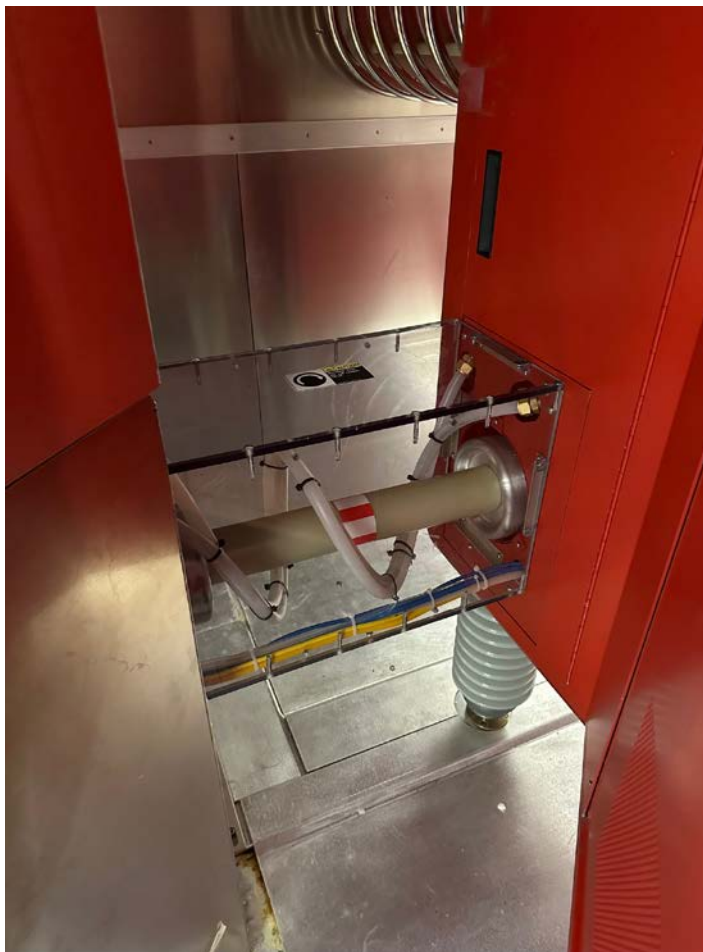
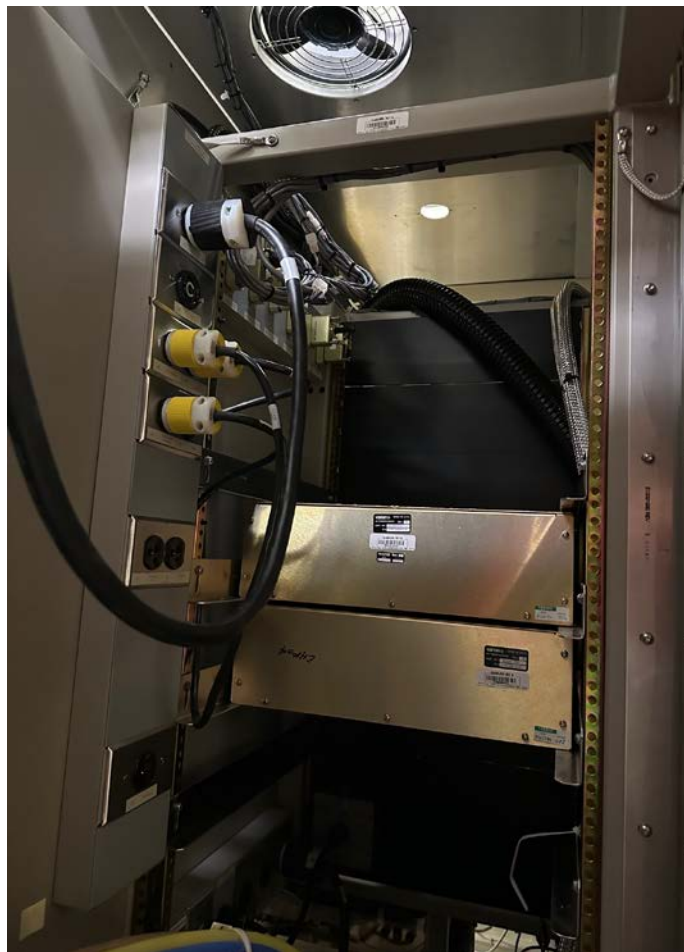
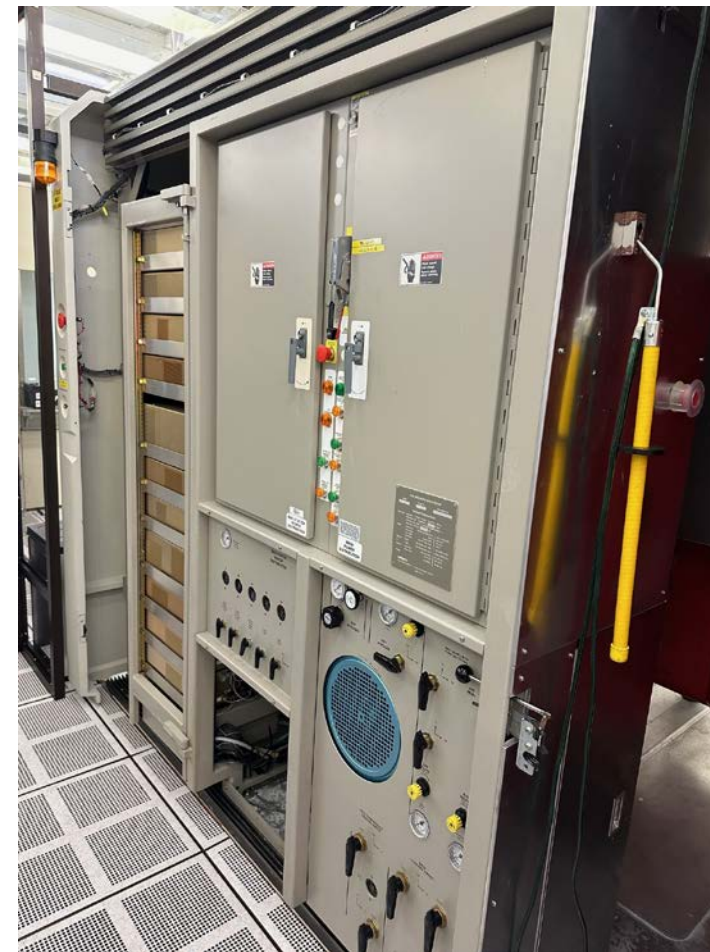
Picture showing
tool condition (4)

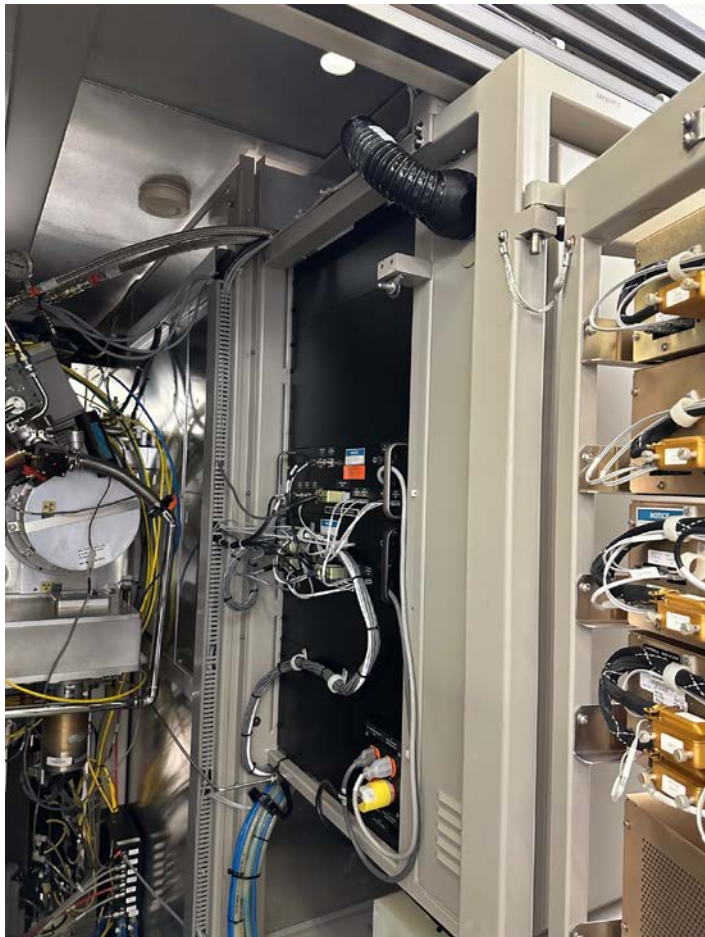
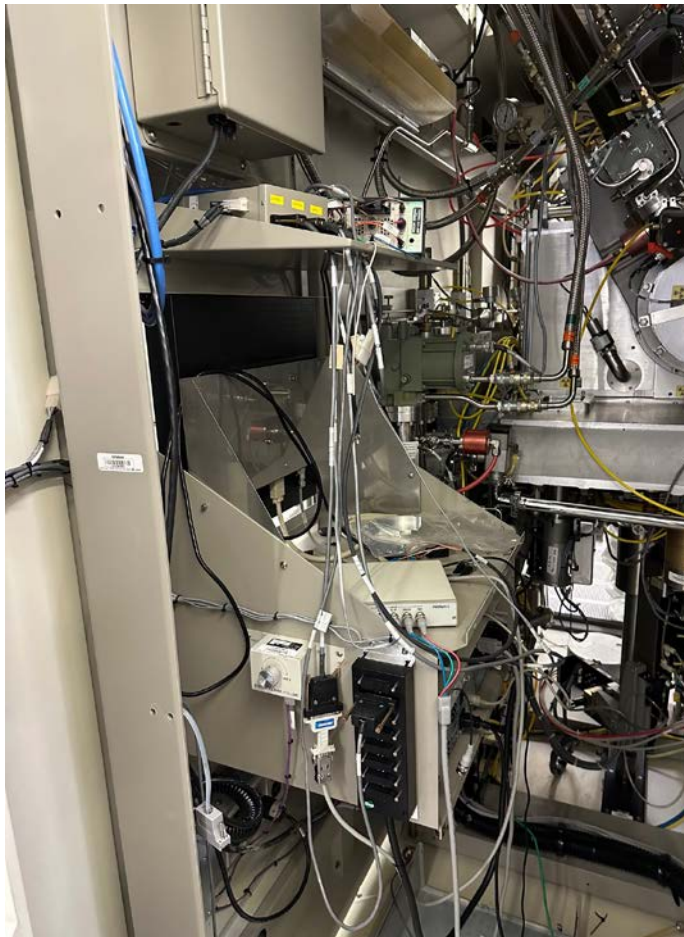
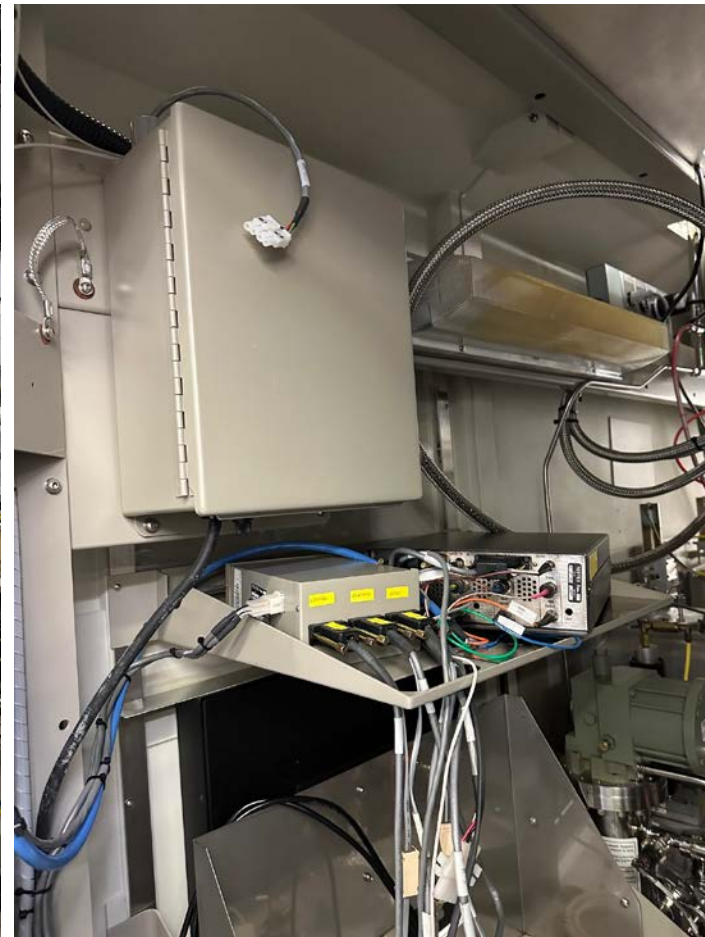
Picture showing
tool condition (5)

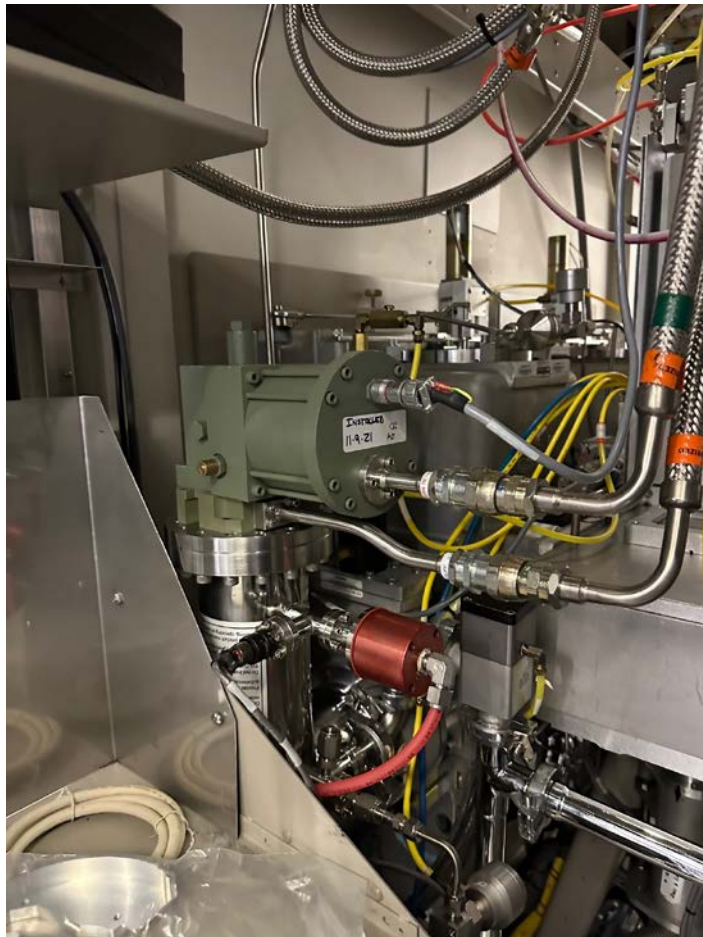
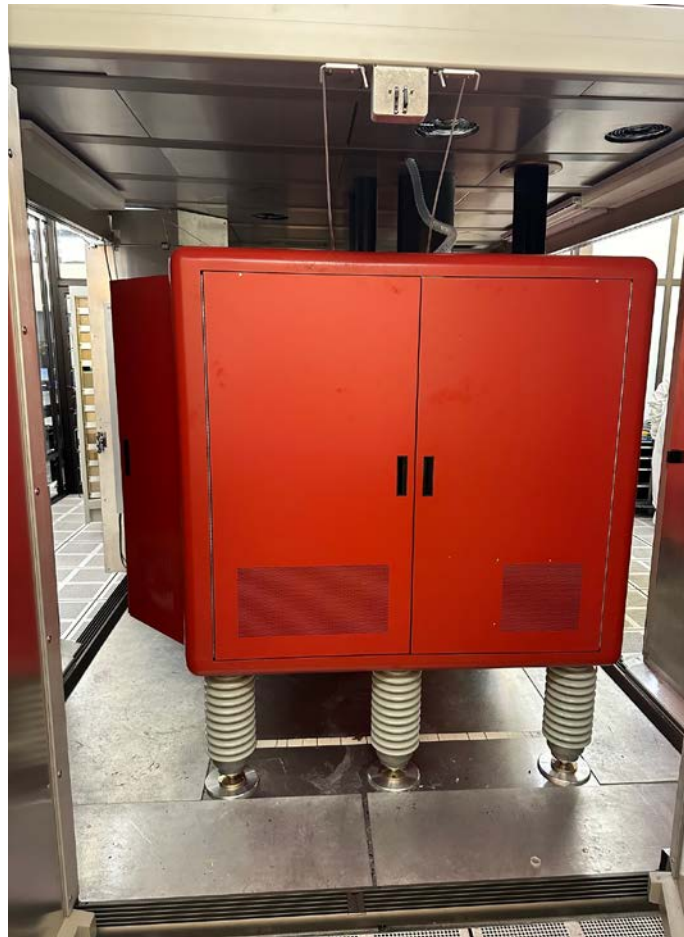
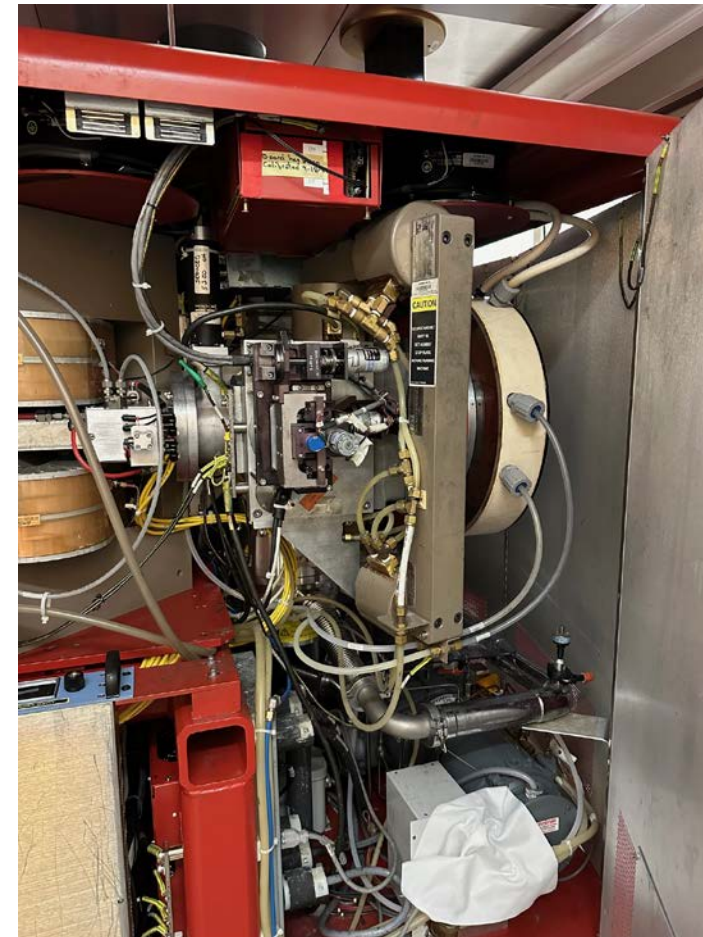
Picture showing
tool condition (6)

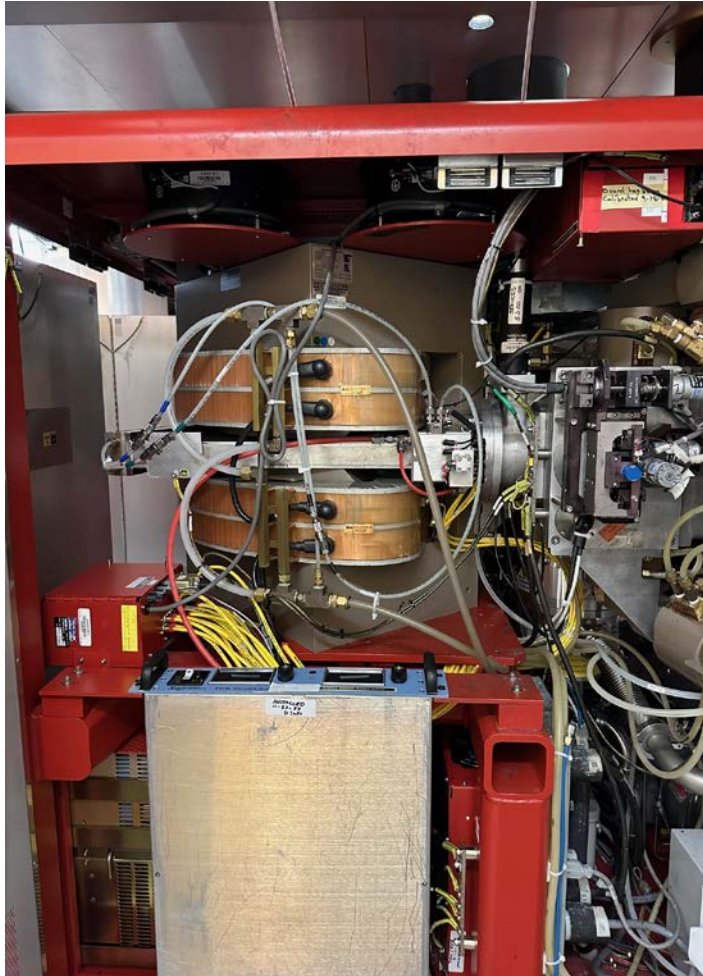
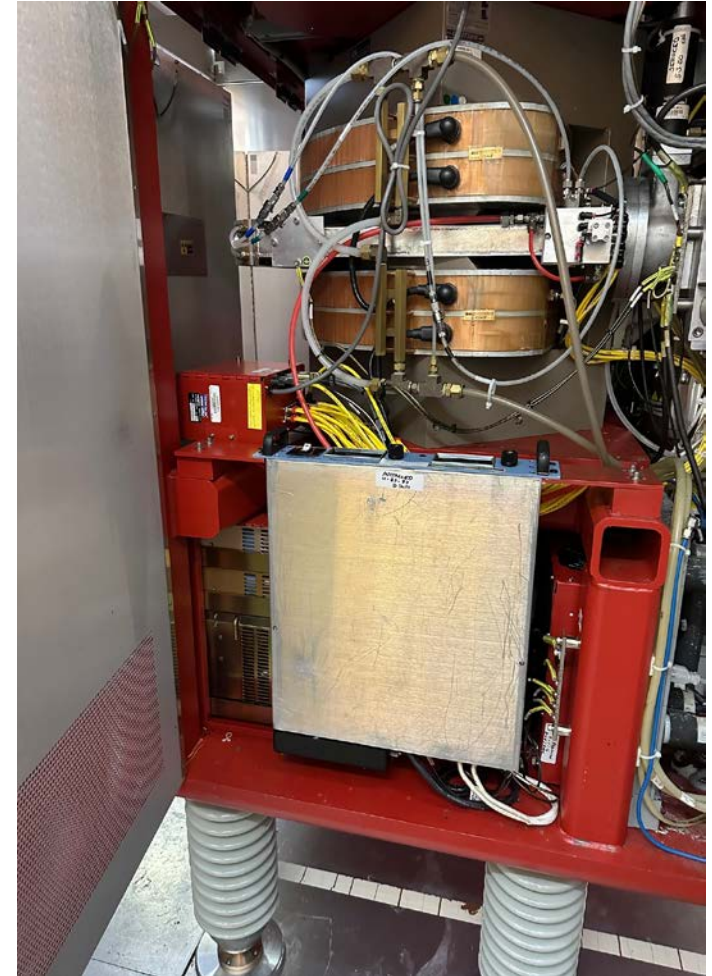
Picture showing tool condition (7)
