**GLOBEPACK**  
EQUIPMENT

# NORDEN 700 REFURBISHMENT PROCESS

Step by Step

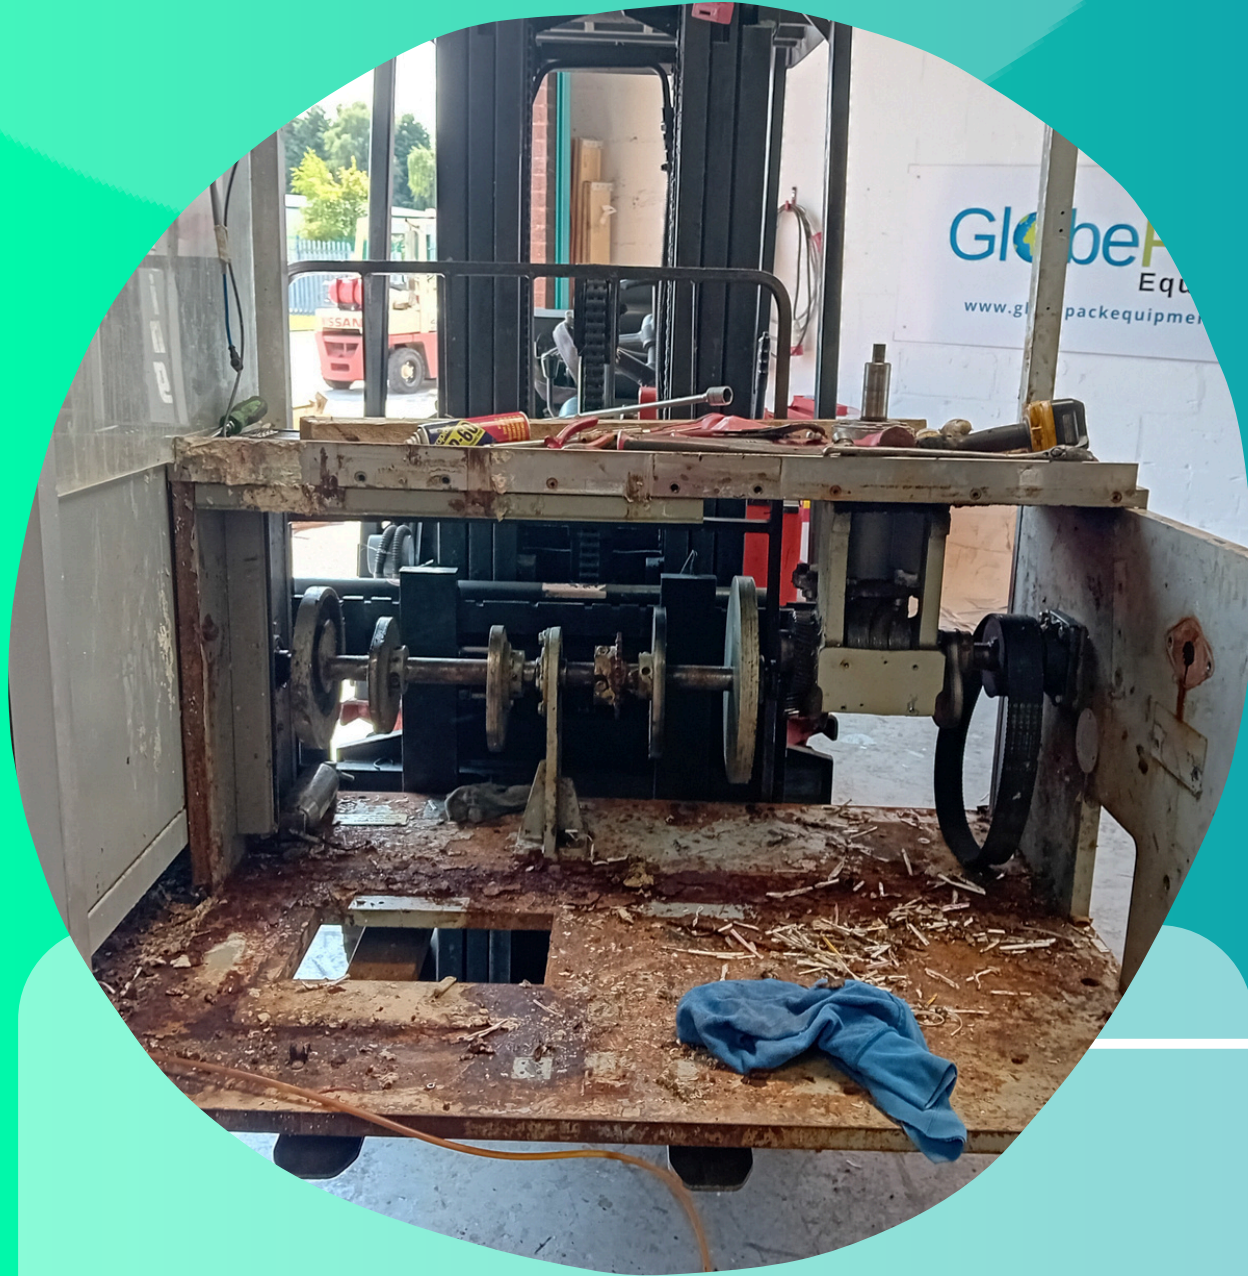
2

### Bottom Half Disassembly:

- Strip-down of the lower frame
- Both structural columns removed
- Filling column dismantled, cleaned, and inspected
- Sealing column dismantled and assessed for wear
- Main camshaft removed, cleaned, and inspected

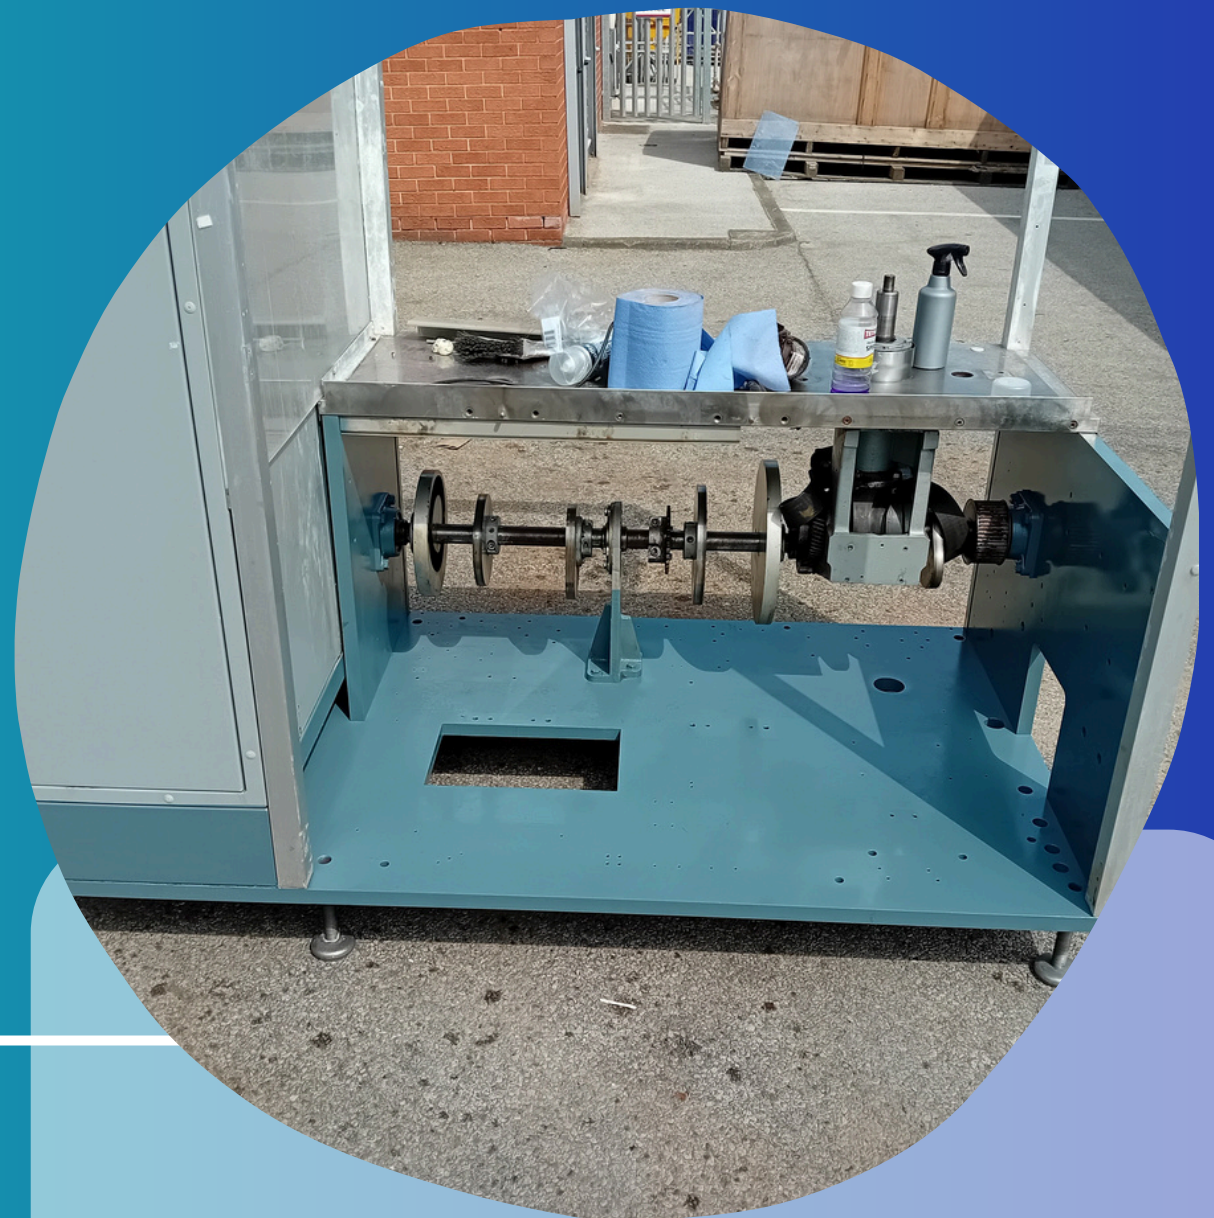
3

### Cleaning and Surface Restoration:

- Intensive degreasing and debris removal
- Painting and refinishing of the bottom half frame
- Top half is also thoroughly cleaned

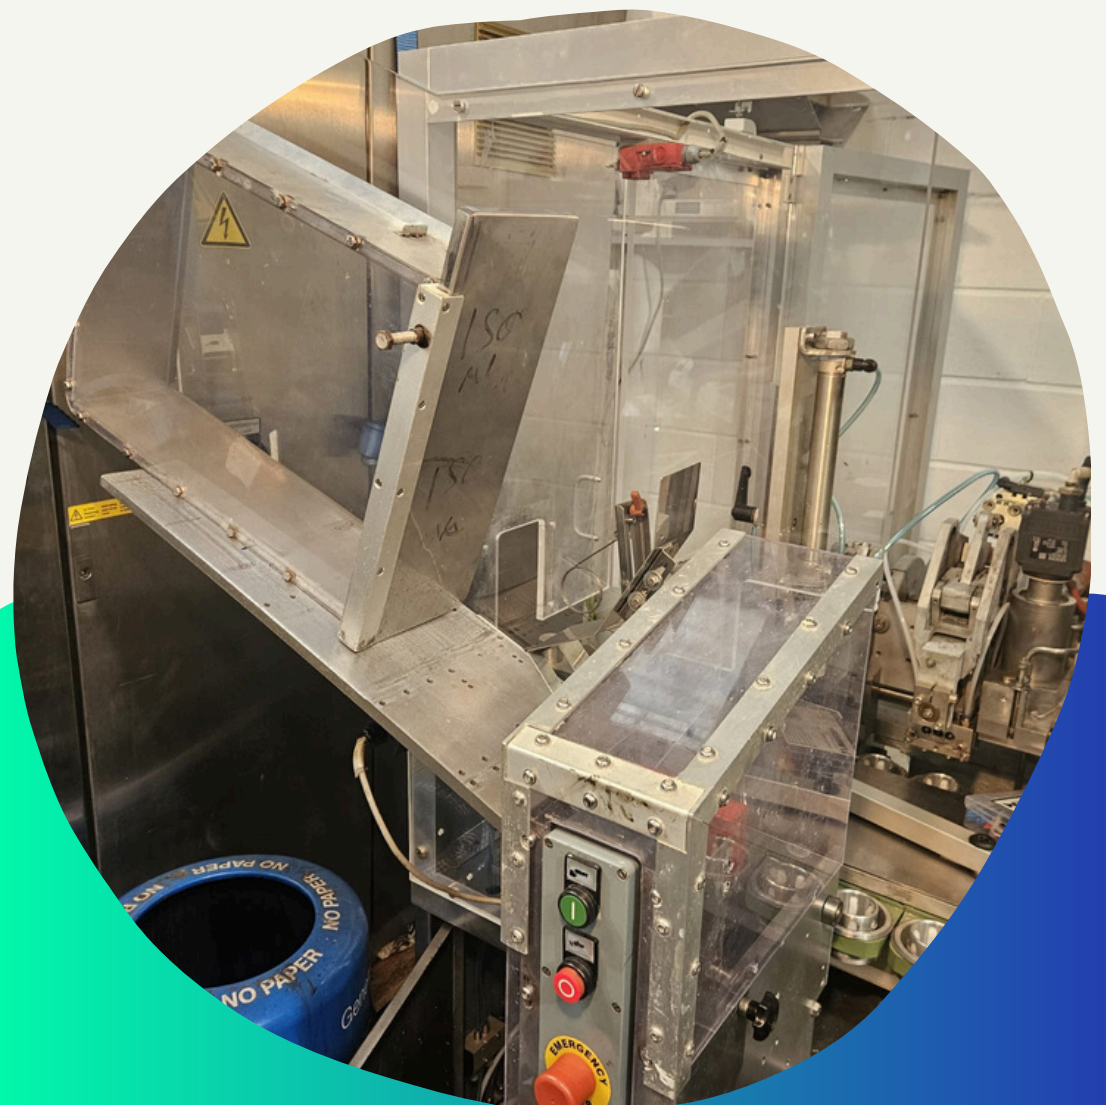
## Final Mechanical Details

- Pneumatic pipework and water lines completely renewed
- All Perspex safety guards and stainless steel guards refitted
- Mechanical refurbishment completed in full

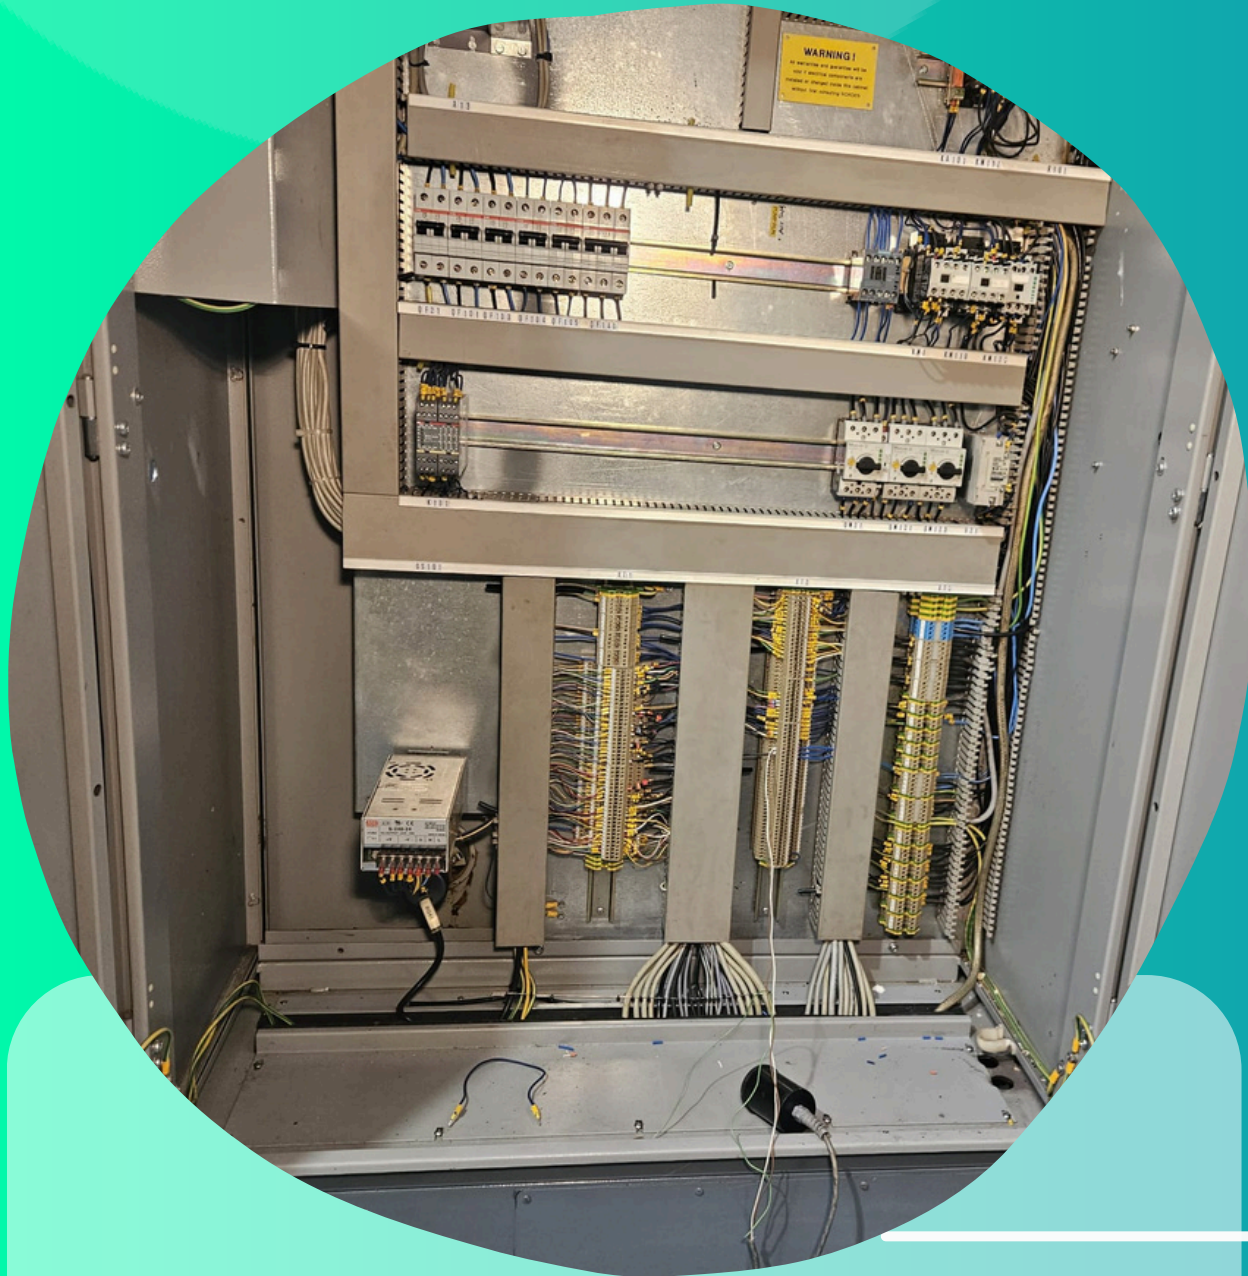
## Rewiring & Integration

- The machine is then fully rewired using modern cable management systems and new aluminium connection boxes, improving both safety and accessibility.
- Our engineers ensure seamless integration with mechanical and pneumatic systems, verifying connections between sensors, actuators, and drives.

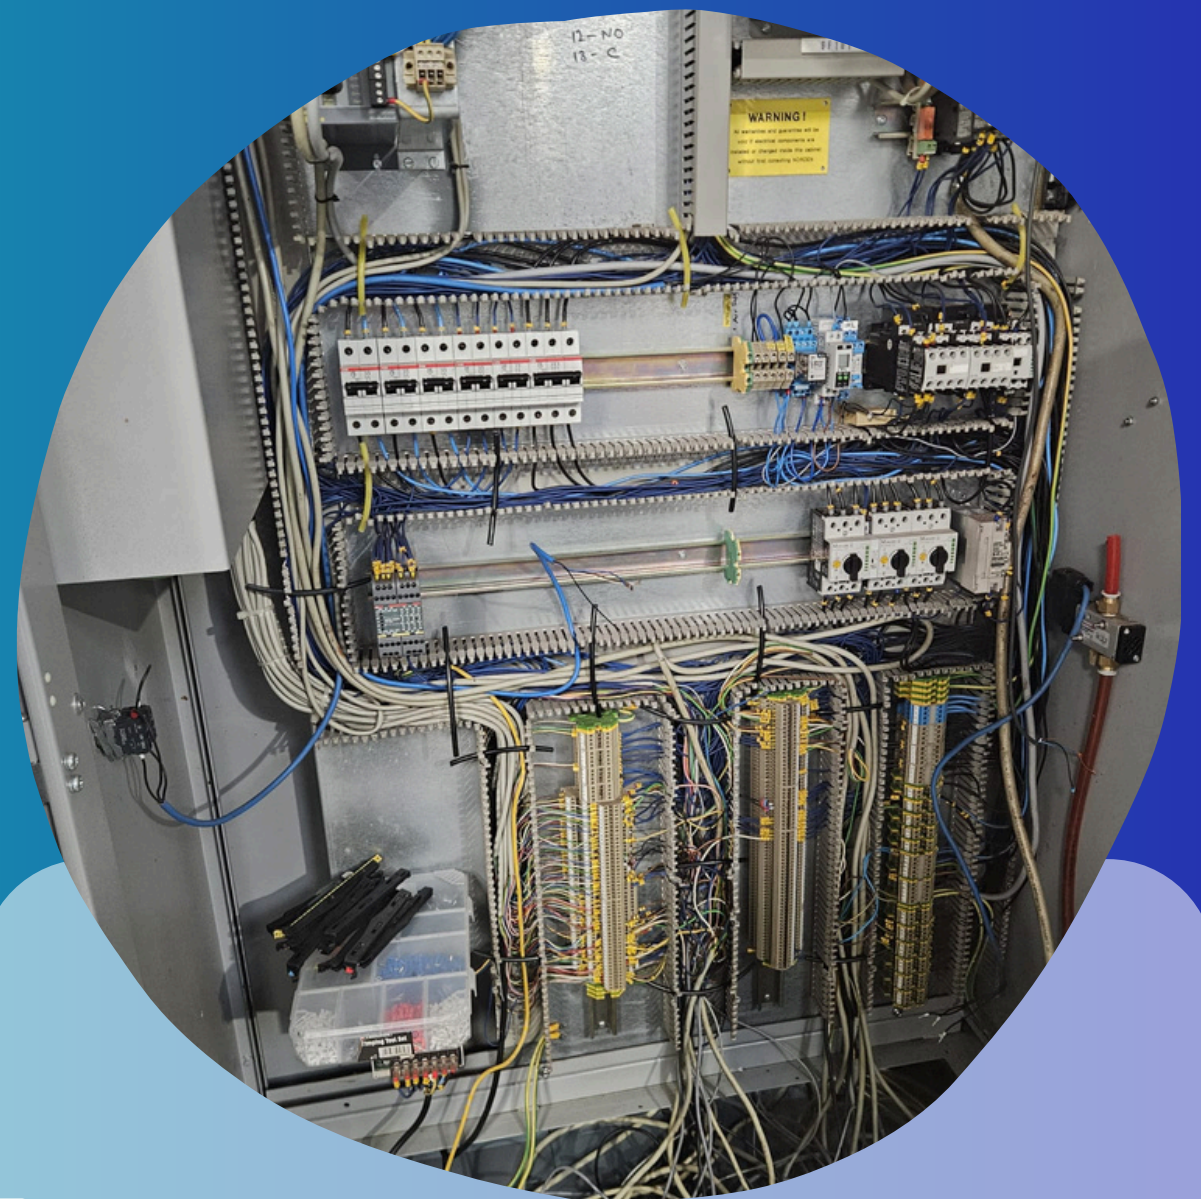
## Electrical Fault Finding

- The main control panel is carefully dismantled, cleaned, and inspected for wear, corrosion, and outdated components.
- All electrical cables, connectors, and components are tested for integrity and replaced where necessary.

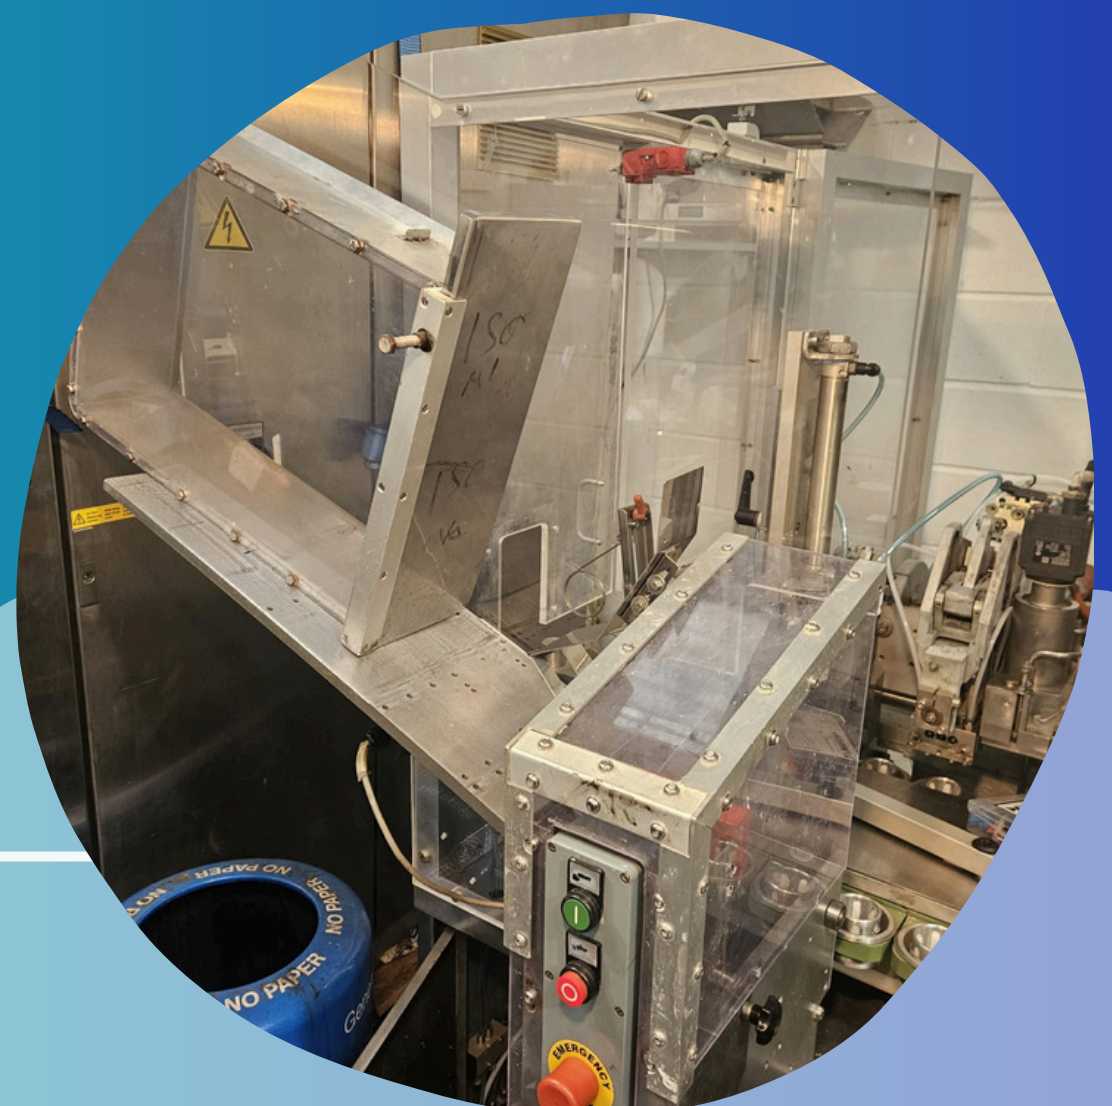
## Electrical Testing

- Once rewiring is complete, the system undergoes final testing, including continuity checks, fault diagnostics, and safety verification to ensure every component operates flawlessly.
