MT / PT / VT INSPECTION REPORT

Date: OCT.21 2026
Client: **RARE OILFIELD**
Location: **RARE OILFIELD SHOP REDCLIFF AB.**

Invoice #: BF26211
Report #: BF26211-M1
Page: 1 of 1

Acceptance Code: API STD 650-2021
Specification:
Procedure: MT-Rev.9
Technique: MT 2 - Wet Visible, Black On White
Contractor: RARE OILFIELD
A.F.E.#:
CPG.#:
Job.#:
Code.#:
Project: MT FLOOR TO SHELL

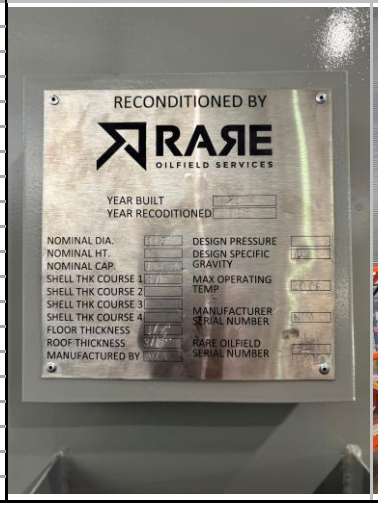
COMMENTS: MAGNETIC PARTICAL INSPECTION PERFORMED ON ITEM/S BELOW.
NO RELEVANT INDICATIONS FOUND AT TIME OF INSPECTION.

Field Weld Number (s)	Size	Thickness	Material	Welder Symbol	Remarks	Accept	Reject
1	MT01		.188"	C		MT SHELL TO FLOOR ACCEPTED	✓	
2								
3								
4								
5								
6								
7								
8								
9								
10								
11								
12								
13								
14								
15								
16								
17								
18								
19								
20								
21								
22								
23								
24								
25								
26								
27								
28
