# BORESCOPE INSPECTION REPORT

GAS TURBINE ENGINE  
TAURUS 60  
COLD END DRIVE

Engine Serial Number  
**OHA22-T3018**

Inspection Date  
**Monday, May 22, 2023**

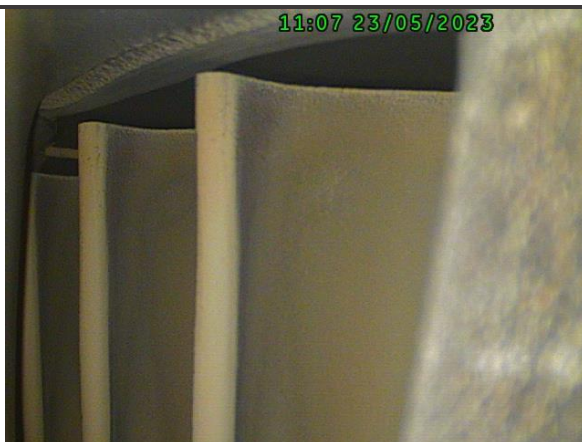
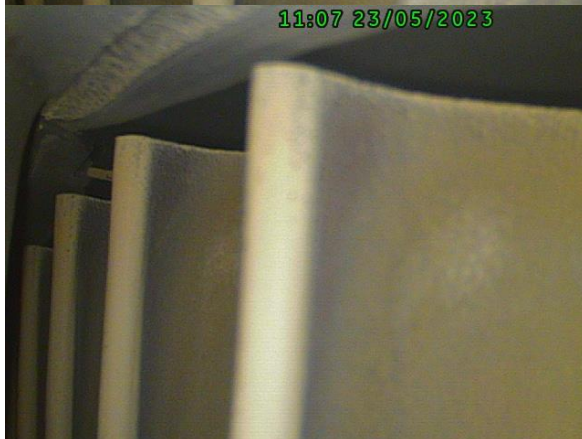
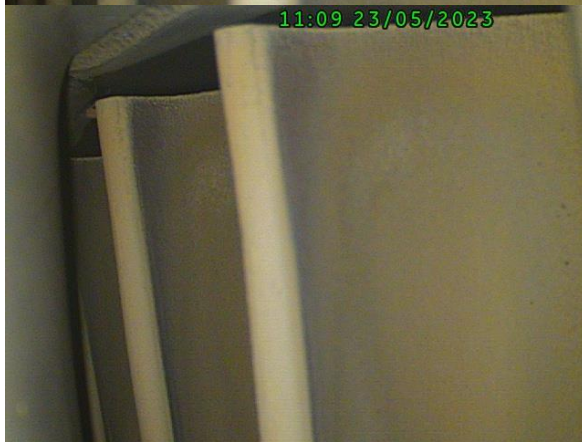
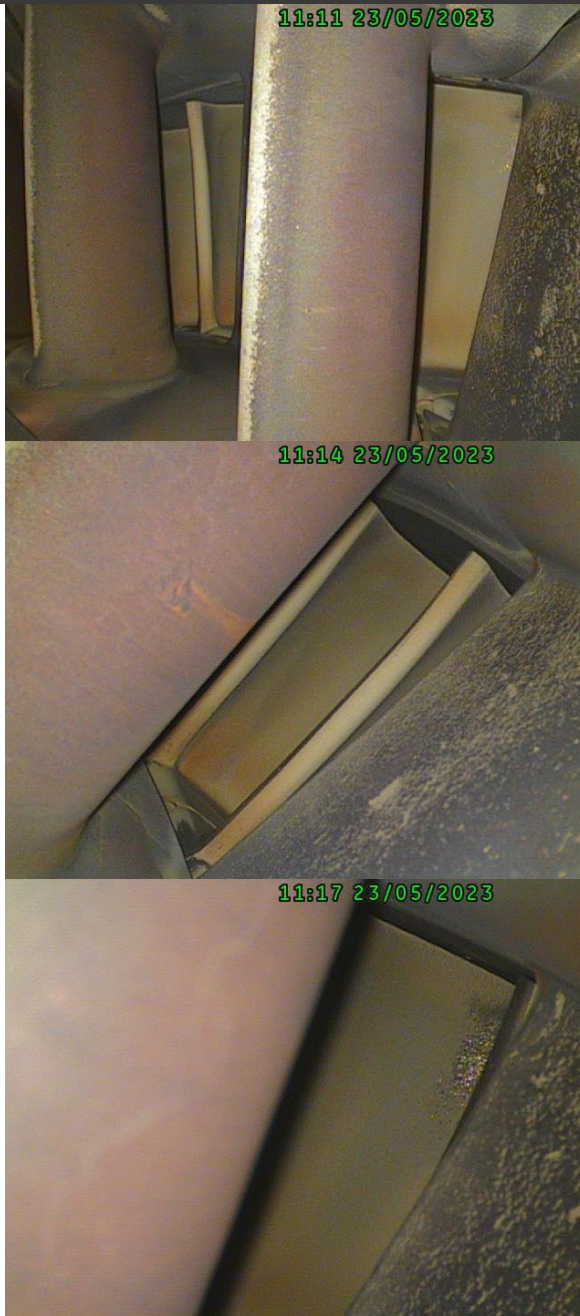
| Access Port | Location | Inspection for | Normal Condition | Minor | Moderate | Severe | Comments |
|---|---|---|---|---|---|---|---|
| <u>B</u> | 1st Stg Turbine Blades | a)Cracks, Qty, length, orientation<br>b)Thermal erosion, Depth and area<br>c)FOD, Affected area<br>d)Tip rub width | ✓ | | | | |

Normal Condition

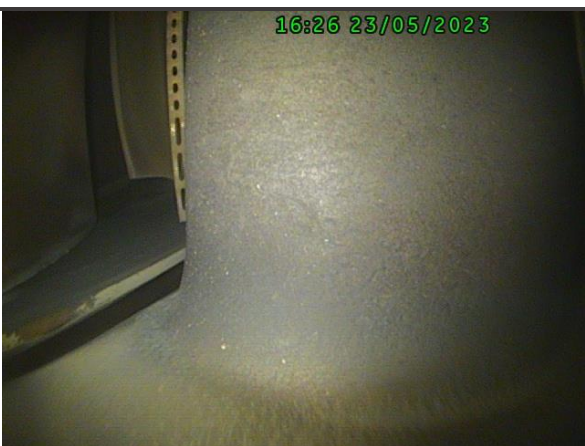
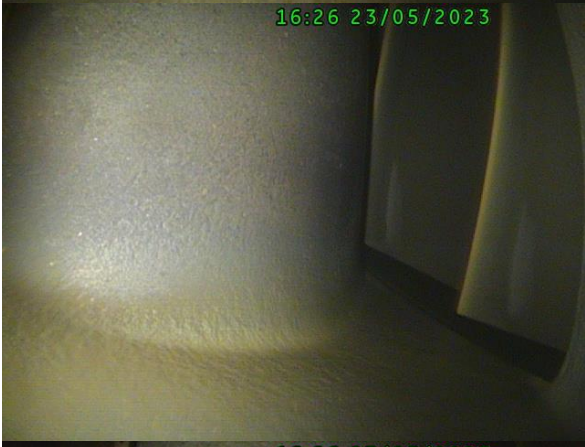
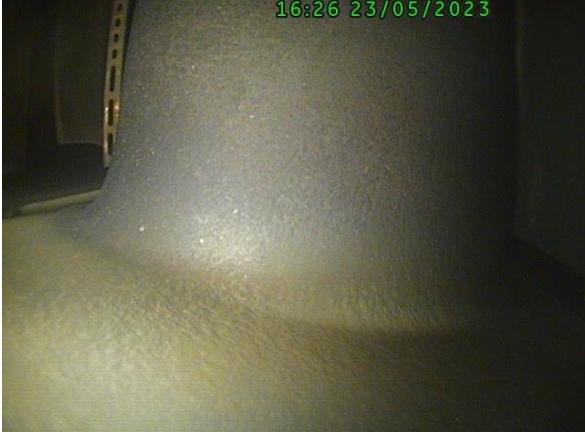
| Access Port | Location | Inspection for | Normal Condition | Minor | Moderate | Severe | Comments |
|---|---|---|---|---|---|---|---|
| <u>C</u> | 2nd Stg Turbine Nozzles | a)Cracks, Qty, length, orientation<br>b)Thermal erosion, Depth, Affected area | ✓ | | | | |

| <p>C</p> <p>2nd Stg Turbine<br/>Nozzles</p> | | <p>a)Cracks, Qty, length,<br/>orientation</p> <p>b)Thermal erosion,<br/>Depth, Affected area</p> | <p>Normal Condition</p> <p>Not applicable</p> |

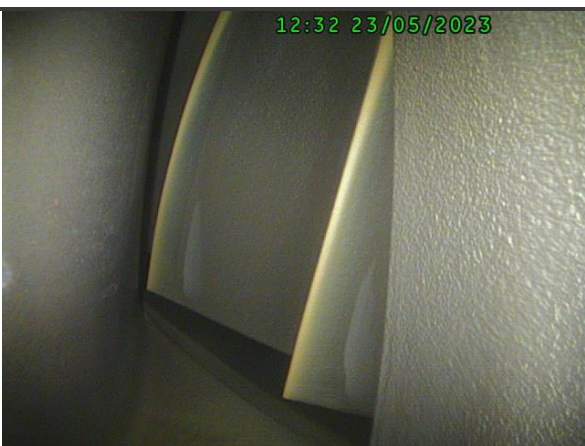
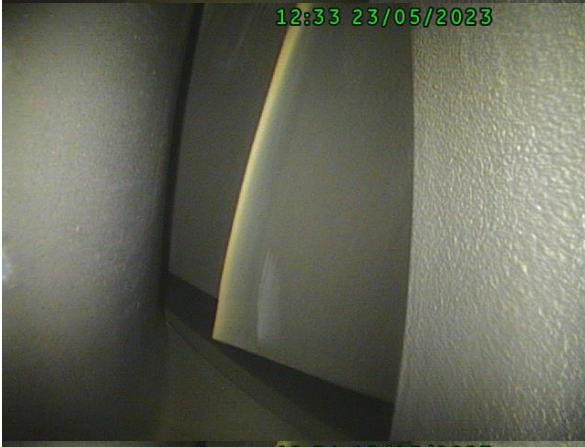
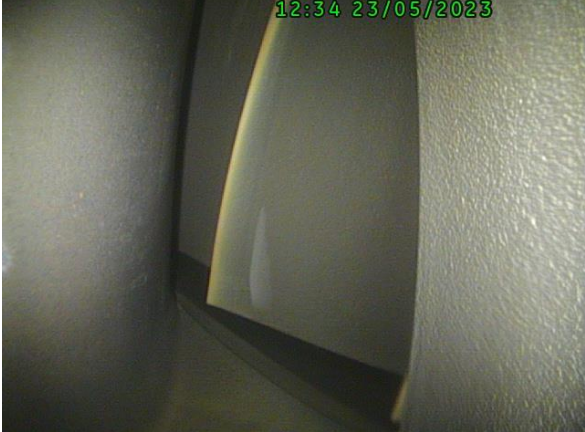
| Access Port | Location | Inspection for | Normal Condition | Minor | Moderate | Severe | Comments |
|---|---|---|---|---|---|---|---|
| <u>C</u> | 2nd Stg Turbine Blades | a)Cracks, Qty, length, orientation<br>b)Thermal erosion, Depth and area<br>c)FOD, Affected area<br>d)Tip rub width | ✓ | | | | |

| <p>C</p> <p>2nd Stg Turbine<br/>Blades</p> | | <p>a)Cracks, Qty, length, orientation</p> <p>b)Thermal erosion, Depth and area</p> <p>c)FOD, Affected area</p> <p>d)Tip rub width</p> | <p>Normal Condition</p> <p>Not applicable</p> |

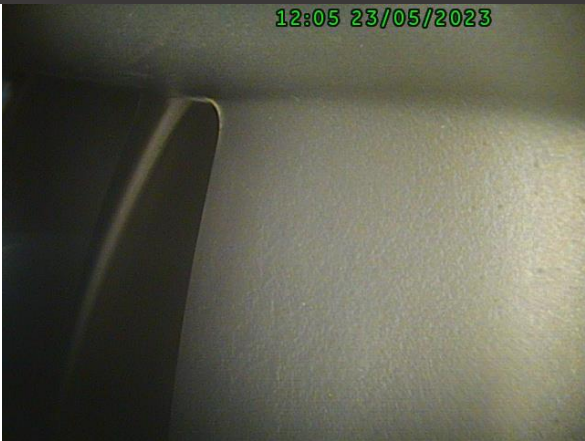
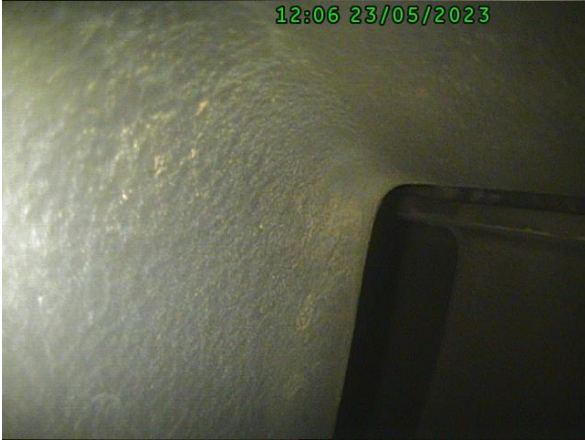
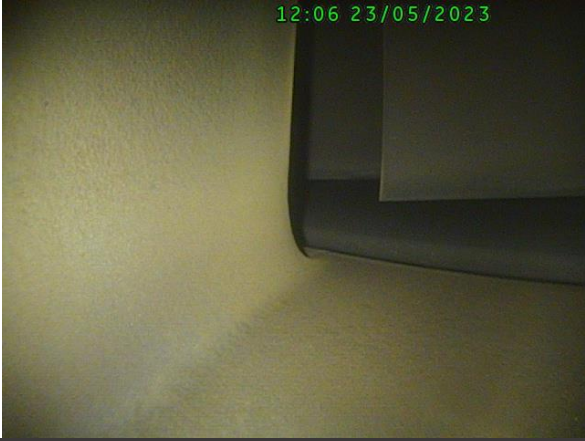
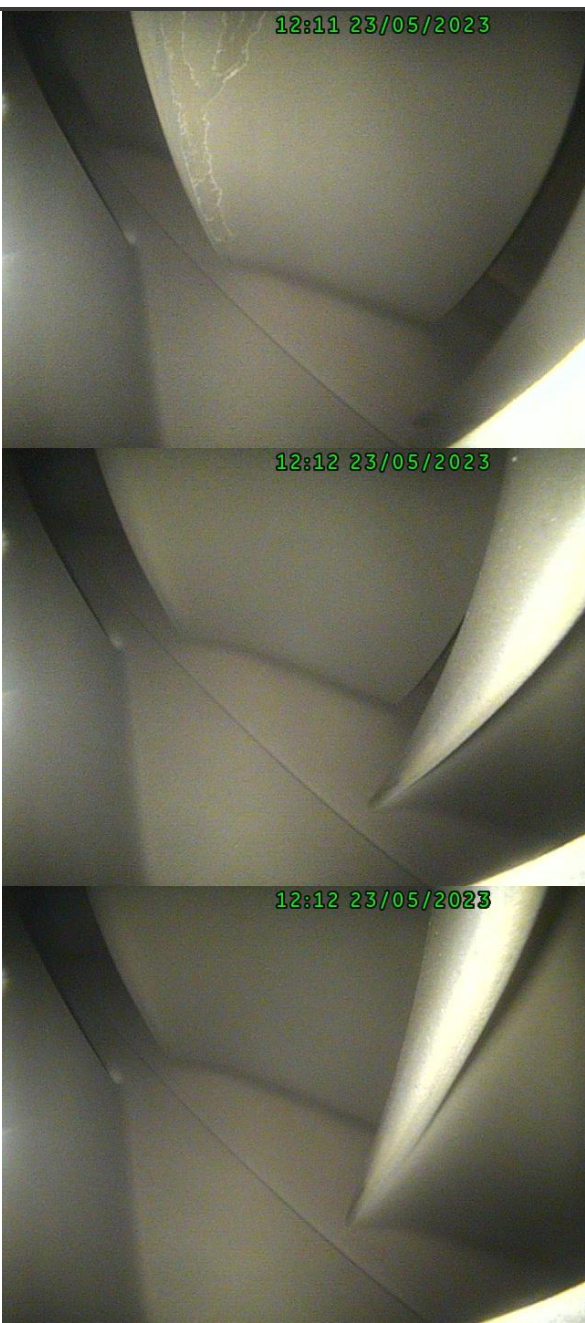
| Access Port | Location | Inspection for | Normal Condition | Minor | Moderate | Severe | Comments |
|---|---|---|---|---|---|---|---|
| <u>D</u> | 3rd Stg Turbine Blades | a)Cracks, Qty, length, orientation<br>b)Thermal erosion, Depth and area<br>c)FOD, Affected area<br>d)Tip rub width | ✓ | | | | |

| <p>D</p> <p>3rd Stg Turbine<br/>Blades</p> | | <p>a)Cracks, Qty, length, orientation</p> <p>b)Thermal erosion, Depth and area</p> <p>c)FOD, Affected area</p> <p>d)Tip rub width</p> | <p>Normal Condition</p> |
