**Job Scope:** To perform informational Visual Inspections with Ultrasonic Testing (UT) on a Horizontal Separator Package (A0521805). This package includes a horizontal Separator and Blowcase.

**Visual Inspection Information – 72” ID Horizontal Separator (A0521805)**

**Informational Visual  
Inspection Report**  
*Informational Visual  
Inspection\_A0521805 Separator  
Package\_oct2025*

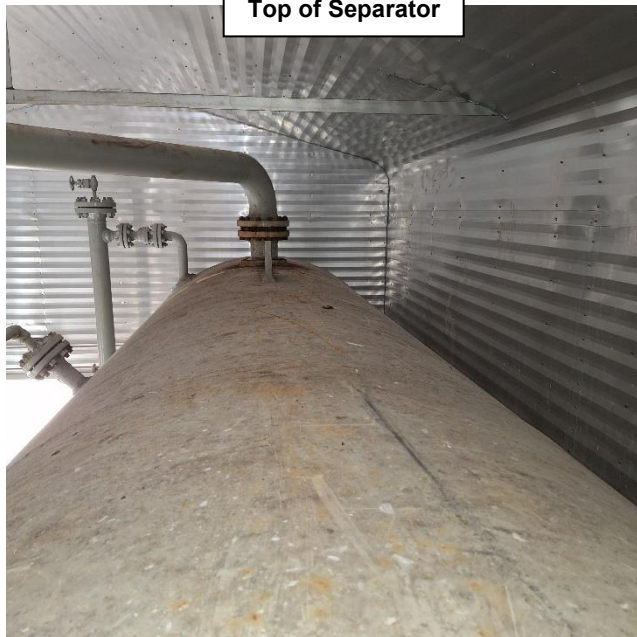
**Top of Separator**

- **Nameplate:** Firmly fastened and legible.
- **Foundation/Support:** This vessel is supported by two saddle supports. No visible signs of damage.
- **External Surface:** This vessel is carbon steel, painted, and uninsulated. No mechanical damage or deflection observed. Minor paint damage and staining noted on vessel shell.

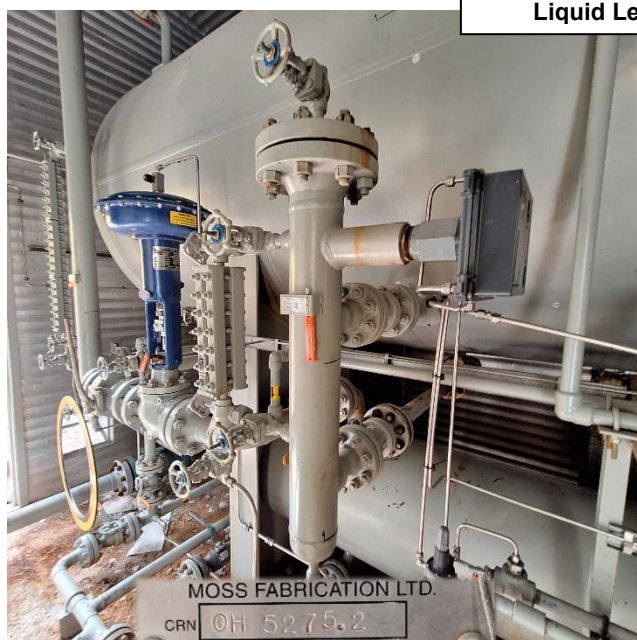
**Liquid Level Columns**

- **External Components:** This package has three attached liquid level columns, four Catadyne heaters, one Roughneck heater, a Barton Meter, a Wizard Controller and an air quality monitoring system installed. All appear to be in good condition.

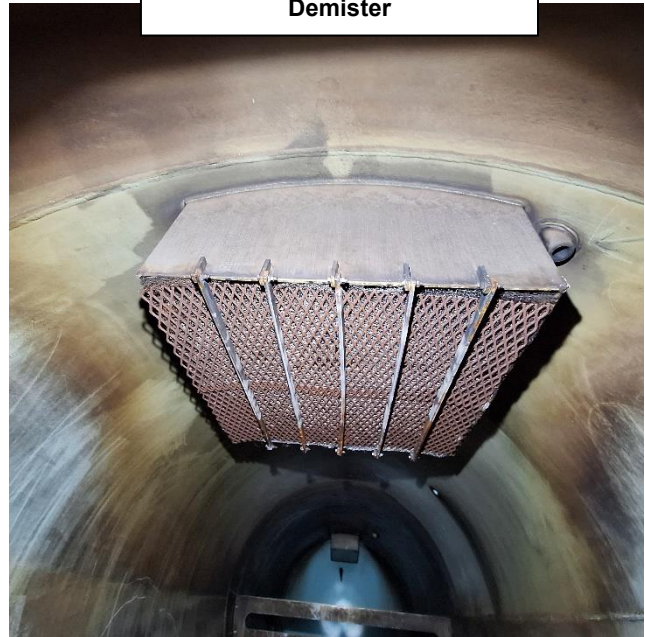
Demister

- **Internal Components:** Visible internal components from the manway include, a demister vane plate, a deflector plate, one side of a weir, one side of a baffle, and internal nozzles. All visible internal components appear to be in good condition.

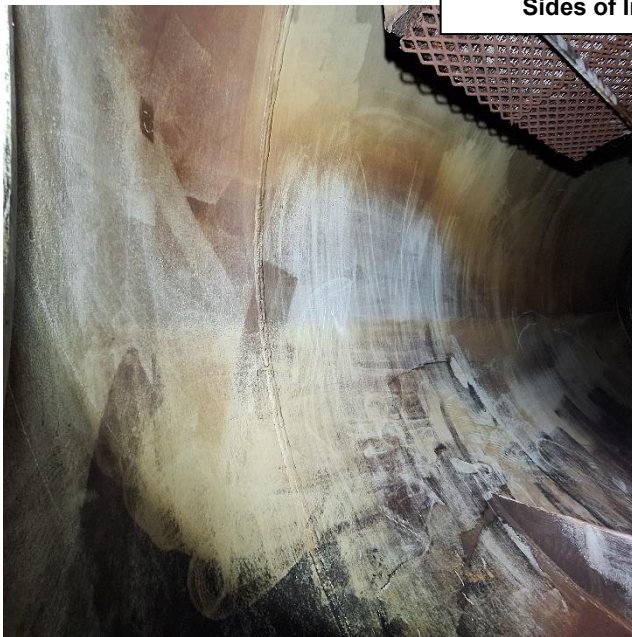
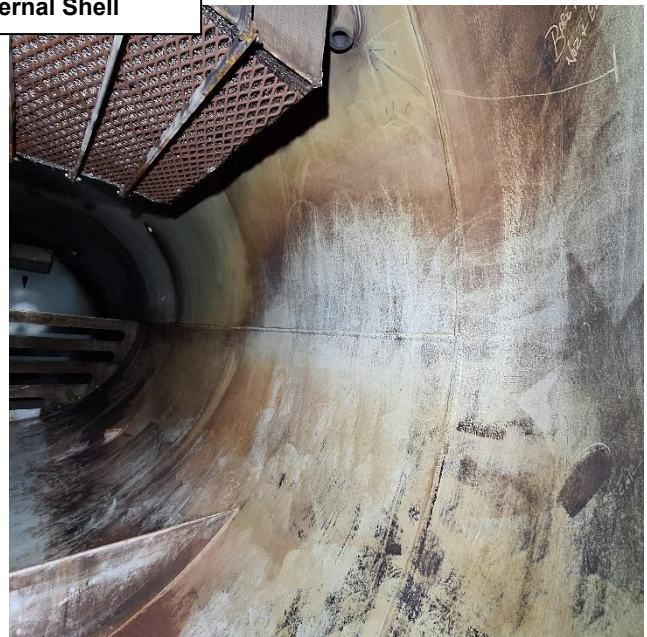
**Sides of Internal Shell**

- **Internal Coating:** Appears to be in good visible condition from the manway. The coating on the manway edges is starting to deteriorate. Some surfaces are not visible due to residual product in the bottom.

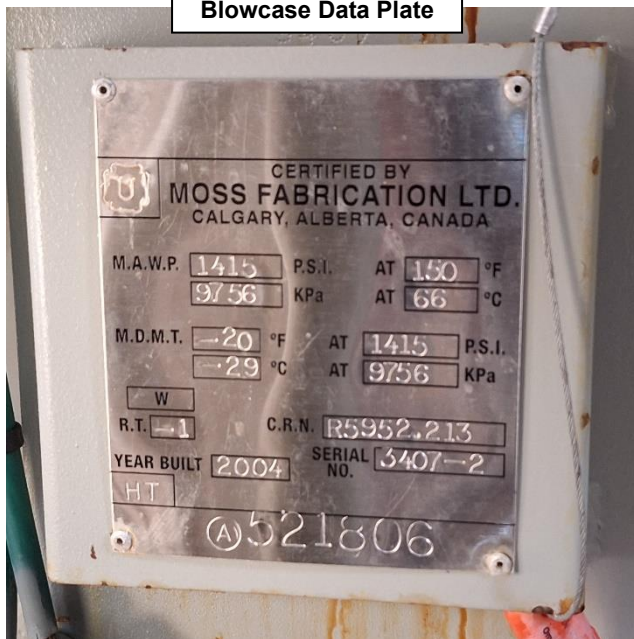
**Blowcase Data Plate**

- **24” OD Horizontal Blowcase (A0521806):** Data plate attached and legible. Painted and Uninsulated. No signs of mechanical damage or deflection. One PSV installed; SN IBT01612-48, last serviced on May 16, 2013 by Unified Valve. 24” Manway not opened for internal assessment at the time of inspection.
