USED TANK FIELD INSPECTION

2000 bbl Tank – 03-07-11 12394

EMPRESS ENGINEERING LTD.

November 18, 2024

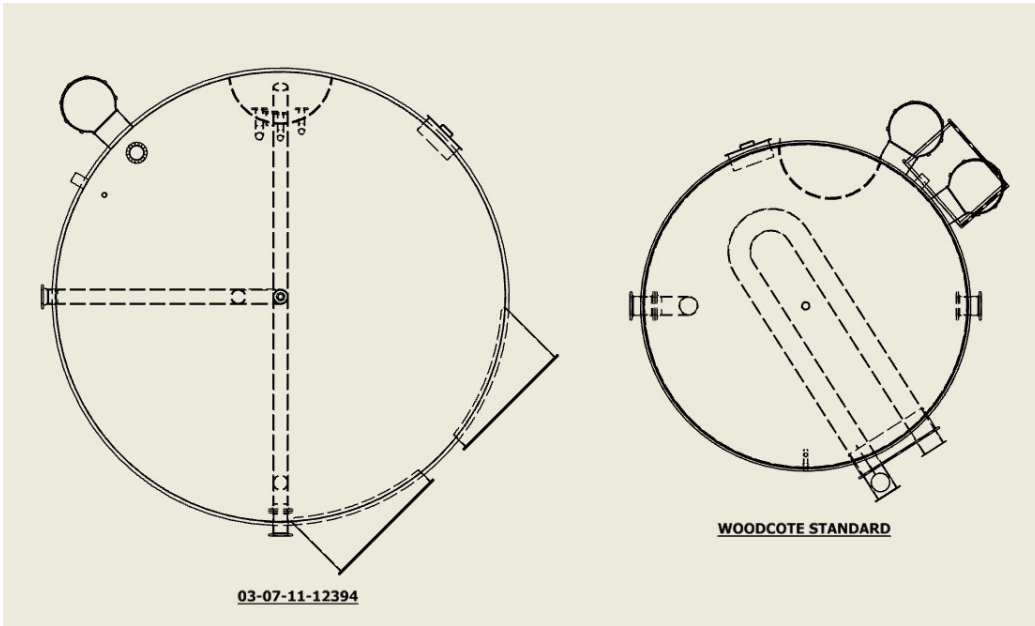
The following is a plan view sketch showing the orientation of this tank.

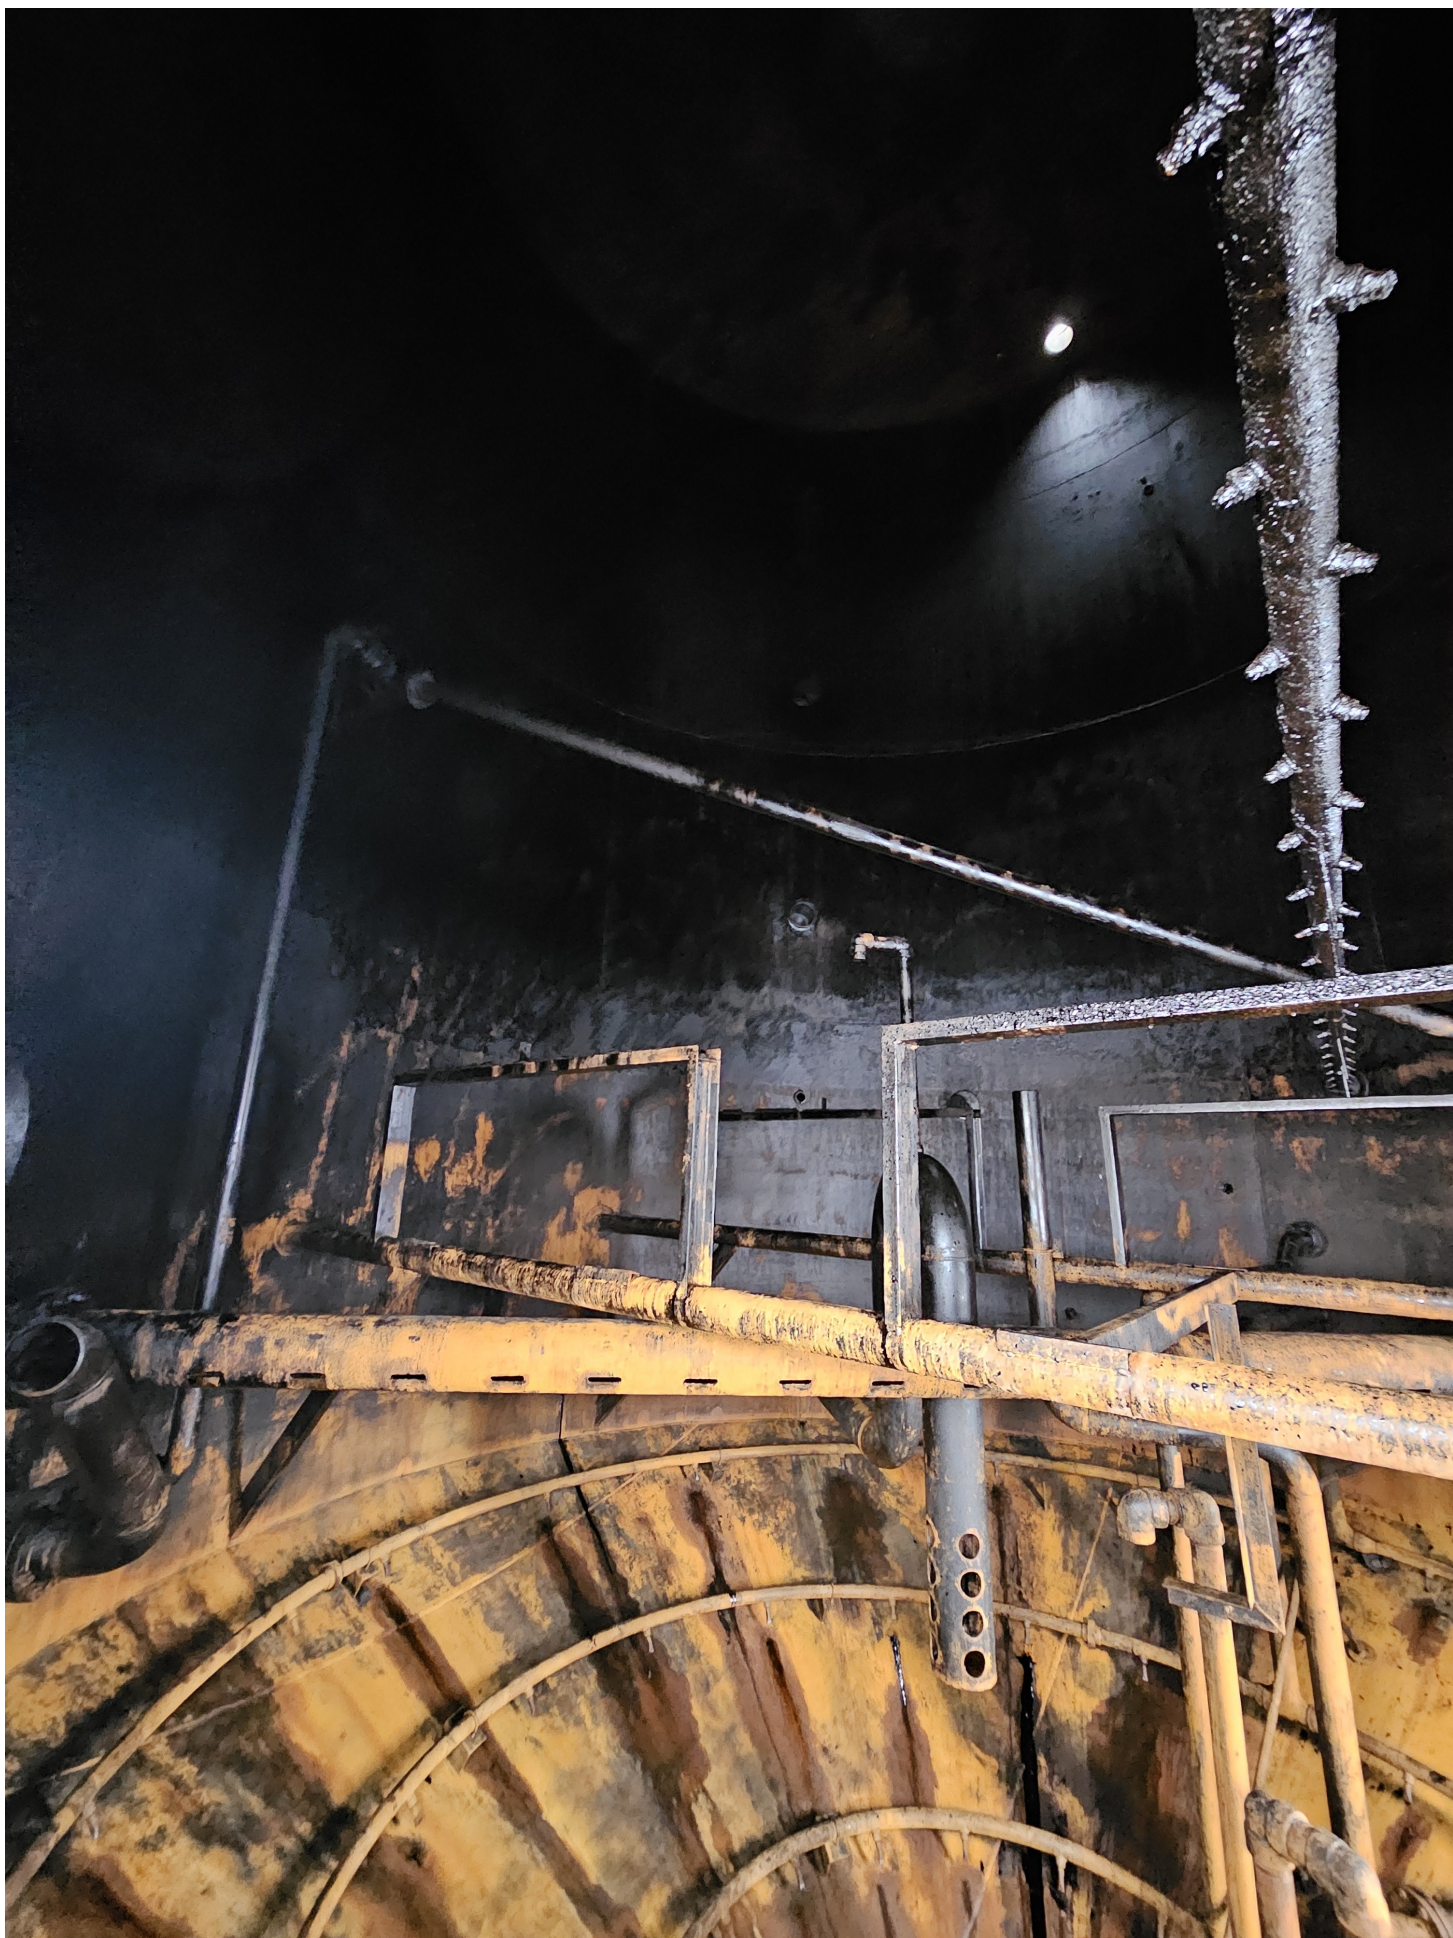
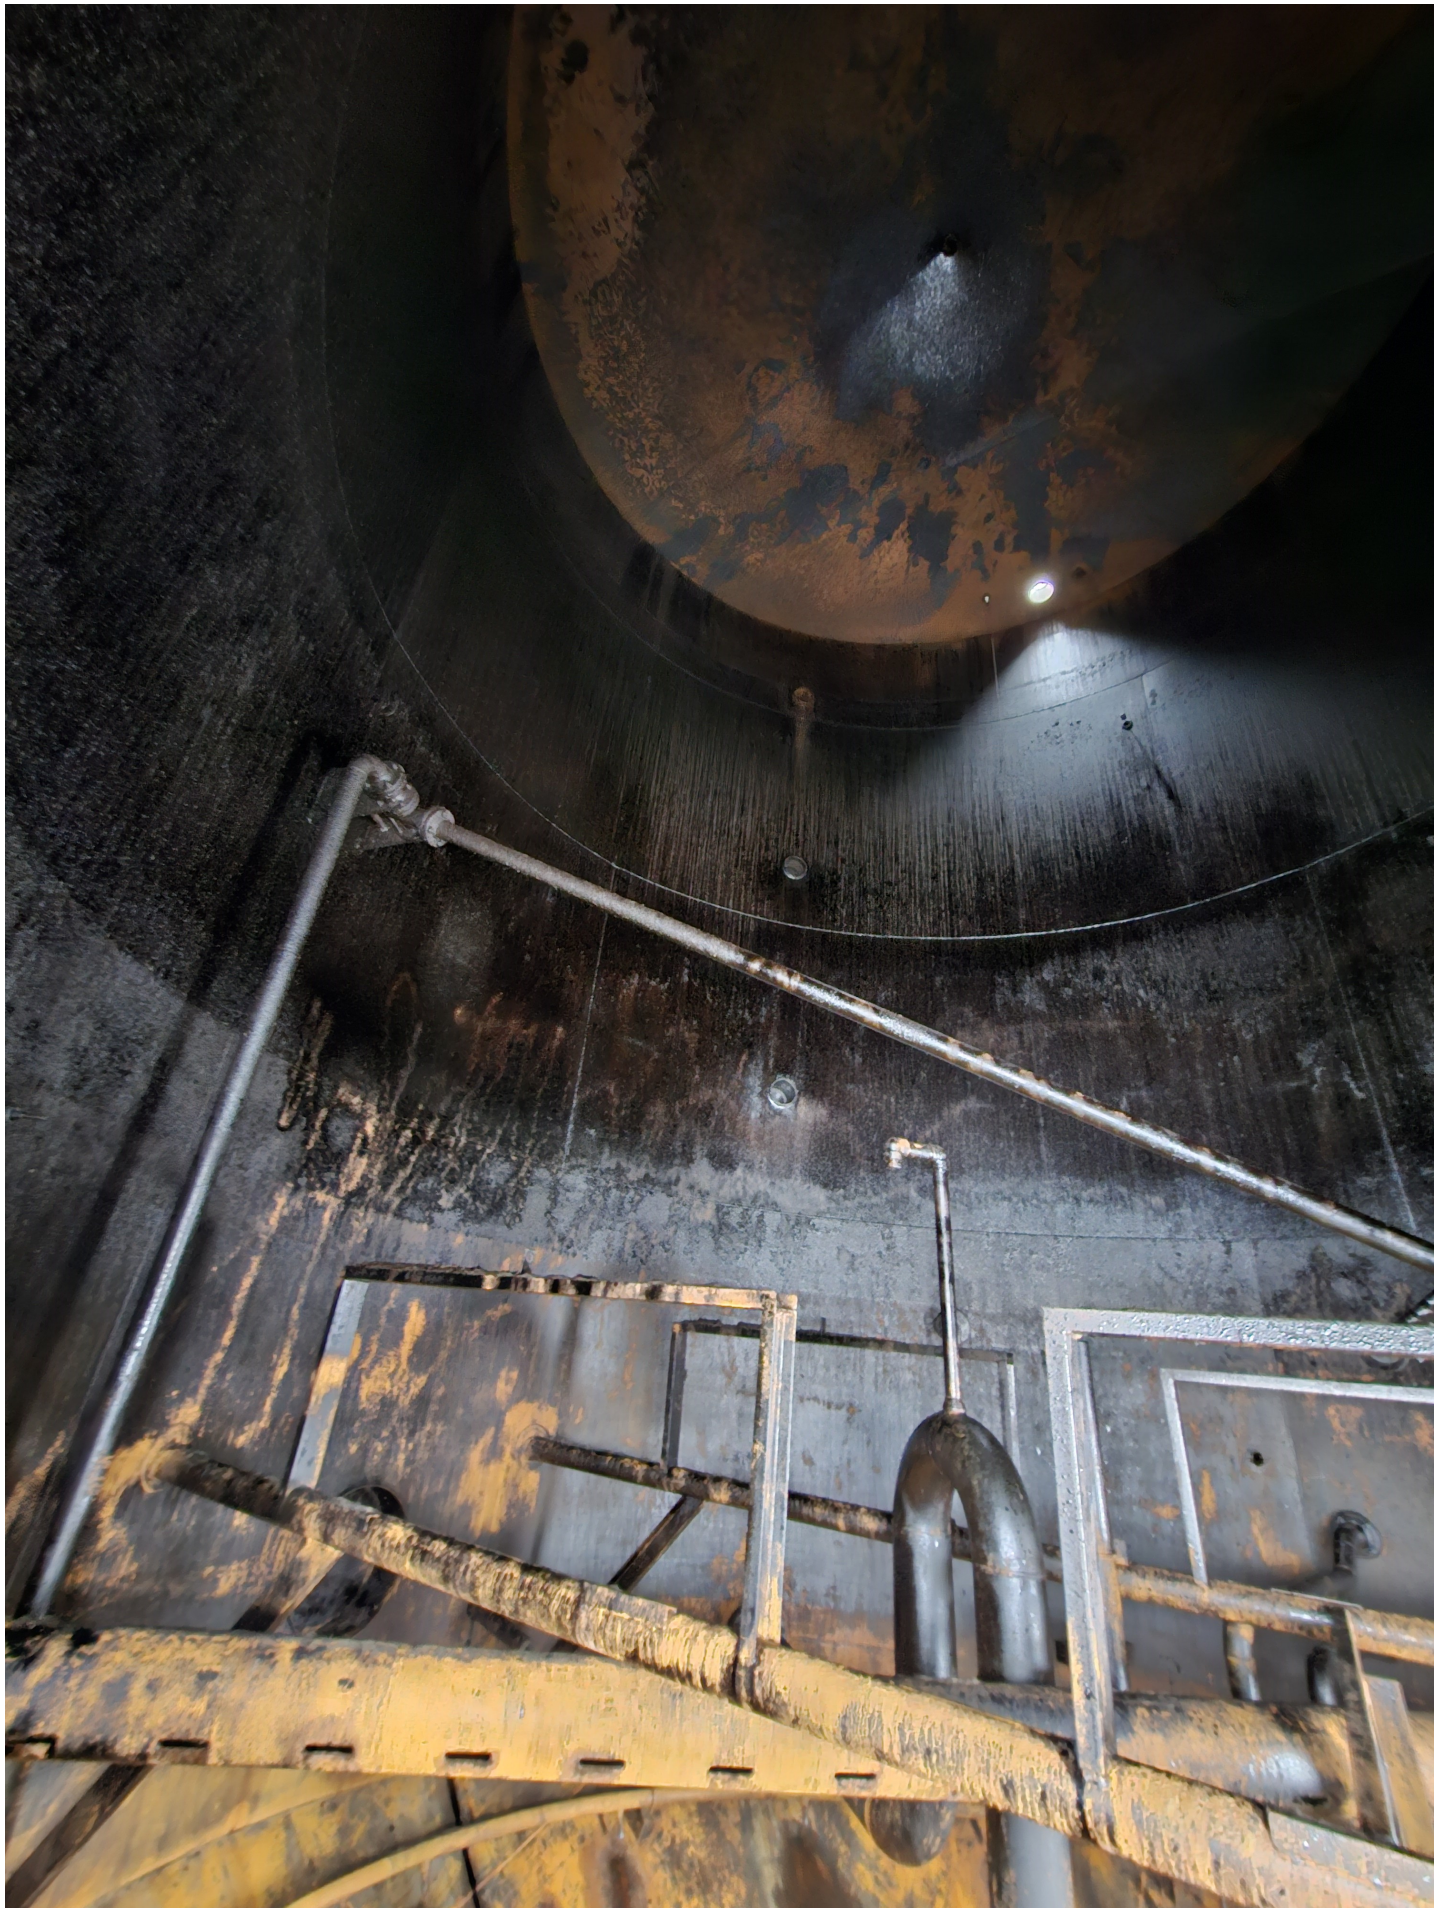
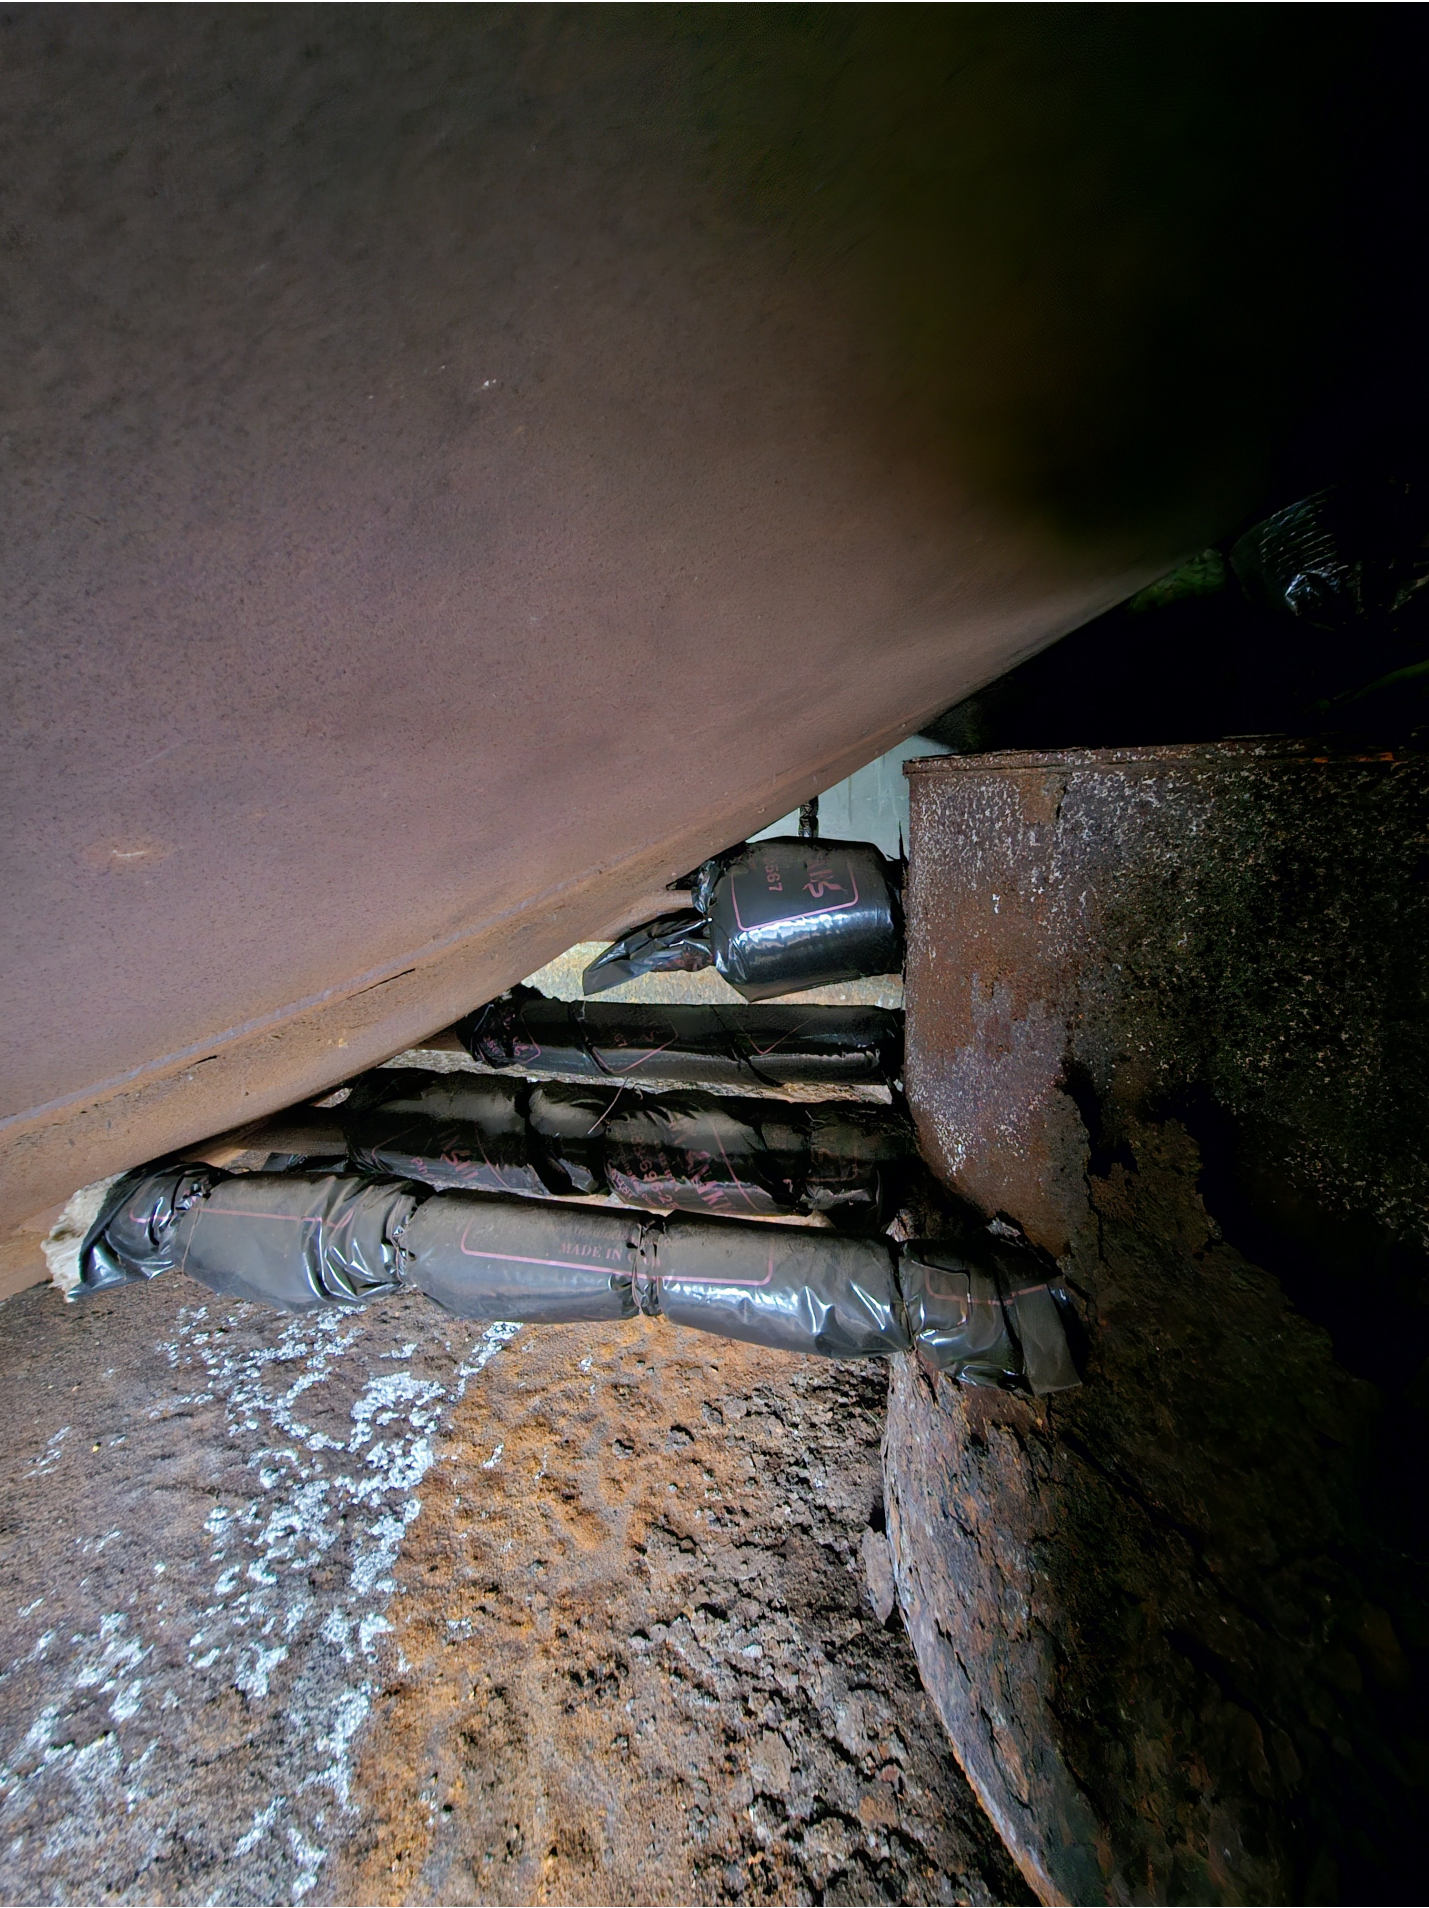
FLOOR

The tank is sitting on concrete rig mats. There is internal corrosion on the skirt up 2' around the tank.
There are three desand rings and a floating suction.
Firetubes are not included, but there are blinds for the throats.
This tank is good to put into service.
