# API 510 PRESSURE VESSEL INSPECTION REPORT

| FACILITY: | Septimus Compressor Station | APPLUS JOB NO.: | 4051051 |
| VESSEL NAME: | Glycol Flash Tank | STATUS: | <input type="checkbox"/> In-service <input checked="" type="checkbox"/> Out of Service |
| EQUIPMENT NO.: | V-2270 | INSPECTION TYPE: | <input checked="" type="checkbox"/> Regulatory <input type="checkbox"/> Inventory <input checked="" type="checkbox"/> VE <input type="checkbox"/> VI |

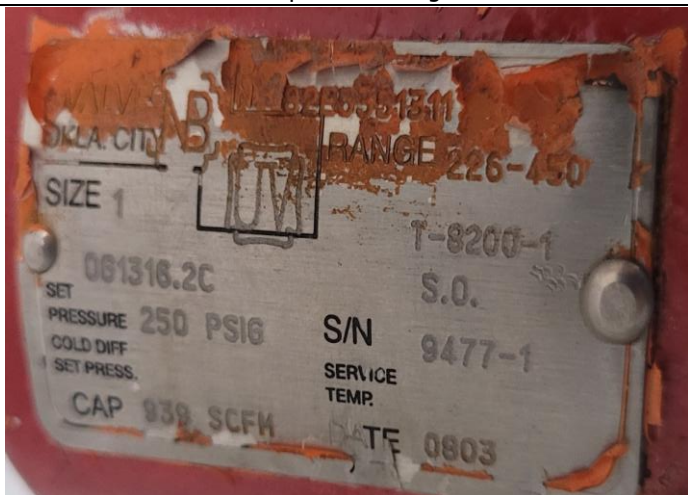
PSV data

| DESCRIPTION | CONDITION | COMMENTS |
|---|---|---|
| <b>VISUAL EXTERNAL SUMMARY:</b> | Visual external inspection carried out – vessel is in good overall condition. Equipment has been out of service for several years. No corrosion or mechanical damage. No sign of leaks. No items of concern. PSV requires service. | |
