**BOILERS AND PRESSURE VESSELS
REPAIR OR ALTERATION REPORT**

1. Name of Organization doing Repair/Alteration Bromley Mechanical Services, A Division of Argo Sales LP,
Address 925-23 Street S.W., Medicine Hat, Alberta, T1A 8R1 AQP No. & Expiry Date AQP-1009, February 25, 2028
2. Name of Owner Rare Oilfield Services Corp
Address 502 Mitchell Street North East, Redcliff, Alberta T0J 2P0
Location of Installation LSD: 15-35-021-07 W4

3. Boiler/Pressure Vessel Description Horizontal Treater CRN N8993.23
Manufacturer's Name Universal Industries Ltd., Serial No. 97-11-73

Fire Tube Repair

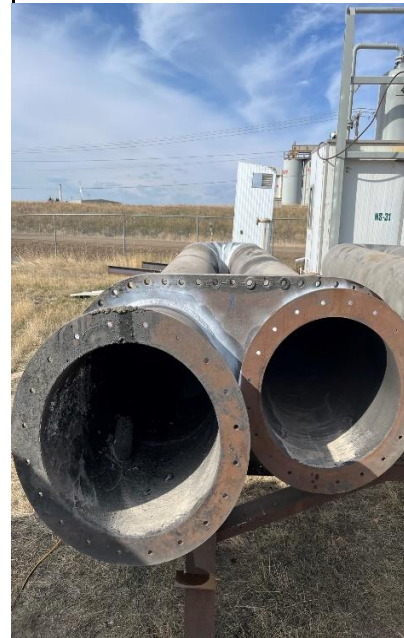
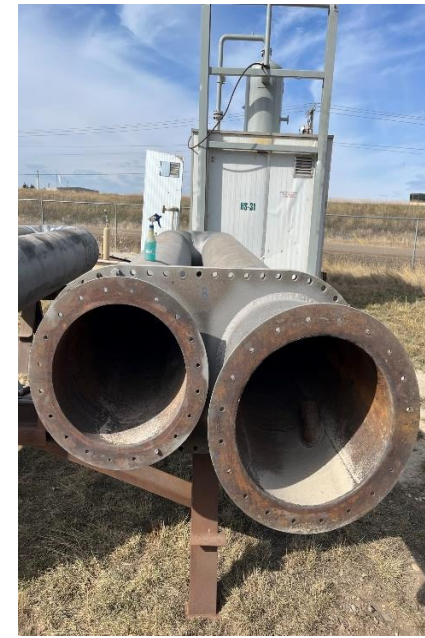
FIRE TUBES:

Crack on pipe to mounting flange at the 9 to 12 O'clock position & crack on miter at the 9 O'clock position

PREFORMED MAG PARTICAL INSPECTION ON ALL PROCESS WELDS AND AREAS OF INTEREST OF FIRE TUBES 'A' AND 'B'.
