MURCO RIG 58 SURVEY

18780953-REP
January 16, 2023

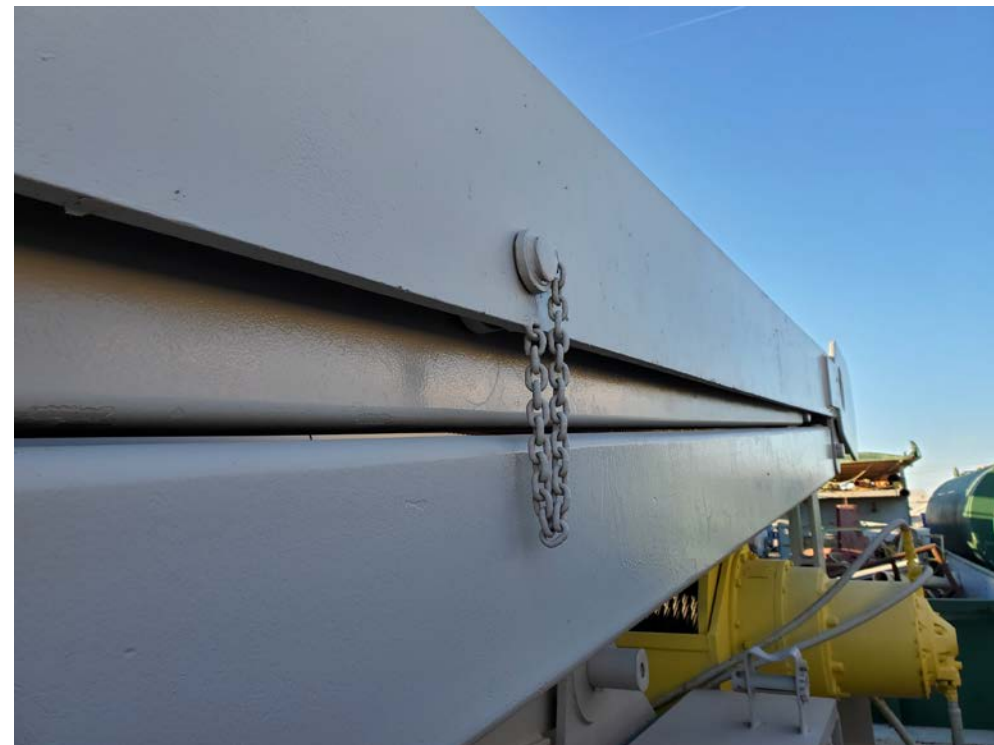
GIN POLE LEGS ARE BOWED UP AND THE COUNTER BRACES ARE BOWED DOWN AROUND A PIN IN THE CENTER. I CANNOT DETERMINE IF THE LEGS WILL BE LIKE THIS PERMANENTLY OR IF THEY WILL RETURN TO NORMAL AFTER THE LOAD IS RELEASED. THREE OF THE FOUR LEGS ARE JUST BOWED UP AND ONE IS BOWED UP AND TWISTED DUE TO AN INCORRECT PIN BEING USED AND THE PIN TAPER IS IN THE WAY. I FEEL LIKE THIS WAS CAUSED BY THE IMPROPER RIG DOWN OF THE GIN POLE LEGS.

- The substructure gin pole legs are bowed up and the counter braces are bowed down around a pin in the center. I cannot determine if the legs will be like this permanently or if they will return to normal after the load is released. Three of the four leg are just bowed up and one is bowed up and twisted due to a incorrect pin being used, and the taper is in the way. I feel like this was caused by the improper rig down on the gin pole legs.

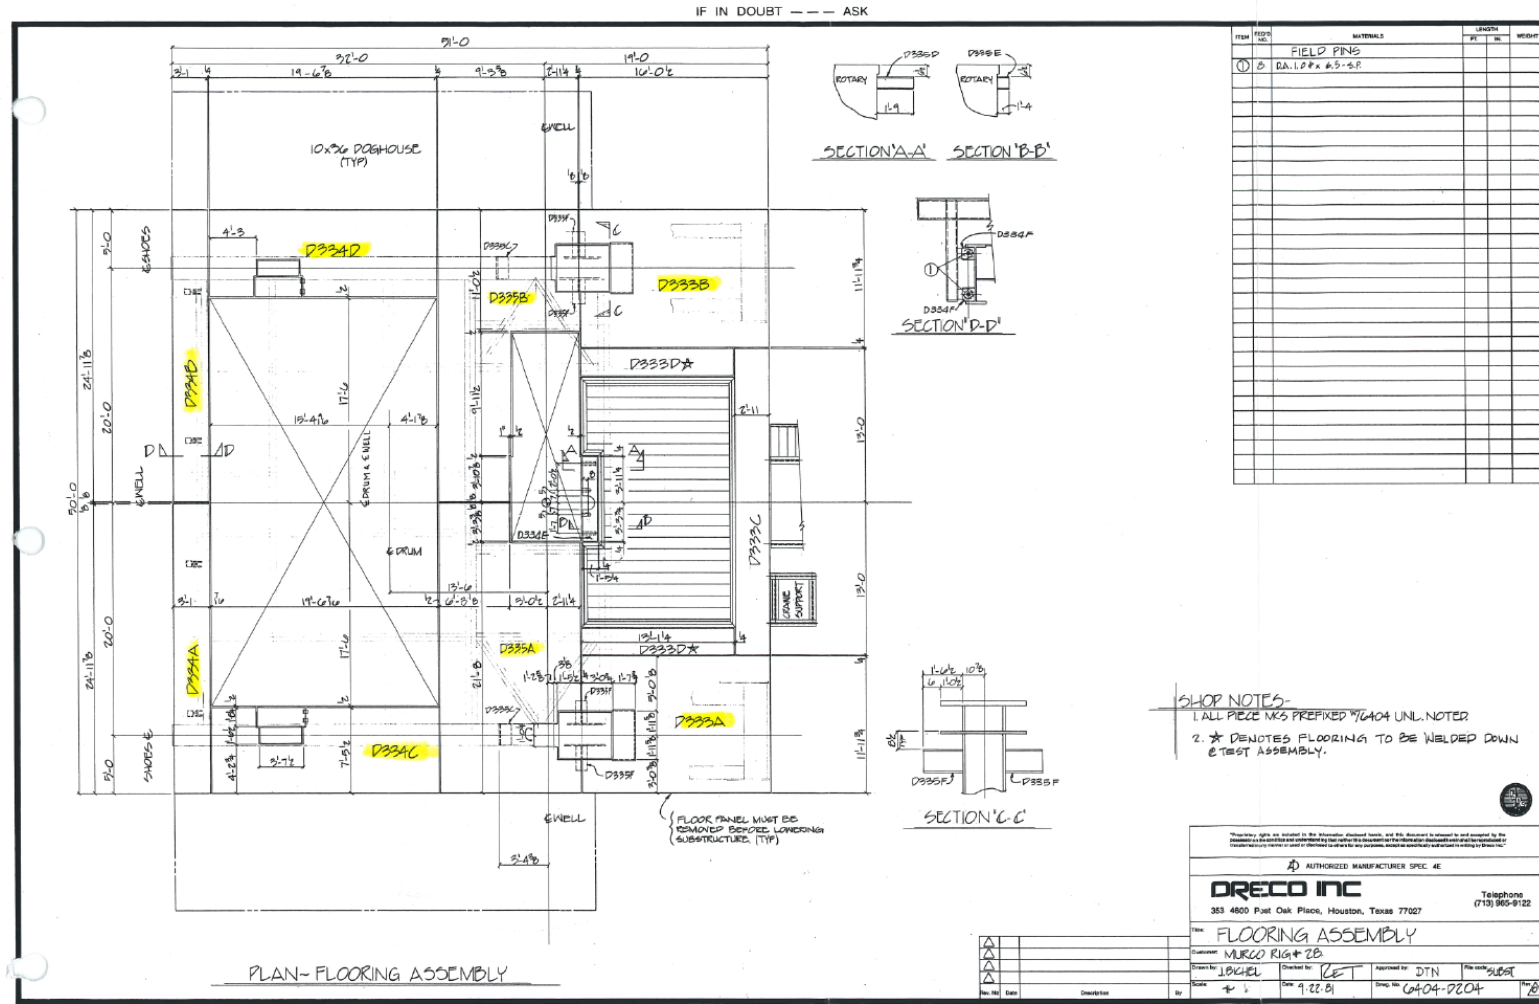
SUBSTRUCTURE FLOORING ASSEMBLY

- Most of the floor panels are there, all the larger pieces as marked in yellow on the flooring assembly .
- The mast pin on windwalls were there in a shipping frame. I am not sure if they all there or the real condition, but they seemed complete and decent condition.
