**FOX RIVER
HOUSATONIC, MASS. 01236**

SUCTION COUCH ROLL (NEW SHELL)

"AS SHIPPED REPORT"

September 16, 2005

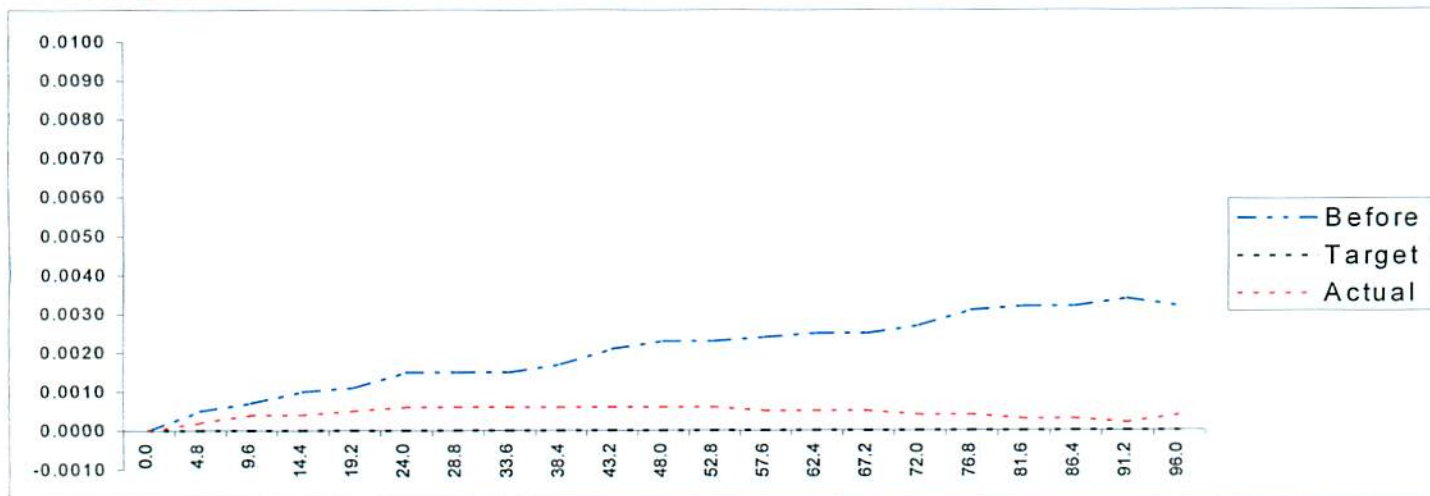
Description: Manchester Suction Couch Roll with new S/S shell

Station	Before	Target	Actual
DS	0.0	0.0000	0.0000	0.0000
	4.8	0.0005	0.0000	0.0002
	9.6	0.0007	0.0000	0.0004
	14.4	0.0010	0.0000	0.0004
	19.2	0.0011	0.0000	0.0005
	24.0	0.0015	0.0000	0.0006
	28.8	0.0015	0.0000	0.0006
	33.6	0.0015	0.0000	0.0006
	38.4	0.0017	0.0000	0.0006
CL	43.2	0.0021	0.0000	0.0006
	48.0	0.0023	0.0000	0.0006
	52.8	0.0023	0.0000	0.0006
	57.6	0.0024	0.0000	0.0005
	62.4	0.0025	0.0000	0.0005
	67.2	0.0025	0.0000	0.0005
	72.0	0.0027	0.0000	0.0004
	76.8	0.0031	0.0000	0.0004
	81.6	0.0032	0.0000	0.0003
TS	86.4	0.0032	0.0000	0.0003
	91.2	0.0034	0.0000	0.0002
	96.0	0.0032	0.0000	0.0004
