Final Report

Client name:	Verso paper - Duluth
Title:	Valve inspection
Job Number:	517700
Date:	5-14-15

JOB TYPE: *Valve inspection*

UNIT TYPE	Condensing Turbine
MODEL & RATING	Turbodyne/Dresser Rand
INSPECTION TYPE	Valve
TURBINE SERIAL NUMBER	37769
CONTROL SYSTEM	Woodward 505
LOAD TYPE	Generator
GEARBOX MODEL	Lufkin N2400C
GEARBOX SERIAL NUMBER	4595
STEAM CONDITIONS INLET PSI	820
INLET TEMPERATURE	720 F
TYPE OF OUTAGE	Planned
DATE UNIT OUT OF SERVICE	5-14-15
DATE UNIT RETURNED TO SERVICE	5-29-15

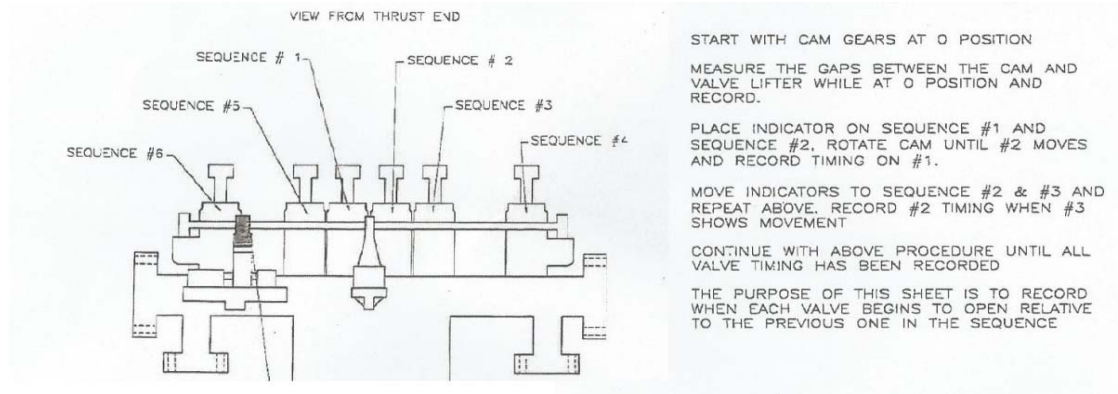
TIMING OF VALVES

Sequence 1	Sequence 2	Sequence 3	Sequence 4	Sequence 5
ACTUAL	0.397	0.323	0.313	0.309	0.373
DESIGN

Valve 1	Valve 2	Valve 3	Valve 4	Valve 5	Valve 6
0.083	0.08	0.088	0.09	0.074	0.082

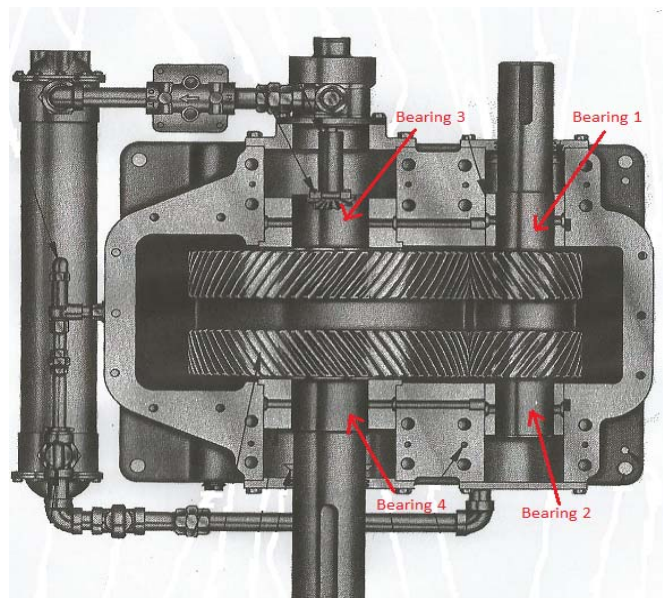
DISASSEMBLY	
DATE	5/30/2015

BEARING	LIFT
1	0.009
2	0.014
3	0.014
4	0.0125

THRUST	0.03
END FLOAT	0.086
BACK LASH	0.025

SEAL CLEARANCE	
	INPUT SHAFT	OUTPUT SHAFT
TOP	0.012	0.012
BOTTOM	0.002	0.012
LEFT	0.006	0.006
RIGHT	0.007	0.009

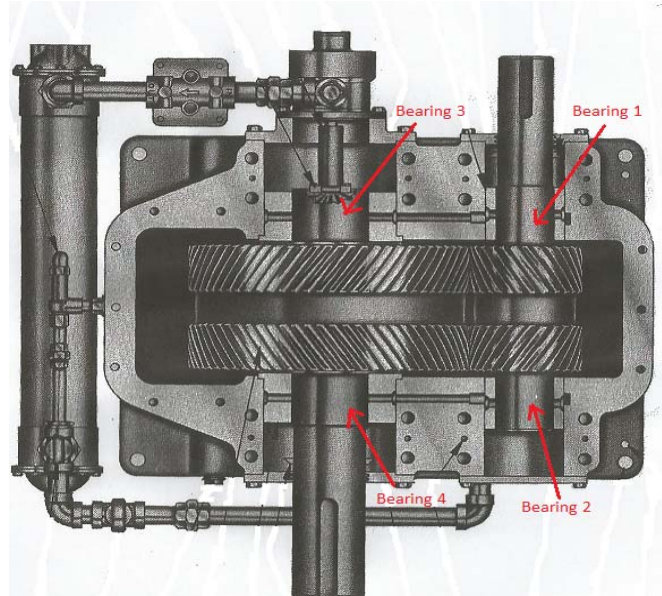
Reassembly	
DATE	5/30/2015

BEARING	LIFT
1	0.011
2	0.011
3	0.009
4	0.01

THRUST	0.015
END FLOAT	0.071
BACK LASH	0.018
