Varian E500 HP

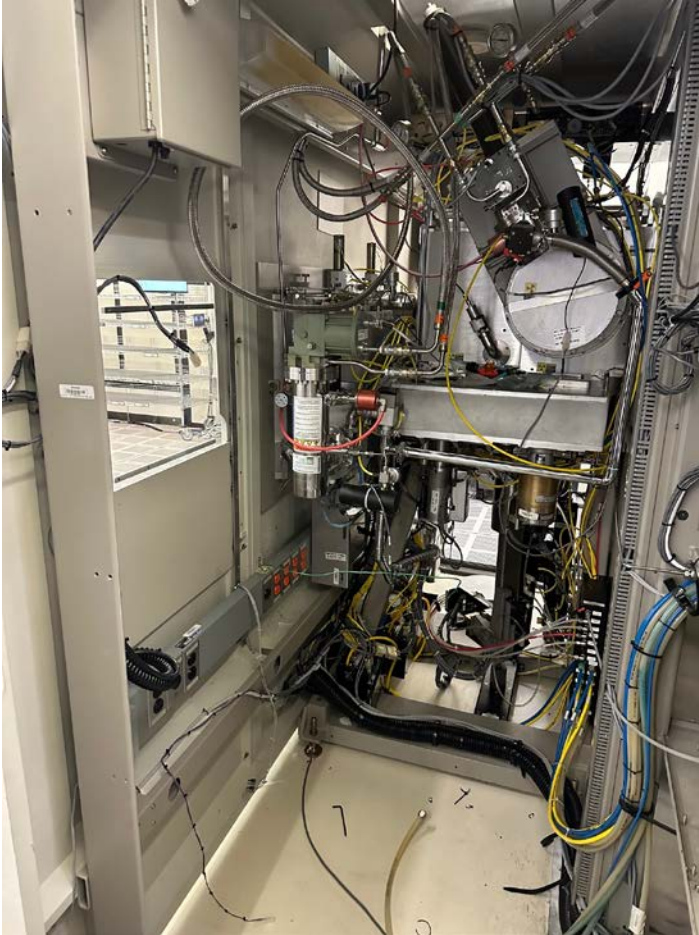
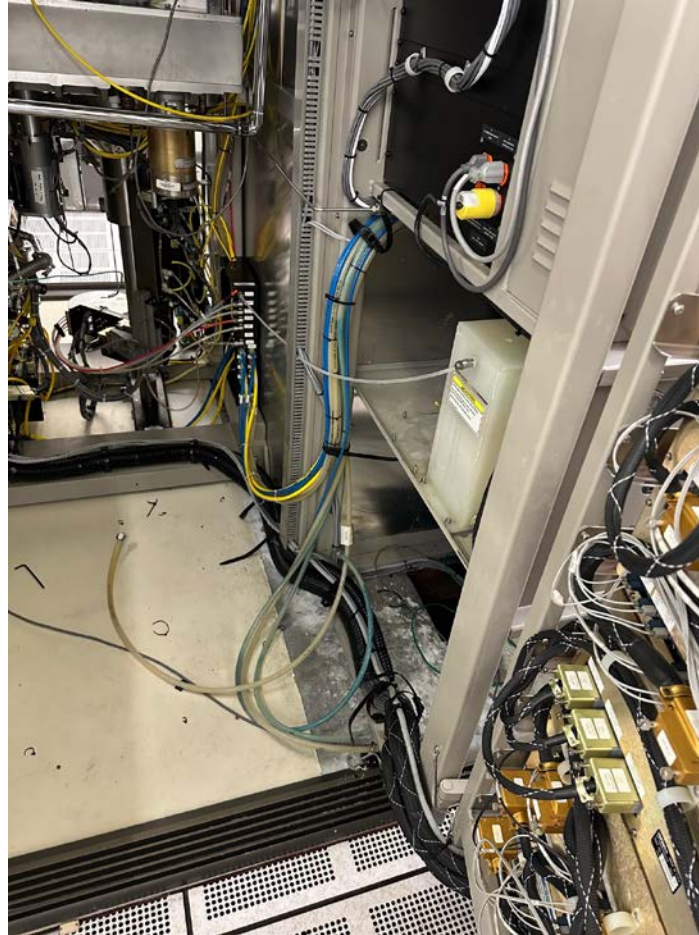
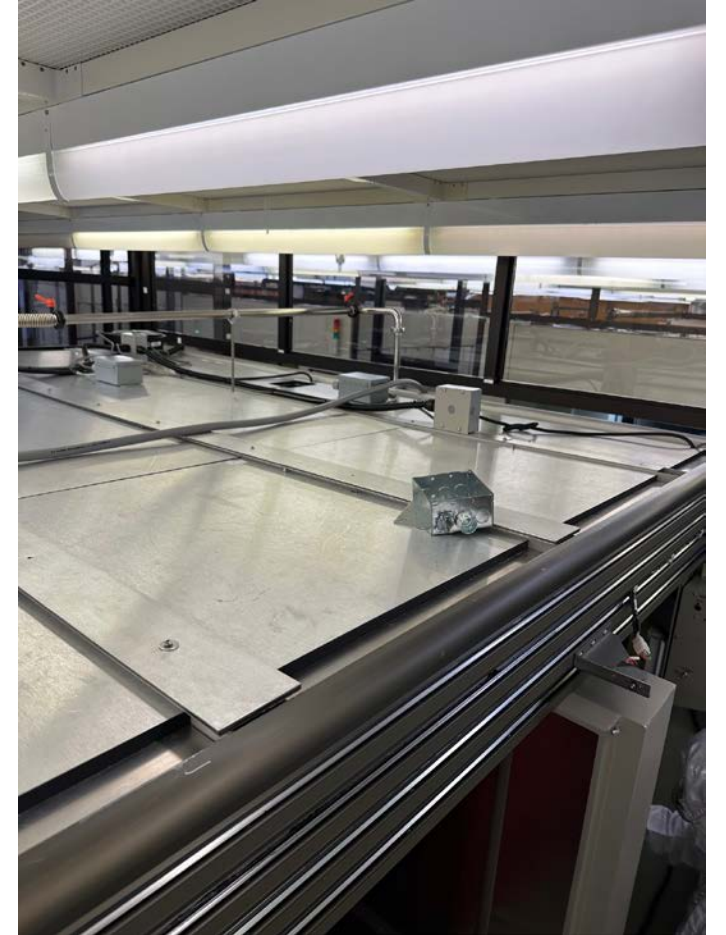
We then started the disassembly by removing all the fans, cabling and raceway power sockets from the roof.

We continued by removing the operators monitor and computer and all associated cabling.

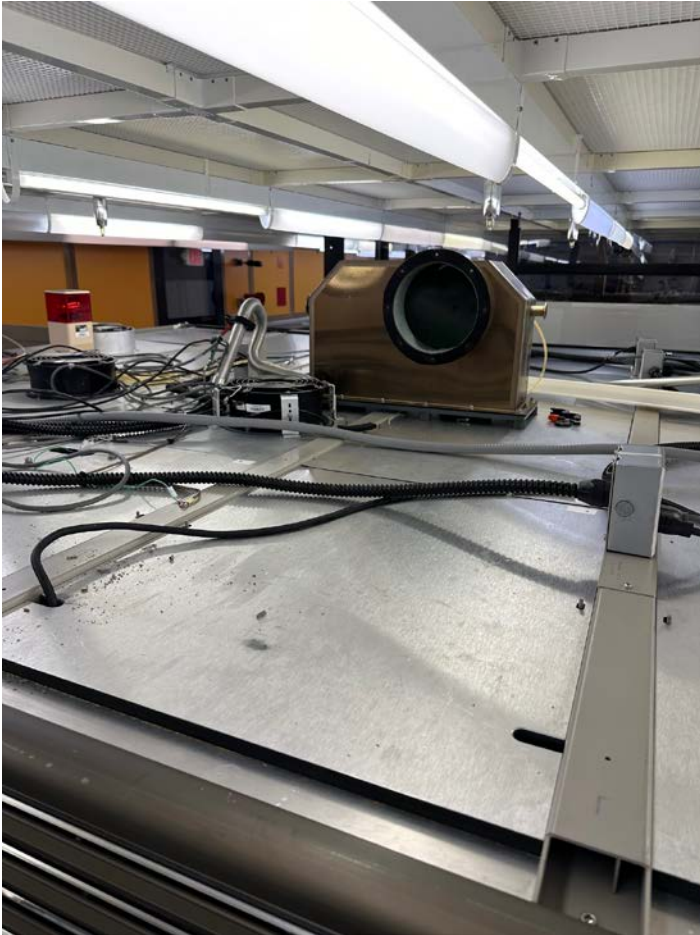
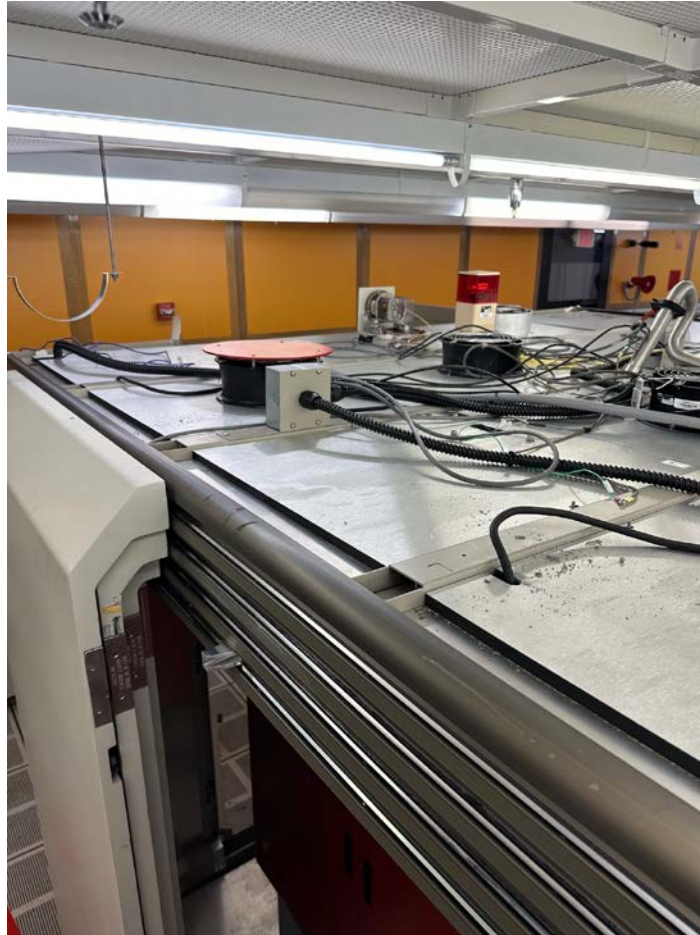
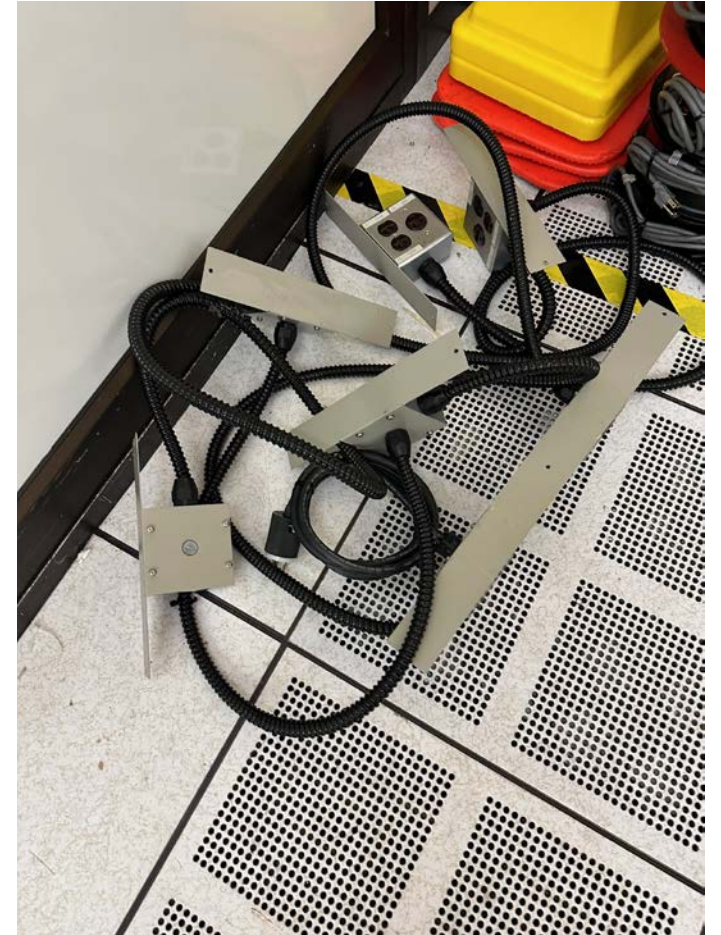
We then started the disassembly by removing all the fans, cabling and raceway power sockets from the roof.

We continued by removing the operators monitor and computer and all associated cabling (2)

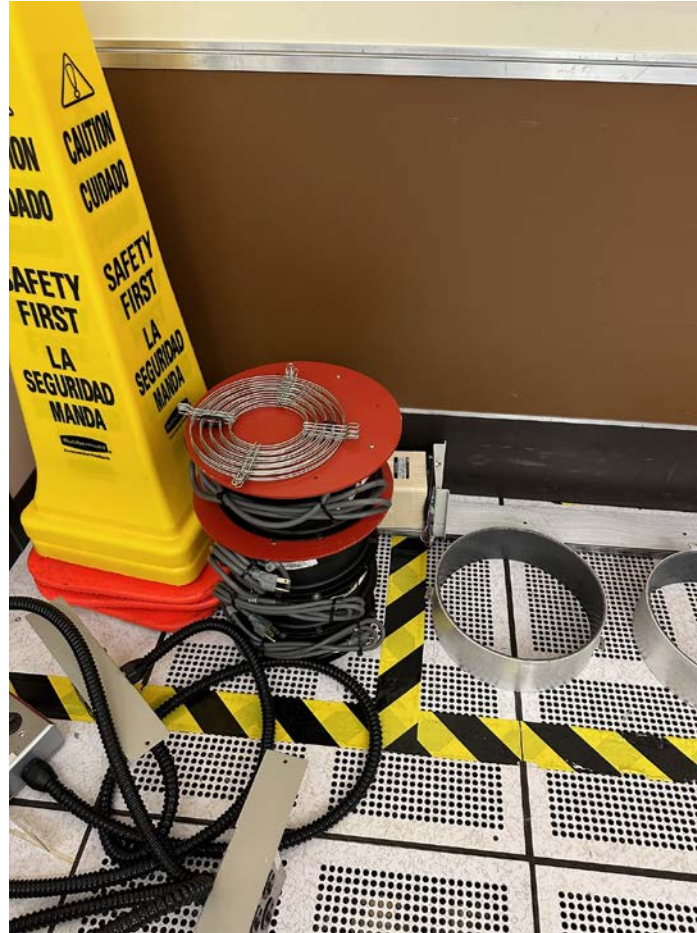
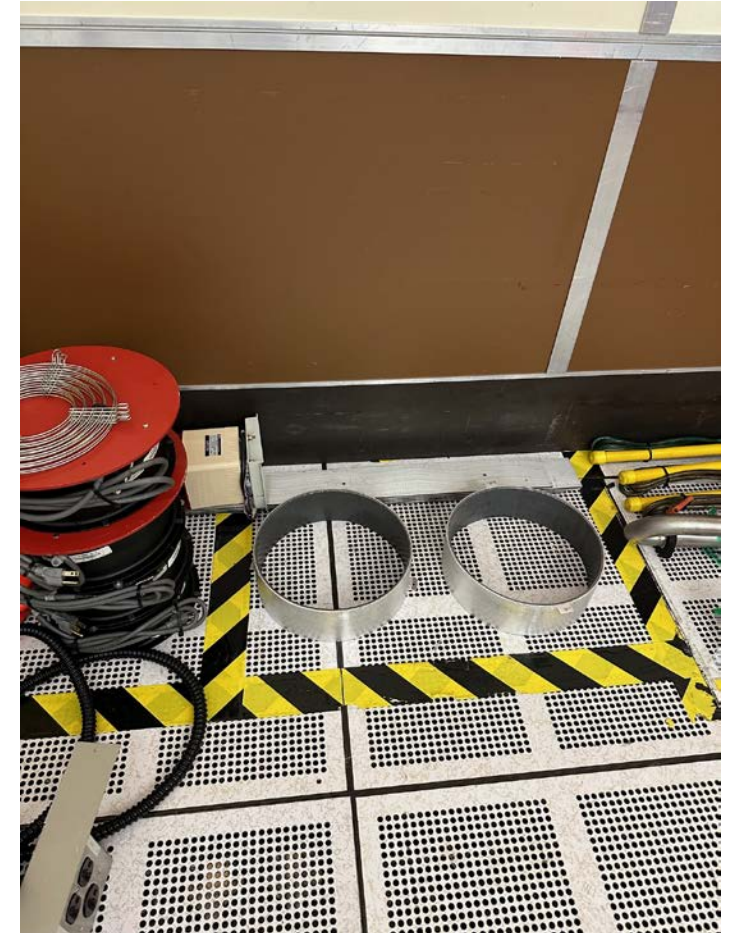
We then started the disassembly by removing all the fans, cabling and raceway power sockets from the roof.

We continued by removing the operators monitor and computer and all associated cabling (3)

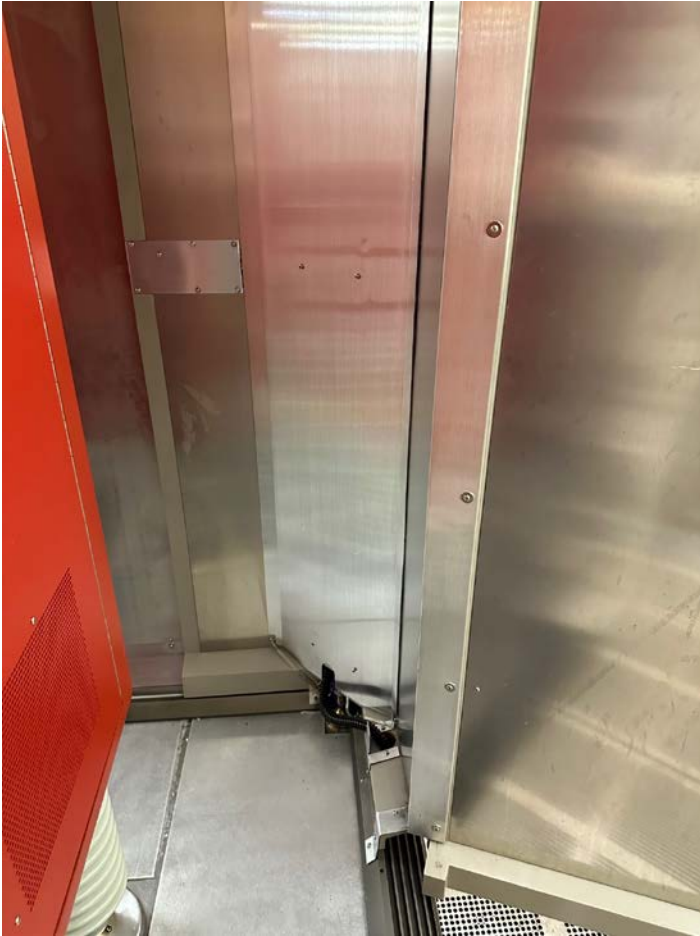
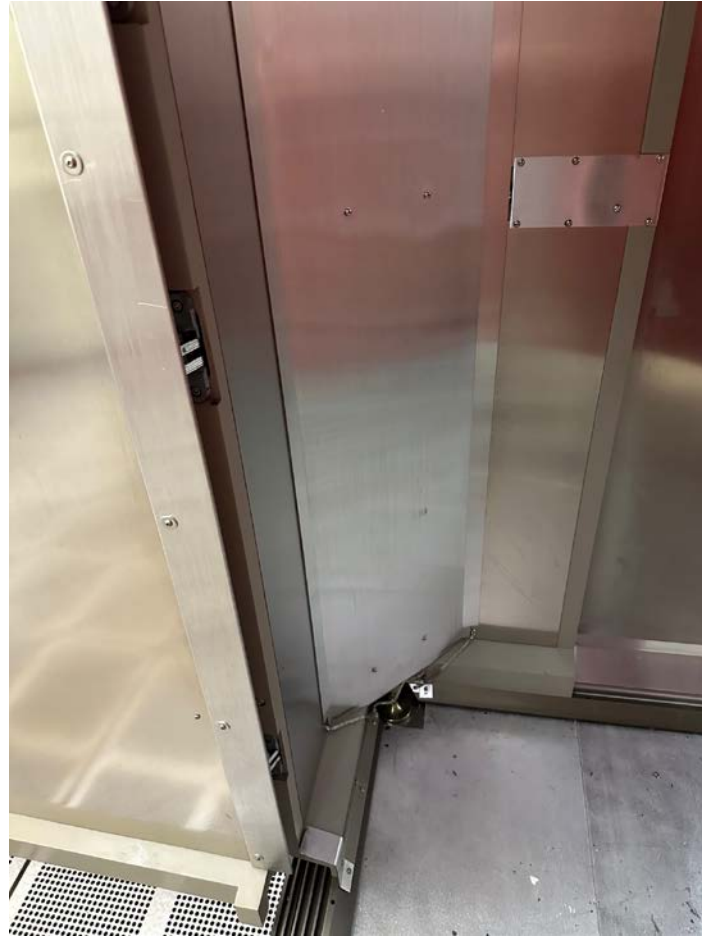
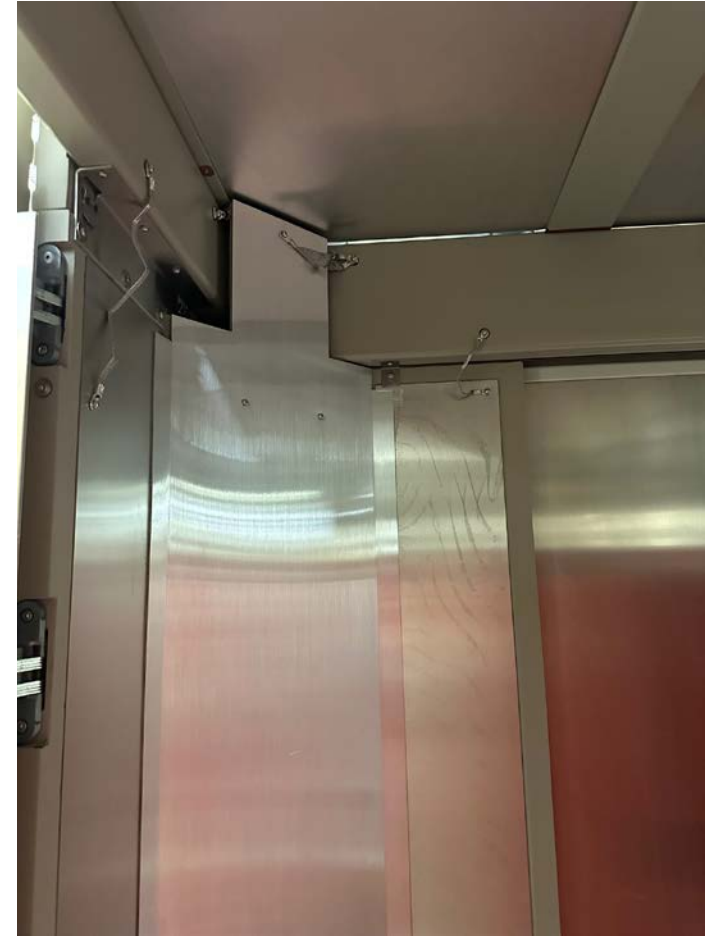
Enclosure internal lead shielding and grounding drop bars were removed

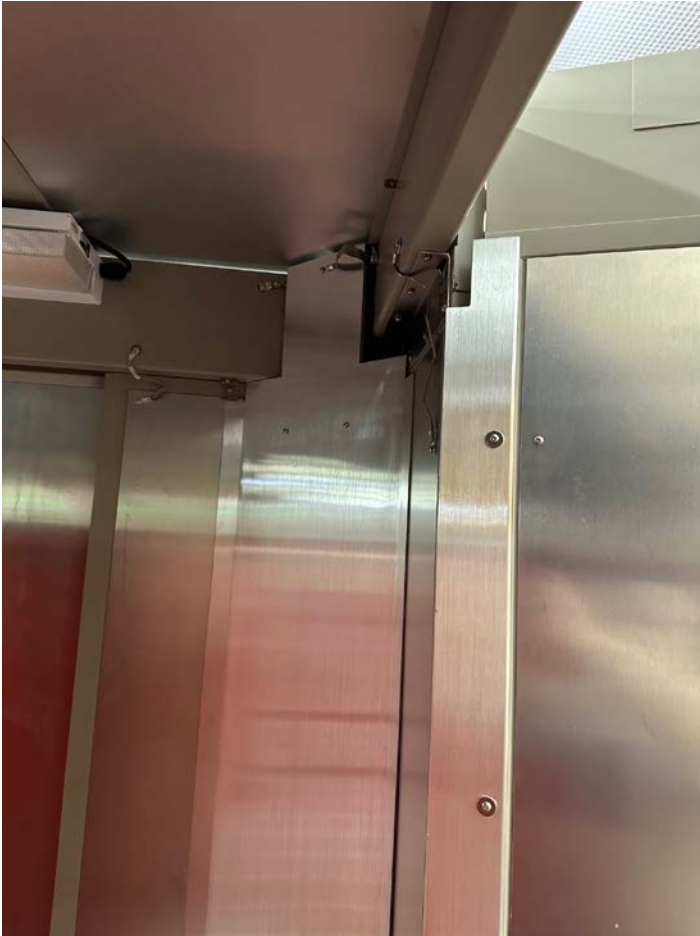
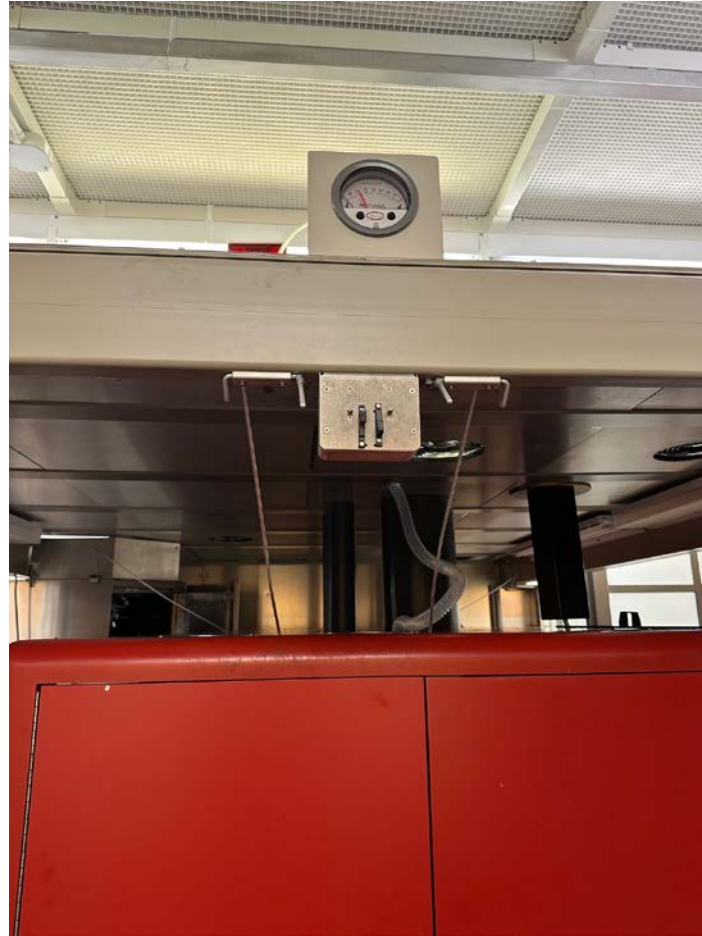
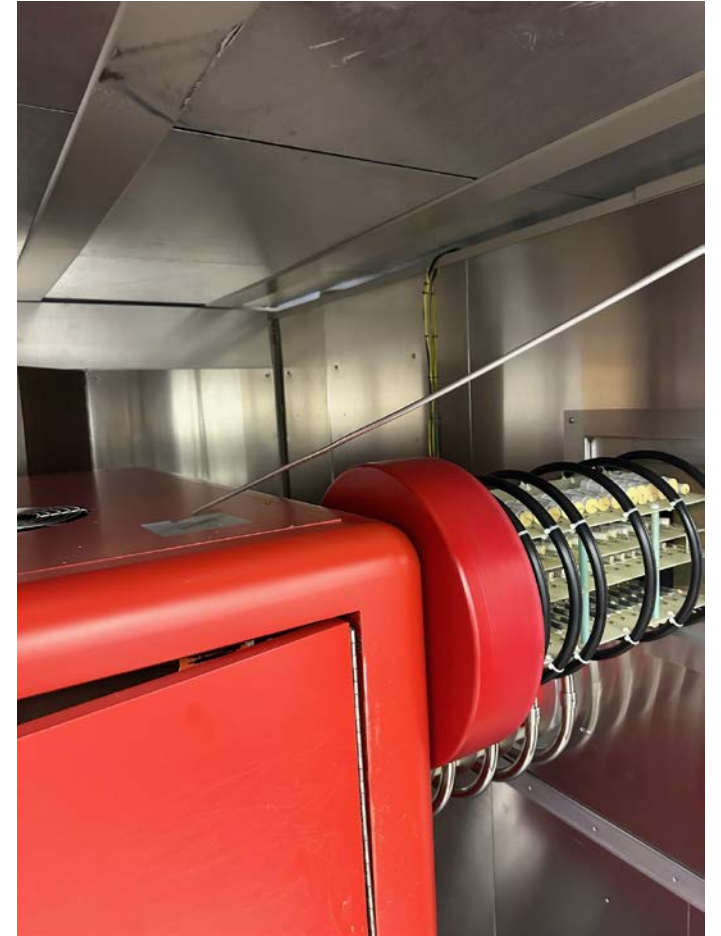
Enclosure internal lead shielding and grounding drop bars were removed (2)

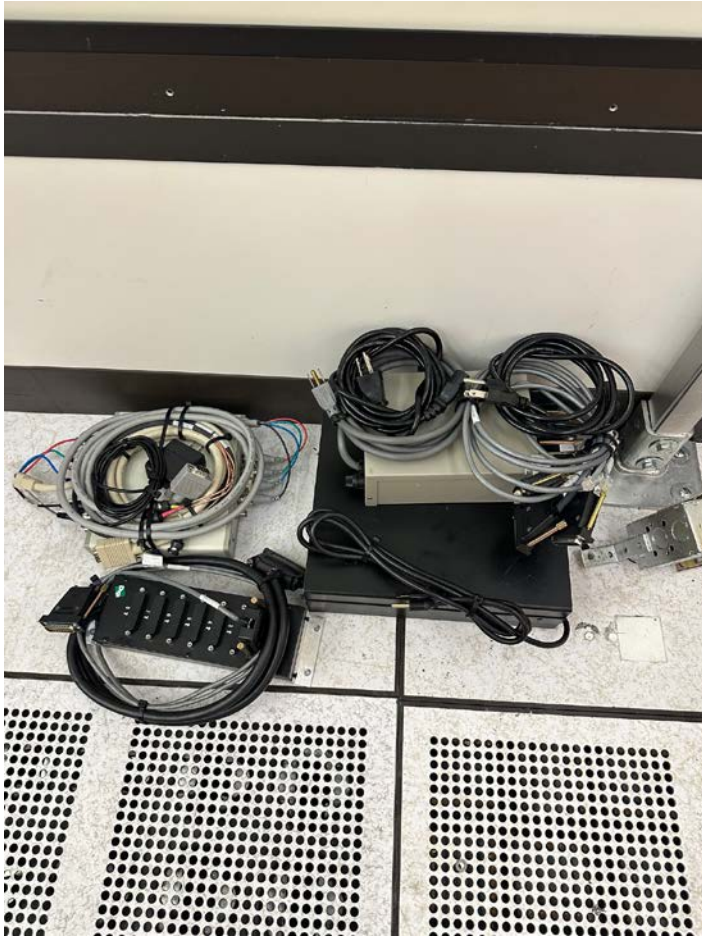
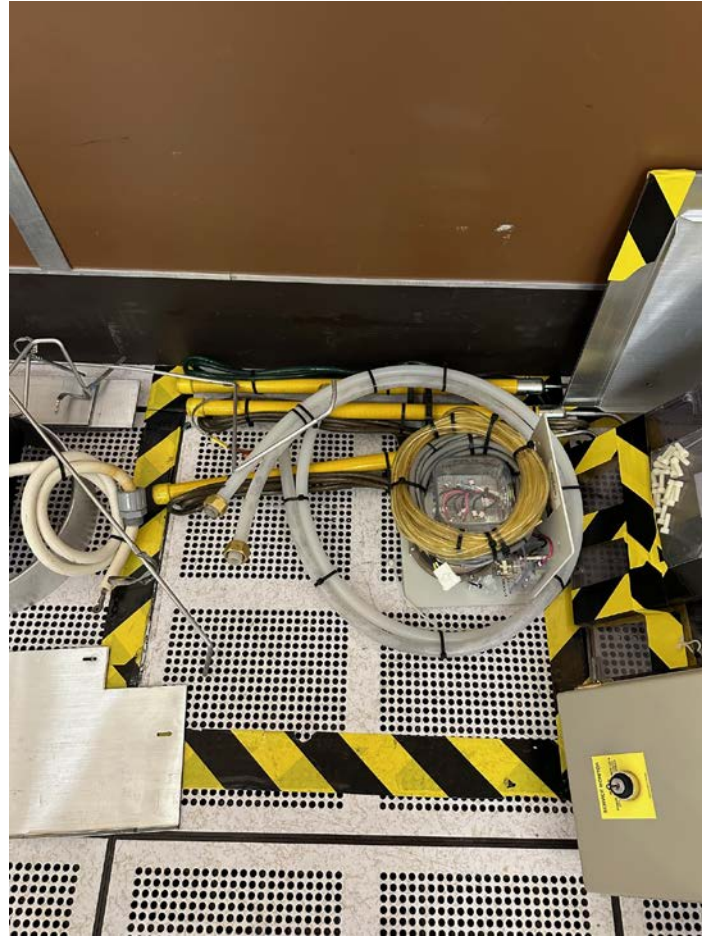
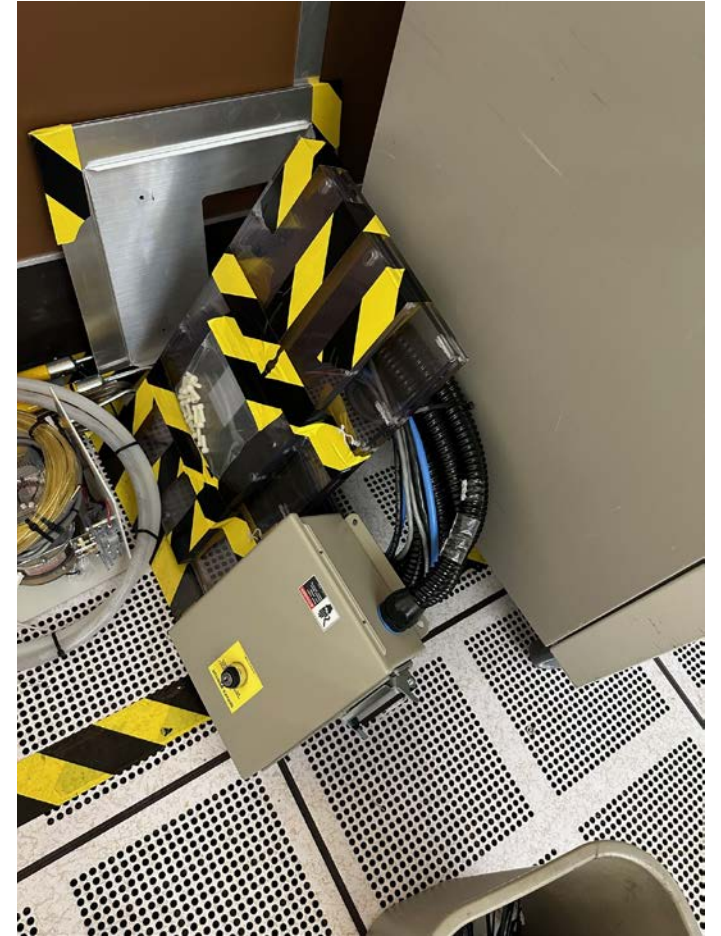
Smaller items were placed into plastic tote boxes

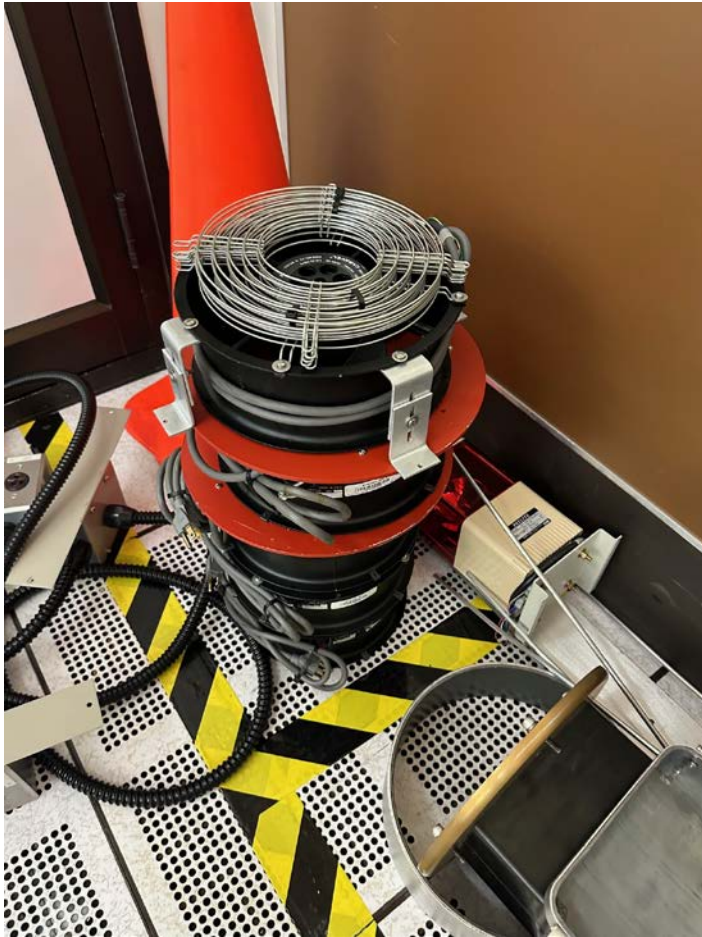
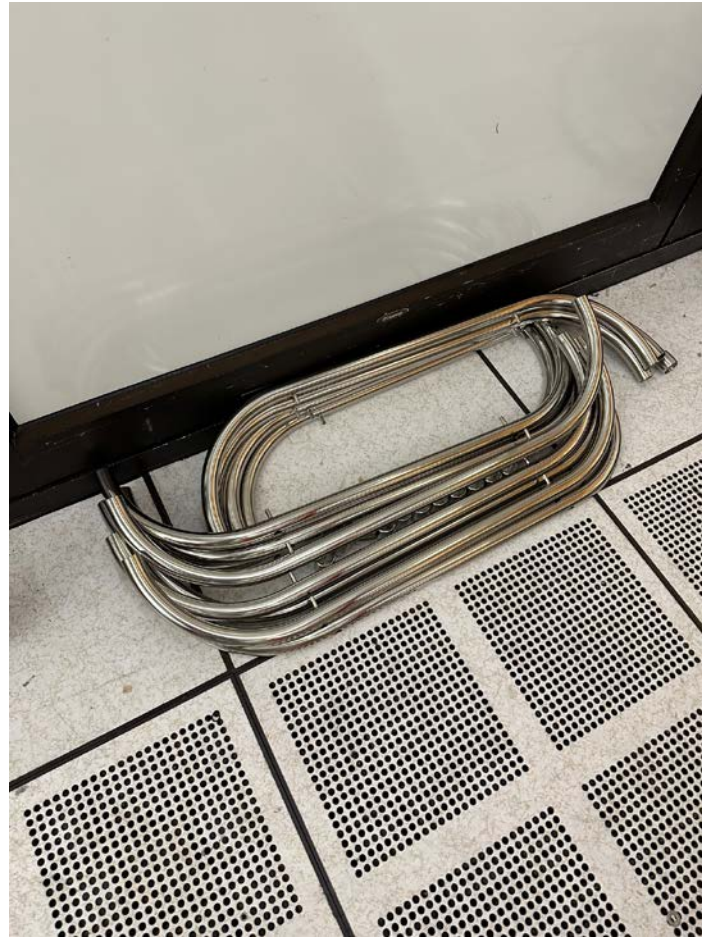
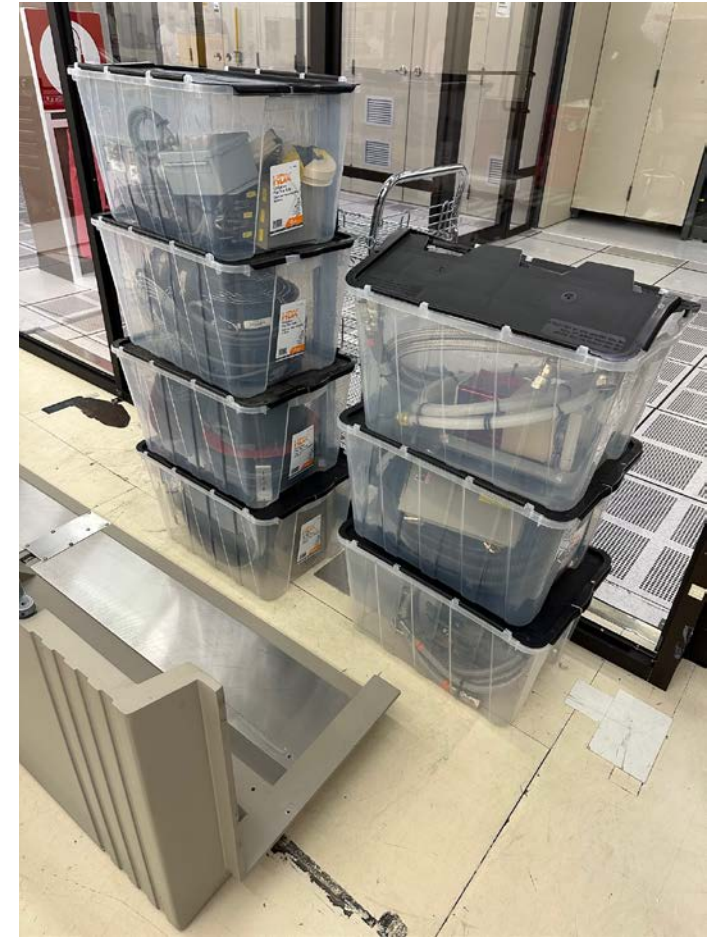
Smaller items were placed into plastic tote boxes (2)

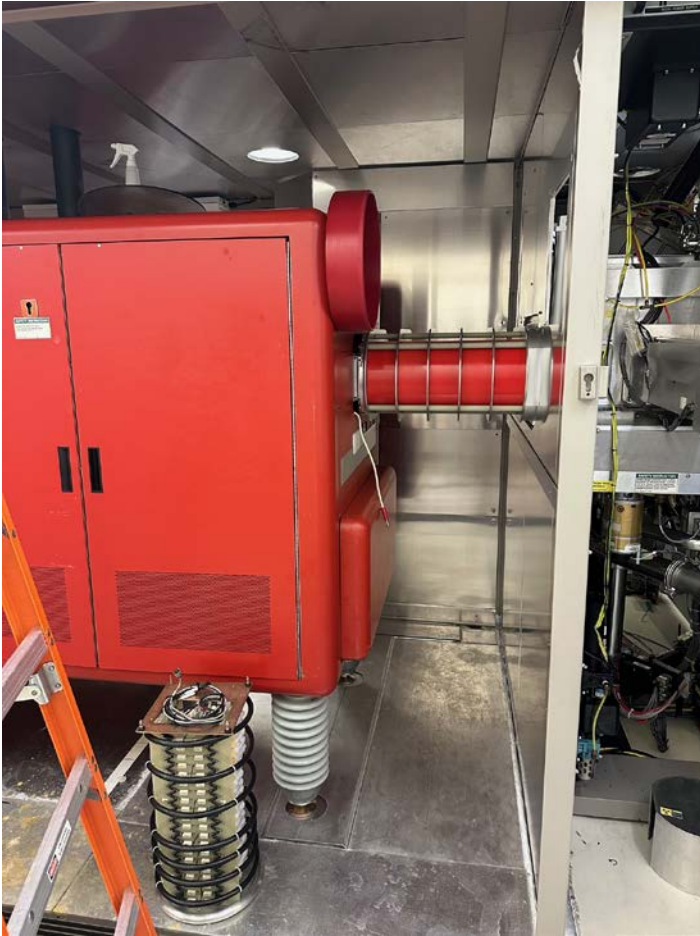
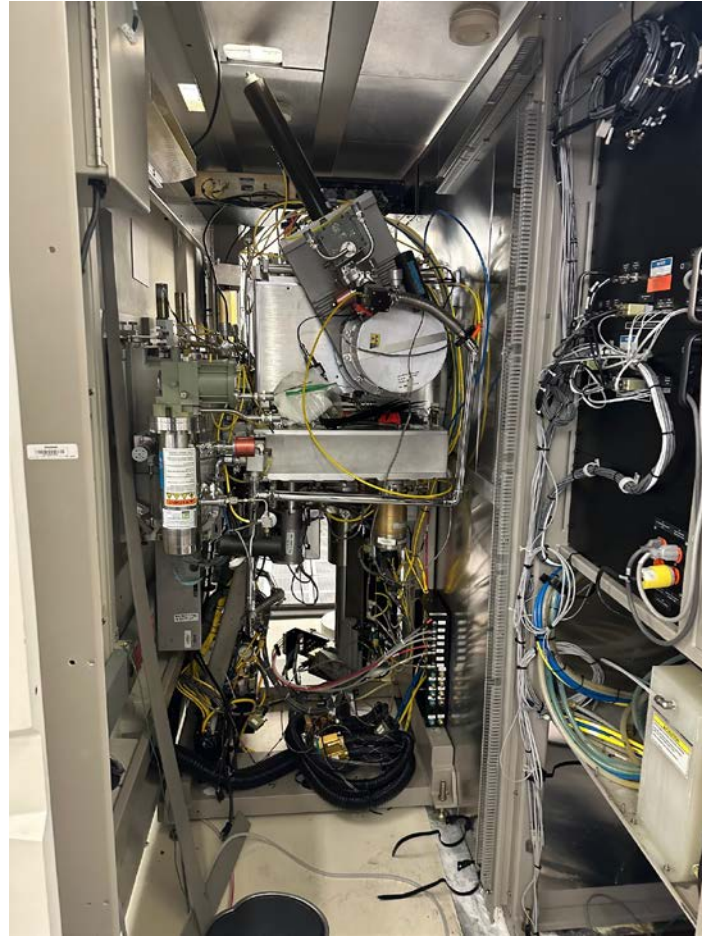
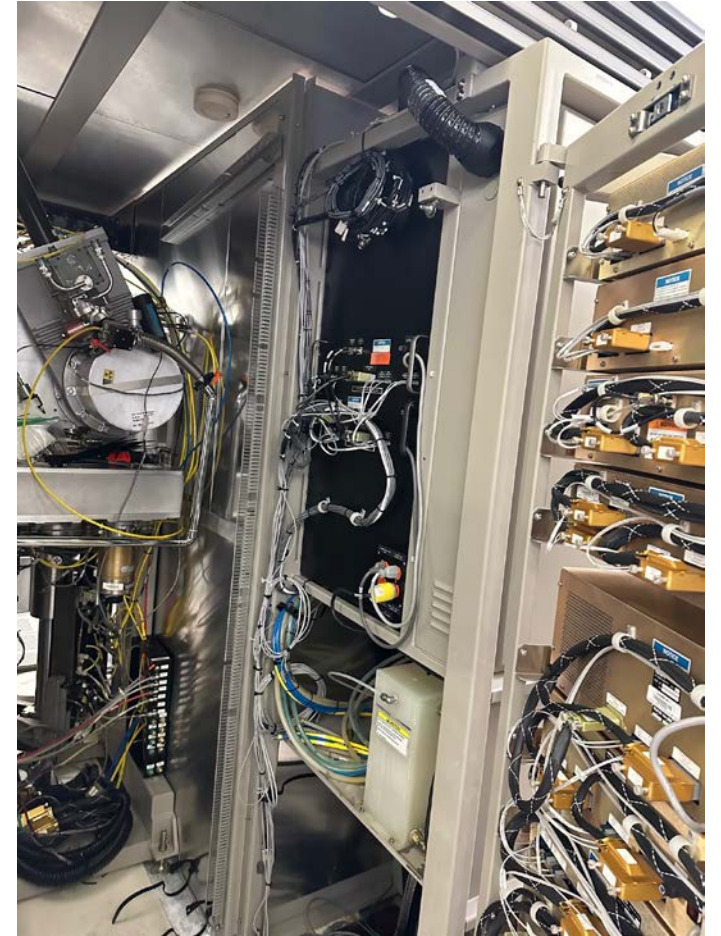
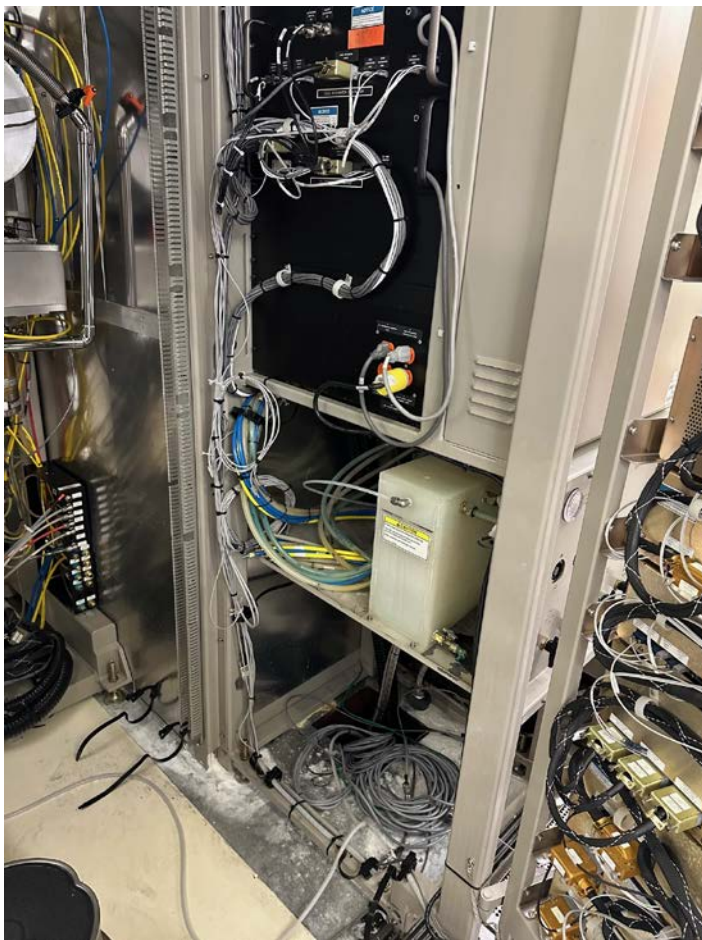
All internal disconnects were removed to separate the end station to the facilities module and neatly cable tied for transit.

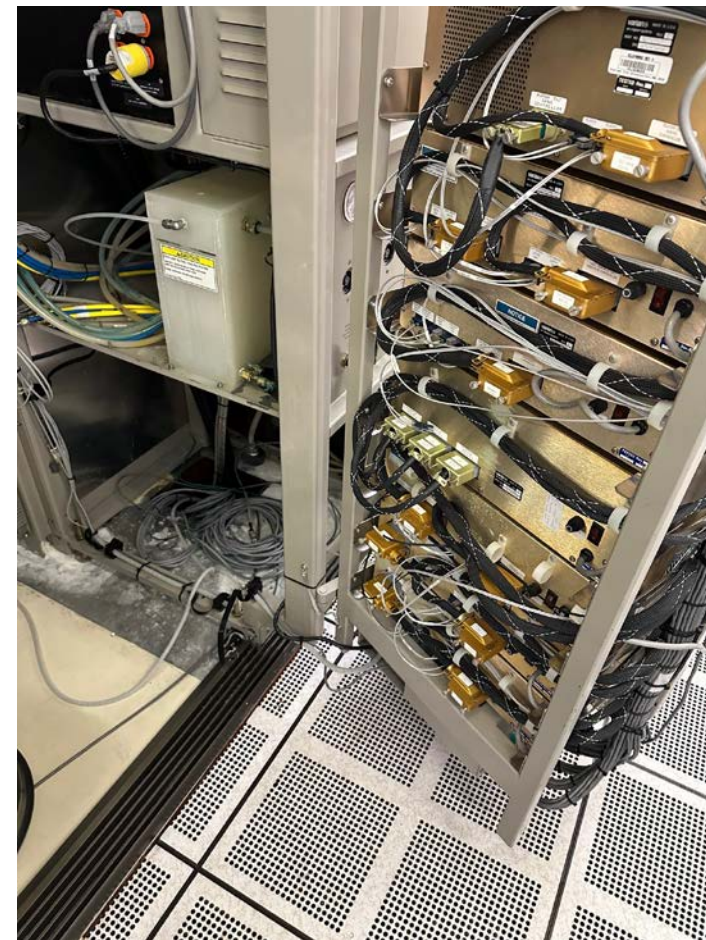
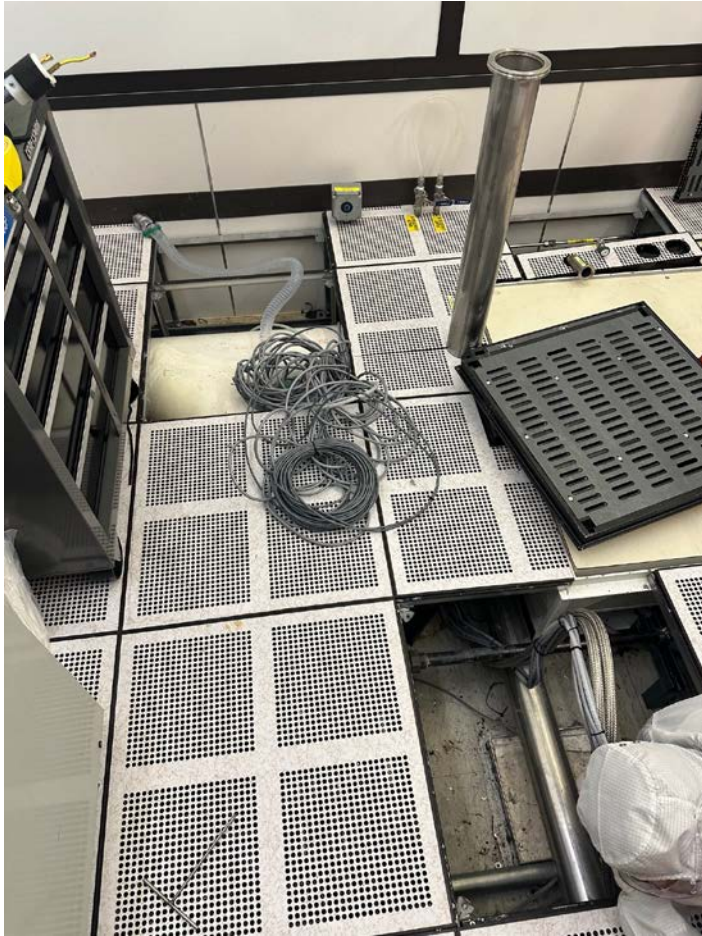
All internal disconnects were removed to separate the end station to the facilities module and neatly cable tied for transit. (2)

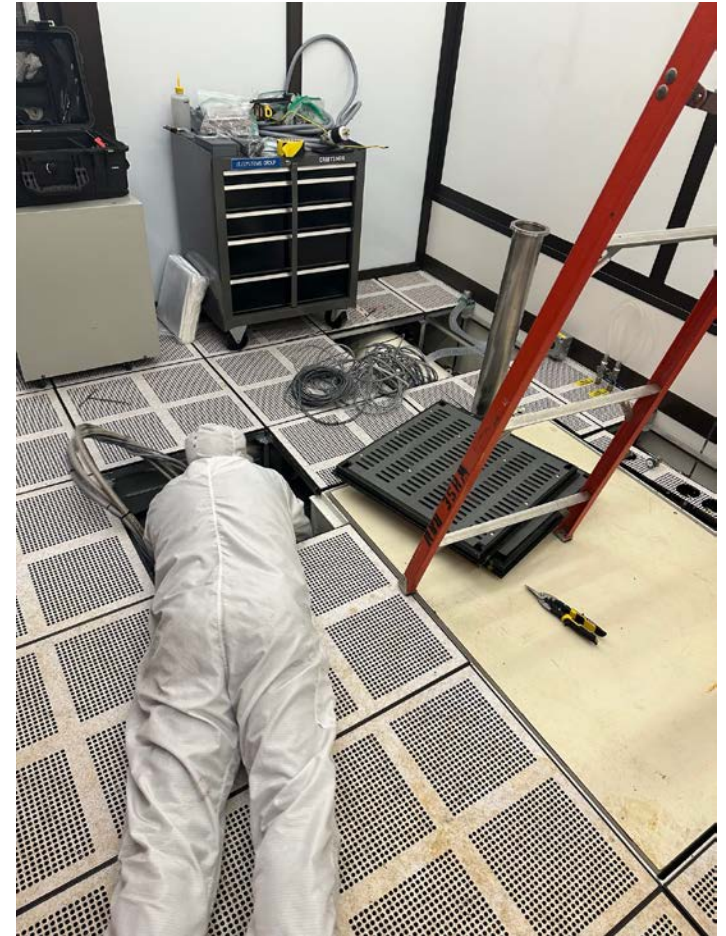
All internal disconnects were removed to separate the end station to the facilities module and neatly cable tied for transit. (3)

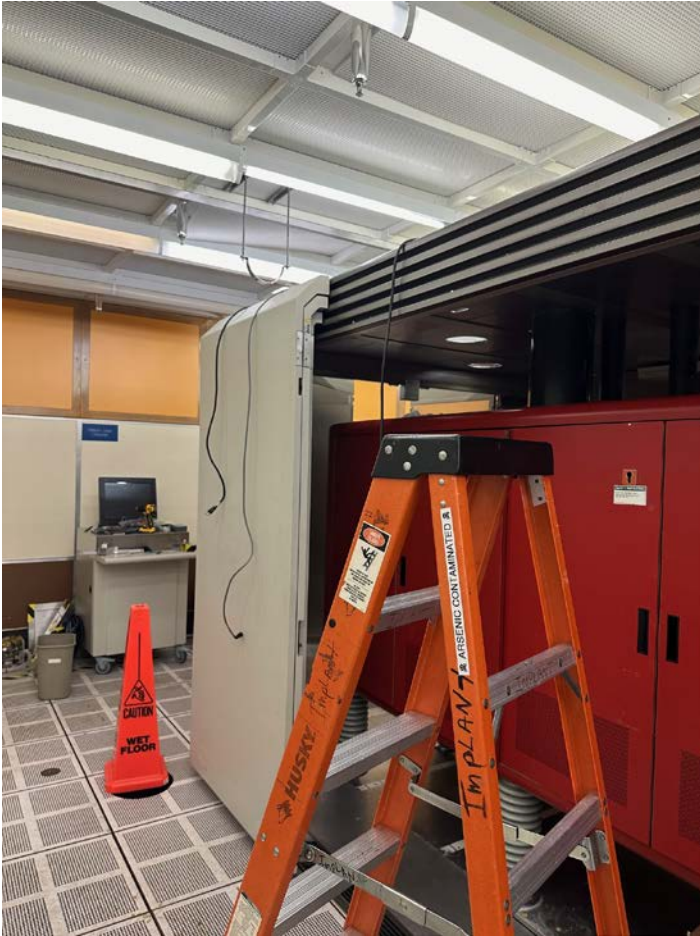
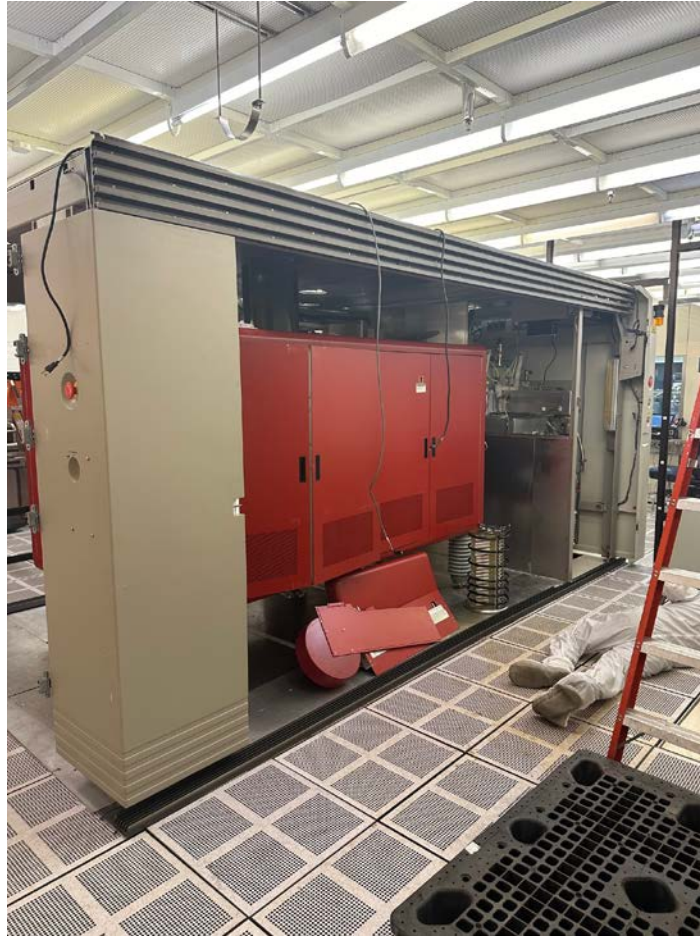
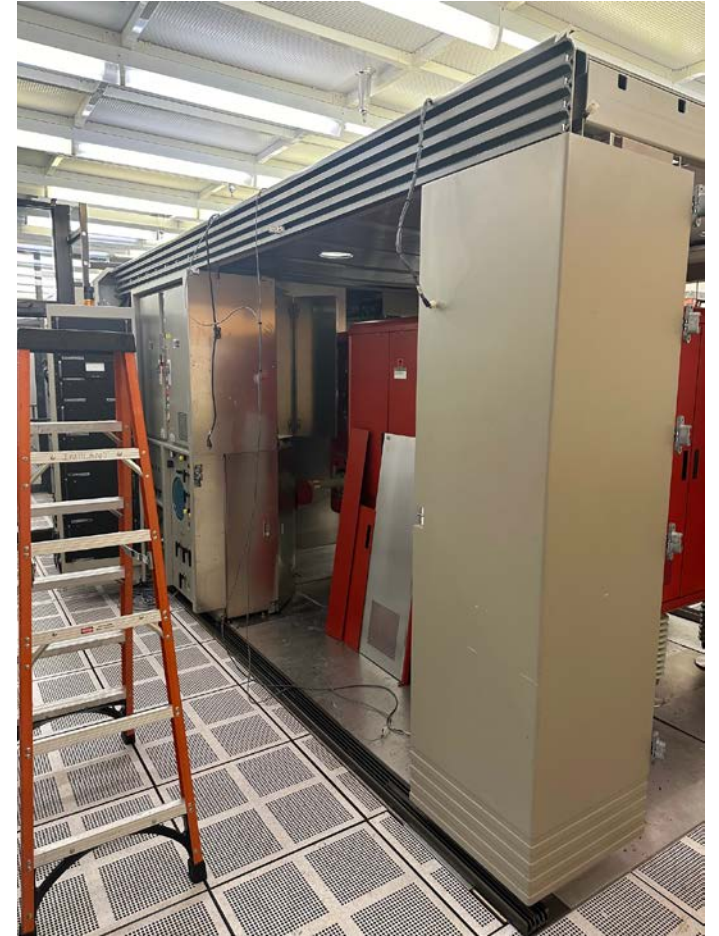
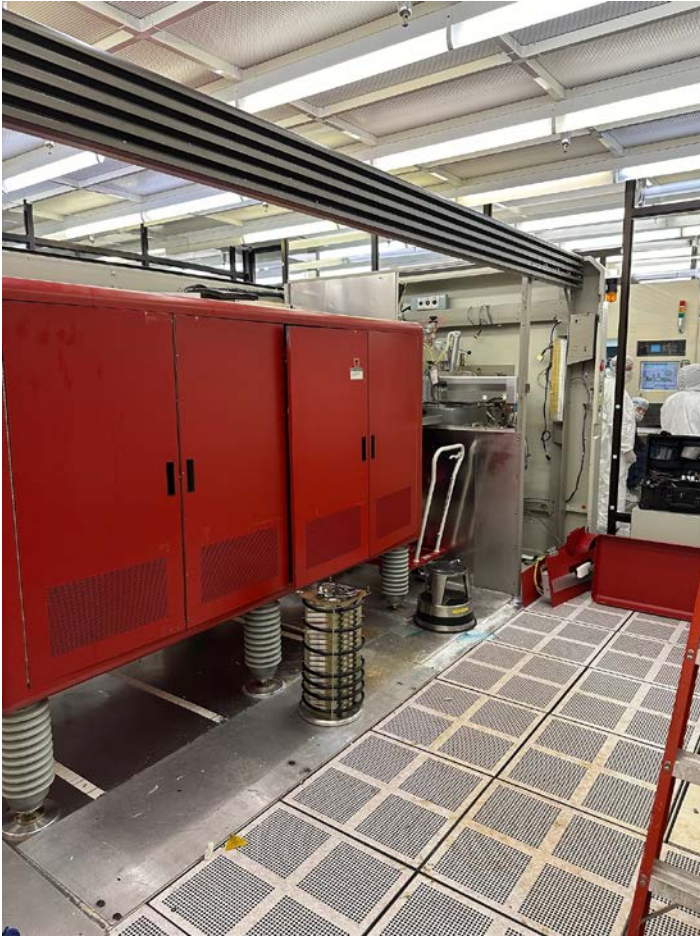
With the help from the riggers, we removed the enclosure doors, roof panels, roof truss sections and enclosure corner sections

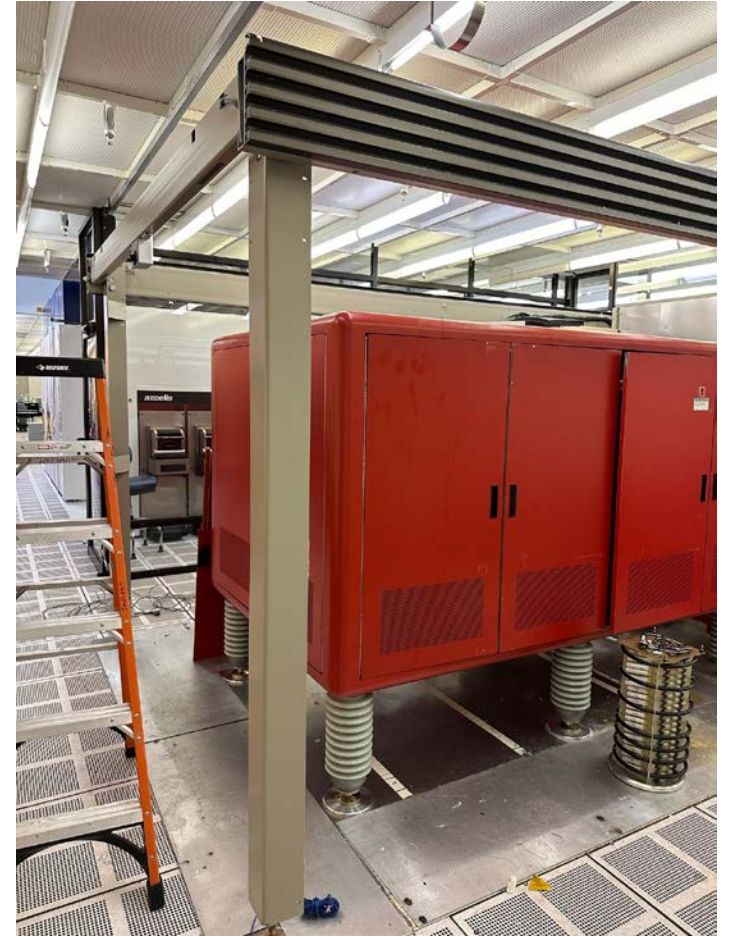
With the help from the riggers, we removed the enclosure doors, roof panels, roof truss sections and enclosure corner sections. (2)
