Varian E500 HP

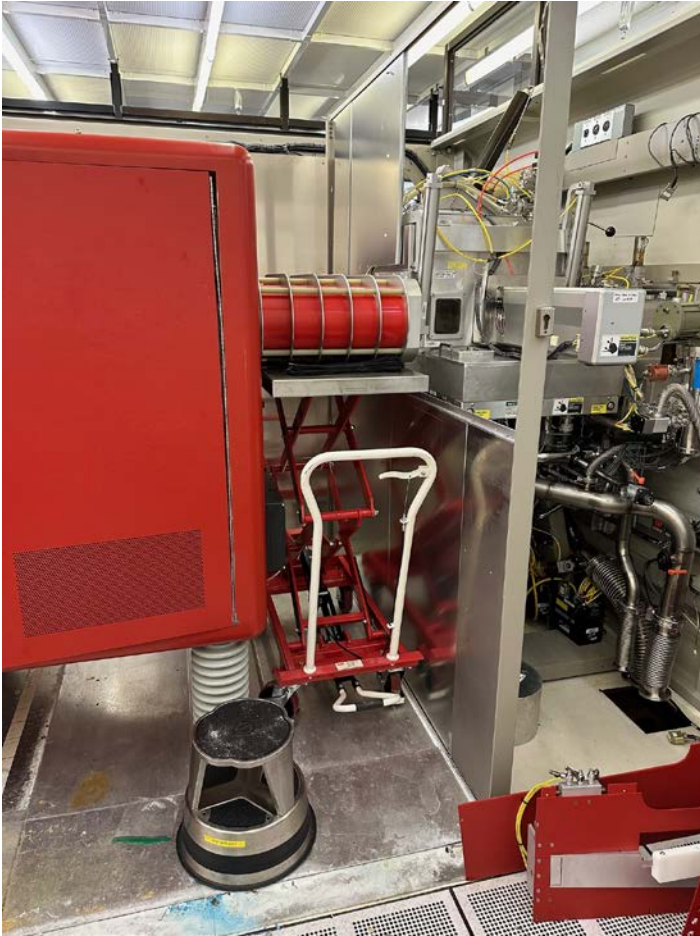
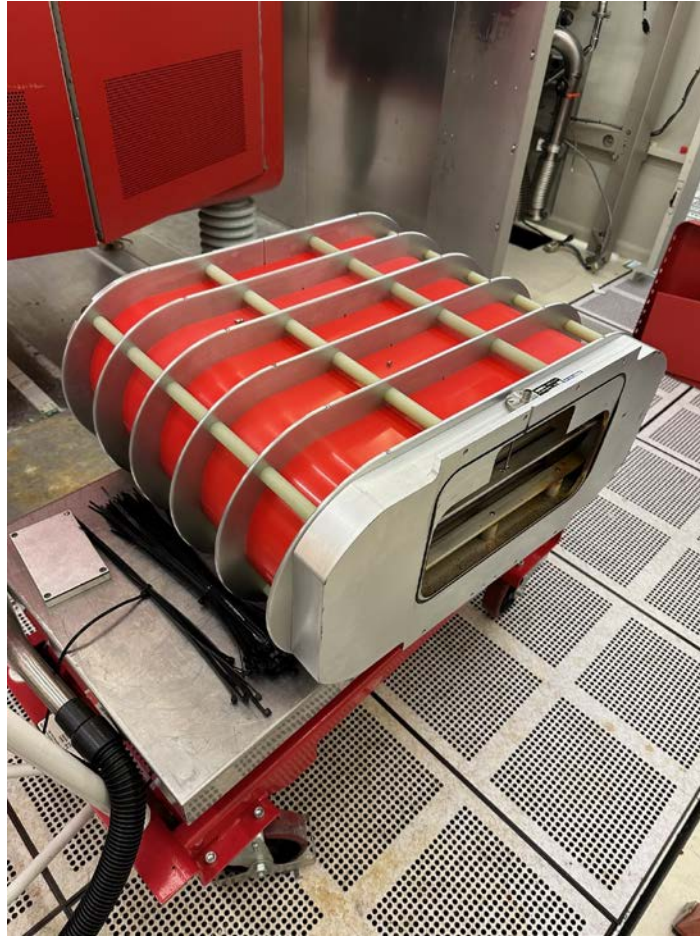
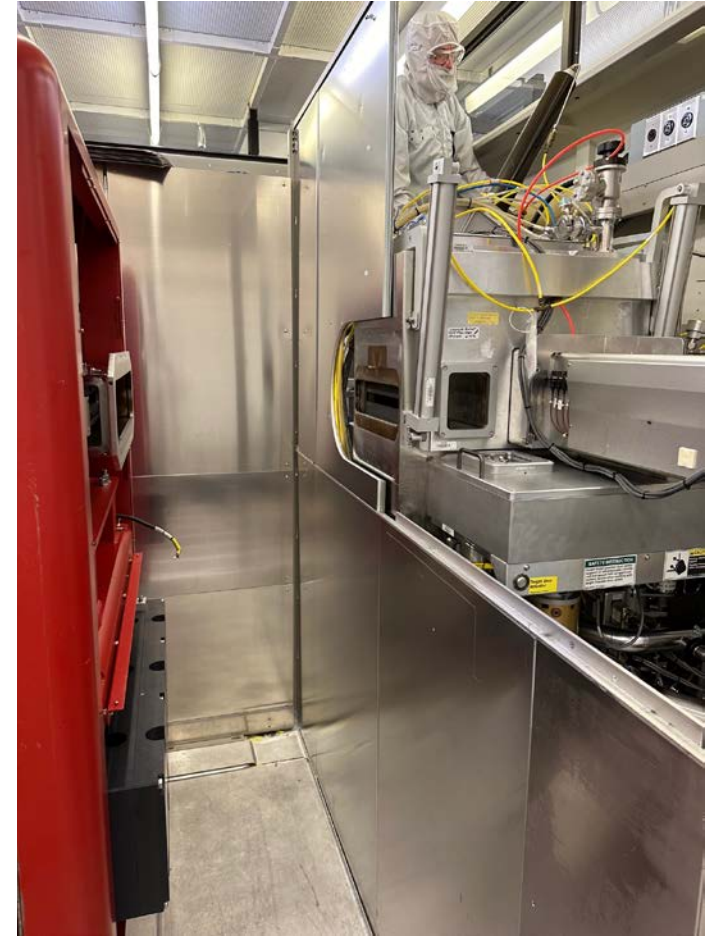
Accel column was then prepped for removal

Using a hydraulic lifting table, we then continued to remove the Accel column.

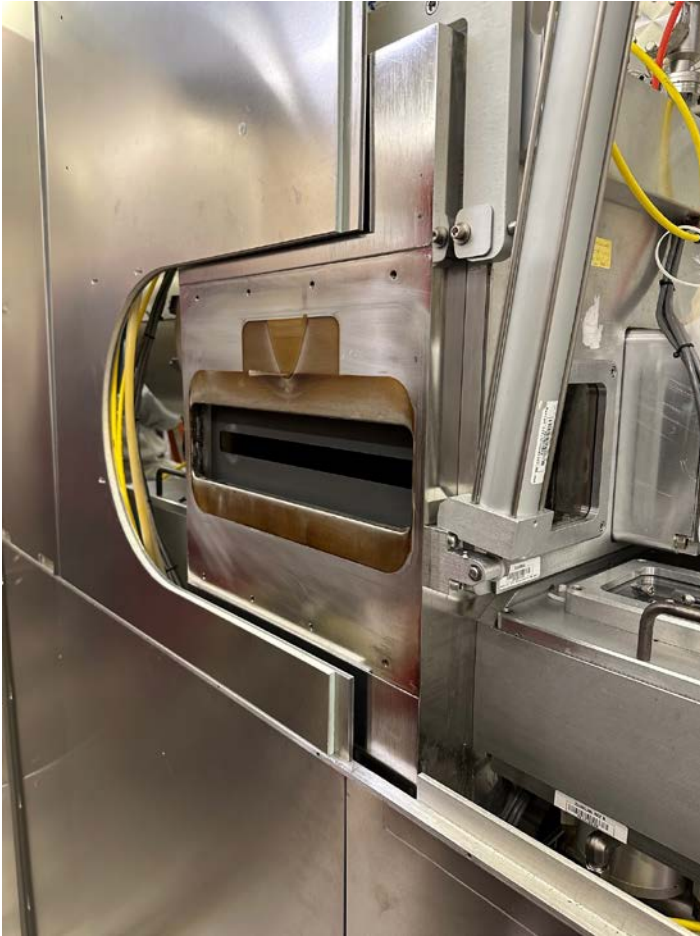
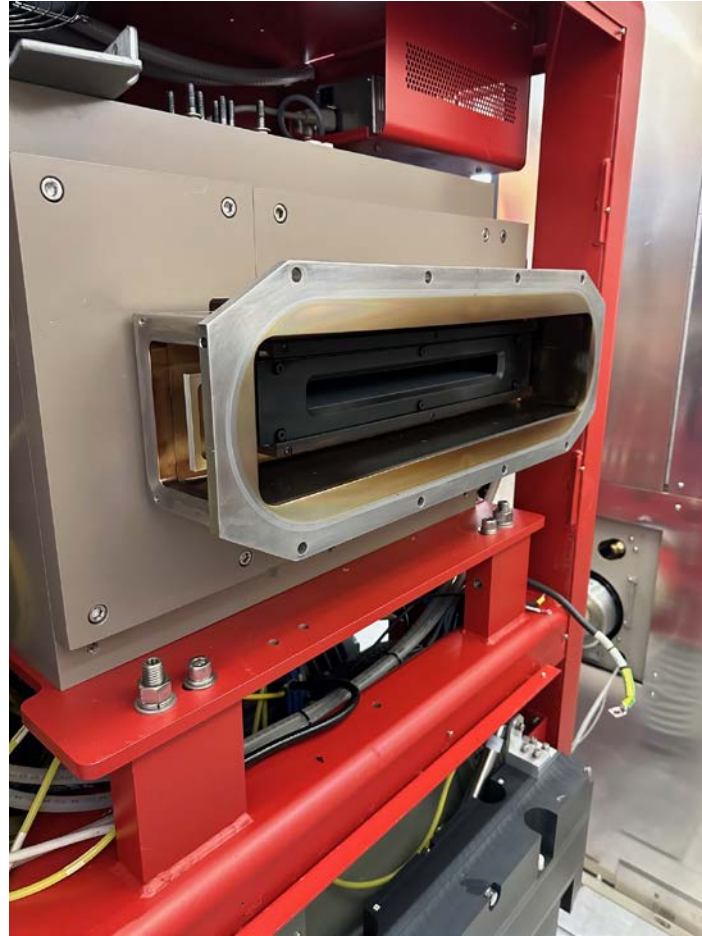
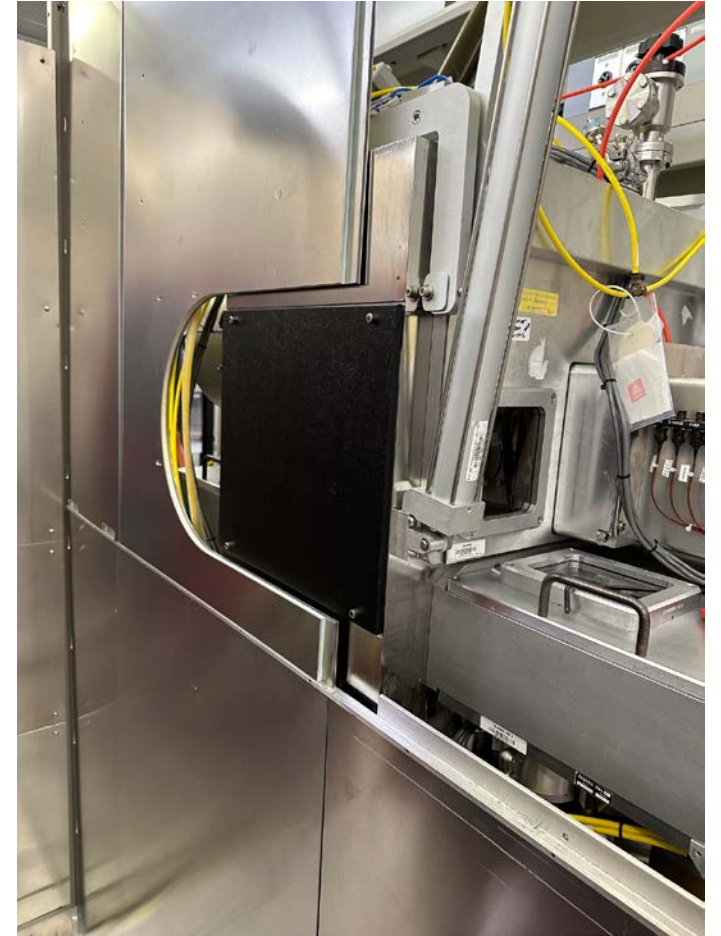
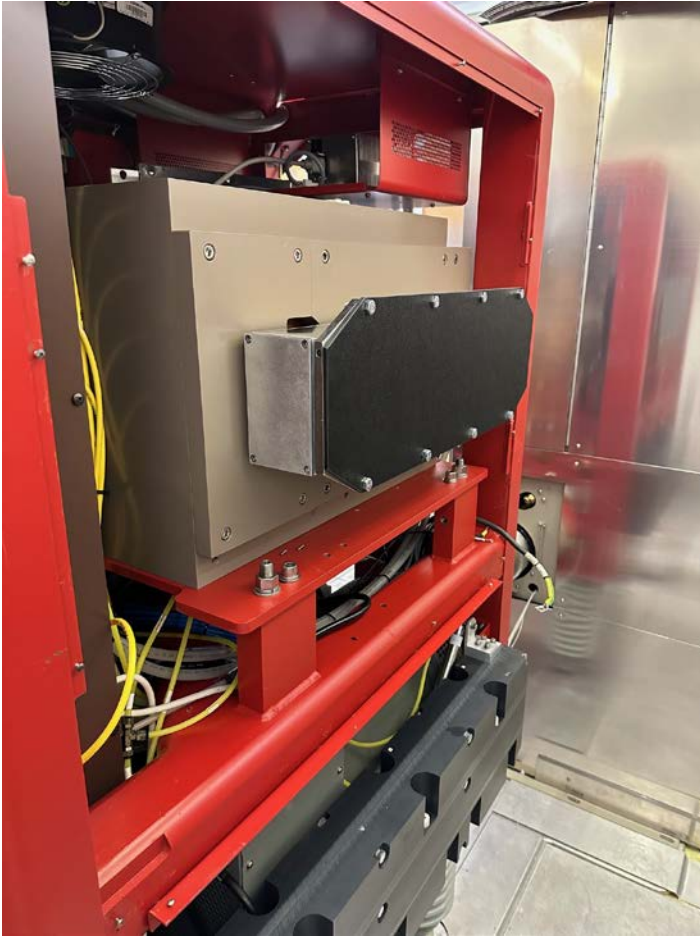
Blanking covers were then used to cover and protect all the vacuum sealing surfaces.

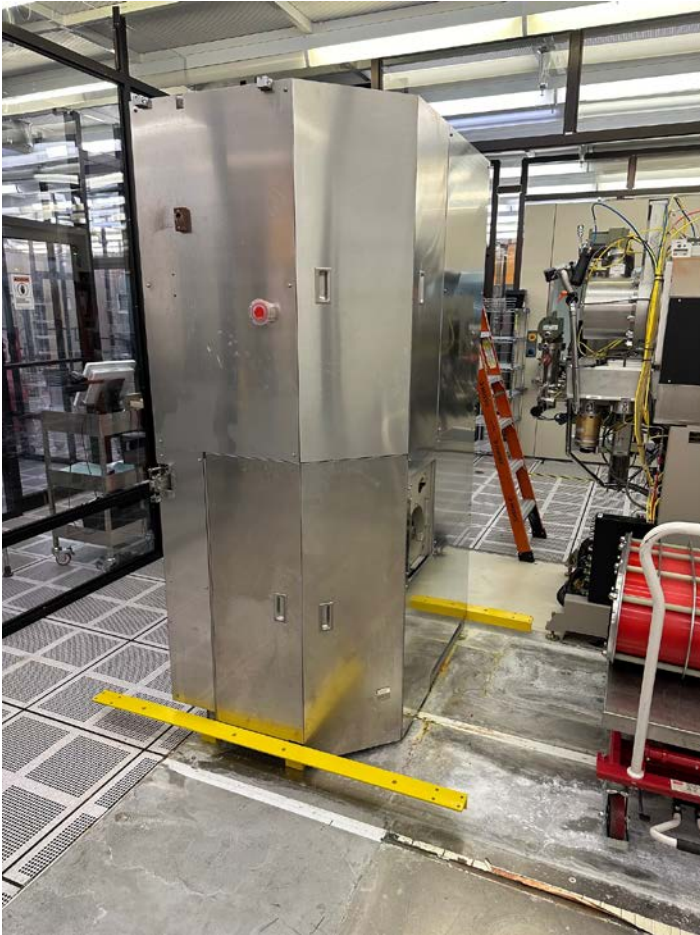
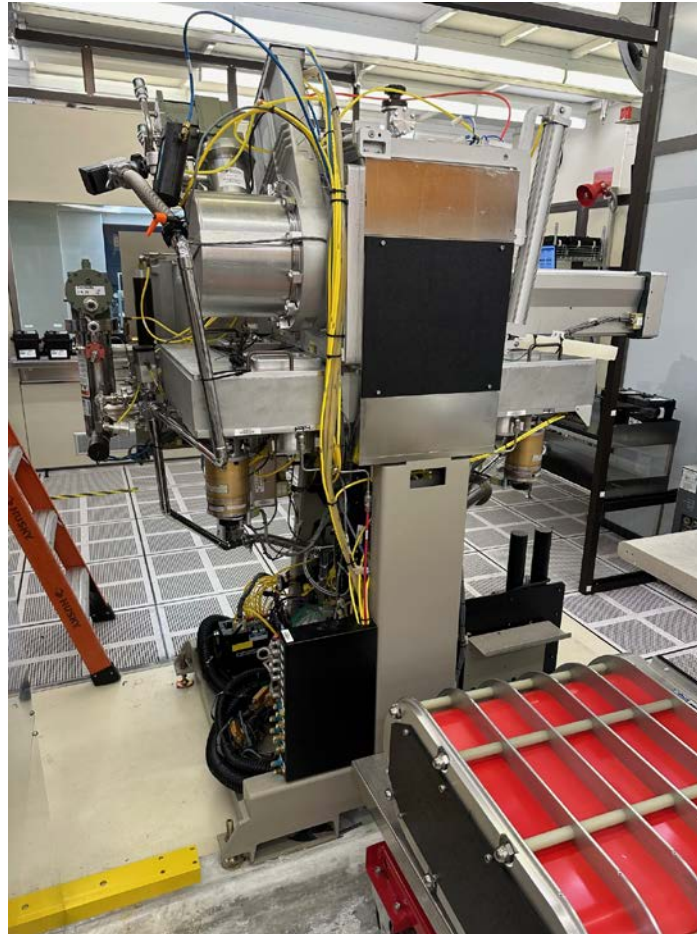
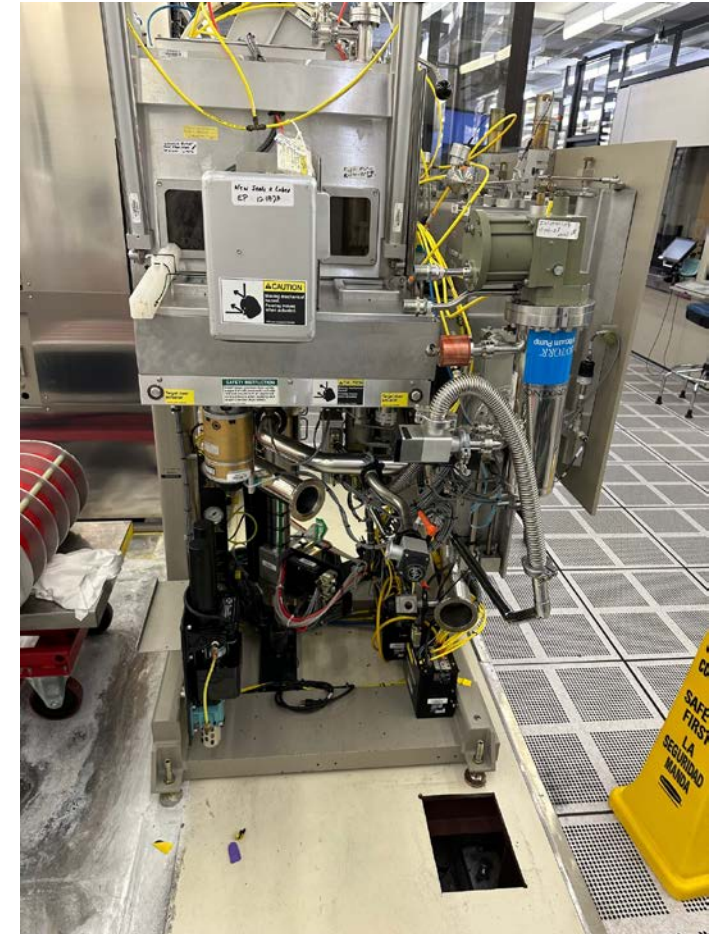
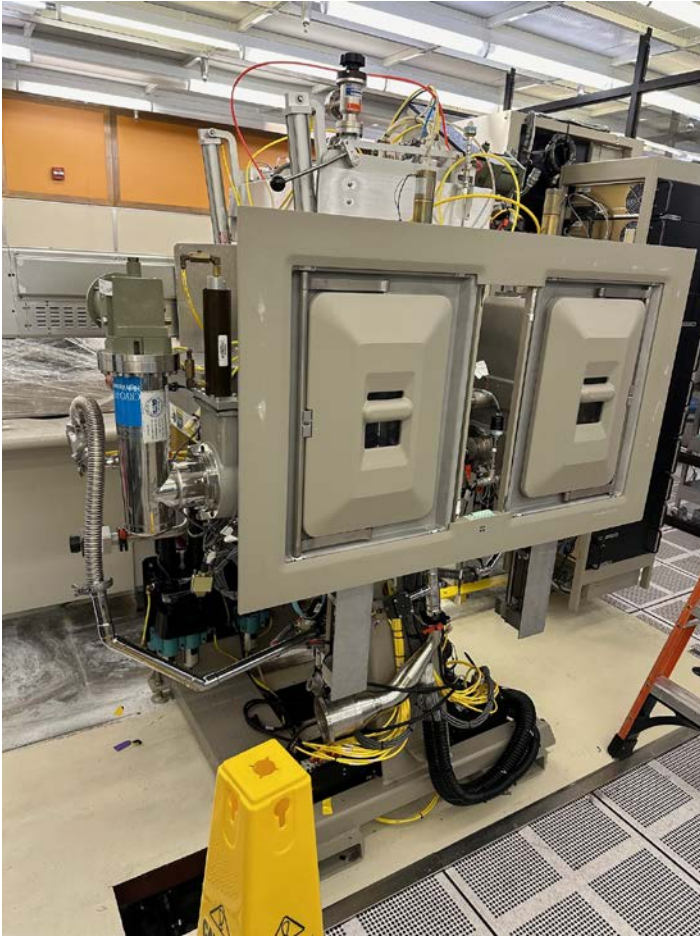
Facilities module was then fitted with its shipping stabilizers.

The remaining modules and assemblies were then cordoned off for removal the following week.

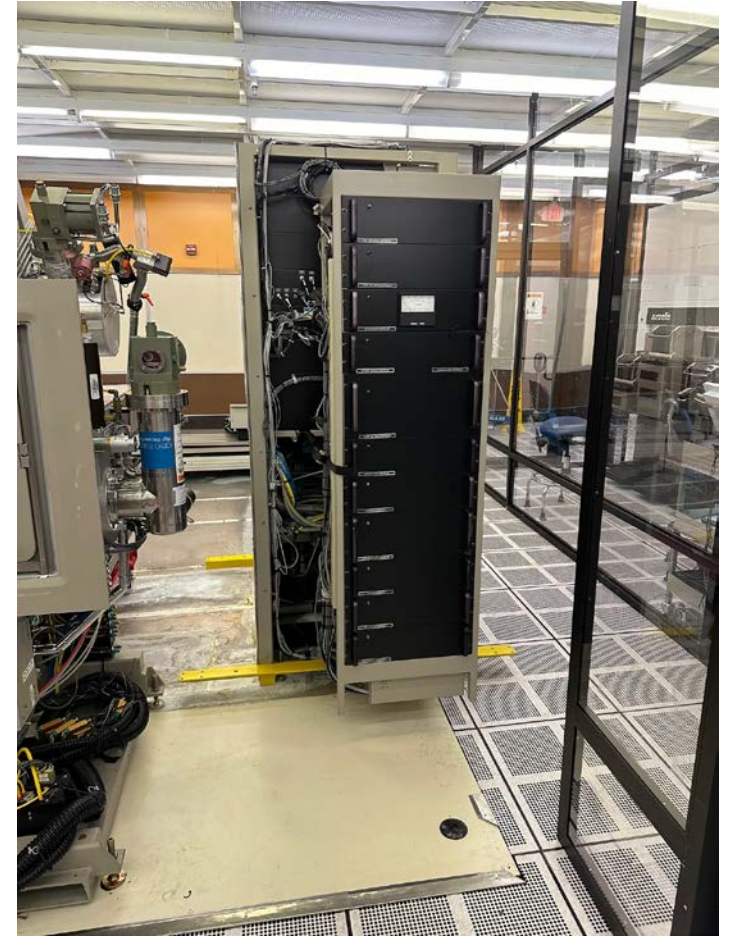
Facilities module was then fitted with its shipping stabilizers.

The remaining modules and assemblies were then cordoned off for removal the following week.

We then left site, happy that the disassembly was complete.
