ULTRASONIC THICKNESS INSPECTION REPORT

RARE OILFIELD

RARE OILFIELD SHOP

JM25433-U2

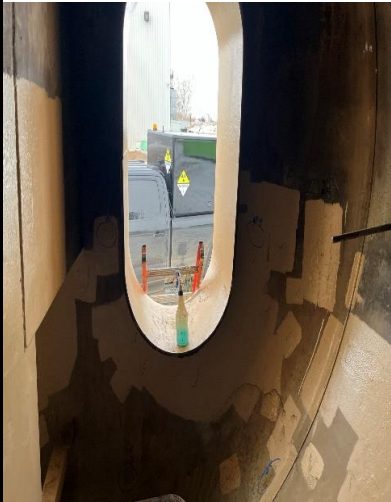
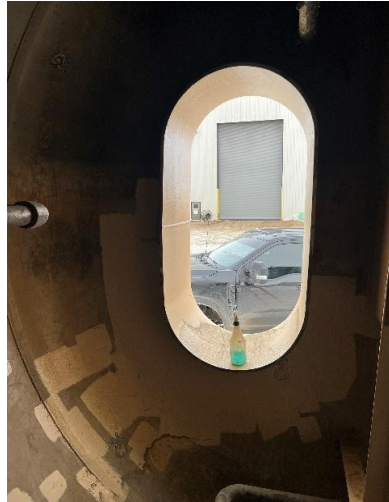
Area Surface Readings: ↓		Nominal Wall Thickness:> 22.23mm		Average Thickness Reading:> 22.35mm		Area Surface Readings: ↓		Nominal Wall Thickness:> 9.53mm		Average Thickness Reading:> 10.67mm	
Location #:	Thickness Min:	Thickness Max:	Location #:	Thickness Min:	Thickness Max:	Location #:	Thickness Min:	Thickness Max:	Location #:	Thickness Min:	Thickness Max:
UT-1	20.75	21.98	UT-6	20.26	20.61	UT-11	10.49	10.65	UT-16	10.44	10.66
UT-2	23.42	23.61	UT-7	21.85	22.35	UT-12	10.62	10.85	UT-17	10.74	10.88
UT-3	22.81	23.51	UT-8	22.64	23.27	UT-13	10.44	10.73	UT-18	10.45	10.69
UT-4	21.95	22.66	UT-9	22.33	22.77	UT-14	10.57	10.88	UT-19	10.79	10.91
UT-5	22.58	22.84	UT-10	22.28	22.65	UT-15	10.68	10.74	UT-20	10.75	10.93

Information On Above: ↓ Material:> Carbon Steel Surface Condition:> Painted / Coated

THICKNESS INSPECTION ON RANDOM POINTS OF HEAD.

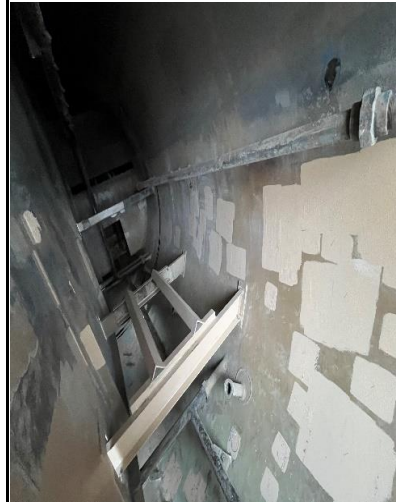
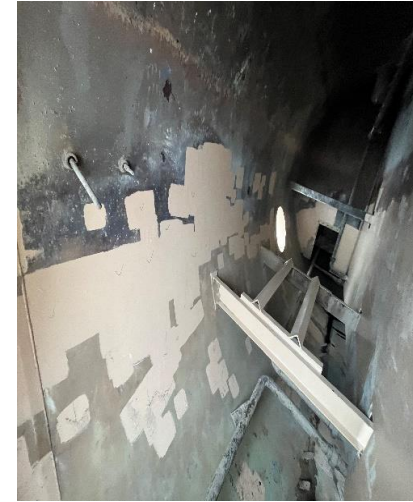
Information On Above: ↓ Material:> Carbon Steel Surface Condition:> Painted / Coated

THICKNESS INSPECTION ON RANDOM POINTS OF SHELL.

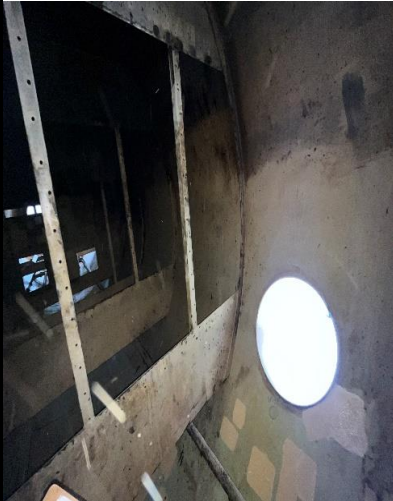
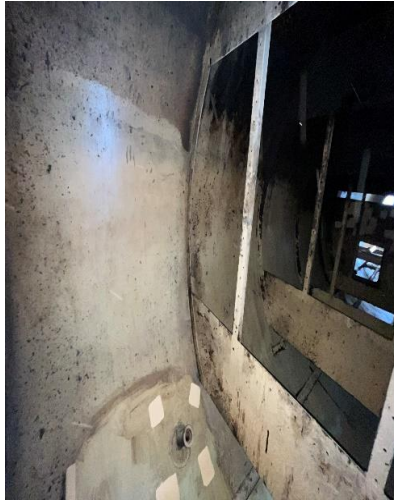
Area Surface Readings: ↓		Nominal Wall Thickness:> 9.53mm		Average Thickness Reading:> 10.59mm		Area Surface Readings: ↓		Nominal Wall Thickness:> 12.70mm		Average Thickness Reading:> 12.76mm	
Location #:	Thickness Min:	Thickness Max:	Location #:	Thickness Min:	Thickness Max:	Location #:	Thickness Min:	Thickness Max:	Location #:	Thickness Min:	Thickness Max:
UT-21	10.75	10.91	UT-26	10.25	10.45	UT-31	12.65	12.81			
UT-22	10.48	10.52	UT-27	10.47	10.59	UT-32	12.87	13.12			
UT-23	10.72	10.93	UT-28	10.39	10.52	UT-33	12.51	12.88			
UT-24	10.33	10.58	UT-29	10.75	10.88	UT-34	12.44	12.74			
UT-25	10.65	10.85	UT-30	10.35	10.45	UT-35	12.69	12.86

Information On Above: ↓ Material:> Carbon Steel Surface Condition:> Painted / Coated

THICKNESS INSPECTION ON RANDOM POINTS OF SHELL.
