DOCUMENT NUMBER	REVISION #	APPROVAL DATE:
	FRM-12004	1	09/03/12
			EFFECTIVE DATE:
TITLE:	Ultrasonic Thickness Examination Report	SOP(s) #: SOP-12004	09/07/12

Customer: Tri-Logic Service	Date: 06/10/21
Address: 555 Cannelton Rd., Darlington, PA	PO #: N/A
Unit Description: Sand Trap	
Work Order #: 1129-05	Manuf. Serial #1C021-17

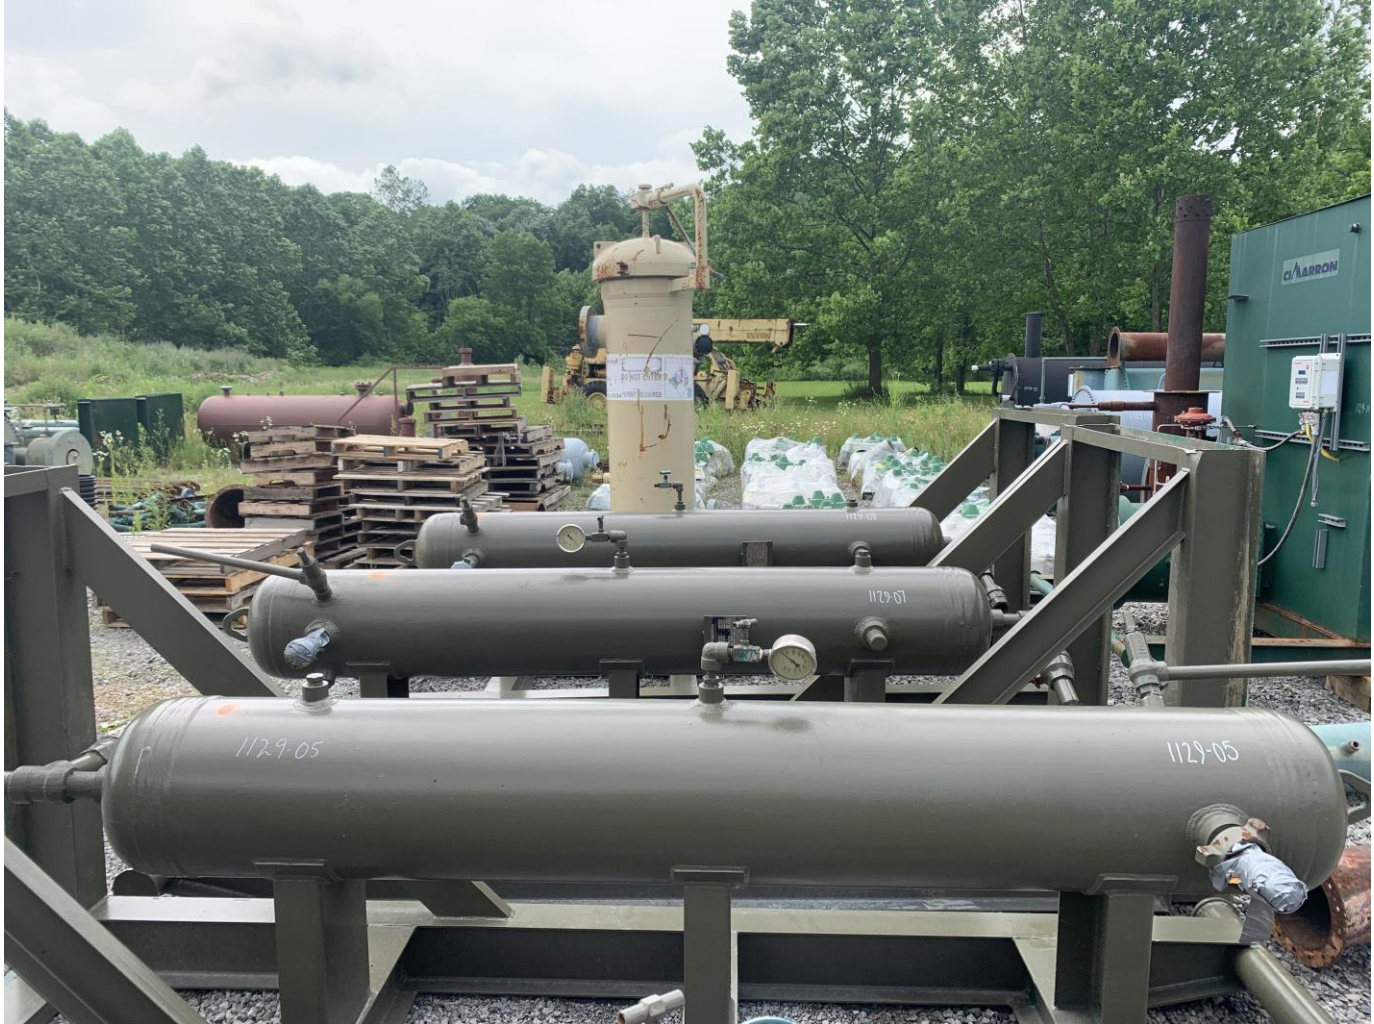
Overall

General Location	Specific Location	Rotational Location	Nominal Diameter (in.)	Lowest Measurement (in.)
Inlet	A1	0 deg	2	0.745
Inlet	A2	90 deg	2	0.736
Inlet	A3	180 deg	2	0.761
Inlet	A4	270 deg	2	0.745
Shell	B1	180 deg	24	1.454
Shell	B2	180 deg	24	1.399
Shell	B3	180 deg	24	1.408
Shell	B4	180 deg	24	1.485
Shell	C1	0 deg	24	1.429
Shell	C2	90 deg	24	1.479
Shell	C3	180 deg	24	1.469
Shell	C4	270 deg	24	1.425
Drain	E1	0 deg	2	0.738
Drain	E2	90 deg	2	0.753
Drain	E3	180 deg	2	0.745
Drain	E4	270 deg	2	0.748
Outlet	F1	0 deg	2	0.714
Outlet	F2	90 deg	2	0.728
Outlet	F3	180 deg	2	0.746
Outlet	F4	270 deg	2	0.765
