API 653 ABOVE GROUND STORAGE TANK INTERNAL AND EXTERNAL INSPECTION REPORT

TANK SERIAL # STTK-QI-T1-15643

DATE: JULY 8 / 2025

NEXTGEN JOB # 18248

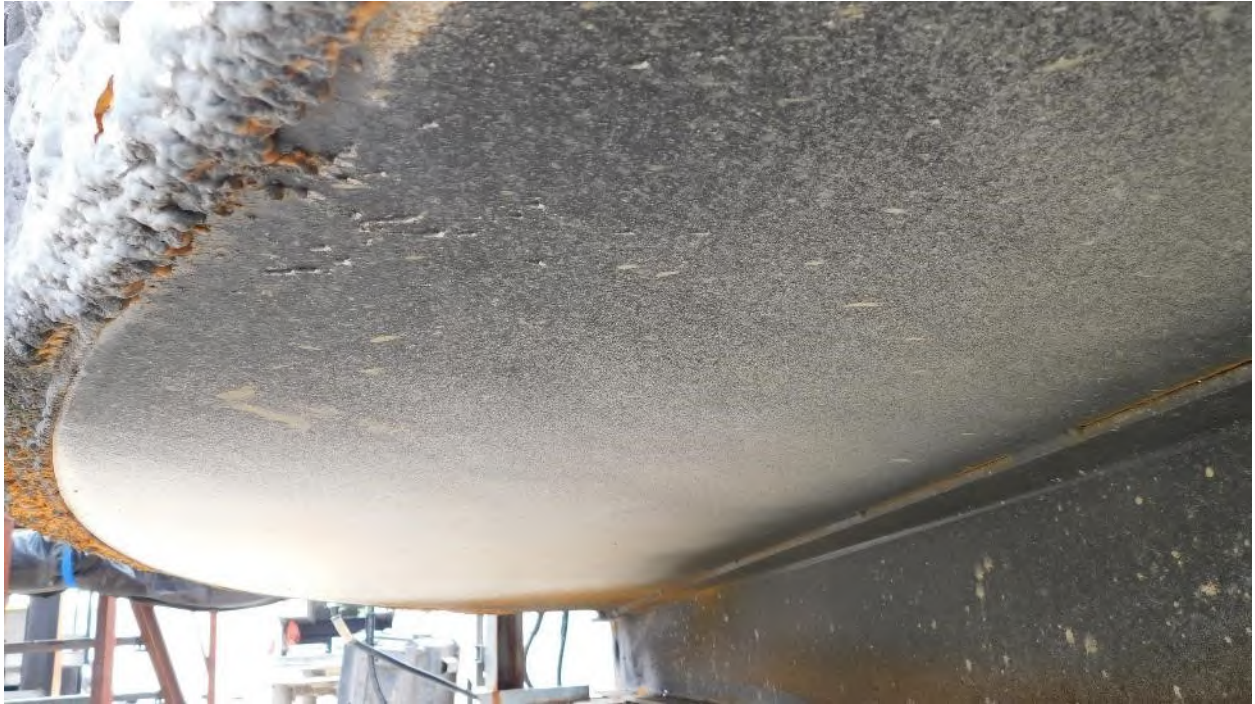
- 1.1.1 A visual examination was performed on the bottom plate externally. The tank was observed to be placed on I-beams resting on elevated piles. The underside of the bottom plate was observed to be coated and in acceptable condition.

Photograph 13: Bottom Plate Underside View

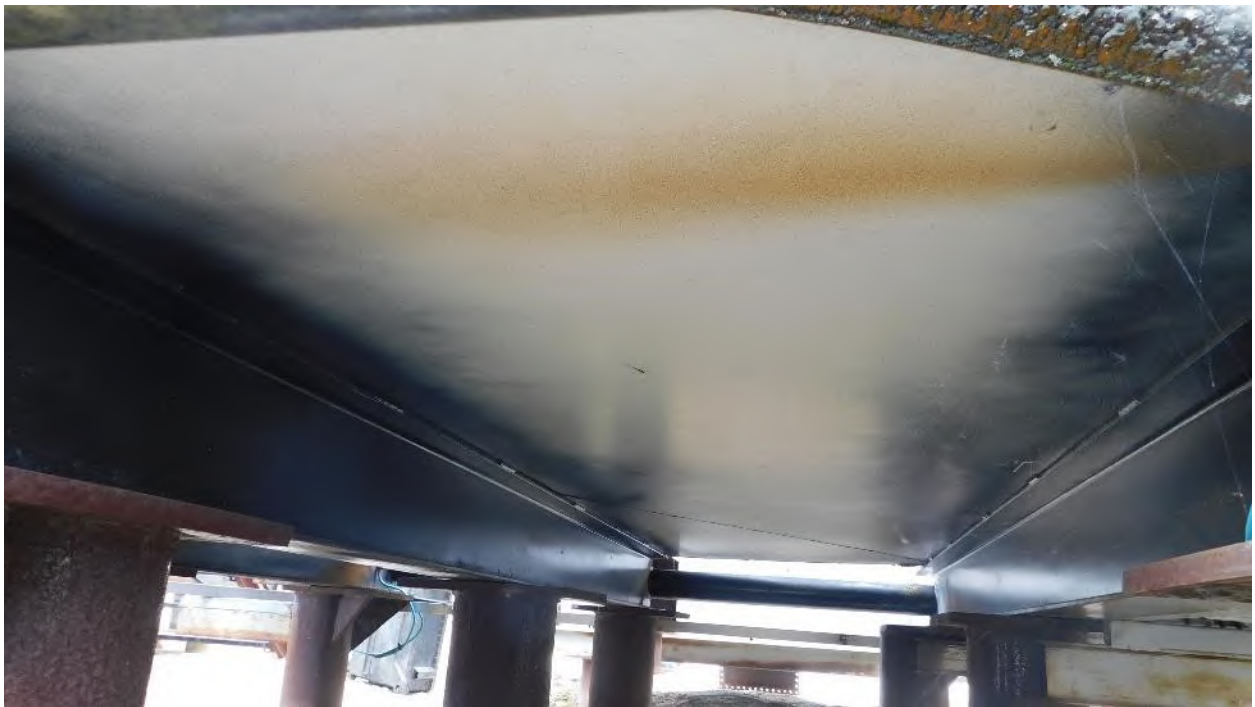
Photograph 14: Bottom Plate Underside View

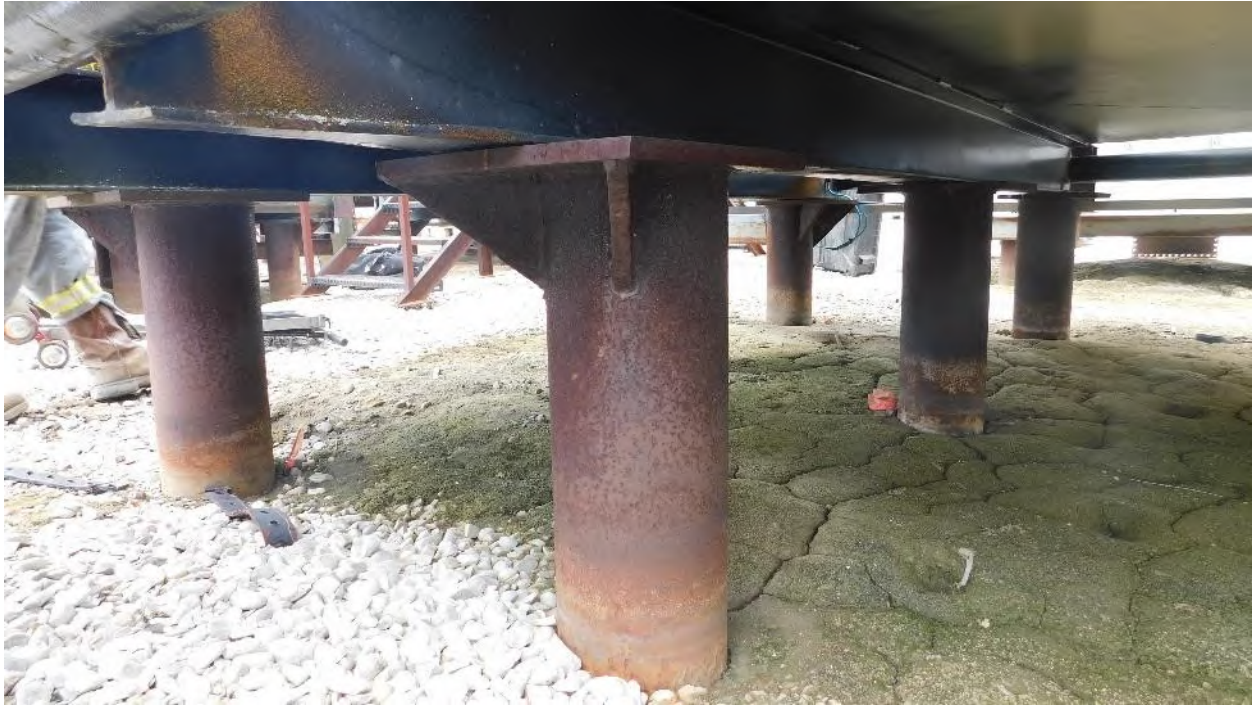
Photograph 15: Tank Resting on Piles and I Beam Structural Steel

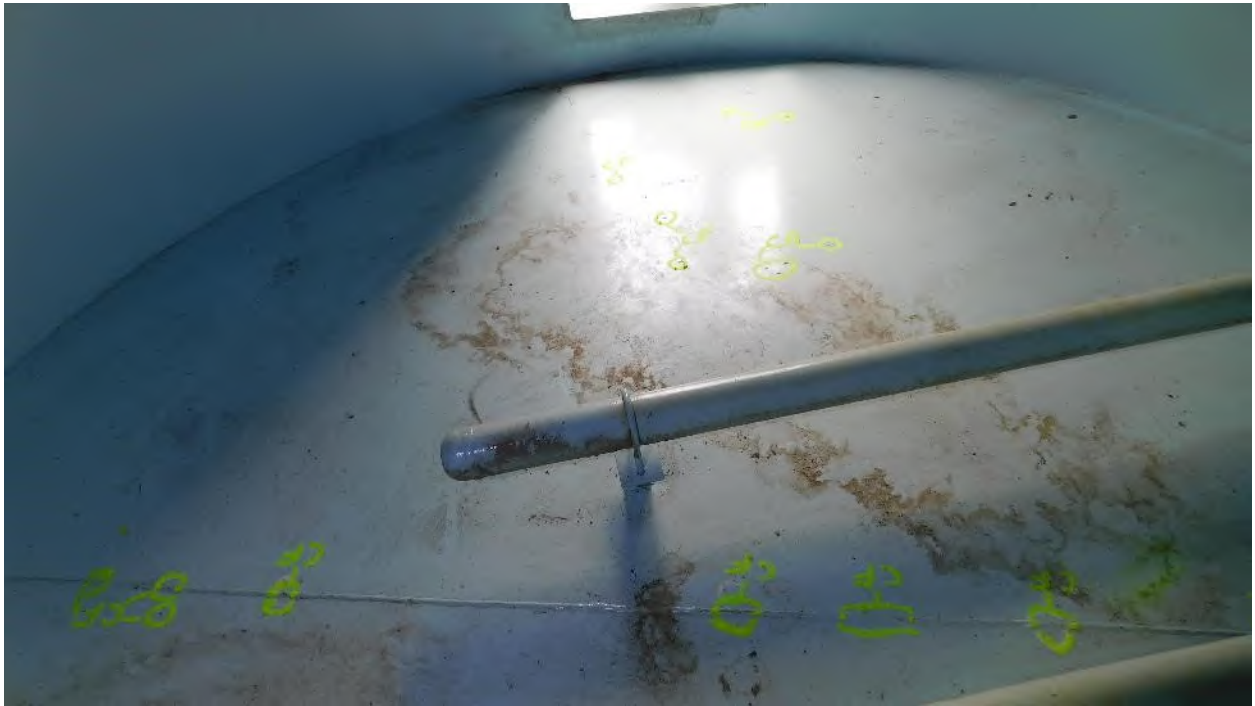
- 1.1.2 Internally, the visual examination was limited due to the product residue on the floor. The bottom plate was observed to be epoxy coated. Eight (8) coating failures was observed on the bottom plate and seven (7) on the bottom weld. Refer to Bottom Plate Layout Drawing for additional details.

Photograph 19: Internal Bottom Plate Overview

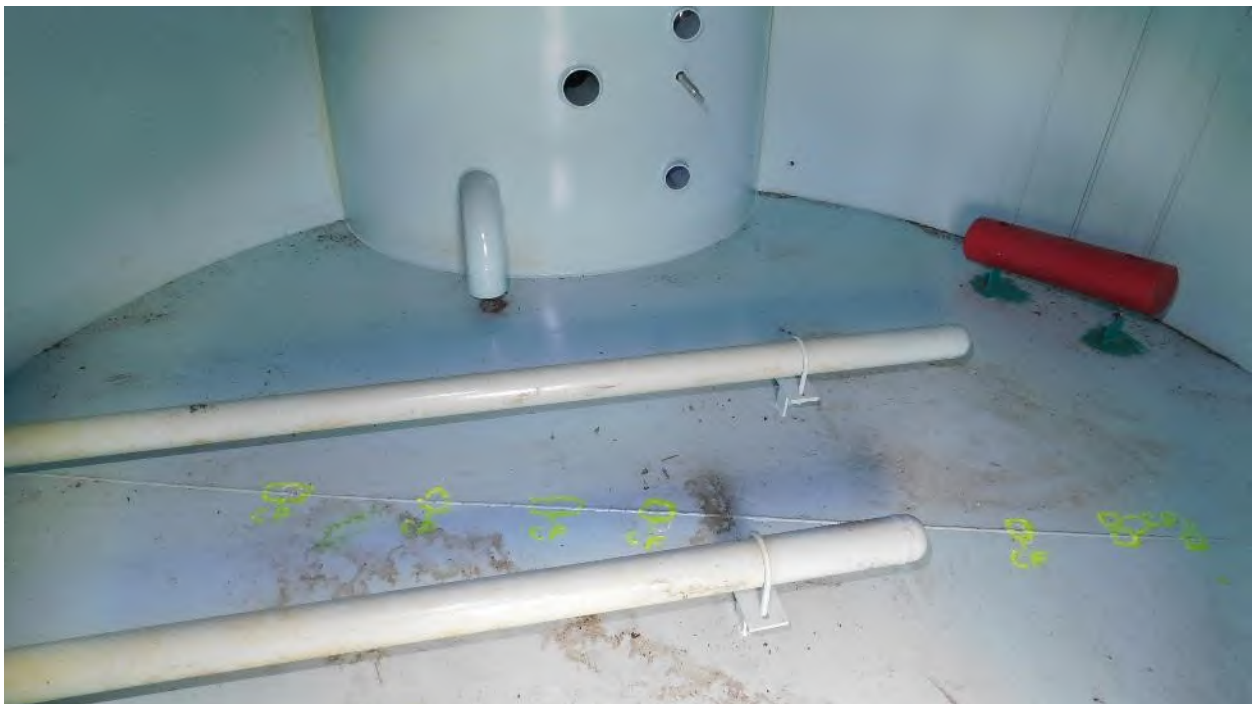
Photograph 20: Internal Bottom Plate Overview

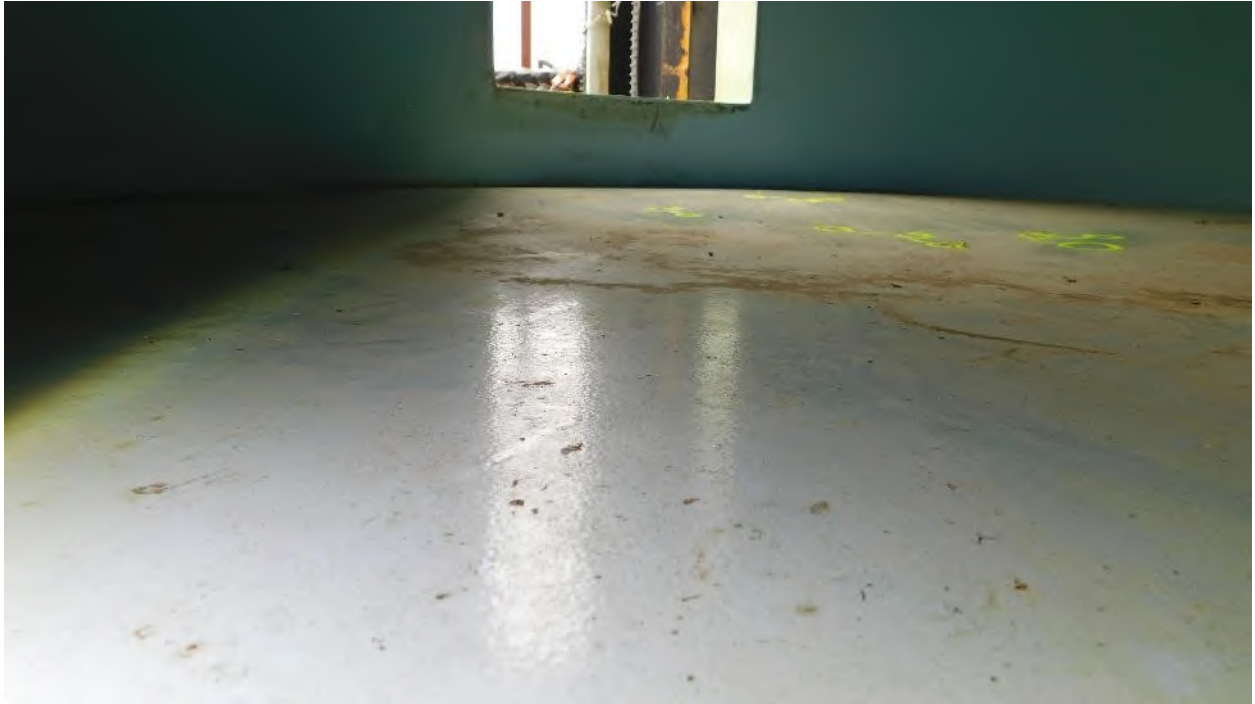
- 1.1.3 Random ultrasonic thickness (UT) measurements were taken on the bottom plate. Five (5) readings were recorded per plate. No material loss was observed. The minimum reading found was 0.248 inch with a nominal thickness of 0.250 inch. Refer to Bottom Plate Layout Drawing for additional details.

Photograph 31: Bottom Plate Profile

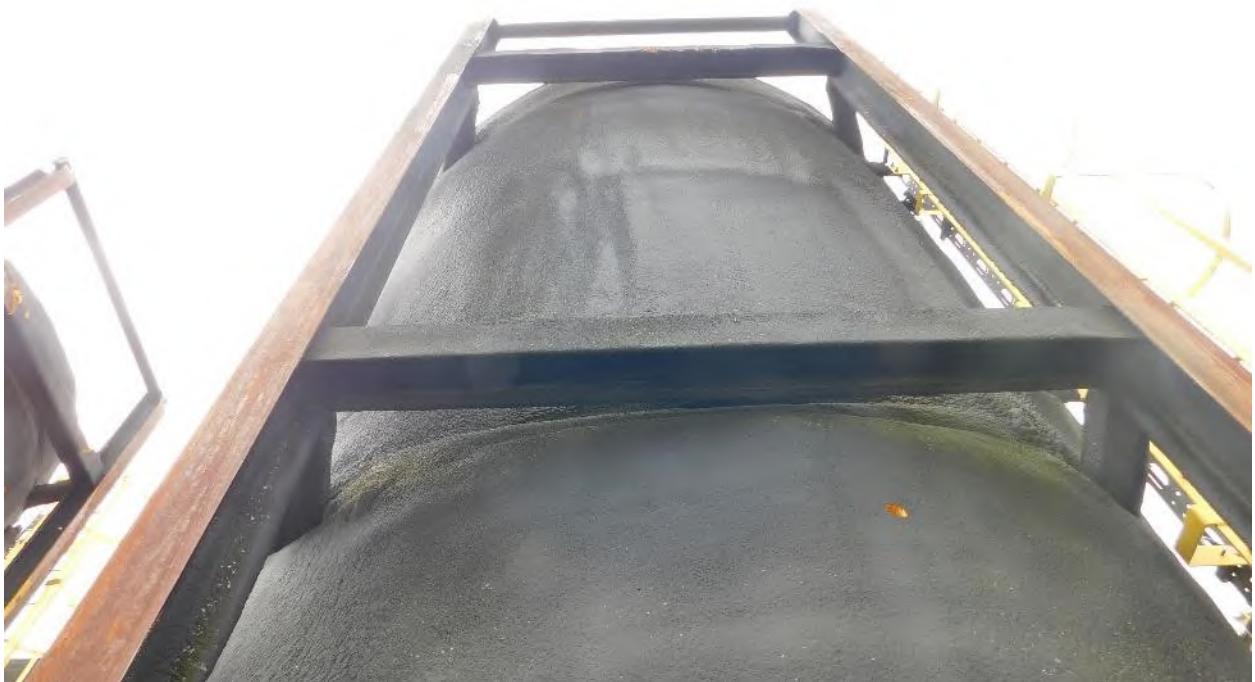
Photograph 37: External Shell Overview

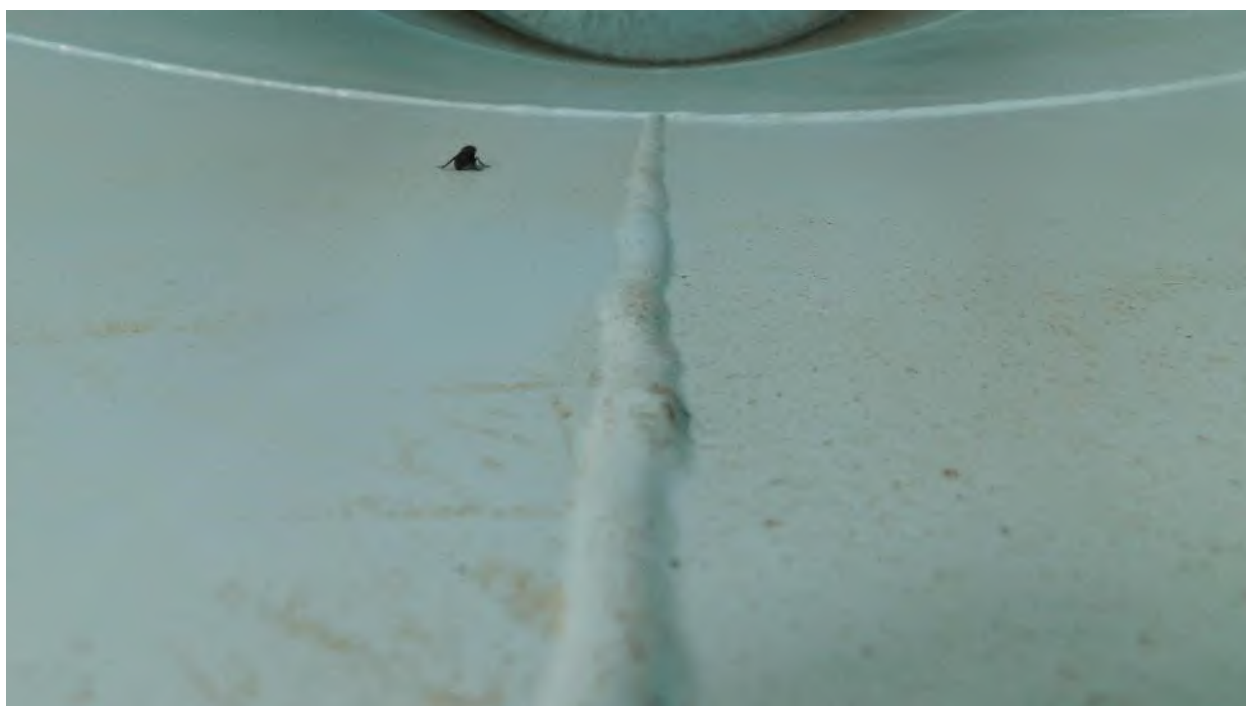
Photograph 43: Shell Butt Vertical Weld Profile

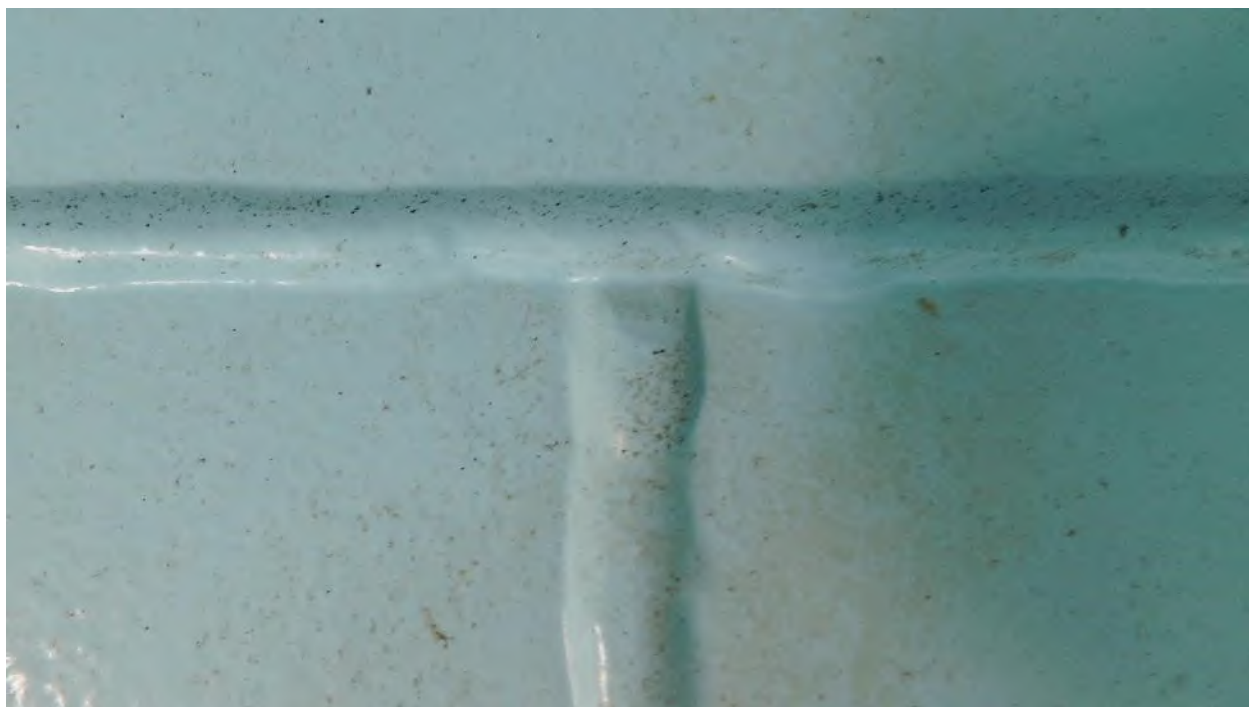
Photograph 44: Shell Butt Weld Detail

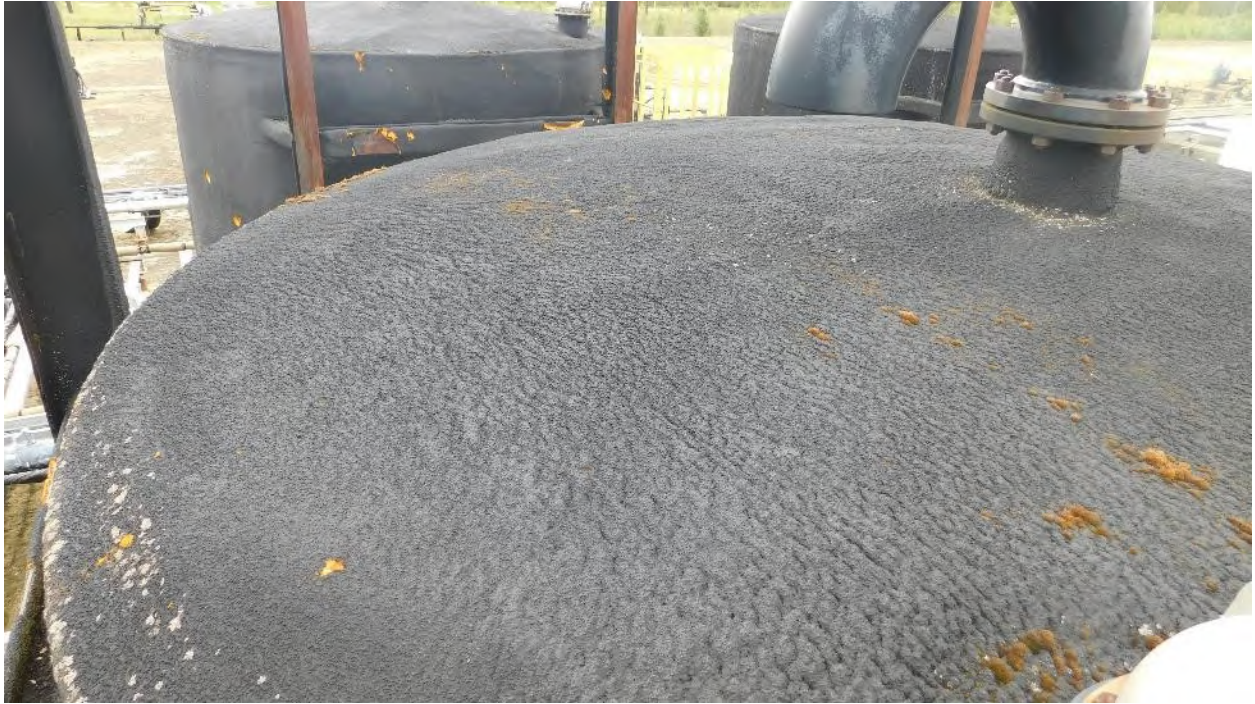
Photograph 64: External Fixed Roof Overview

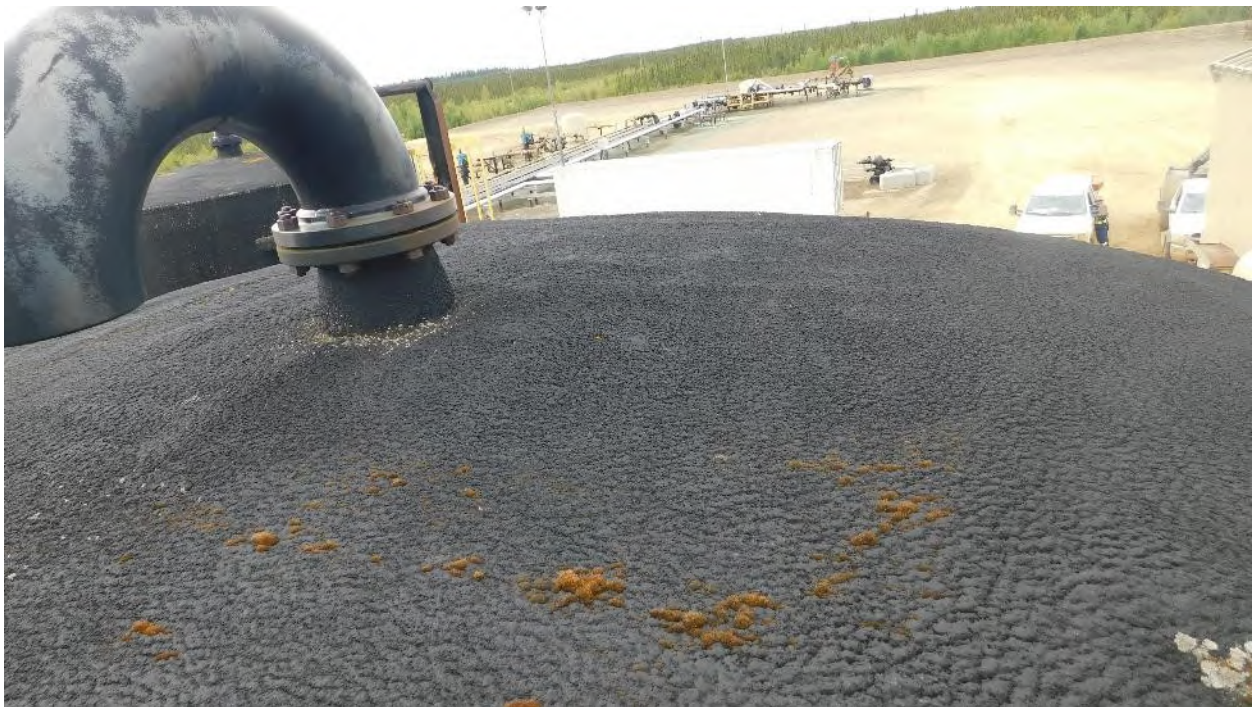
Photograph 65: External Fixed Roof Overview

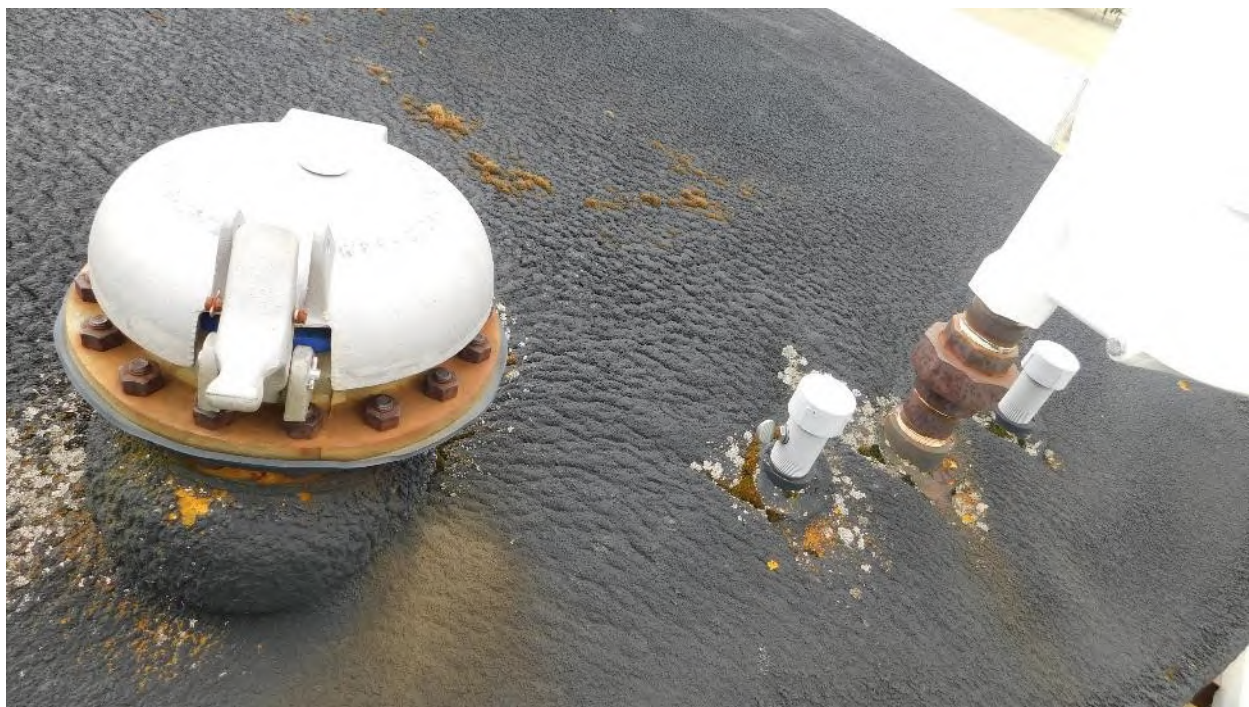
Photograph 66: External Fixed Roof Nozzles Overview

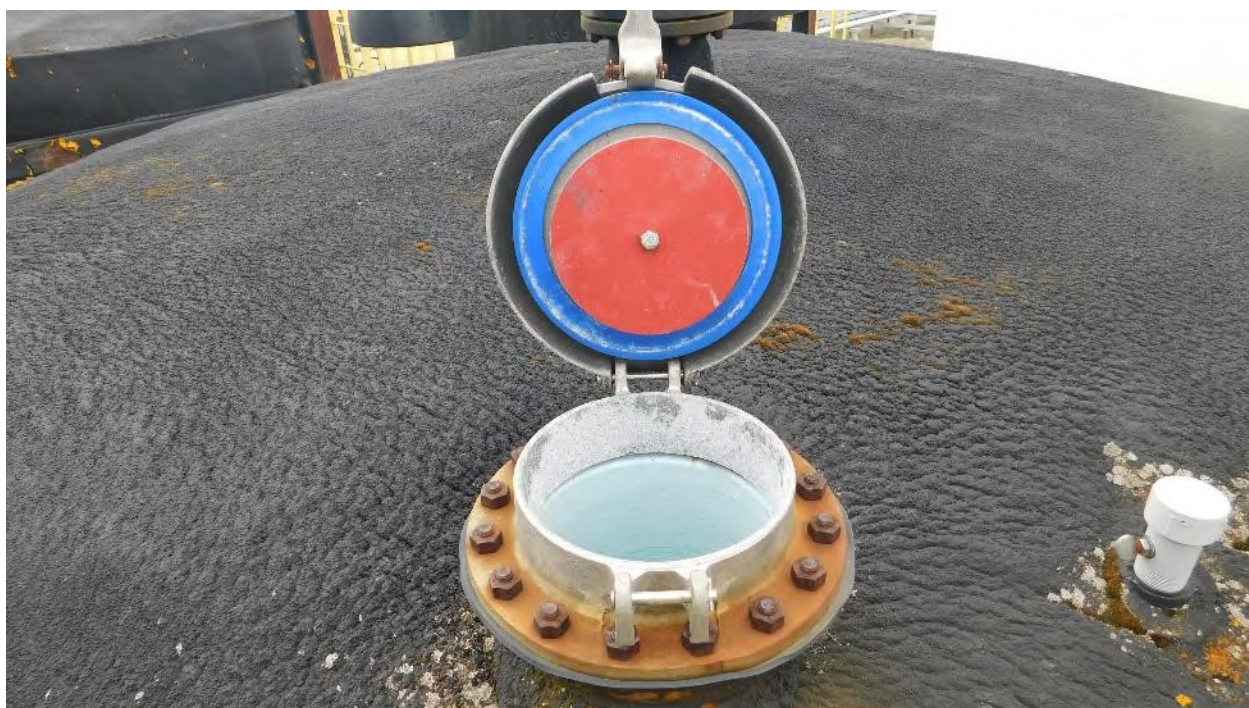
25.	Inspect sample hatch for corrosion	Acceptable condition	
26.	Check that the cover operates properly	Acceptable condition	
27.	If the tank has no gauge well, check for a hold off distance marker	N/A	
Roof Insulation		Condition	Comments

Photograph 67: Gauge Hatch Detail

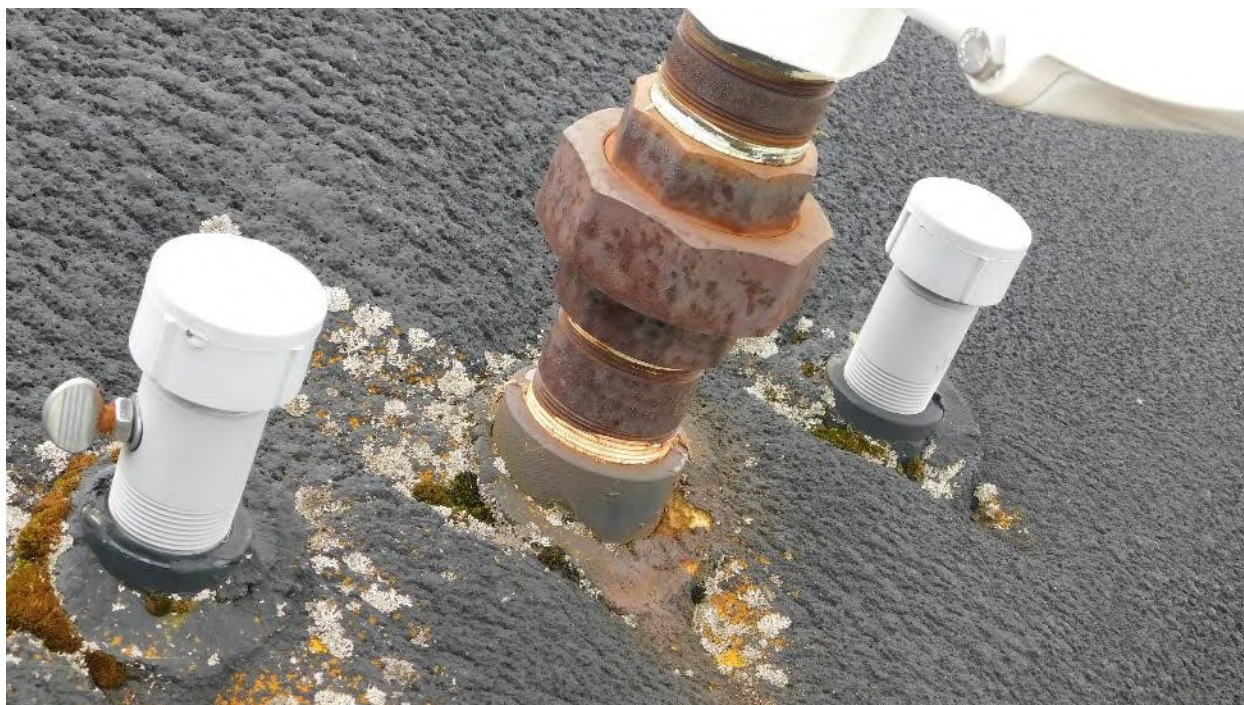
28.	Visually inspect for cracks or leaks in the insulation weather coat where runoff rainwater could penetrate the insulation.	Acceptable condition	Moss growth present in some areas

29.	Inspect for wet insulation under the weather coat	Unsatisfactory condition	Moss growth present in some areas
30.	Remove small test sections of insulation and check roof plate for corrosion and holes near areas susceptible to water ingress	N/A

Photograph 70: Fixed Roof Gauge Board Threaded Nozzles – Moss Growth

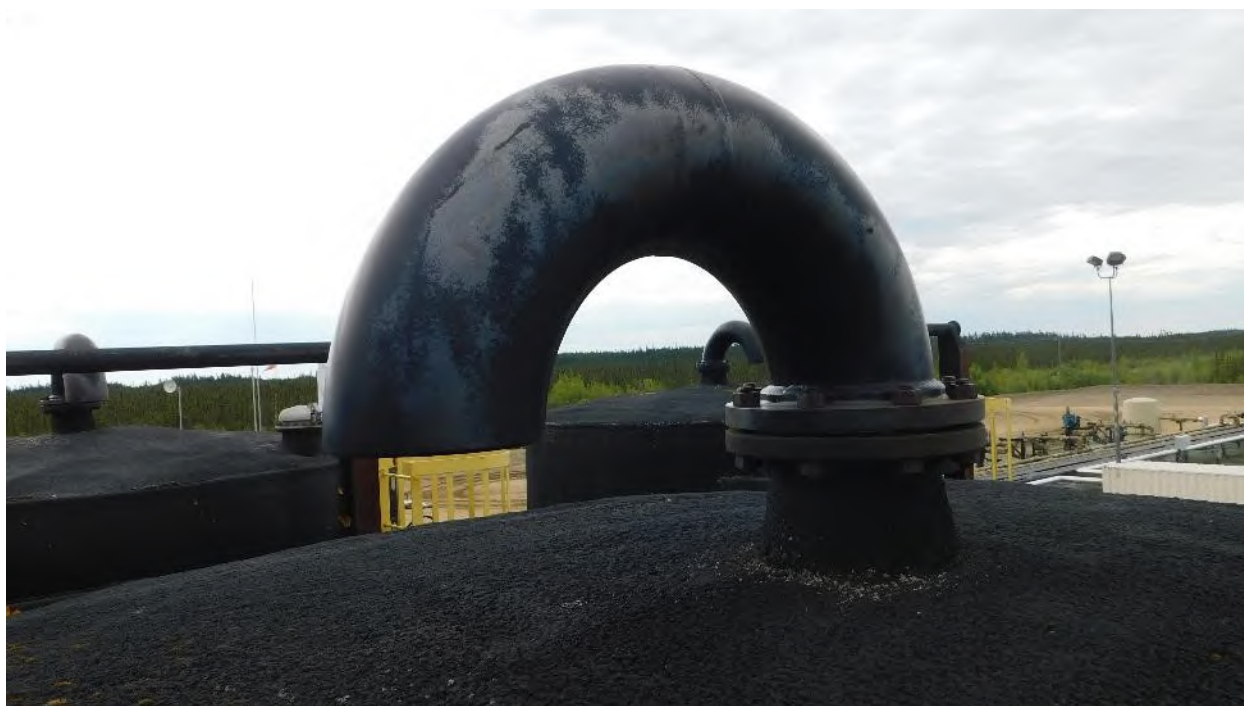
Photograph 71: Gooseneck Vent Overview

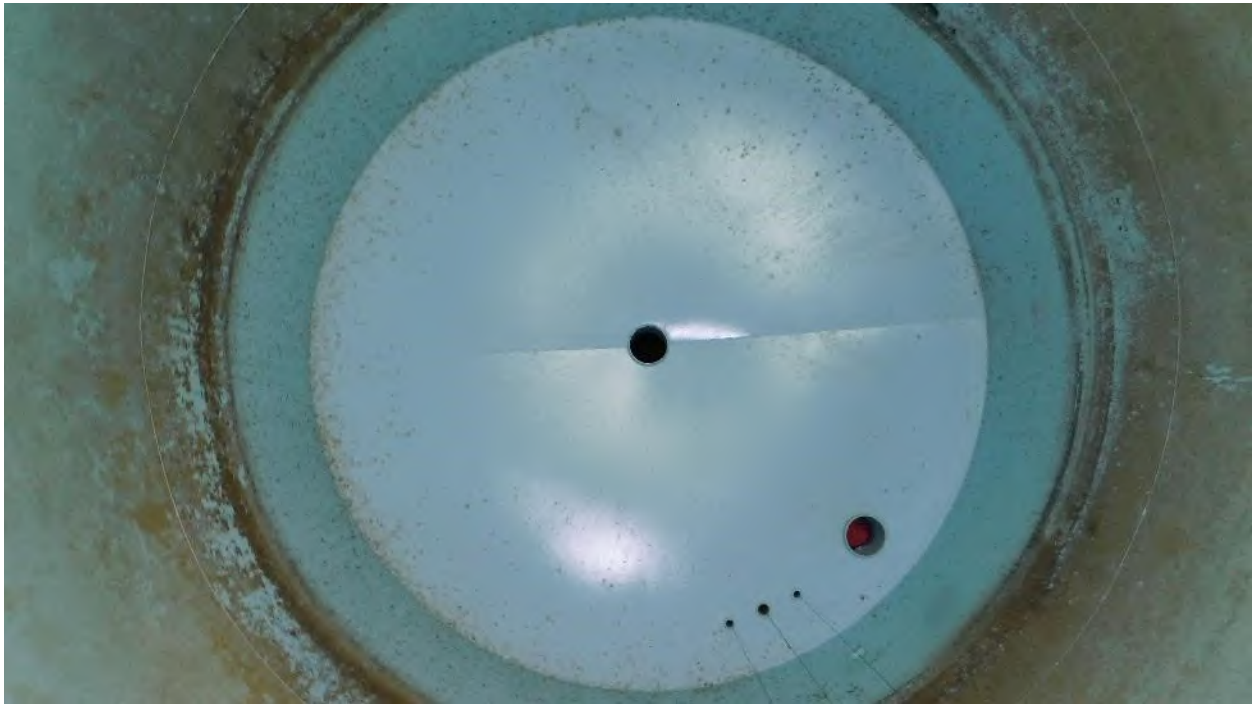
Photograph 74: Fixed Roof Internal View
